HOME INSPECTION REPORT

205 H St SE
Auburn WA 98002

Tom Helm
NOVEMBER 25, 2019

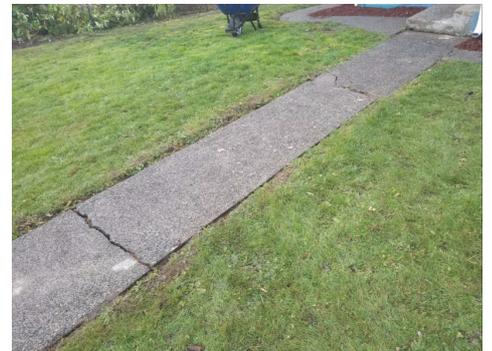
3.2.1 Driveway, Walkways & Patio

CRACKS IN WALKWAYS

There are a few cracks in the walkways around the residence that are mostly cosmetic. We suggest you view these yourself and repair as necessary.

Contact a qualified professional.

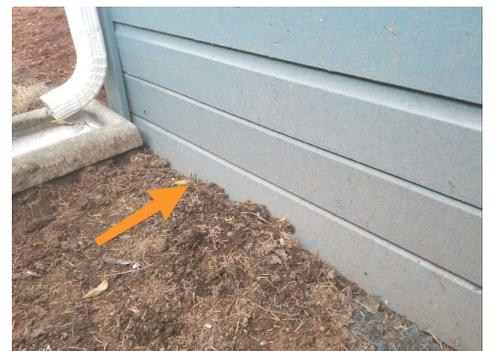
3.3.1 Site & Other Observations

WOOD TO EARTH CONTACT

Contact a qualified professional.

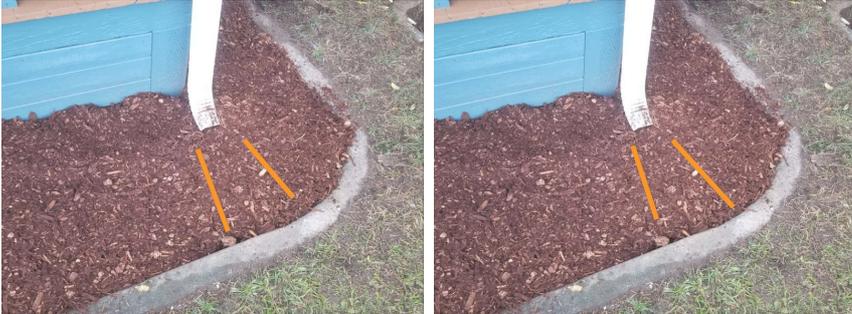
3.9.1 Downspouts

DOWNSPOUTS MISSING COMPONENTS

The downspouts are missing parts. (splashblocks) Recommend repairs to allow for proper drainage away from the structure.

Contact a qualified professional.

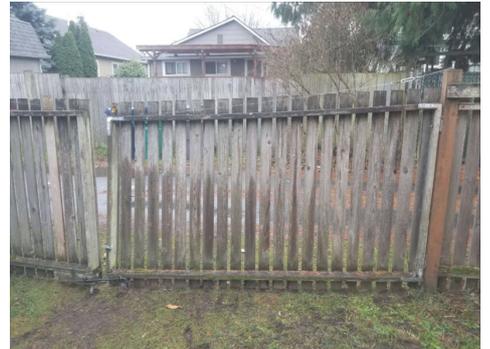
3.12.1 Fences & Gates

GATE NEEDS ADJUSTMENT / REPAIR

A gate needs adjustment or repair to operate smoothly. Recommend repair by a qualified professional.

Contact a qualified professional.

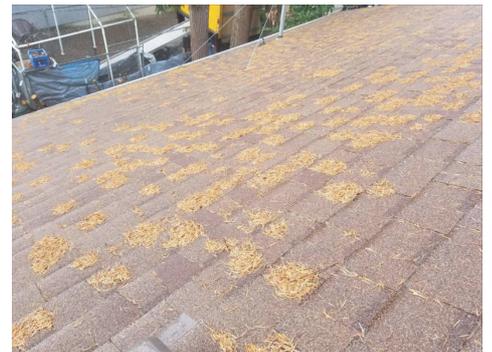
ROOF NEEDS CLEANING OF TREE DEBRIS

The roof needs to be cleaned of tree debris build-up (leaves, sticks etc) to help prevent holding moisture on the roof which can lead to moisture intrusion.

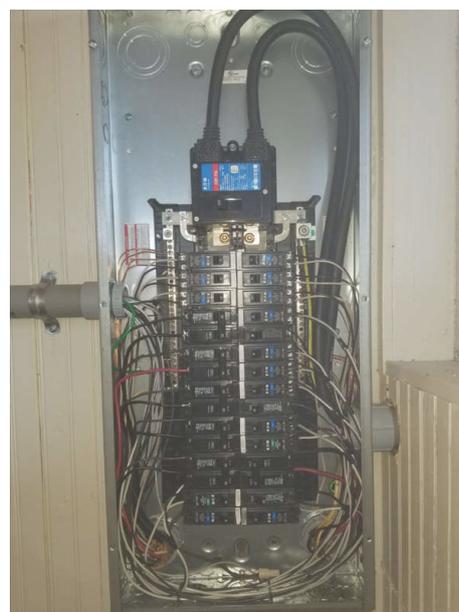
Panel Size, Location & Photo: Panel Amps, Location and Picture

Rear, Inside, 200 AMP

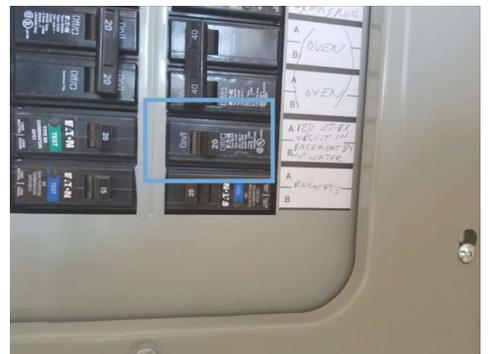
5.6.1 Circuit Breakers

One or more circuit breakers were in the off position. Washington State law prohibits us from turning on these Breakers. Recommended testing all circuits and connected appliances once these Breakers are turned on.

Contact a qualified professional.

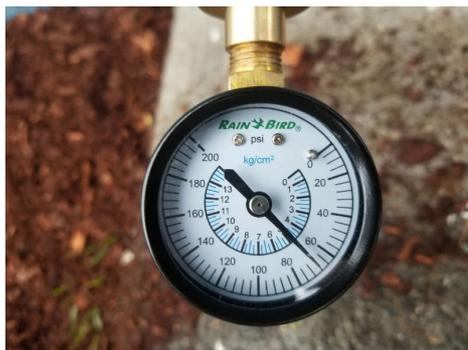
Main Water Shut-Off, Distribution & Supply: House Pressure PICTURE-Acceptable

The pressure at the street was within industry standards, between 40 and 80 and a regulator is not required on the plumbing system.

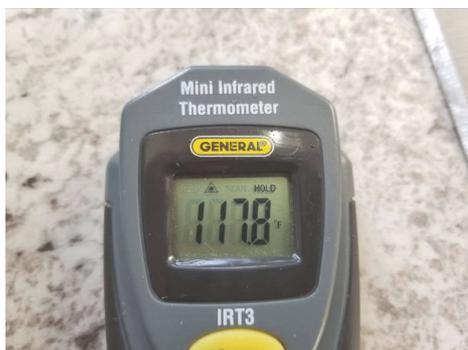
Sink and Faucet: Water temp

The Water temp at the Kitchen Faucet is Currently noted in the photo below. The U.S. Consumer Product Safety Commission (CPSC) urges all users to keep their water heater temps at 120 degrees Fahrenheit to prevent scalding and bacteria prevention reasons.

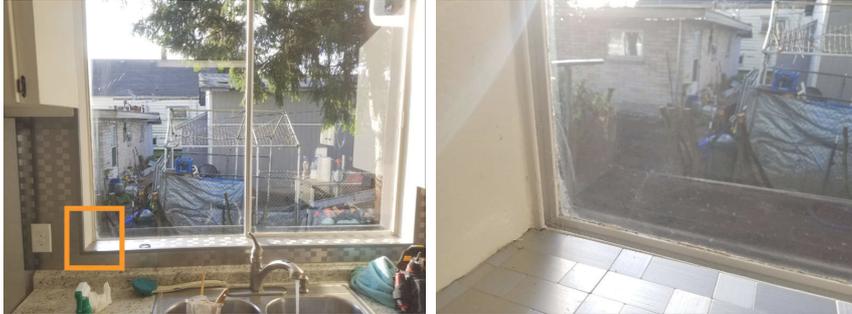
WINDOW IS CRACKED

A window is cracked or broken and recommended to be serviced or replaced as necessary by a qualified technician.

Contact a qualified window repair/installation contractor.

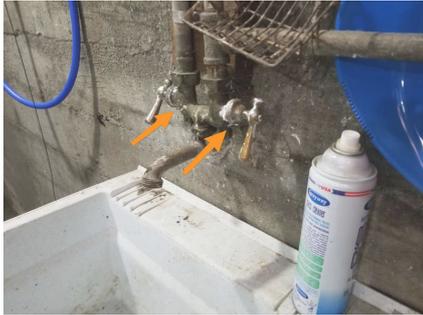
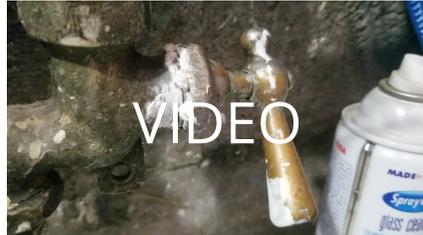
Medium Priority**FAUCET LEAKS AROUND THE VALVE**

The laundry sink faucet leaks around the valve while in use, which is indicative of a defective seal, and should be repaired or replaced as necessary.

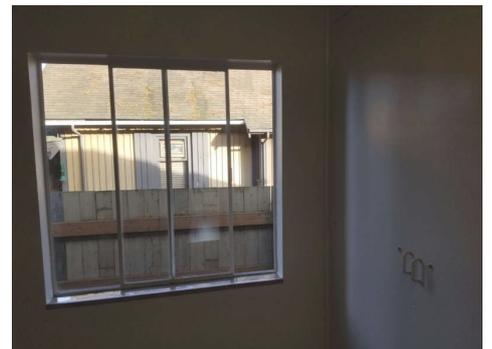
SCREENS DAMAGED/MISSING

Window screens were missing or damaged in one or more areas. We recommend repair or replacement as needed.

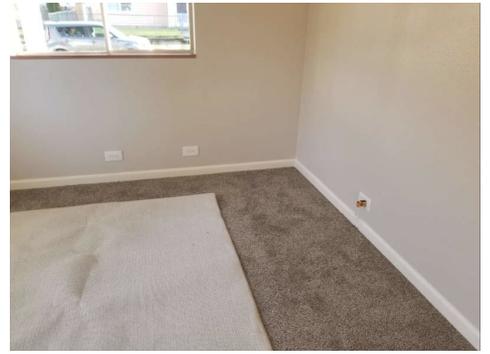
12.11.1 Outlets, Electrical

UNGROUND outlets

Several of the Interior Outlets are ungrounded. This is common in older homes. Grounding all Outlets would be a beneficial and recommended update.

Contact a qualified electrical contractor.

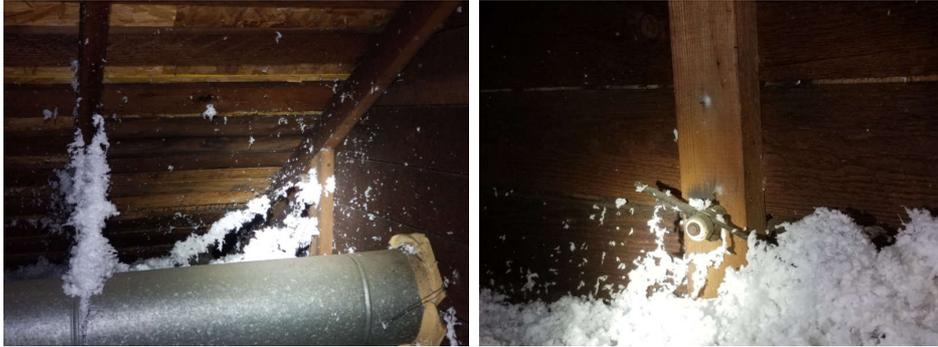
Electrical Notes: Knob & Tube Wiring

This home is equipped with the knob & tube wiring, in the attic, which is very common in older homes. Knob & tube wiring is not necessarily a defect due to being be old, but if it has been modified improperly it can pose hazards. We recommend that you consult your insurance company about having this type of wiring and can the home be insured due to this type of wire installed. It some cases you can consult a professional electrical contractor for a certificate of a safe and proper operation or to determine how much, if any is in use or active.
