MOUNTAINS TO SOUND HOME INSPECTION LLC

HOME INSPECTION REPORT

19031 SE 164th St
Renton WA 98058

MARCH 25, 2020

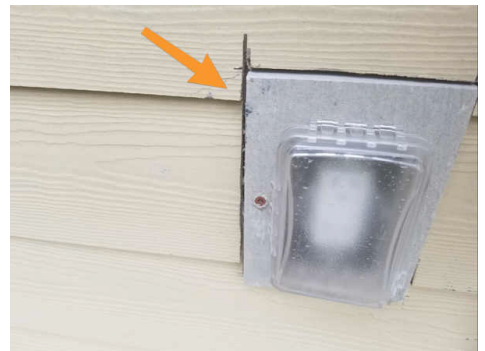
Gaps and/or holes were observed on one or more sides in the siding around plumbing, gas, cable, wiring and/or other penetrations. We advise that all the holes and the gaps be caulked and/or sealed to prevent moisture and/or pest intrusion.

Contact a qualified professional.

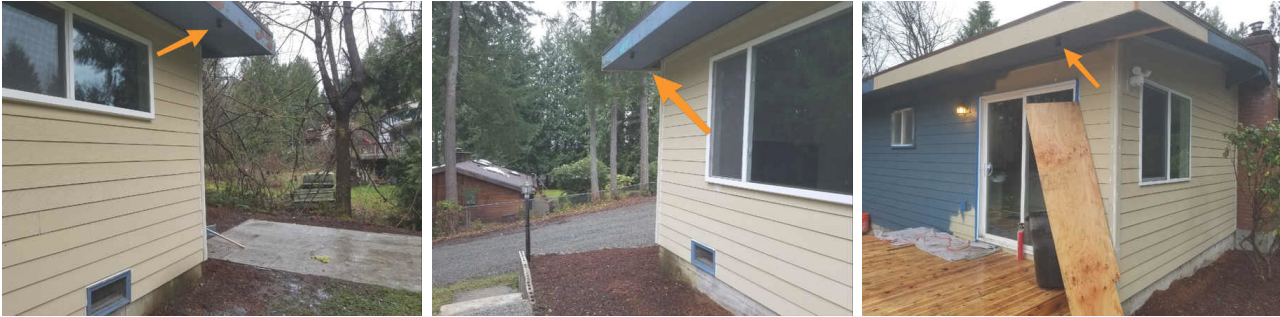
3.9.1 Downspouts

SOME DOWNSPOUTS ARE MISSING OR NEED TO BE RECONNECTED OR SERVICED

Some downspouts are missing parts or need to be reconnected or serviced.

Contact a qualified roofing professional.

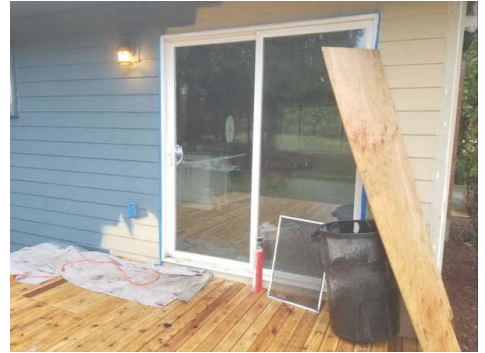
3.10.1 Exterior Doors

SLIDING DOOR SCREEN MISSING/DAMAGED

The rear sliding screen is missing or needs work. Have it repaired by a qualified contractor.

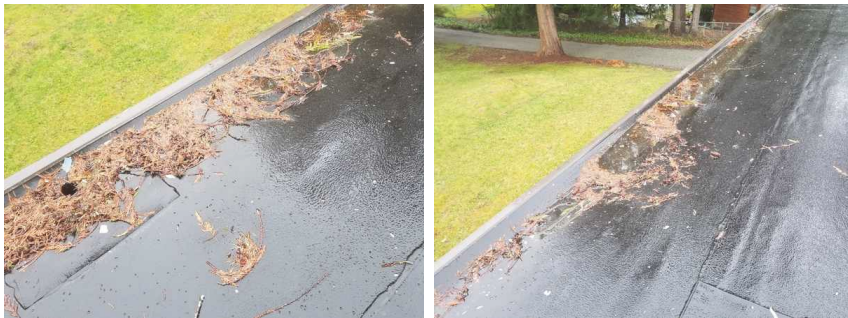
Parts of the roof needs to be cleaned of debris such as leaves and sticks or moss. This can restrict drainage and lead to moisture intrusion and moisture damage if not corrected.

Contact a qualified handyman.

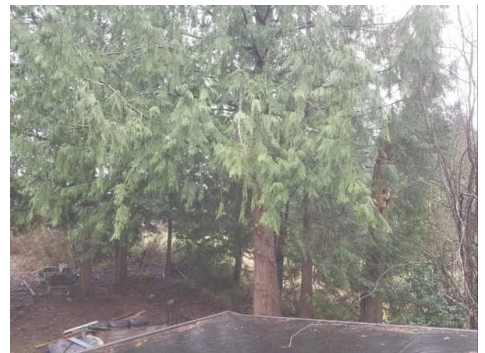
4.3.2 General Observations

Trees near the dwelling have overhanging branches and/or branches in contact with the roof surface, which may cause damage to the roof surface. This condition may also cause the obstruction of roof water runoff and is a access for rodents, animals and carpenter ants. All overhanging or touching branches in contact of the roof surface should be trimmed to eliminate this condition.

Contact a qualified professional.

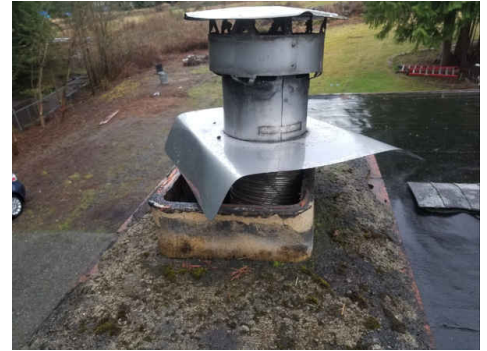
4.5.1 Chimney On Roof & Photo

The rain cap needs repair or adjustment for proper support or functionality.

Contact a qualified professional.

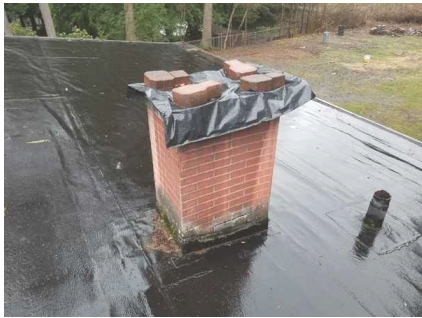
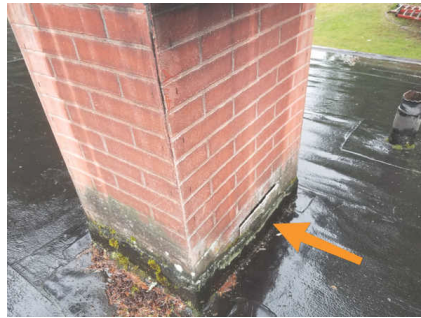
4.5.2 Chimney On Roof & Photo

FLUE COVER BOX DAMAGED

What appeared to be a flue or vent penetration cover box was damaged and/or unfinished. Recommend repairs to ensure a barrier against weather/pest intrusion.

Contact a qualified professional.

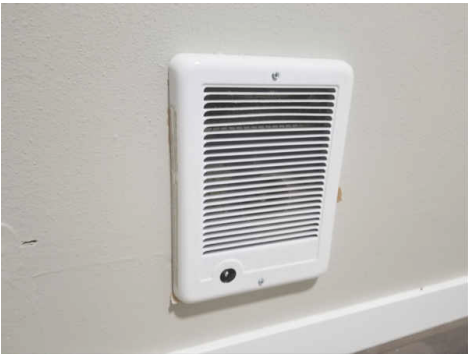
6.1.1 Electric Heating Notes HEATER KNOB MISSING

One or more of the heater knobs were missing. Recommend replacing as needed.

Recommendation
Contact a qualified professional.

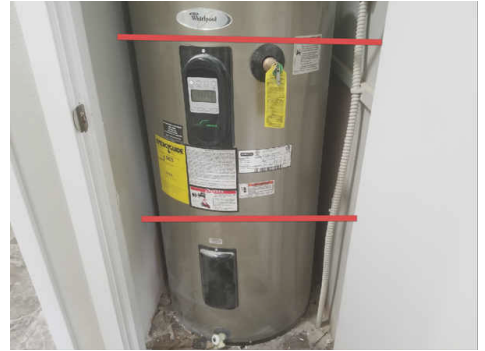
SEISMIC STRAPS - MISSING/INSUFFICIENT

The hot water heater was missing seismic straps or was insufficiently anchored. Recommend two straps to properly secure water heater in the case of an earthquake.

Contact a qualified professional.

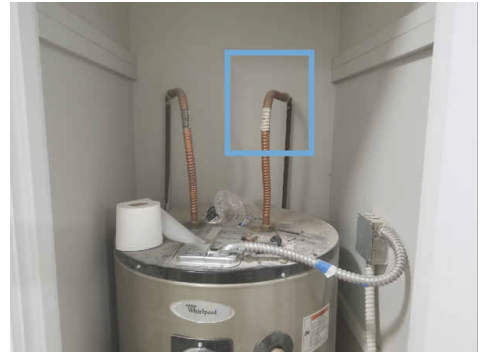
7.1.2 Water Heating System

A thermal expansion tank was not installed. We recommend installation

Contact a qualified professional.

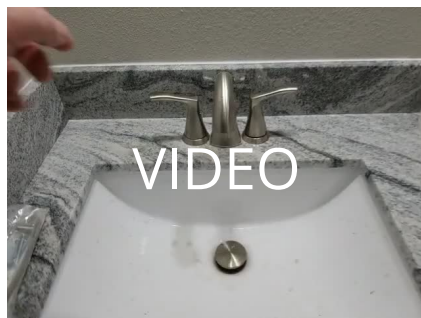
The water pressure was low. Recommend further evaluation to determine the cause and repair as needed.

Contact a qualified professional.

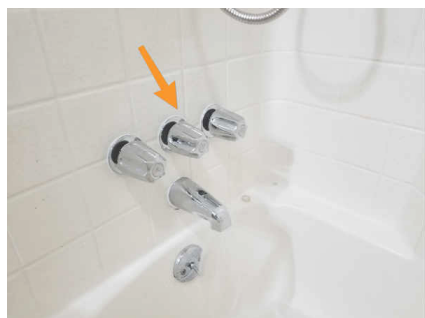
10.4.1 Tub-Shower

DIVERTER VALVE PARTIALLY WORKING

Contact a qualified handyman.

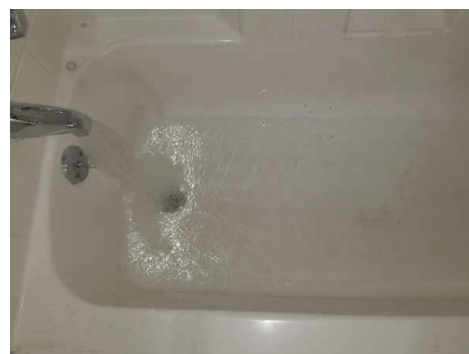
10.4.2 Tub-Shower

SLOW DRAIN

Contact a qualified plumbing contractor.

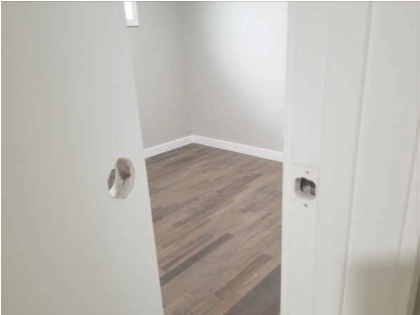
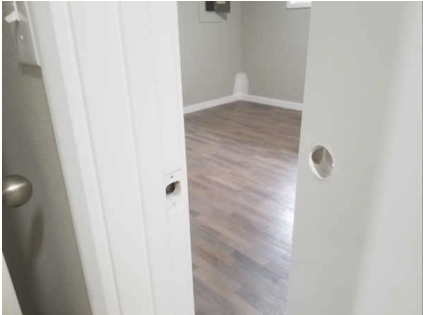
12.2.2 Doors

DOOR HARDWARE MISSING

One more doors have Hardware that is missing or in need repair or adjustment.

Contact a qualified professional.

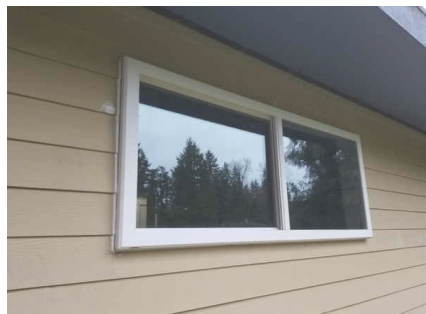
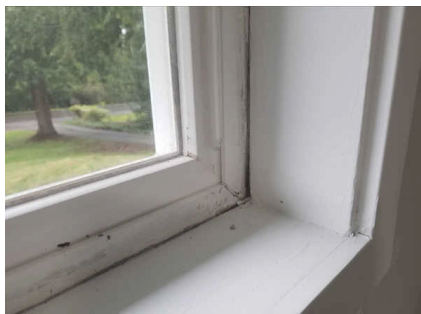
12.5.1 Windows

SCREENS DAMAGED/MISSING

Window screens were missing or damaged in one or more areas. We recommend repair or replacement as needed.

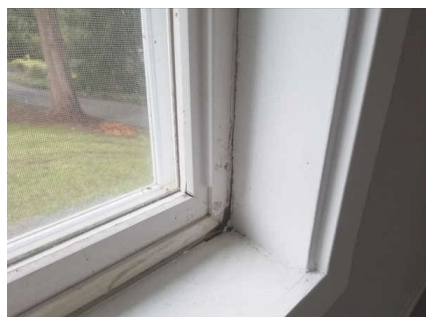
12.5.2 Windows

WINDOW SILLS AND SLIDING DOOR FRAME PAINT TOUCH UP/CAULK

The sliding door frame and some window sills around the residence were in need of minor repairs/paint touch up.

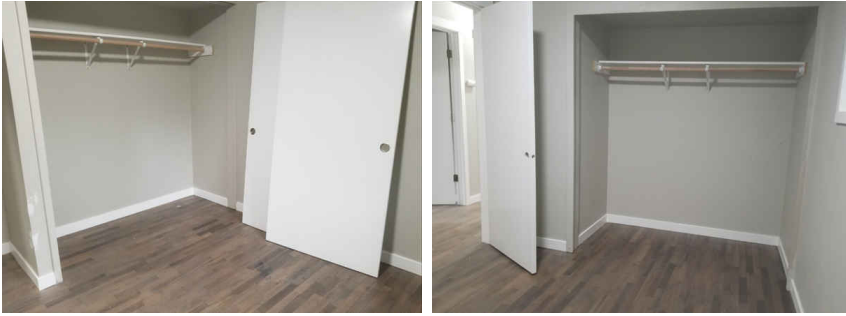
12.6.1 Closet

CLOSET DOORS OFF TRACK

The closet doors weren't installed at the time of inspection. Recommend repair as needed.

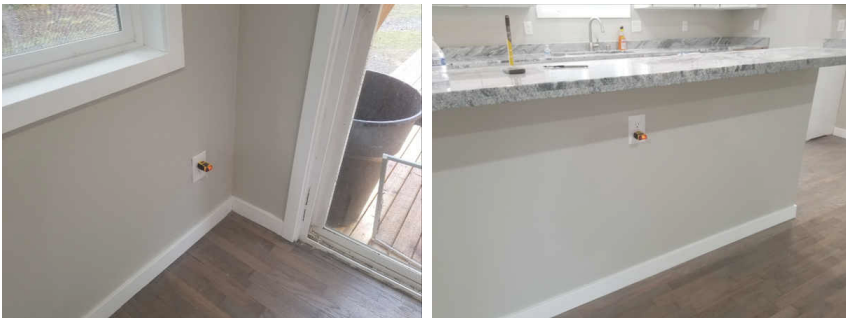
12.10.1 Outlets, Electrical

UNGROUNDED OUTLETS

Several of the Interior Outlets are ungrounded. This is common in older homes. Grounding all Outlets would be a beneficial and recommended update.

Contact a qualified electrical contractor.

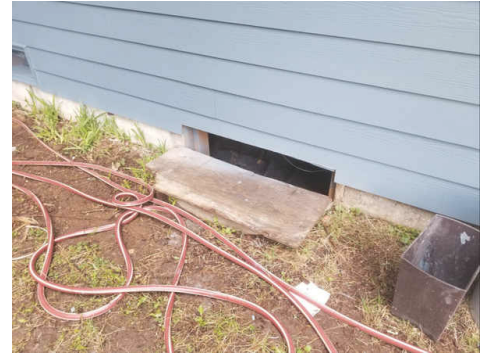
The crawl space hatch is damaged or does not seal. This may allow passage to rodents. We recommend necessary repairs to seal.

Contact a qualified professional.

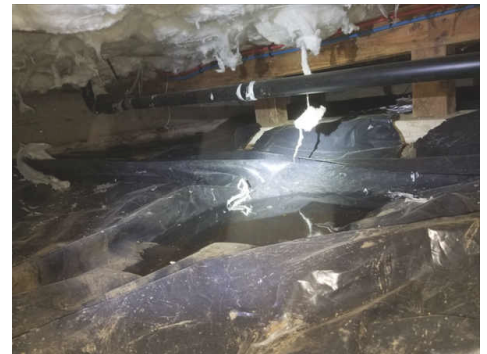
13.1.2 Crawlspace Notes

Observed standing water in the crawl space Recommend a qualified contractor evaluate and find potential source of moisture.

Contact a qualified professional.

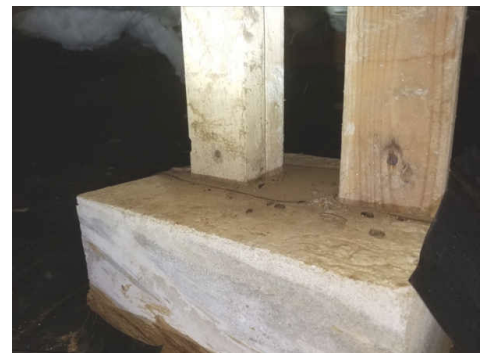
13.1.3 Crawlspace Notes

Evidence of rodent activity in the form of feces or urine stains was observed in the crawl space. We recommend sealing all access points and eliminating any active infestation.

Contact a qualified pest control specialist.
