HOME INSPECTION REPORT

16620 SE 161st St
Renton WA 98058

Calvin Osili
MAY 19, 2020

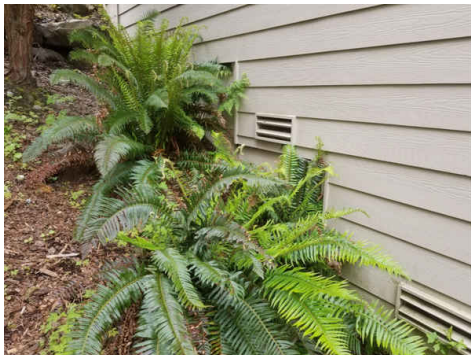
Vegetation is encroaching on the structure, and should be kept a minimum of twelve inches away for the general welfare of the walls and foundation.

Contact a qualified landscaping contractor

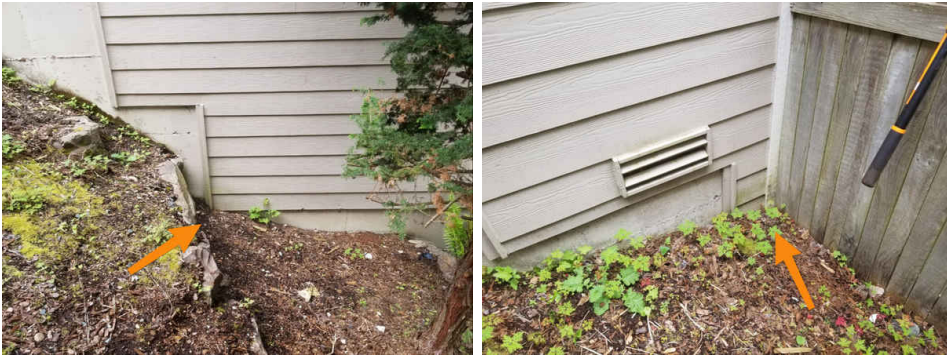
3.5.2 Exterior Siding Notes

EARTH TO SIDING CONTACT**RIGHT SIDE**

The siding was in contact with or nearly contacting soil or mulch or concrete. This is a condition conducive to deterioration and wood destroying organism infestation. We recommend removing soil a six-inch space between any siding material and soil where possible and repairs to any damaged or deteriorated siding.

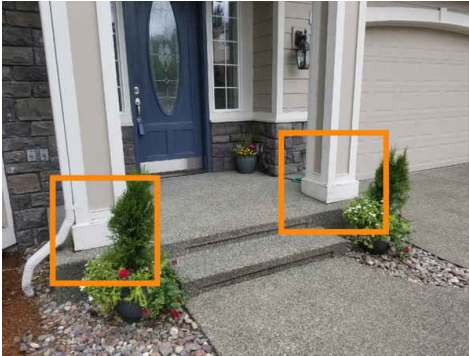
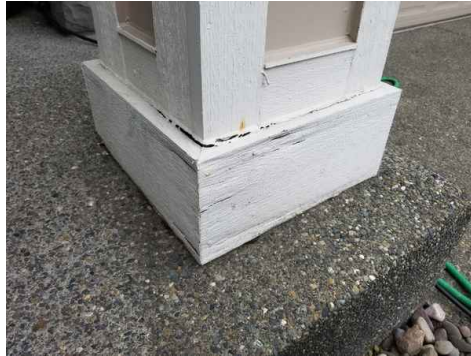
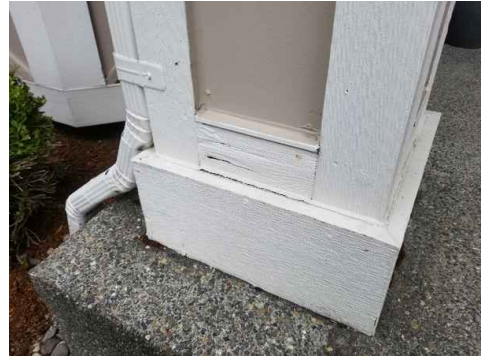
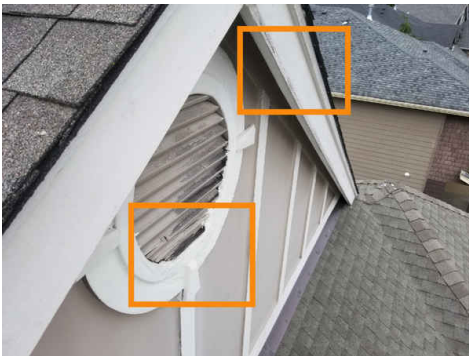
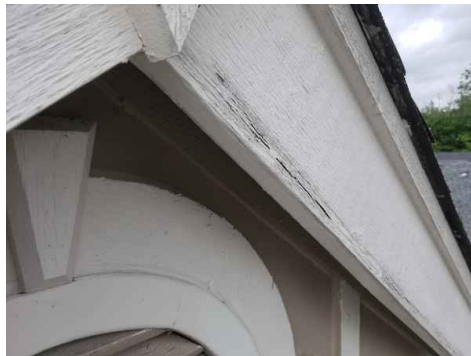
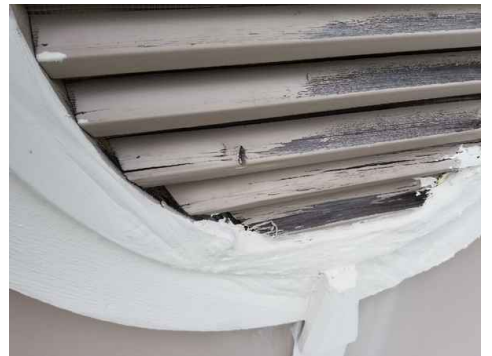
3.7.1 Fascia, Trim & Eaves

TRIM MISSING/DAMAGED

One or more sections of trim are damaged or missing. Recommend repairs.

Contact a qualified professional.

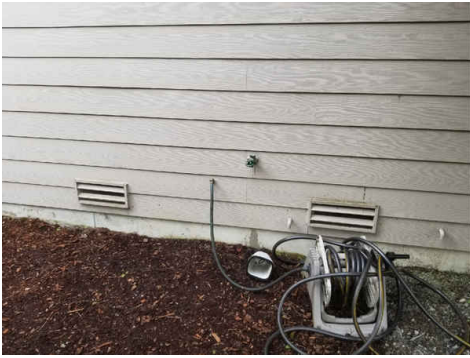
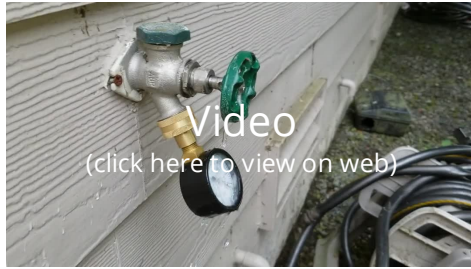
3.8.1 Exterior Plumbing

HOSE BIB LEAKS WHILE IN USE

The hose bib leaks at the handle while in use and you may want to have it repaired by a licensed professional.

Contact a qualified handyman.

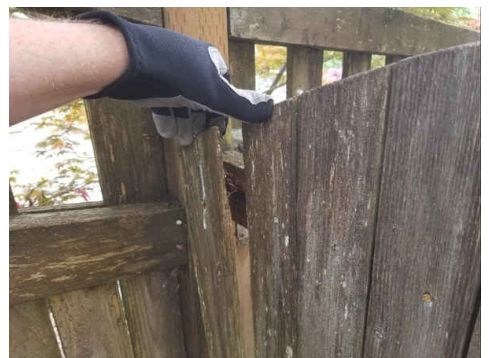
3.13.1 Fences & Gates

GATE LIGHT DAMAGE

Observed some light damage in one or more sections of the gates or fencing on the property. Recommend repairs.

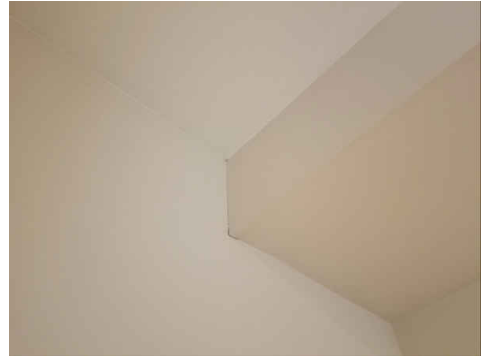
13.4.1 Walls and Ceiling

TYPICAL SETTLEMENT CRACKING/NAIL POPS

Observed typical settlement type cracking and nail pops on walls and ceilings. Recommend repairs as needed. Home owner to identify all areas for repair.

Recommend monitoring.

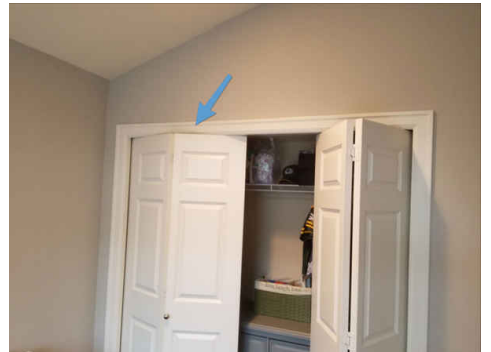
13.6.1 Closet

DOOR RUBS

The door rubs and service is recommended.

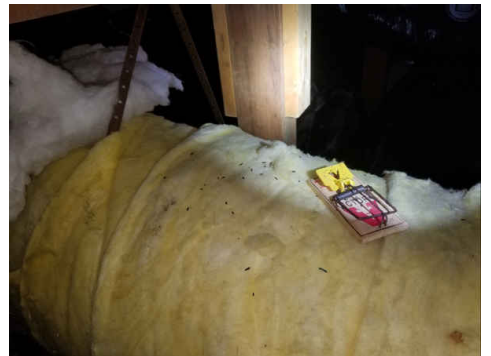
Empty rodent traps were observed in the crawl space. We recommend monitoring for rodent activity.
