## HOME INSPECTION REPORT

19112 35th Ave SE  
Bothell WA 98012

APRIL 29, 2020

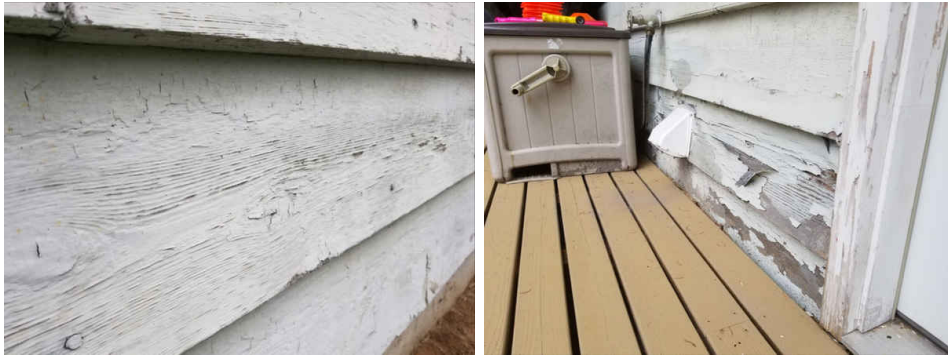
### 3.5.1 Exterior Siding Notes

The exterior siding is weathered. Maintenance and minor repairs are recommended.

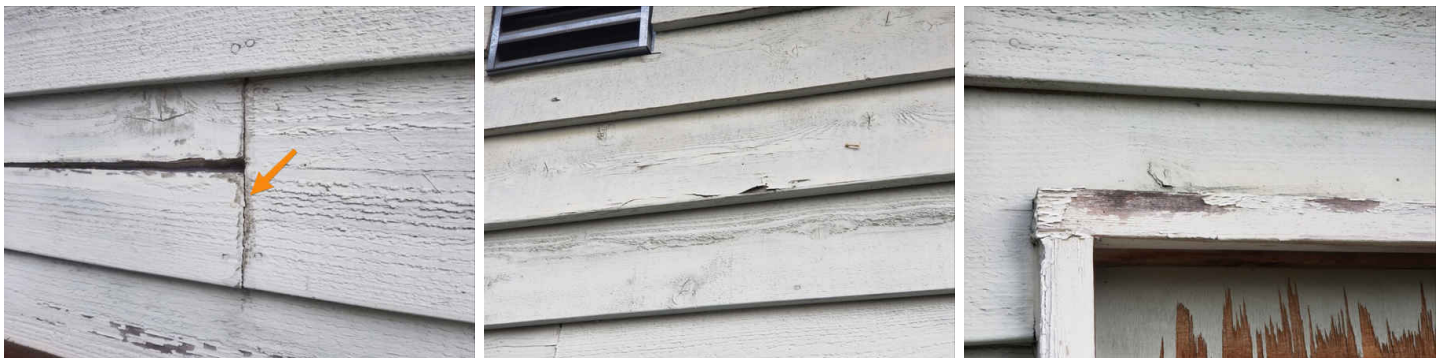
### 3.5.2 Exterior Siding Notes

#### TOUCH-UP PAINT/CAULK

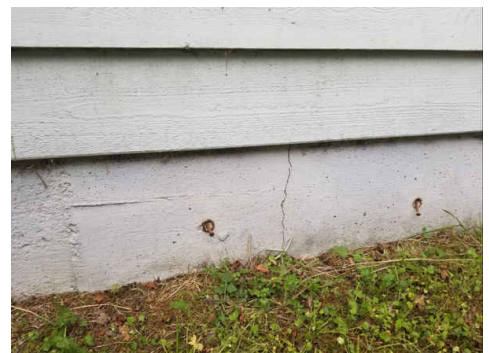
### 3.6.1 Foundation as Viewed from the Exterior

#### SMALL CRACKS

Hairline and/or small cracks, within normal tolerances were visible. This type of cracking is often a result of shrinkage of materials and/or minor settlement and usually does not affect the performance of the foundation.

Recommend monitoring.

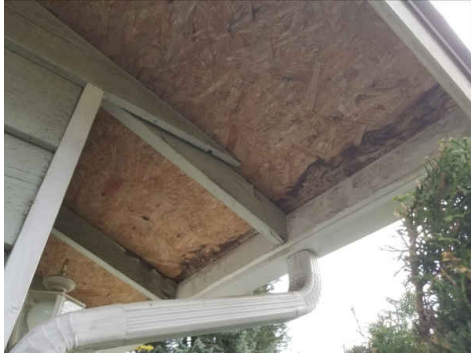
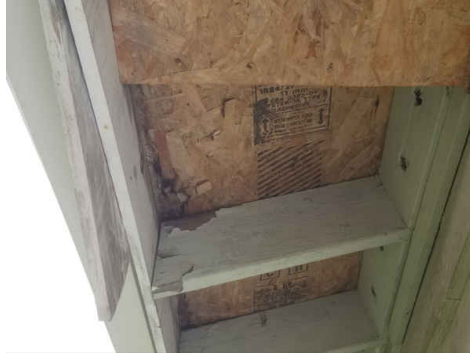
## 3.7.1 Fascia, Trim &amp; Eaves

**MOISTURE STAINING TO EAVES**

The eaves have some moisture staining which should be explored further and repaired.

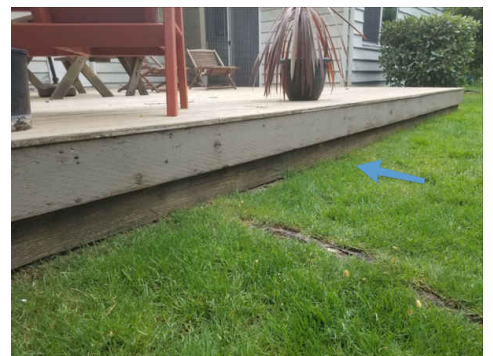
## 3.15.1 Deck

**EARTH TO WOOD CONTACT**

The deck has Earth to wood contact. This can accelerate deterioration. We recommend removing soil from contacting any wood components.

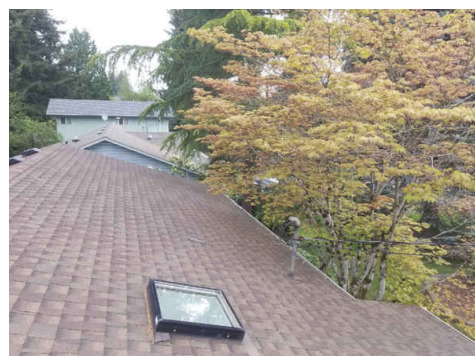
Trees near the dwelling have overhanging branches and/or branches in contact with the roof surface, which may cause damage to the roof surface. This condition may also cause the obstruction of roof water runoff and is a access for rodents, animals and carpenter ants. All overhanging or touching branches in contact of the roof surface should be trimmed to eliminate this condition.

Contact a qualified professional.

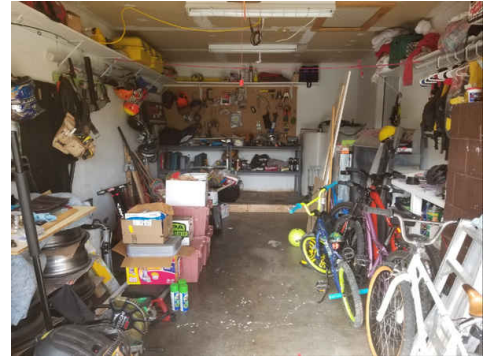
## 5.5.1 Slab Floor

**FULL OF STORAGE SLAB BLOCKED**

The garage is too full of storage to permit a clear view of the entire slab. I recommend evaluating the floor yourself once the storage is removed.

Recommended DIY Project

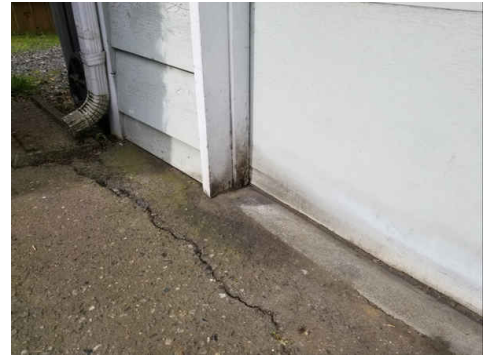
## 5.9.1 Walls and Ceiling

**EVIDENCE OF MOISTURE INTRUSION**

There is evidence of moisture intrusion on the on the floor. You should ask the sellers about this or have the condition further evaluated

Contact a qualified general contractor.

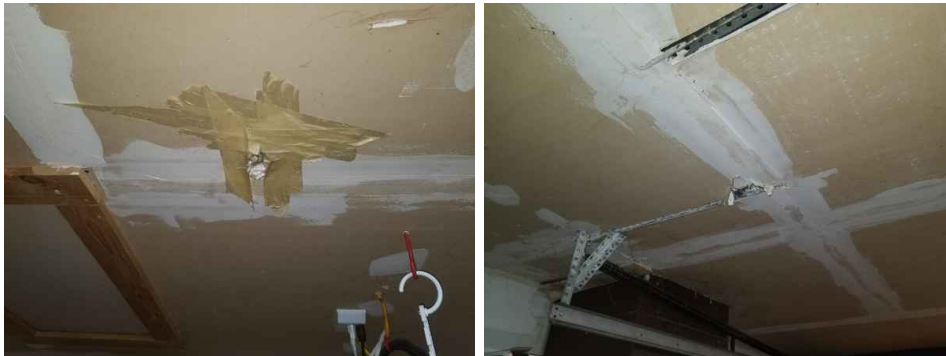
#### 5.9.2 Walls and Ceiling

### **WALLS/CEILING HAVE DAMAGE**

The walls/ceiling have some damage and repair is recommended.

Contact a qualified drywall contractor.

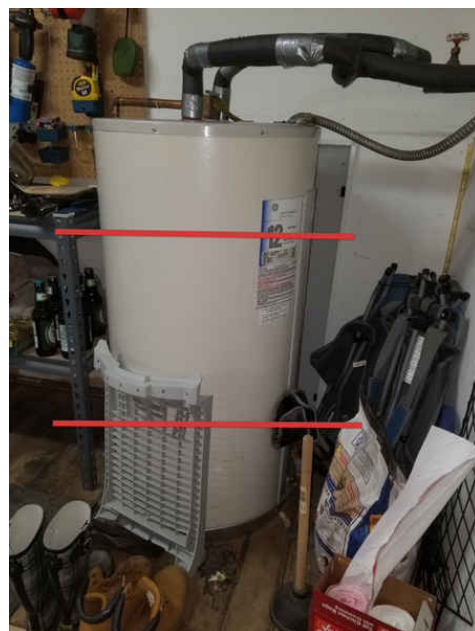
**SEISMIC STRAPS - MISSING/INSUFFICIENT**

The hot water heater was missing seismic straps or was insufficiently anchored. Recommend two straps to properly secure water heater in the case of an earthquake.

Contact a qualified professional.

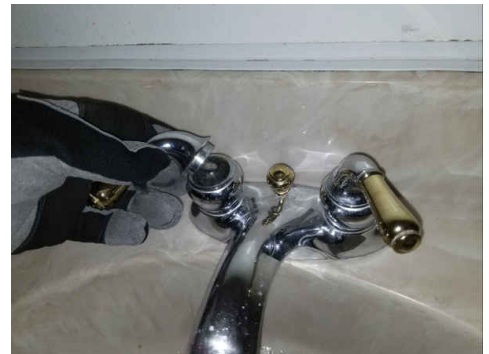
#### LOOSE FAUCET HANDLE

The faucet handle is loose or damaged and should be secured or repaired as necessary.

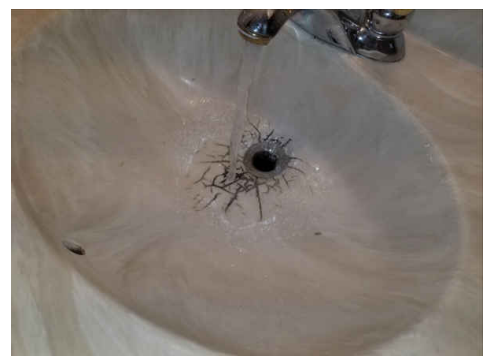
### 11.1.2 Sink and Faucet

#### SINK IS CRACKED

The sink is cracked and should be monitored or replaced.

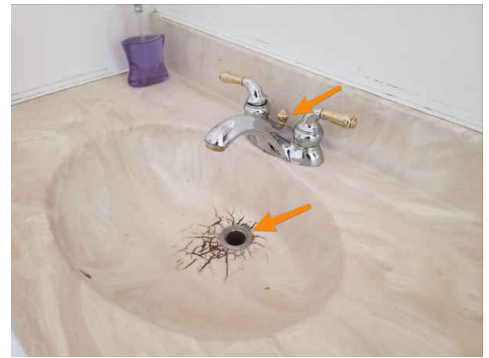
## 11.1.3 Sink and Faucet

The sinkstopper does not work properly and repair is recommended.

Contact a qualified handyman.

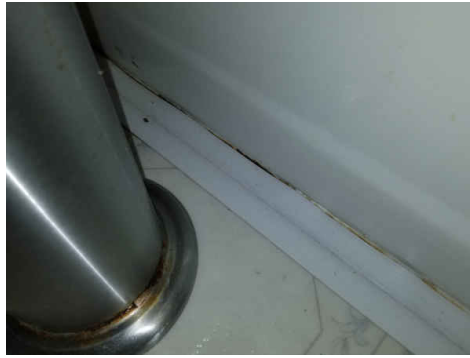
## 11.4.3 Tub-Shower

**MISSING OR DETERIORATED CAULK/GROUT**

The tub surround is has missing or deteriorated caulk/grout. Recommend caulking or sealing to prevent moisture intrusion.

Contact a qualified professional.

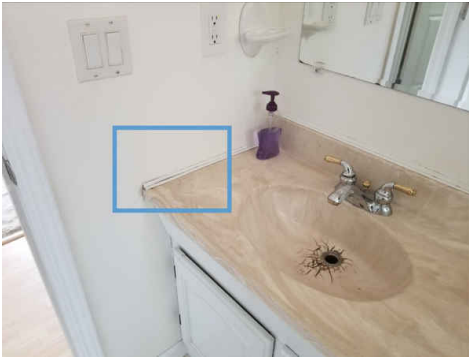
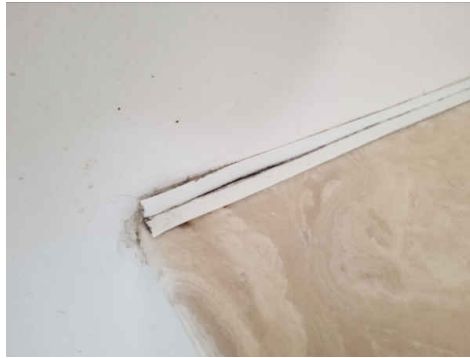
## 11.6.1 Countertop

**MISSING OR DETERIORATED CAULK/GROUT**

The caulking or grout for the backsplash is missing, has gaps and/or not installed properly. We advise caulking/grout be installed and/or gaps filled to prevent possible water intrusion.

Recommended DIY Project

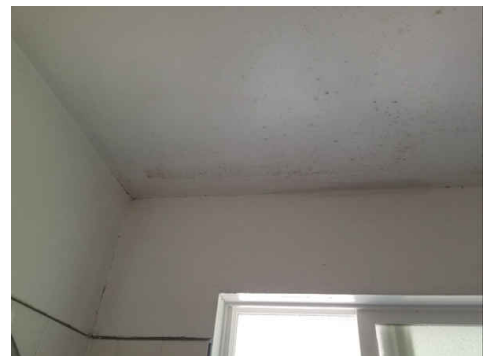
## 11.11.1 Walls and Ceiling

**SMALL MOISTURE STAIN ON THE CEILING**

Contact a qualified roofing professional.

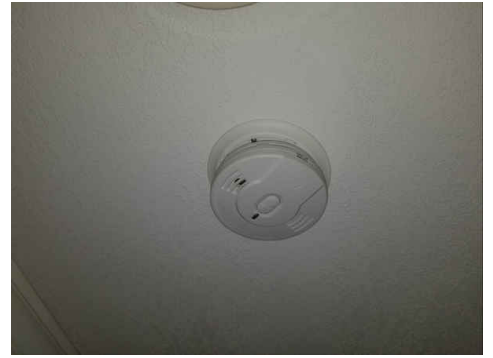
### 13.8.1 Smoke & CO Detectors Notes

#### ADD CARBON MONOXIDE DETECTOR

Contact a qualified handyman.
