# MOUNTAINS TO SOUND HOME INSPECTION LLC

## HOME INSPECTION REPORT

1320 181st St Ct E  
Spanaway WA 98387

Jerimy Kline  
JANUARY 23, 2020

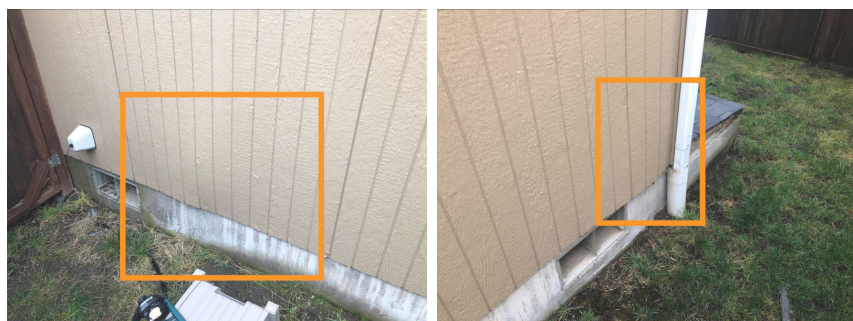
The siding is warped or buckled and we recommend it be evaluated by a specialist to determine if the damage is due to defective material or the method of installation.

Contact a qualified siding specialist.

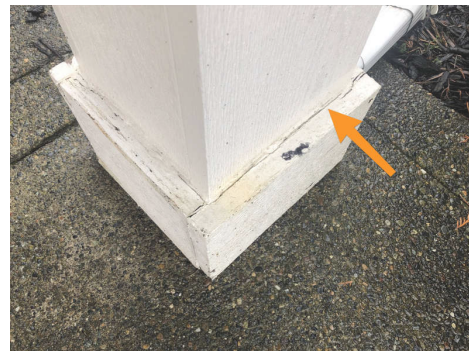
### 3.5.2 Exterior Siding Notes

**TOUCH-UP PAINT/CAULK****FRONT**

Contact a qualified handyman.

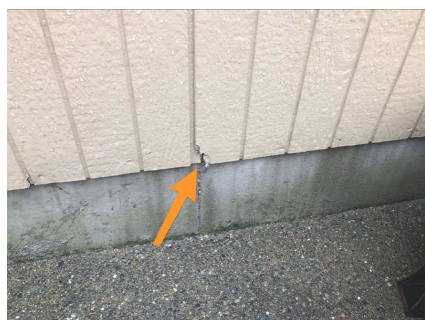
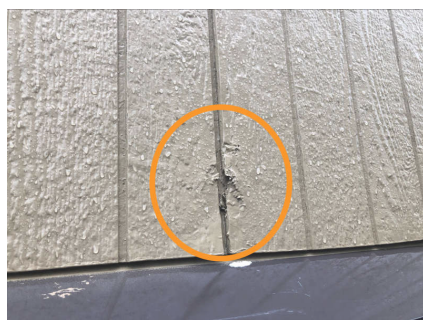
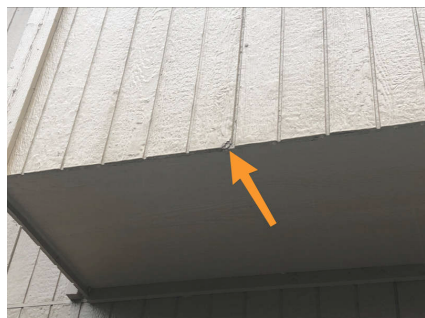
## 3.5.3 Exterior Siding Notes

**DAMAGED SIDING**

Observed areas of damaged siding and moisture damaged siding around the residence that should be repaired to help prevent moisture intrusion issues. These damaged areas can allow moisture to penetrate the walls if not properly repaired.

Contact a qualified handyman.

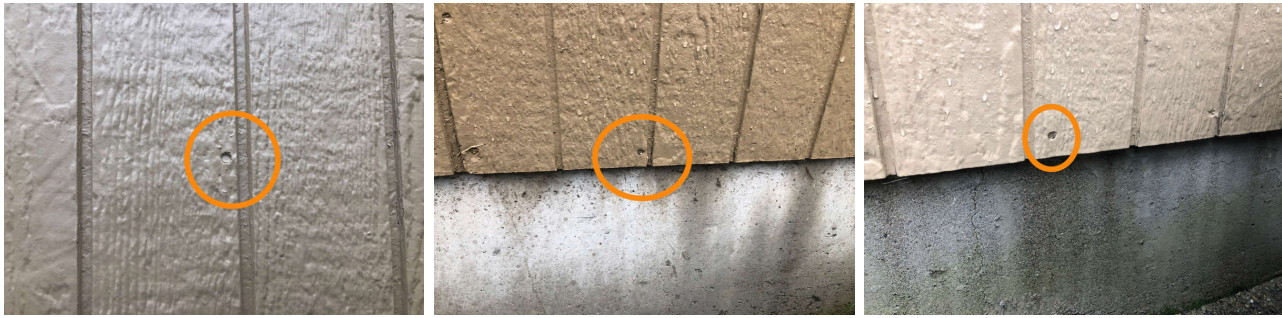
## 3.5.4 Exterior Siding Notes

**COUNTER-SUNK NAILS**

A number of holes or deflections through the surface of the siding material were not properly caulked and sealed. These were caused by driving nails deep into the siding material. This can cause accelerated deterioration of the siding from moisture. Caulking and painting of all nail heads, surface breaks and depressions that have broken through the siding surfaces is recommended.

Contact a qualified professional.

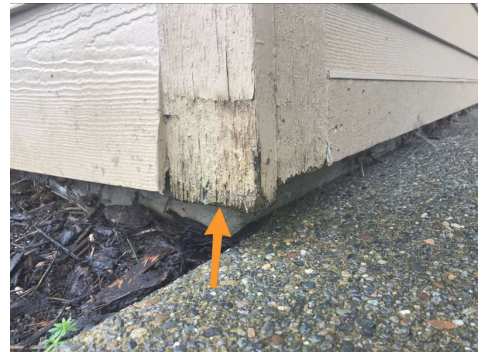
### 3.7.1 Fascia, Trim & Eaves

## SECTIONS OF FASCIA & TRIM MOISTURE DAMAGED

Sections of the fascia board or wood trim are weathered, moisture damaged and should be serviced or replaced as necessary by a qualified professional contractor to help prevent further wear or deterioration.

Contact a qualified handyman.

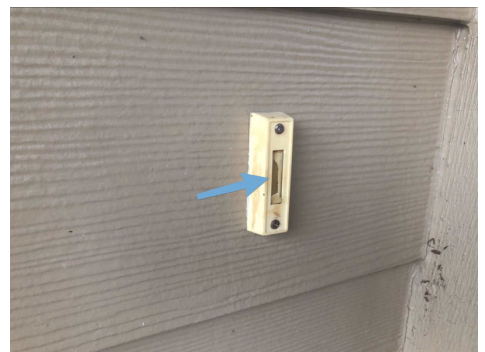
### 3.12.1 Doorbell

## BUTTON IS DAMAGED OR MISSING

The doorbell button is damaged or missing and you may want to have it replaced.

Contact a qualified handyman.

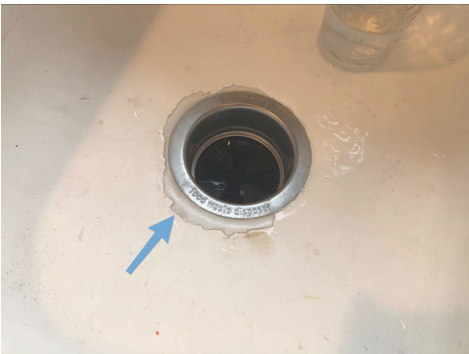
**SINK FINISH CRACKING/PEELING**

The finish on the sink is cracking/peeling in an area. Recommend repairs.

Recommendation  
Contact a qualified professional.

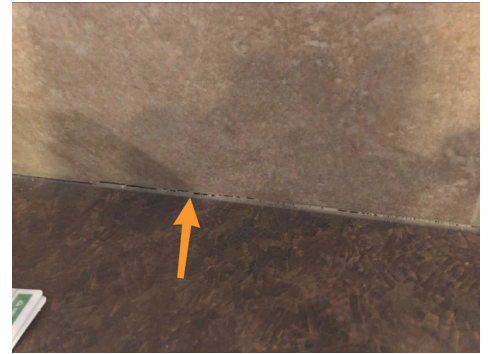
## 9.4.1 Countertop

**MISSING OR DETERIORATED  
CAULK/GROUT**

The caulking or grout for the backsplash is missing, has gaps and/or not installed properly. We advise caulking/grout be installed and/or gaps filled to prevent possible water intrusion.

Recommended DIY Project

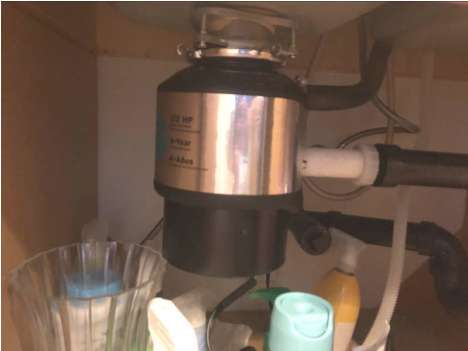
Foreign debris is stuck within the garbage disposal, which should be removed and the disposal repaired and tested as necessary.

Recommended DIY Project

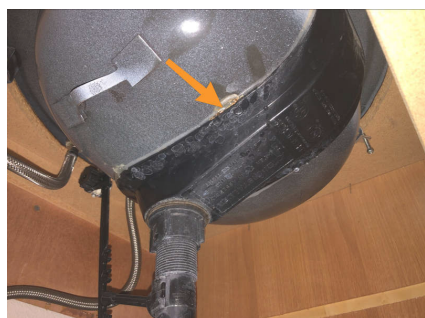
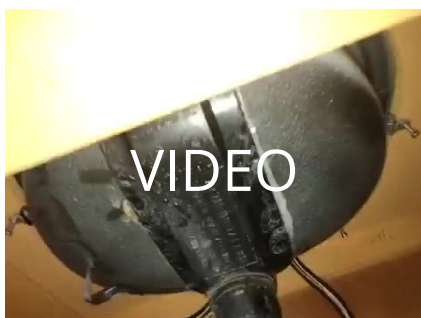
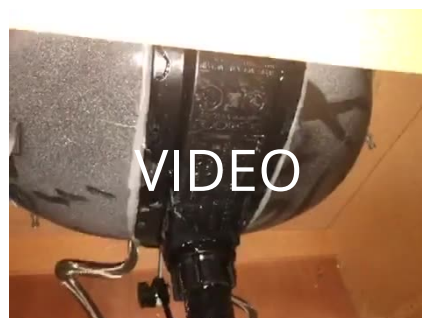
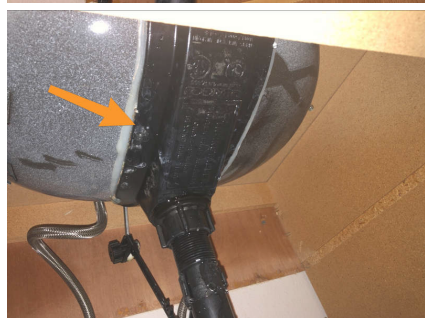
**OVERFLOW LEAK**

The overflow drain on the sink was leaking. The sink should be replaced to restore proper function.

Contact a qualified professional.

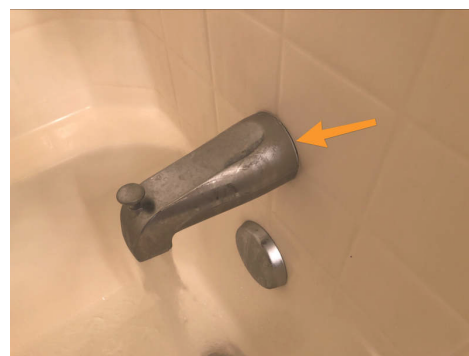
## 11.4.1 Tub-Shower

**CAULKING OR SEALING**

I recommend caulking or sealing around shower valves and faucets etc to help prevent moisture intrusion behind or into the walls.

Monitoring these areas is also recommended to help ensure an adequate seal is in place.

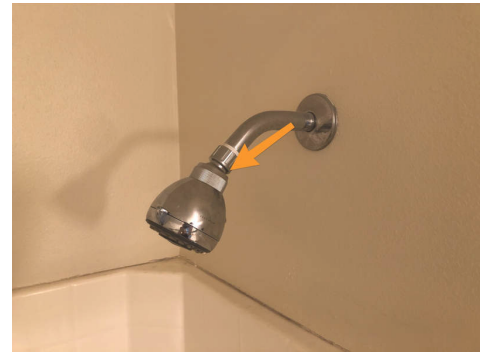
## 11.4.2 Tub-Shower

**SHOWER HEAD LEAK**

The shower head leaked at the base of the head or hose. The joint should be tightened or sealed to prevent leakage.

Contact a qualified professional.

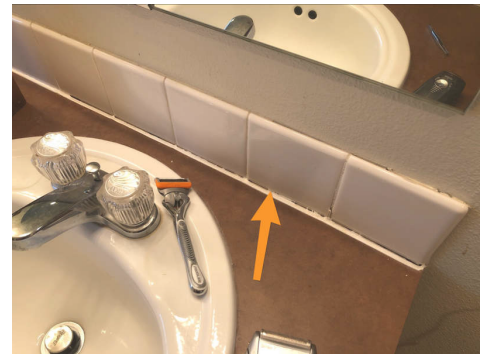
## 11.6.1 Countertop

**MISSING OR DETERIORATED CAULK/GROUT**

The caulking or grout for the backsplash is missing, has gaps and/or not installed properly. We advise caulking/grout be installed and/or gaps filled to prevent possible water intrusion.

Recommended DIY Project

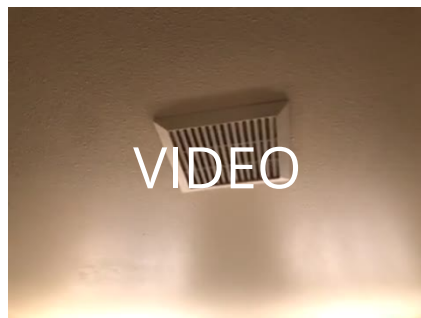
## 11.8.1 Exhaust Fan

**THE EXHAUST FAN IS NOISY**

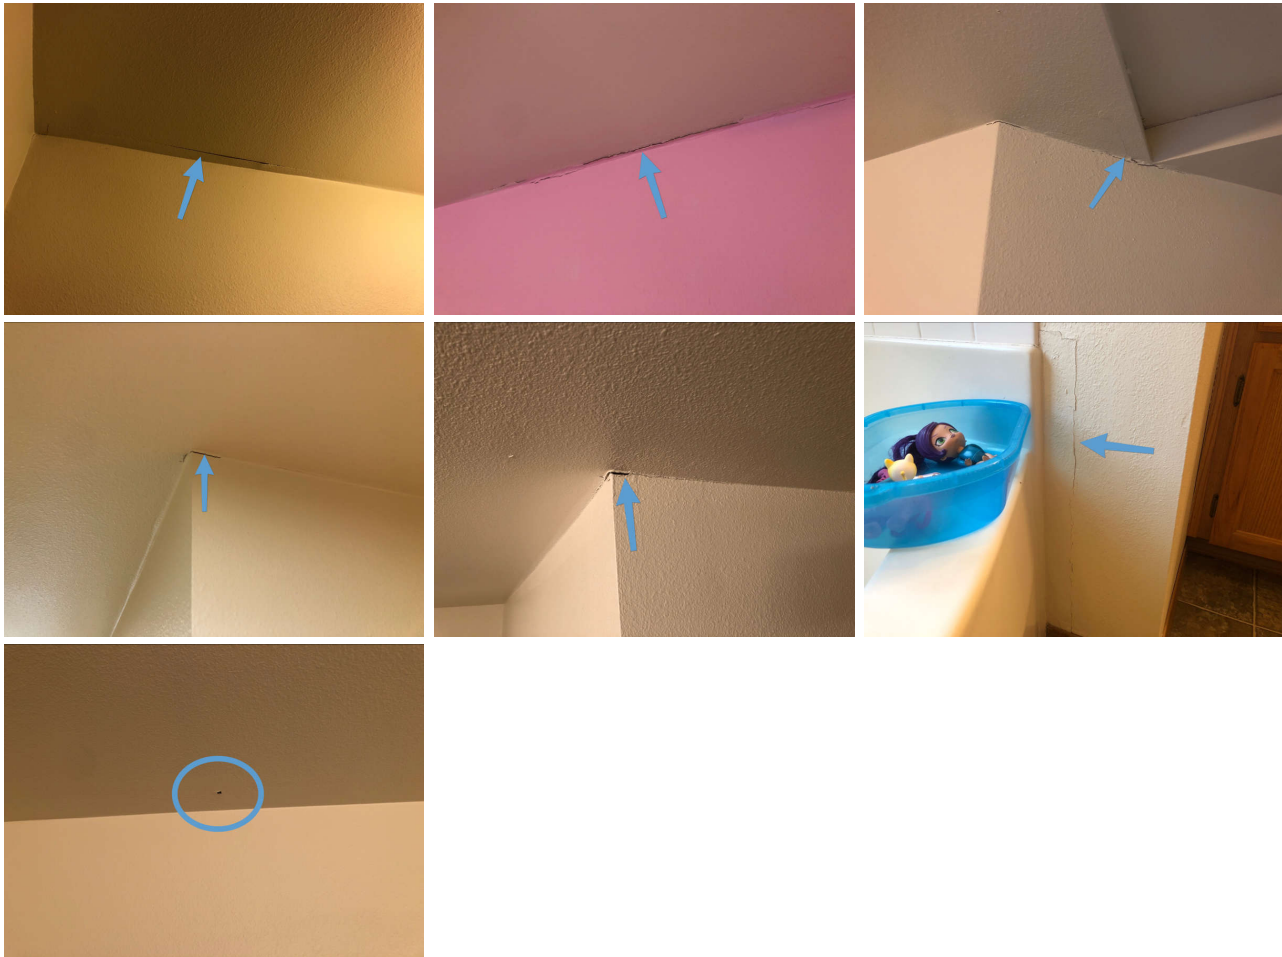
### 13.4.1 Walls and Ceiling

#### **TYPICAL SETTLEMENT CRACKING/NAIL POPS**

Recommend monitoring.

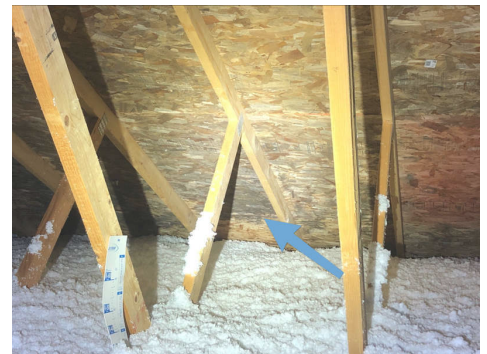
**DECK STAINING**

Discoloration and dark staining was observed on the roof sheathing. This is often caused by poor ventilation and is commonly considered a microbial growth. Recommend improving ventilation and cleaning.

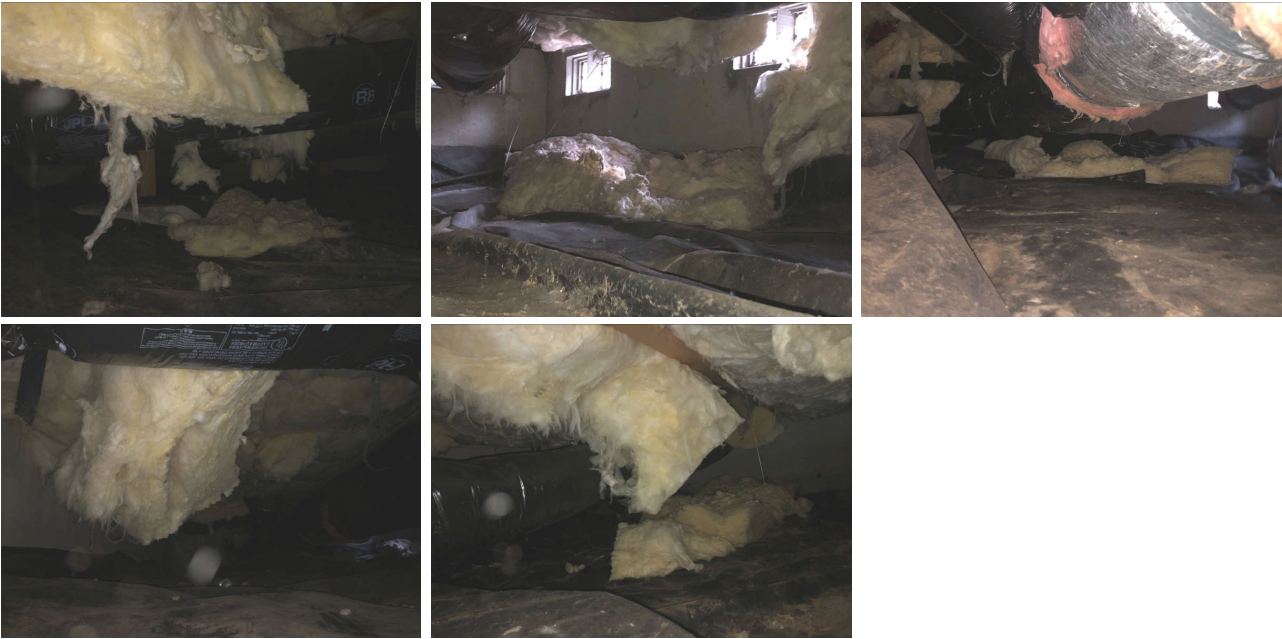
15.1.2 Crawlspace Notes

INSULATION-FALLING DOWN

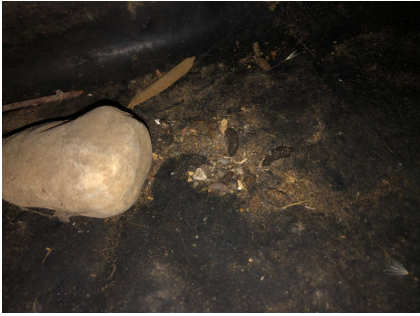
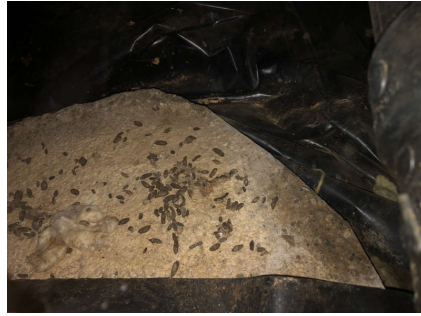
15.1.3 Crawlspace Notes

RODENT ACTIVITY

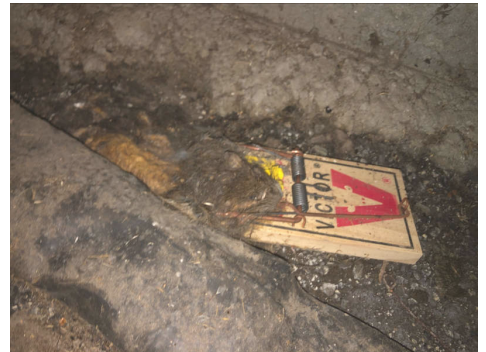
#### 15.1.4 Crawlspace Notes

### DEAD ANIMAL
