MOUNTAINS TO SOUND HOME INSPECTION LLC

HOME INSPECTION REPORT

15427 SE 182nd St
Renton WA 98058

APRIL 13, 2020

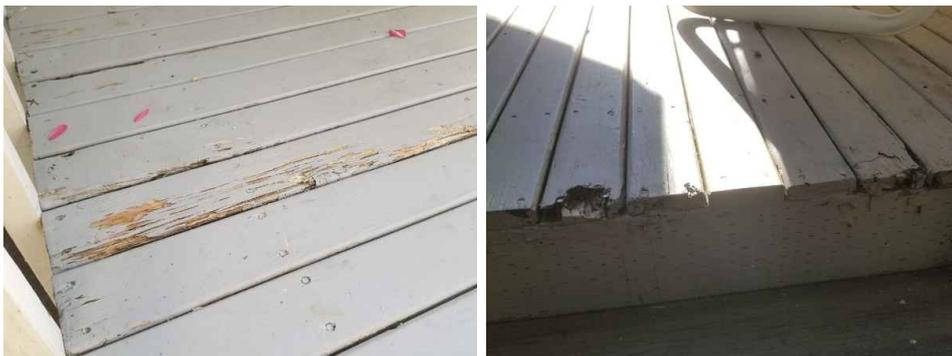
3.17.2 Deck

EARTH TO WOOD CONTACT

The deck has Earth to wood contact. This can accelerate deterioration. We recommend removing soil from contacting any wood components.

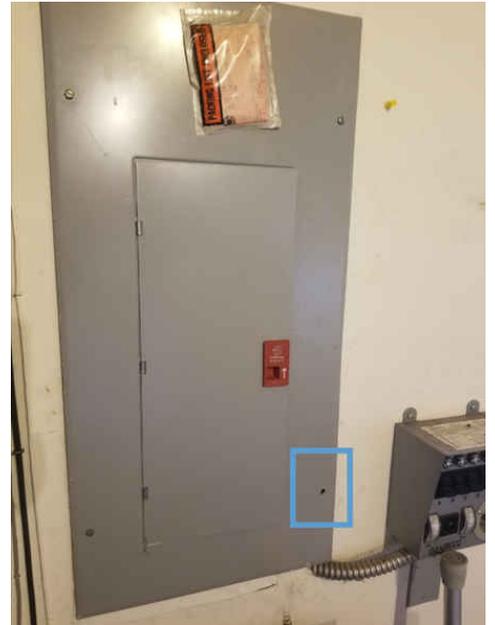
6.4.1 Panel Cover Condition

MISSING SCREWS

The main electrical exterior panel cover is missing screws, which should be replaced.

Contact a qualified electrical contractor.

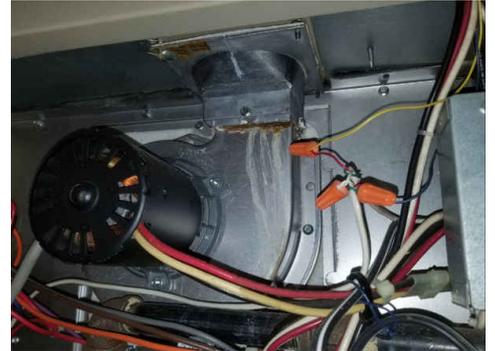
7.2.2 Furnace Notes

RUST OR STAINING NOTED

Rust or moisture stains were noted on the gas furnace. They are typically caused by condensation or moisture accumulation, but should be removed before more particulates gather. Further evaluation of the furnace and its related components is recommended by a qualified HVAC service before the close of escrow.

Contact a qualified HVAC professional.

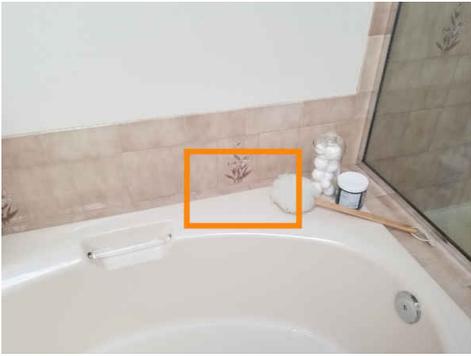
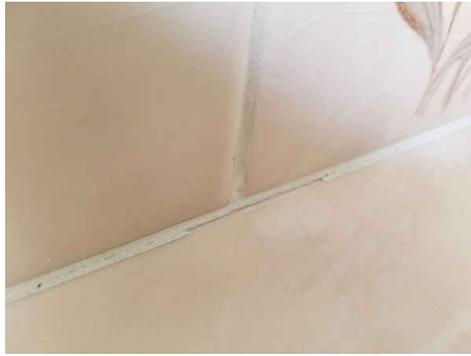
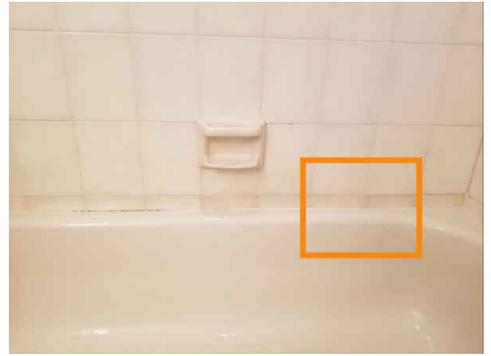
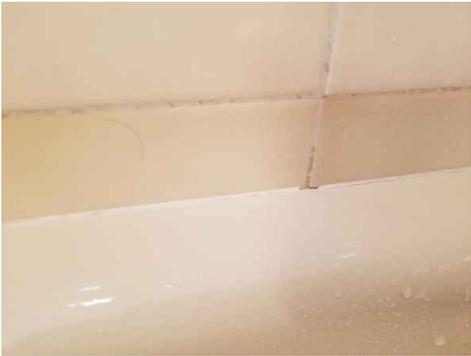
11.4.3 Tub-Shower

MISSING OR DETERIORATED CAULK/GROUT

The tub surround is has missing or deteriorated caulk/grout. Recommend caulking or sealing to prevent moisture intrusion.

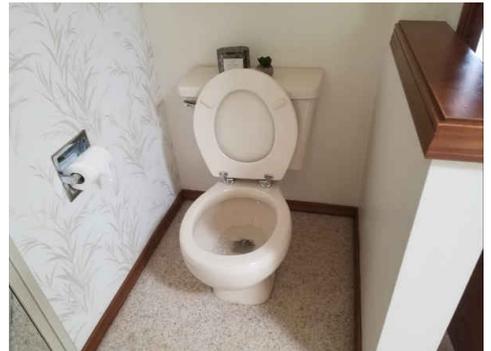
11.5.1 Toilet

FUNCTIONAL BUT LOOSE

The toilet is functional, but loose on the floor and should be secured by a qualified technician, for safety reasons and to prevent possible damage or leaking from around the toilet.

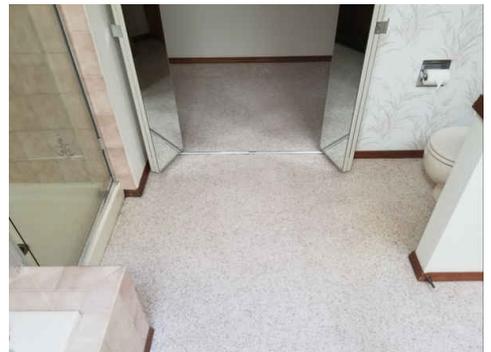
11.10.1 Flooring

CARPETED BATHROOM FLOOR

The bathroom floor is covered with carpet adjacent to the shower and/or tub. We recommend that this be removed and replaced with vinyl or tile materials. Carpet in a wet location such as a Bathroom can allow moisture damage or mold growth under the carpet.

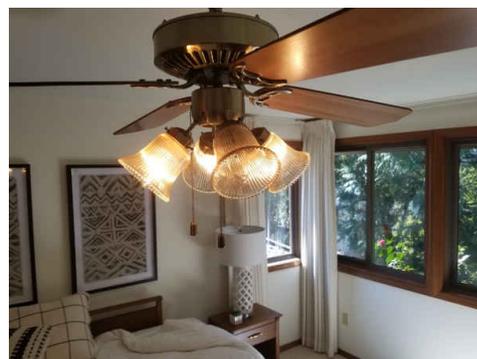
13.12.1 Lights, Wall Switches

A light fixture did not have light bulbs or the bulbs were burnt out. Recommend replacing bulbs and testing.

Contact a qualified handyman.
