HOME INSPECTION REPORT

202 Summer Pl
Enumclaw WA 98022

MARCH 17, 2020

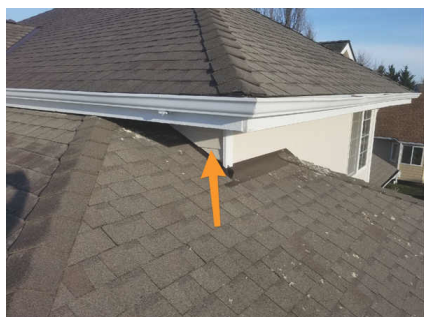
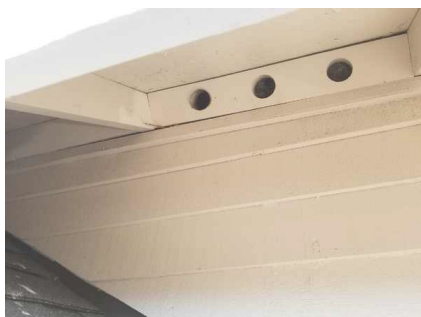
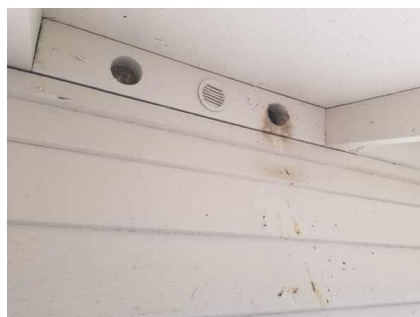
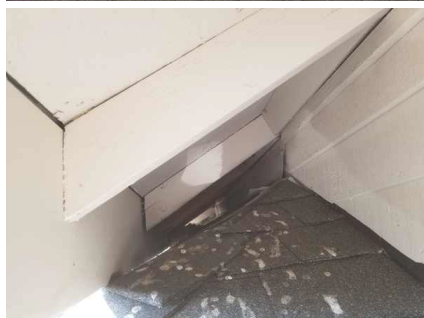
Bird nests or activity were observed on the exterior and attic space of the house. Recommend removal.

Recommendation

Contact a qualified professional.

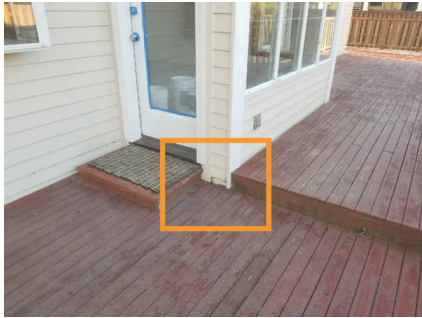
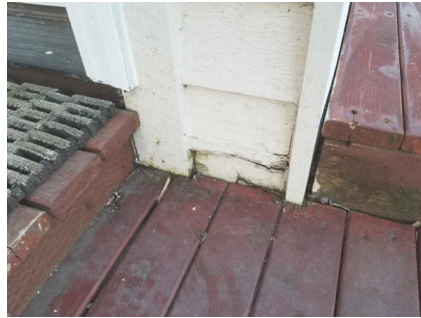
3.5.1 Exterior Siding Notes

Medium Priority**DAMAGED SIDING**

Observed one or more sections of damaged siding around the residence that should be repaired to help prevent moisture intrusion issues. These damaged areas can allow moisture to penetrate the walls if not properly repaired.

Recommendation

Contact a qualified handyman.

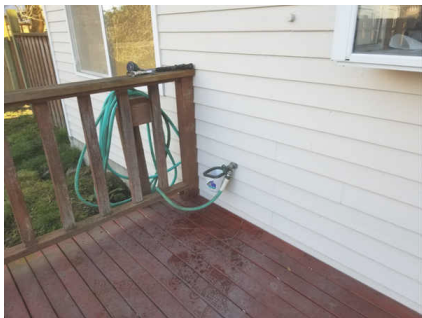
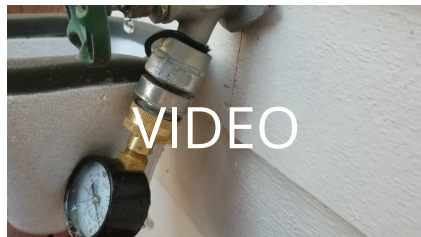
3.8.1 Exterior Plumbing

Medium Priority**LEAKING VACUUM BREAKER**

There is a leaking vacuum breaker, on the property irrigation system, that needs evaluation and service as necessary from a qualified technician.

Recommendation

Contact a qualified plumbing contractor.

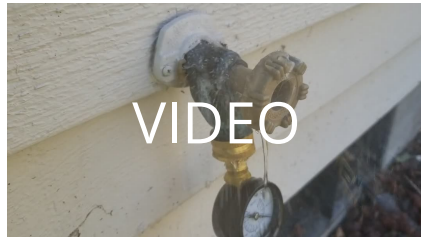
3.8.2 Exterior Plumbing

Medium Priority**HOSE BIB LEAKS WHILE IN USE**

The hose bib leaks at the handle while in use and you may want to have it repaired or replaced by a licensed professional. Sometimes they just need to be tightened.

Recommendation

Contact a qualified handyman.

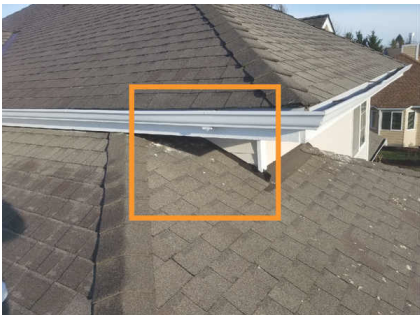
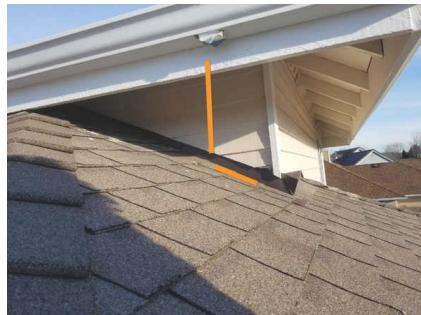
3.9.1 Downspouts

DOWNSPOUTS MISSING COMPONENTS

The downspouts are missing parts. Recommend repairs to allow for proper drainage away from the structure.

Recommendation

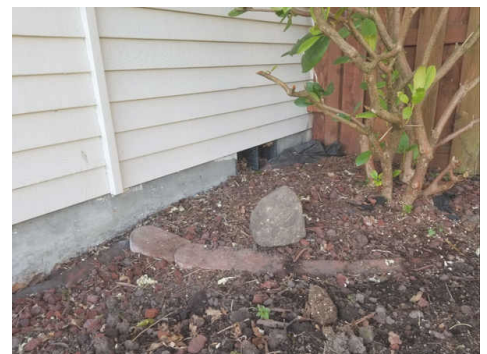
3.11.1 Crawlspace Vents

BELOW GRADE

The foundation vents were at or below grade level. This can allow moisture to infiltrate into the crawlspace. Monitor for water intrusion. If observed, proper drainage away from the vents is recommended.

Recommendation

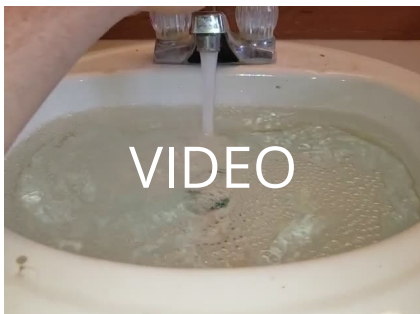
11.1.1 Sink and Faucet

OVERFLOW LEAK

The overflow drain on the sink was leaking. The sink should be replaced to restore proper function.

Recommendation

Contact a qualified professional.

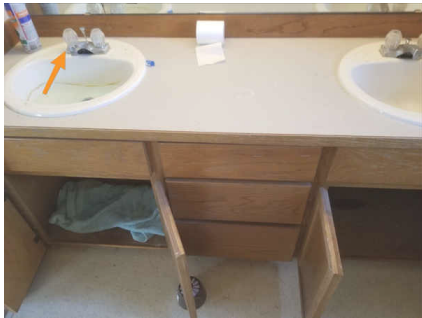
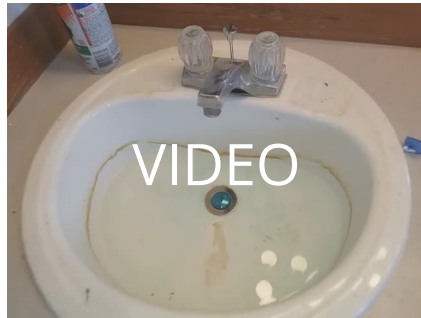
11.1.2 Sink and Faucet

HOT NOT WORKING

The hot side on a sink is not working and further evaluation and repair is recommended.

Recommendation

Contact a qualified handyman.

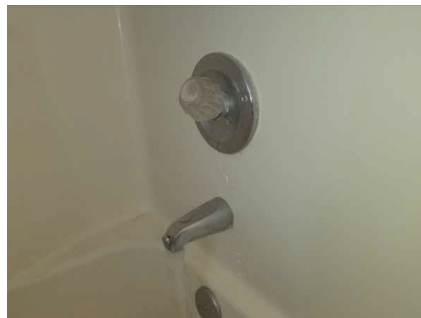
11.4.1 Tub-Shower

VALVES LEAK WHILE IN USE

The shower, bath valves leak while in use and should be repaired.

Recommendation

Contact a qualified plumbing contractor.

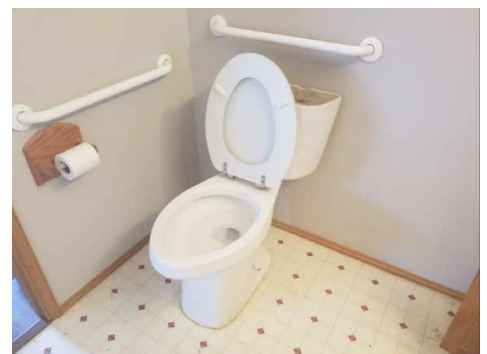
11.5.1 Toilet

FUNCTIONAL BUT LOOSE

The toilet is functional, but loose on the floor and should be secured by a qualified technician, for safety reasons and to prevent possible damage or leaking from around the toilet.

Recommendation

Contact a qualified plumbing contractor.

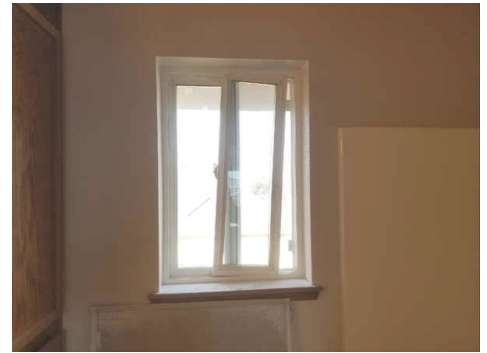
11.12.1 Windows

DIFFICULT TO OPEN OR CLOSE.

Recommendation

Contact a qualified window repair/installation contractor.

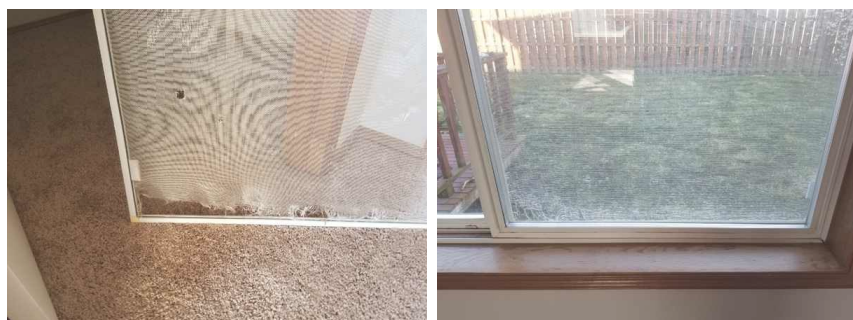
13.5.1 Windows

SCREENS DAMAGED/MISSING

Window screens were missing or damaged in one or more areas. We recommend repair or replacement as needed.

Recommendation

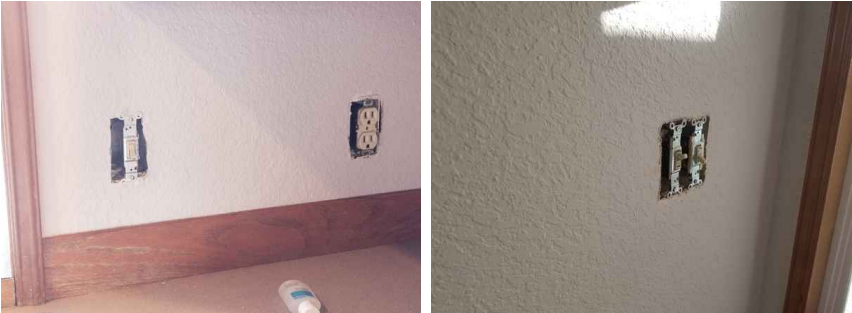
MISSING COVERS

There were missing covers that should be installed

Recommendation
