HOME RESOURCE SOLUTIONS

RESIDENTIAL REPORT

123 Sample Street Sample Report WA 98765

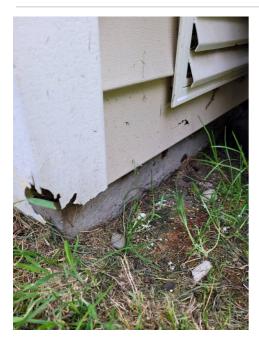
2.1.2 Siding, Flashing & Trim

PAINT OVERSPRAY

Paint overspray on siding has discolored siding in some areas Recommendation
Contact a qualified professional.

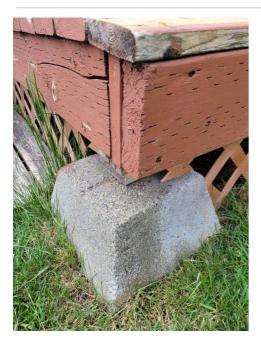
2.5.1 Eaves, Soffits & Fascia

PAINT/FINISH FAILING

The paint or finish is failing. This can lead to deterioration and rot of the material. Recommend that the araes be properly prepared and painted / finished.

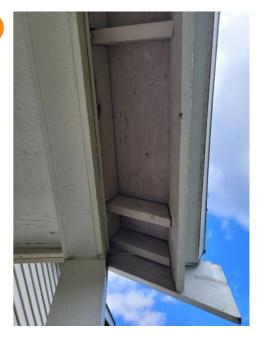
2.5.2 Eaves, Soffits & Fascia

WASPS NEST

Wasp nests were visible under the soffits. Recommend a qualified exterminator evaluate and remove.

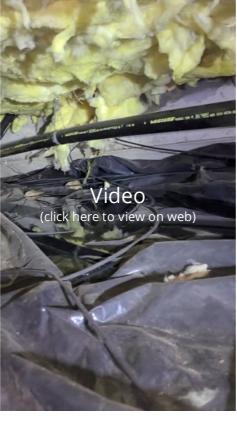
6.3.1 Water Supply, Distribution Systems & Fixtures

DISTRIBUTION PIPE LEAKING

Distribution pipe was leaking. Recommend a qualified plumber evaluate and repair.
