INSPECTION REPORT BY AXIUM INSPECTIONS

5647 S King St
Littleton, CO 80123

Nick Frager
JUNE 30, 2022

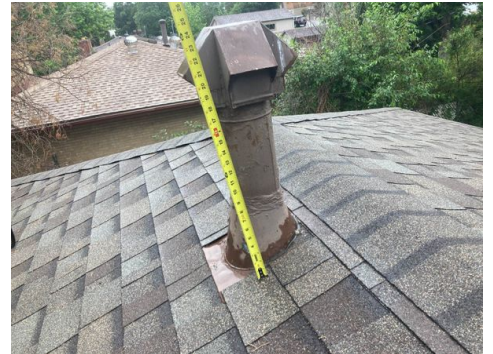
INADEQUATE CLEARANCE - ROOF

One or more combustion appliance exhaust flue(s) did not extend far enough above the roof. To ensure proper draw, furnace flues should extend at least 3 feet above the roof, and 2 feet above any portion of the roof within 10 feet (measured horizontally). The correction could include the addition of a flue extension to encourage a proper draft. A qualified contractor should evaluate and repair/replace as necessary.

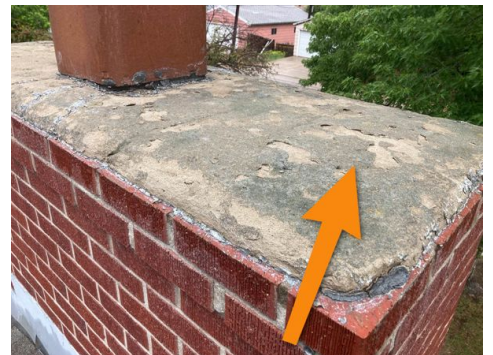
If the crown on top of the chimney is not properly sealed or is extensively cracked, defective, spalled, or displays rust stains, it should be replaced. Sheet metal caps/crowns with minor rust or corrosion should be repaired, but if rust or corrosion is extensive, replacement is recommended.

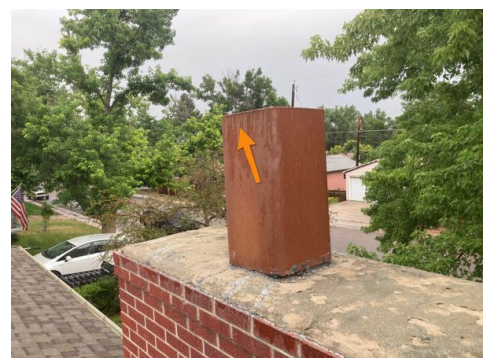
Spark arrestors are to prevent floating embers from a fire (particularly one burning wood) setting light to a flammable roofing surface or falling onto combustible material on the ground. Such a spark arrestor typically consists of a double layer of metal mesh, which catches the ember and allows the flue gas to escape. Spark arrestors also help prevent animals from entering the chimney.

Recommend a qualified contractor evaluate and install the required components.

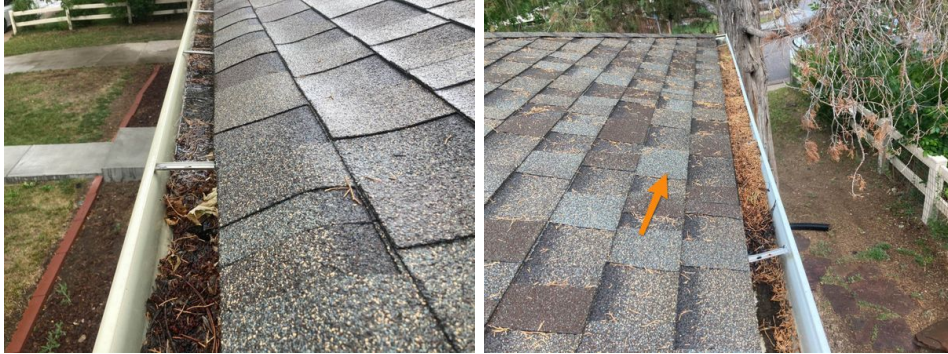
2.8.1 Roof Drainage Systems

DEBRIS IN GUTTERS

Debris in gutters can also conceal rust, deterioration or leaks that are not visible until cleaned.

A qualified contractor should evaluate and repair or replace as necessary and according to current standards.

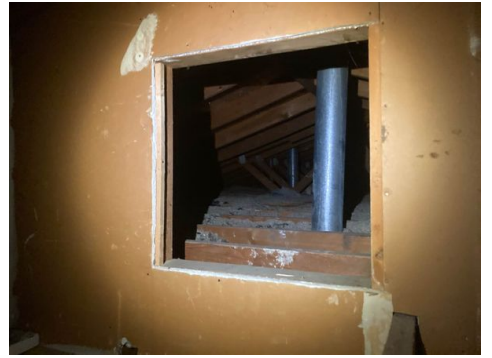
The attic access hatch was missing. A qualified contractor should evaluate and repair or replace as necessary.

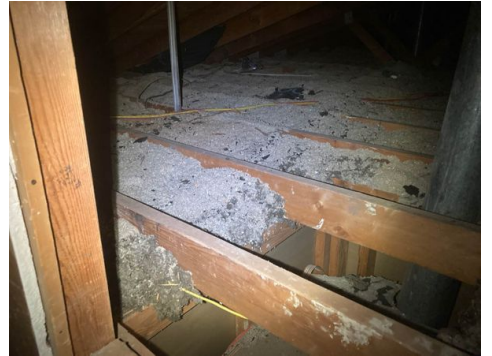
The insulation is thinner than current thermal resistance (R-value) standards.

Recommend a qualified contractor evaluate and repair or replace as needed.

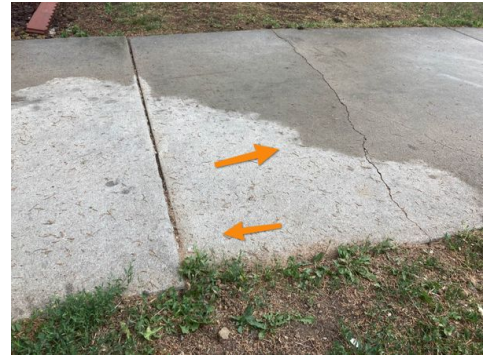
The driveway showed signs of heaving and/or settling in areas. Heaving is often caused by soil that has expanded in volume due to increased moisture content, or by wet soil which has expanded as it became frozen. Settlement is when the soil below a concrete slab is loose, or it can no longer support the weight causing it to sink or crack. This condition could potentially cause a trip hazard.

A qualified contractor should evaluate and repair or replace as necessary and according to current standards.

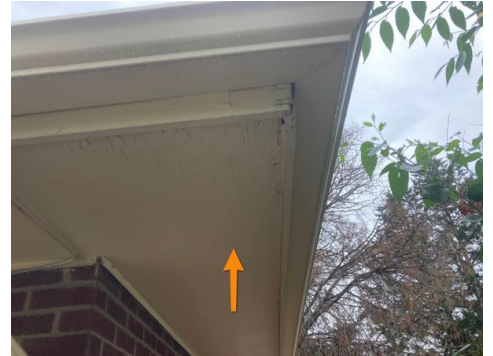
4.5.1 Eaves, Soffits & Fascia

MOISTURE DAMAGE

Components of the eaves, fascia, and/or soffit was warped, swollen, or had peeling paint which are signs of water damage. The materials will eventually begin to rot if left untreated or cause has not been corrected.

A qualified contractor should evaluate and repair or replace as necessary.

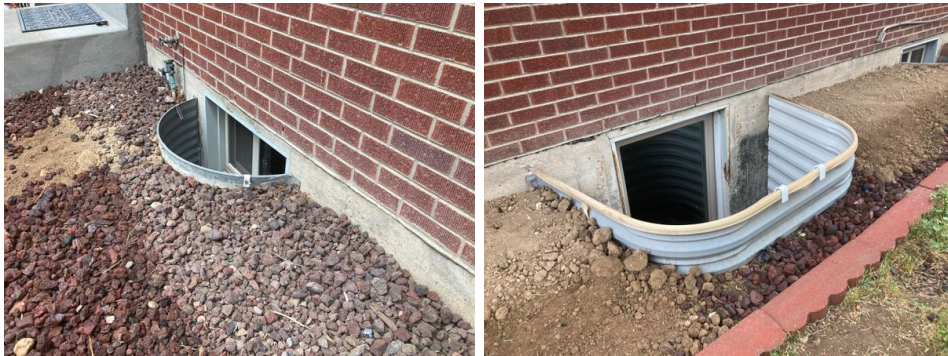
4.10.1 Window Wells

Window Well(s) lacked covers and may represent a danger to small children and may trap pests. A qualified contractor should evaluate and repair or replace as necessary.

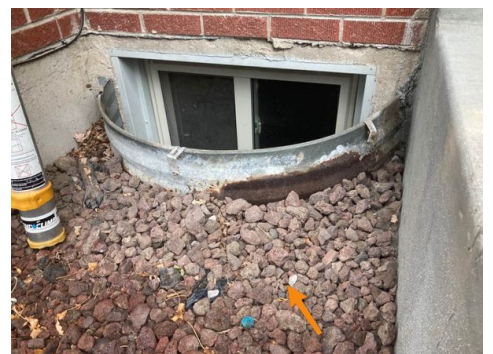
WINDOW WELL RUSTED

Window well(s) were rusted or corroded in areas. A qualified contractor should evaluate and repair or replace as necessary and according to current standards.

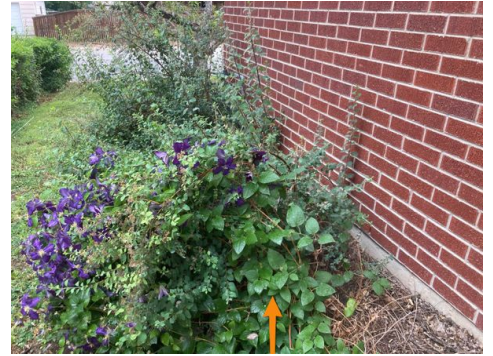
Dense vegetation was present around the house in areas. This condition limited and restricted my visual inspection. Dense vegetation and landscaping up against or near the house foundation and exterior walls may be prone to water penetration and insect infestation. Trimming, pruning and some landscaping is recommended by a qualified contractor

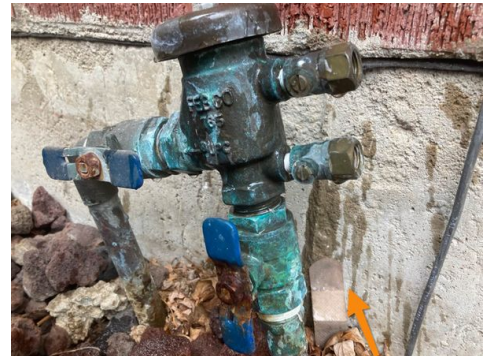
4.13.1 Sprinkler System Supply Line

The lawn sprinkler system supply valves appeared to be corroded and/or leaking at time of inspection. A qualified contractor should evaluate and repair/replace as necessary according to current standards.

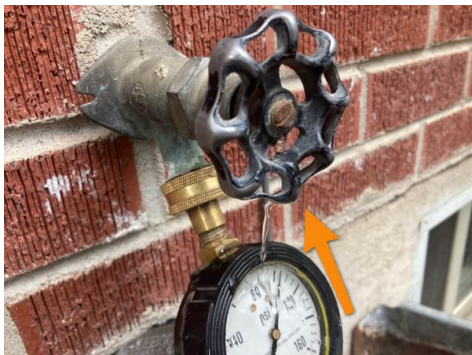
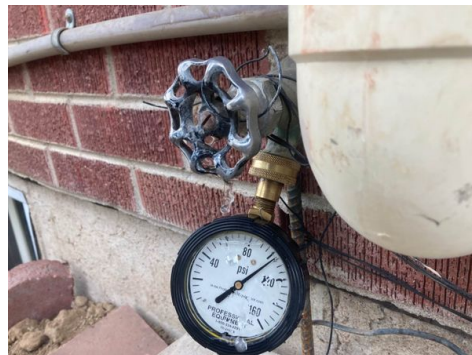
SIGNIFICANT LEAK - KNOB

The outside water faucet had a significant leak from the knob/handle when the water pressure gauge was attached. A qualified contractor should evaluate and repair or replace as necessary and according to current standards.

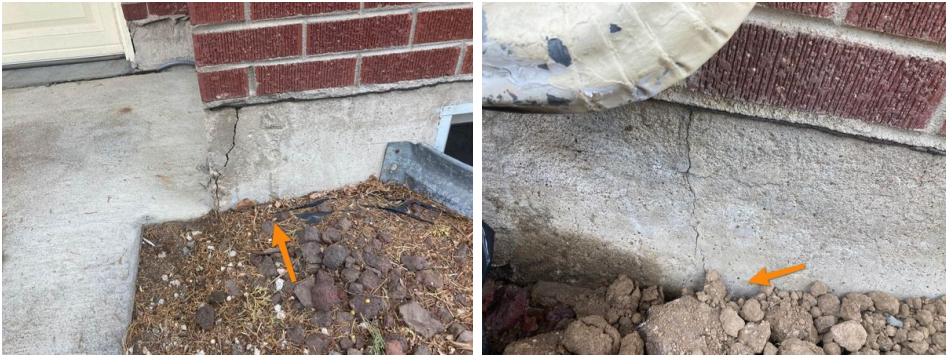
The exterior foundation wall had cracks at the corner. A qualified contractor should evaluate and repair or replace as necessary. Axium recommends our premier partner - Level Engineering. They can be contacted at 720-706-8540 or online at www.axiuminspections.com/structural-engineer.

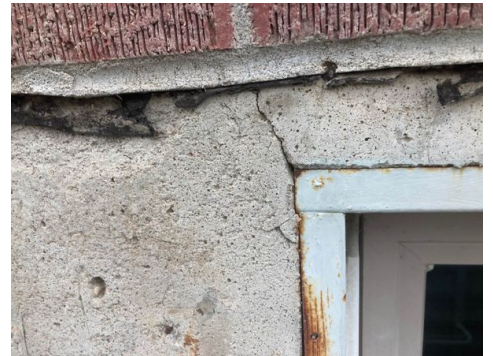
4.17.2 Exterior Foundation Wall

The exterior foundation wall had settlement crack(s.) A qualified contractor should evaluate and repair or replace as necessary. Axium recommends our premier partner - Level Engineering. They can be contacted at 720-706-8540 or online at www.axiuminspections.com/structural-engineer.

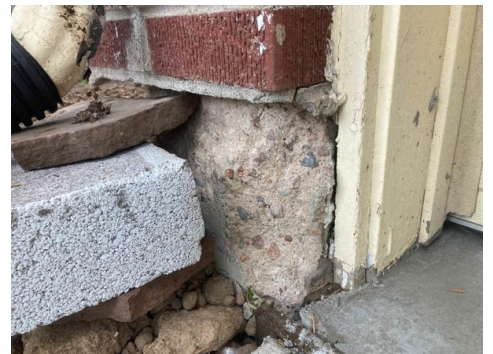
MINOR DAMAGE TO CONCRETE

The visible concrete foundation wall surface was damaged or deteriorated in areas. Recommend a qualified contractor evaluate and repair or replace as needed.

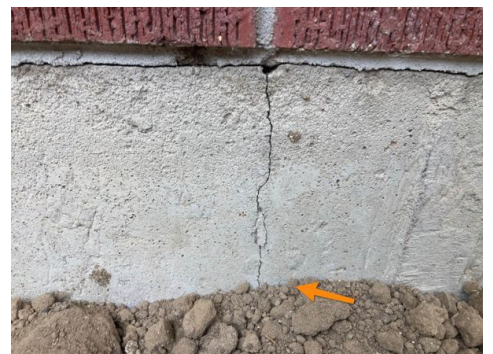
4.17.4 Exterior Foundation Wall

SURFACE CRACKS

The exterior foundation wall appears to have cracks on the surface, or outer portion of concrete. Minimum recommendation is to monitor for any advancement in the defect. Overall recommendation is to have a qualified contractor evaluate and repair or replace as needed.

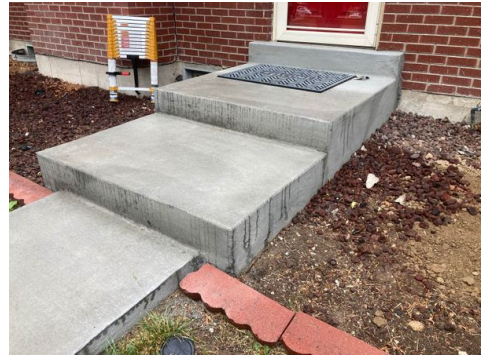
A stairway of more than 3 steps or drop of over 30" was missing a handrail.

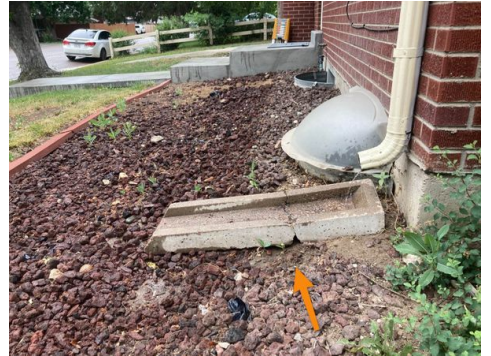
4.21.1 Roof Drainage - Downspouts & Extensions

One or more down spout extensions were too short. Recommend installing 6-8ft long (or greater as needed) extensions to divert rainwater runoff away from the property.

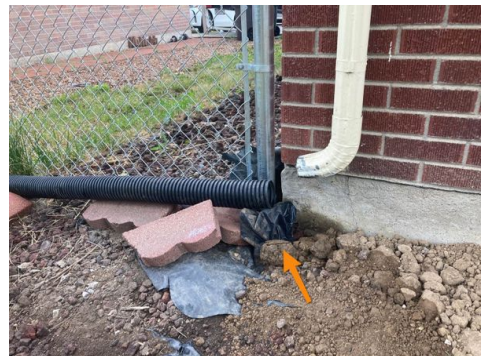
4.21.2 Roof Drainage - Downspouts & Extensions

Downspout(s) need to have extensions reconnected. This condition may cause problems by introducing excessive amounts of moisture to the soil beneath the foundation. Excessive moisture in soil supporting the foundation can affect its ability to support the weight of the structure above and may cause foundation damage from soil movement. When moisture is introduced to the foundation it could also cause possible mold growth. A qualified contractor should evaluate and repair or replace as necessary and according to current standards.

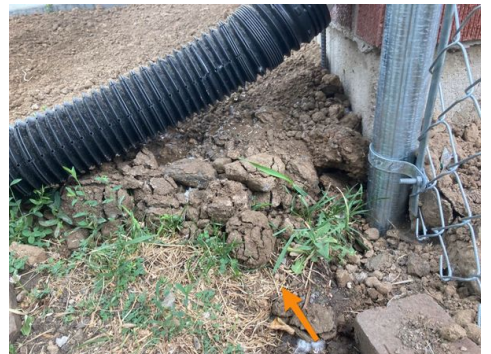
4.21.3 Roof Drainage - Downspouts & Extensions

LEAK

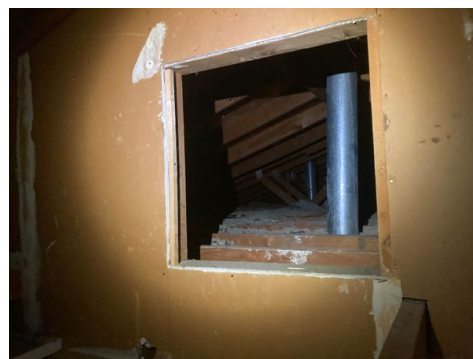
Should the interior attic span across the entire structure, the attic access should be installed according to current fire rating standards. Alternatively, there may be a wall to separate the garage and the house or attic space. This wall must be covered with at least 1/2-inch thick (and preferably 5/8-inch thick Type X) gypsum board or equivalent applied to the garage side.

Recommend a qualified contractor evaluate and repair or replace as needed.

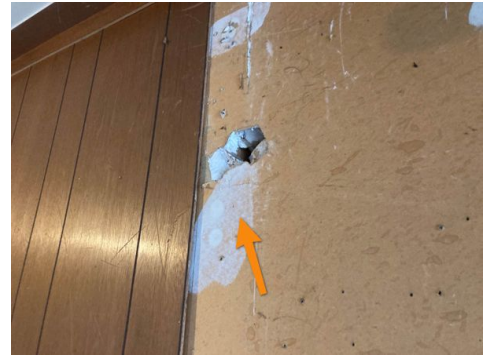
5.3.2 Ceiling, Walls & Firewalls

FIREWALL BREAK - WALL

The wall to separate the garage and living areas, including an attic wall, should be fire-rated. This wall must be covered with at least 1/2-inch thick (and preferably 5/8-inch thick Type X) gypsum board or equivalent applied to the garage side.

Recommend a qualified contractor evaluate and repair and seal all openings as necessary.

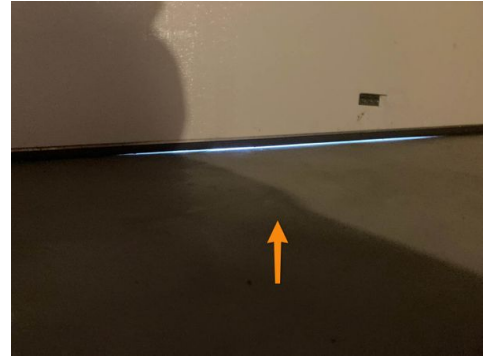
5.5.1 Vehicle Door

The garage door was missing weather stripping or did not evenly seal at the floor or sides of the door. A qualified contractor should evaluate and make adjustments, repair, or replace as necessary.

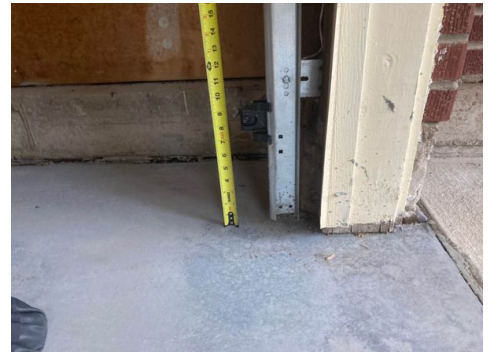
The photo-electric reverse sensors are installed too high from the garage floor surface.

The vertical distance between the photo-eye beam and the floor should be no more than 6 inches.

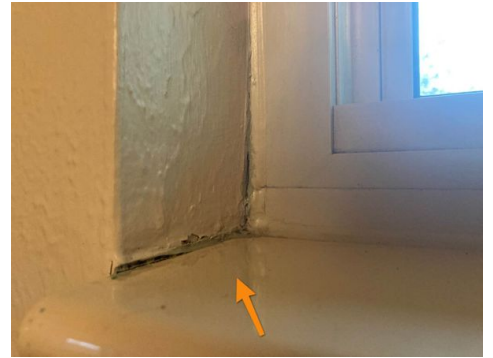
There was cracking around some windows on the interior (where the window meets the wall). A qualified contractor should evaluate and repair or replace as necessary.

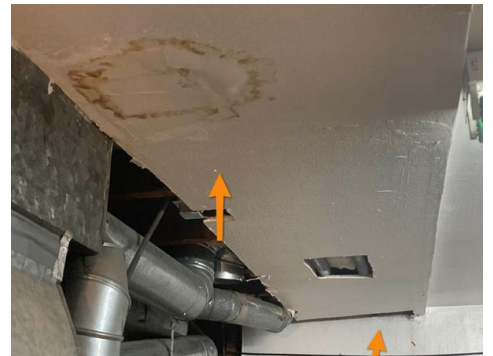
6.2.3 Ceilings & Walls

The ceilings showed evidence that moisture was entering from behind possibly including damage and deterioration. A qualified contractor should evaluate and repair or replace as necessary.

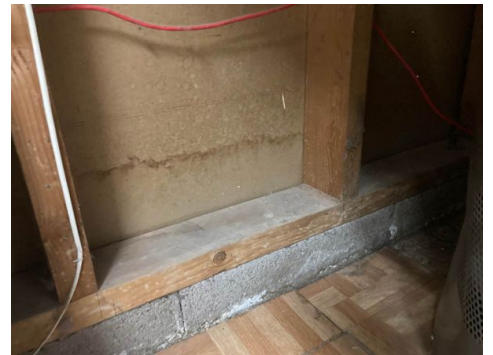
6.2.4 Ceilings & Walls

The interior walls showed evidence that moisture was entering from behind possibly including damage and deterioration. A qualified contractor should evaluate and repair or replace as necessary.

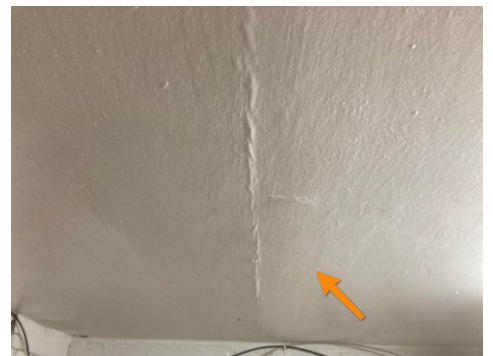
6.2.5 Ceilings & Walls

Minor cracking was visible on the interior ceilings. A qualified contractor should evaluate and repair or replace as necessary.

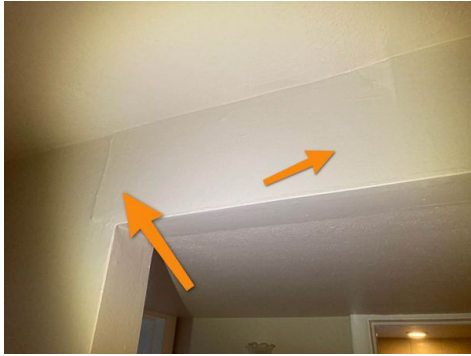
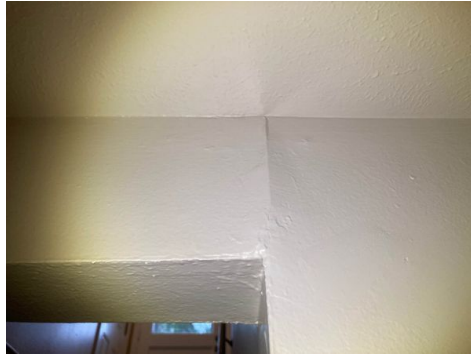
6.2.7 Ceilings & Walls

POSSIBLE MOLD

Evidence of a possible mold like substance was observed on the interior walls and/or ceilings. We did not inspect, test or determine if this growth is or is not a health hazard. The underlying cause is moisture. It is recommended to consult a mold inspector or mold remediation specialist to determine if further action is needed.

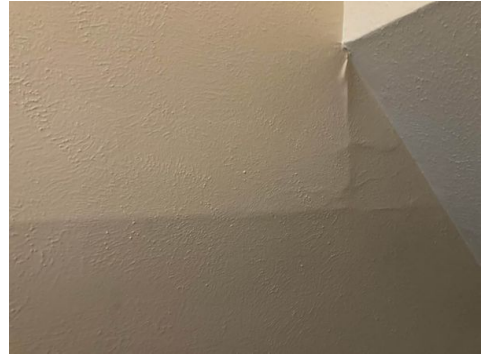
6.2.6 Ceilings & Walls

Minor cracking was visible on the interior walls. A qualified contractor should evaluate and repair or replace as necessary.

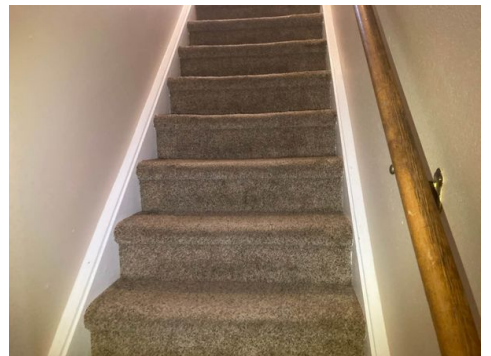
6.3.1 Floors

The carpet was stained in areas. A qualified contractor should evaluate and repair or replace as necessary.

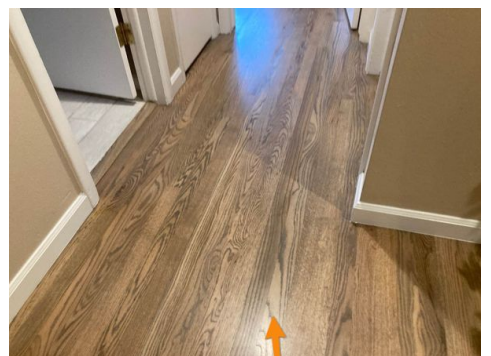
6.3.2 Floors

The floor squeaks when stepped on. A qualified contractor should evaluate and repair or replace as necessary.

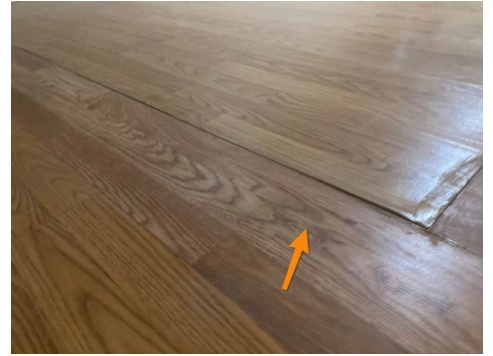
6.3.3 Floors**SEAMS WIDE/INCONSISTENT**

The flooring had seams that were wide or inconsistent possibly indication loose flooring or poor installation. A qualified contractor should evaluate and repair or replace as necessary.

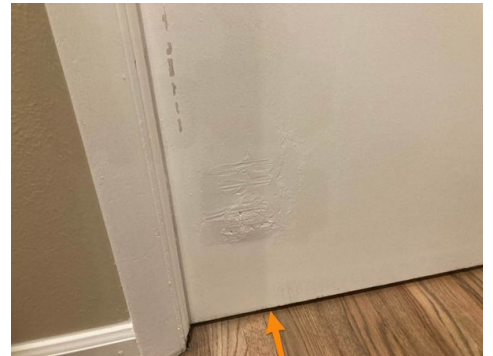
6.4.1 Doors**DAMAGED - DOOR**

The door surface was damaged. A qualified contractor should evaluate and repair or replace as necessary.

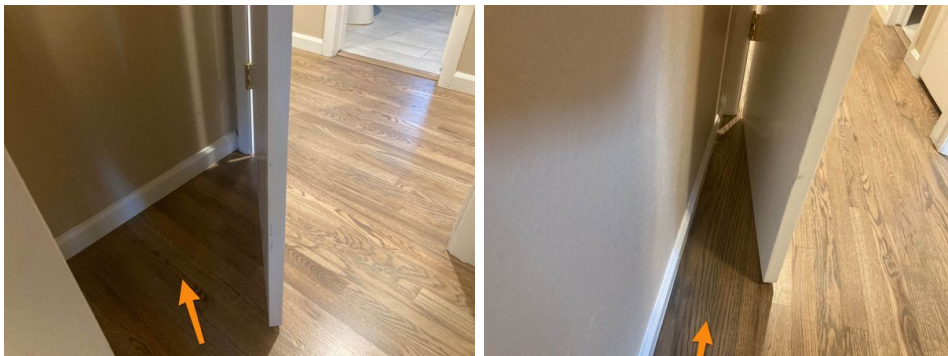
6.4.2 Doors**MISSING - DOORSTOP**

The door had a damaged or missing doorstop. A qualified contractor should evaluate and repair or replace as necessary.

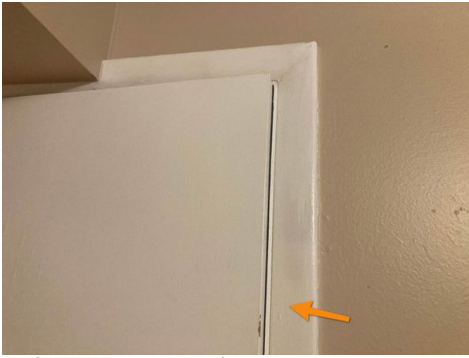
An interior door rubs at the door frame when closing. This may mean the door or frame is out of square or that hinges may not be installed properly.

A qualified contractor should evaluate and repair or replace as necessary.

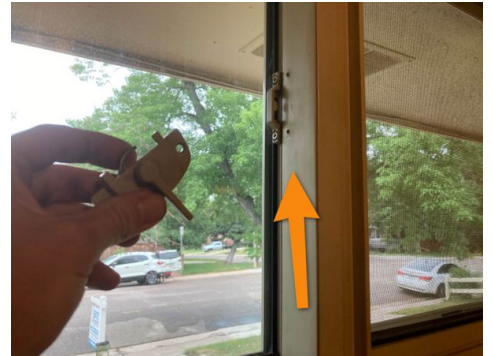
The window had damaged or missing lock hardware. A qualified contractor should evaluate and repair or replace as necessary.

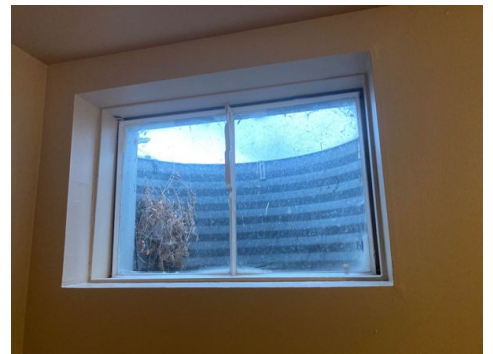
WORN OR NEARING THE END OF LIFE EXPECTANCY

Windows installed in the home appeared to be worn or aged. This apparent condition can mean the windows are deteriorated or difficult to operate, and can also mean they are not consistent with current efficiency standards. They were possibly original and were either at or near their serviceable lifespan. Recommend further evaluation by a qualified contractor and budgeting for potential future replacement.

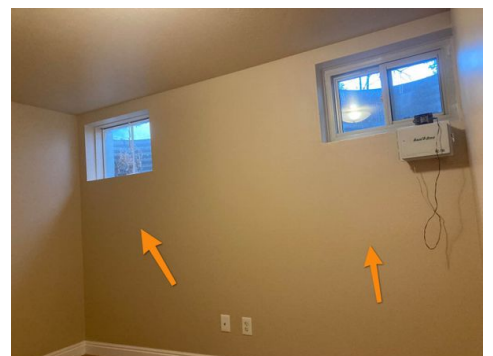
6.5.3 Windows

NO EGRESS

At the time of the inspection, the property did not have emergency escape and rescue openings which met generally-accepted current standards. Egress opening requirements:

For safety reasons, all sleeping room and basements greater than 200 square feet and new properties should meet the generally-accepted current standards for emergency escape and rescue openings, which include the following requirements:

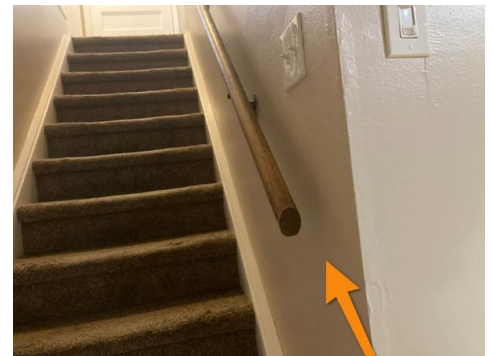
At the interior stairs, the handrail had a railing end that did not return to the wall or post. A fall could occur if something (purse, backpack etc.) caught the end of the railing when descending. A fall or injury could occur if not corrected. A qualified contractor should evaluate and repair or replace as necessary.

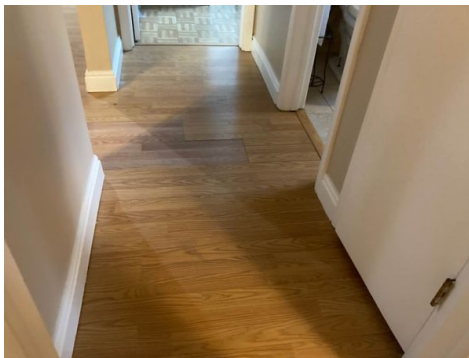
Carbon monoxide detectors were not installed within a specified distance of each room lawfully used for sleeping purposes. The inspector recommends installation of carbon monoxide detectors in appropriate locations. Colorado House bill 1091 became effective on July 1, 2009 that requires Carbon Monoxide detectors to be installed in most properties that has a fuel-burning heater or appliance, a fireplace, or an attached garage.

There are no carbon monoxide detectors on the lower or upper level.

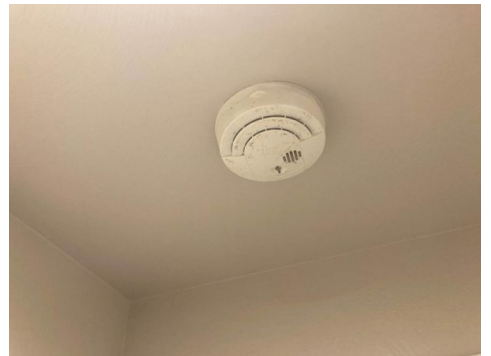
Some of the smoke detectors appeared to be old and beyond their expected life. A qualified person should repair or replace as needed. The existing smoke detectors were tested if present, but they are only noted as to presence and operation as of date of inspection. Smoke detectors may work today but not work when you need them to work. This is why it is important for you to test them on a regular basis, monthly at least. Smoke detectors are recommended by the U.S. Product Safety Commission to be installed inside each bedroom and adjoining hallway and on each living level of the property and basement level.

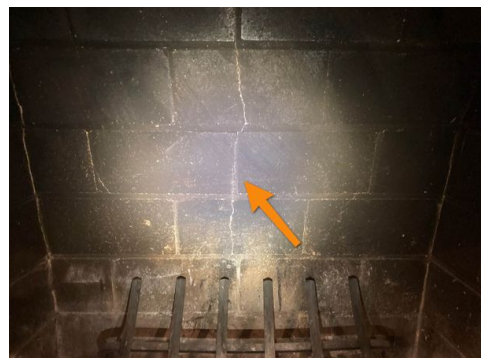
6.11.1 Fireplace Wood-Burning

The fireplace had damage to the interior chamber. A qualified contractor should evaluate and repair or replace as necessary.

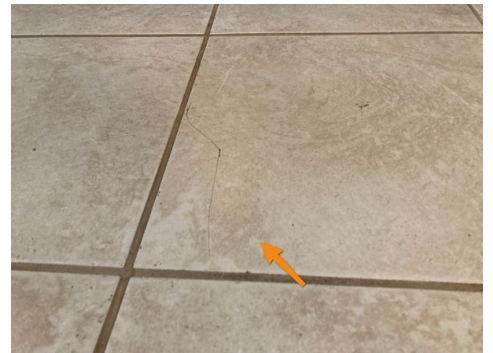
CRACKED/DAMAGED TILE

The tile floor was cracked/damaged. A qualified contractor should evaluate and repair or replace as necessary.

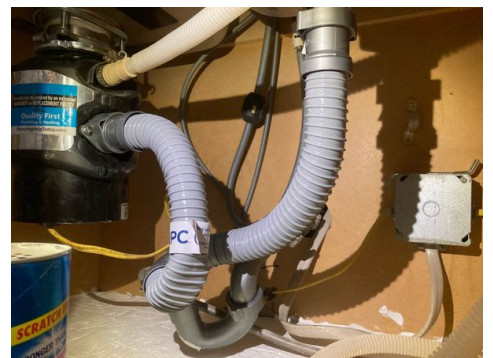
The sink drain line had a flex pipe used as part of the drain line. Flexible drain lines can smell, clog, leak or fail. Flex lines design includes multiple folds in which moisture may become trapped and mold may grow. A qualified contractor should evaluate and repair or replace as necessary.

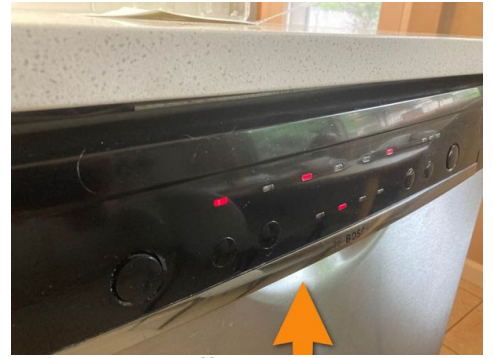
7.13.1 Dishwasher

The dishwasher control panel was illegible, inoperable, or damaged. A qualified contractor should evaluate and repair or replace as necessary.

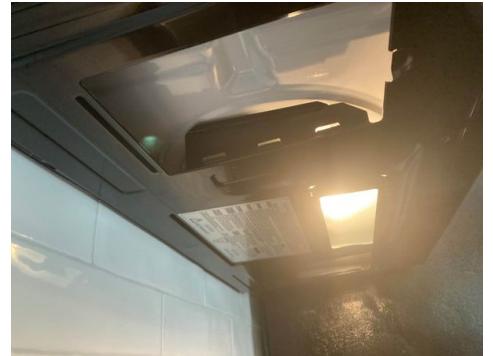
MISSING SCREEN, FAN COVER

The vent hood was missing the screen and/or fan cover. A qualified contractor should evaluate and repair or replace as necessary.

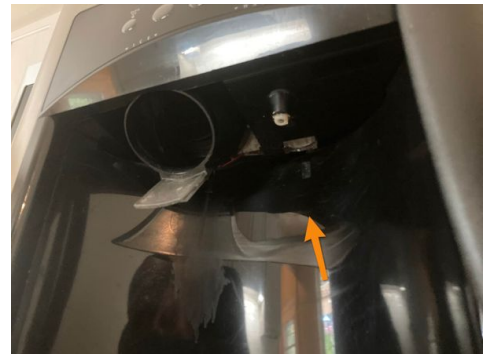
7.17.1 Refrigerator

WATER/ICE DISPENSER NOT OPERATIONAL

Although outside the scope of a general home inspection, the inspector noted the refrigerator ice and/or water dispenser was not working. A qualified contractor should evaluate and repair or replace as necessary.

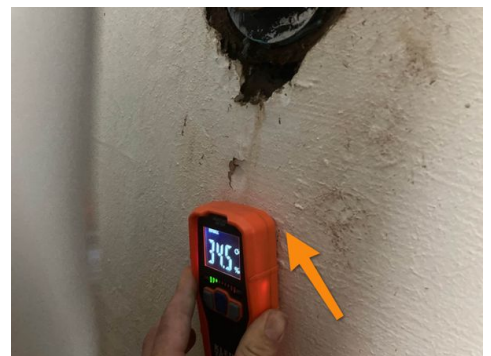
MOISTURE DAMAGE-WALLS

The interior walls showed evidence that moisture was entering from behind possibly including damage and deterioration. A qualified contractor should evaluate and repair or replace as necessary.

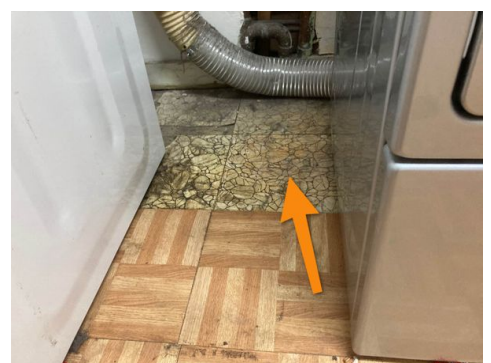
8.8.1 Floors

ASBESTOS TILES

The property had tiles that may contain asbestos. A qualified contractor should evaluate and repair or replace as necessary. Flooring, including sheet vinyl, vinyl or asphalt floor tiles and any associated paper-like backing, mastic, adhesive or glue, may contain asbestos. In the past, asbestos fibers were added during the production of flooring materials to strengthen the flooring and to increase its durability. Flooring that contains asbestos, when intact and in good condition, is generally considered non-friable and is not hazardous. Heat, water, weathering or aging can weaken flooring to the point where it is considered friable. Friable material includes any material containing more than 1 percent asbestos that can be crumbled, pulverized or reduced to powder with hand pressure. This includes previously non-friable material which has been damaged to the extent that it may be crumbled, pulverized or reduced to powder by hand pressure and can also be made friable during its removal. Friable materials can release asbestos fibers into the air. Once in the air, asbestos fibers present a health hazard to people who inhale those fibers.

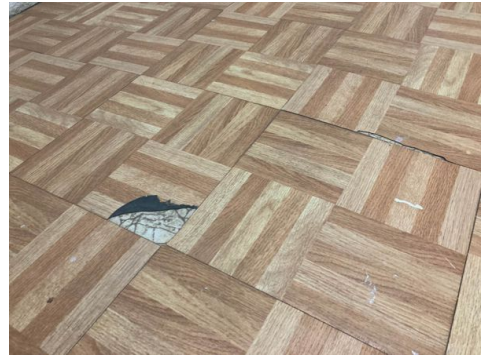
8.8.2 Floors

FLOOR DAMAGED

There appeared to be some damage to the interior flooring in areas. Recommend a qualified contractor evaluate and repair or replace as needed.

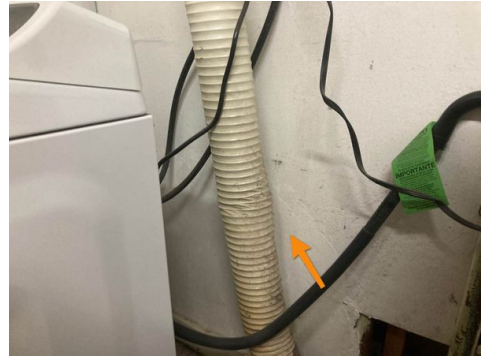
8.11.1 Dryer Vent Piping

PLASTIC VENT

A dryer vent connection was installed in the laundry area. The dryer was vented using a flexible plastic vent which is not approved by the Underwriter's Laboratory (UL). Flexible plastic dryer vent is more likely to accumulate lint than a smooth metal vent creating a potential fire hazard. Excessive lint accumulation can increase drying time and shorten the dryer's lifespan. The inspector recommends replacing the plastic vent with a properly installed UL approved dryer vent. A qualified contractor should evaluate and repair or replace as necessary.

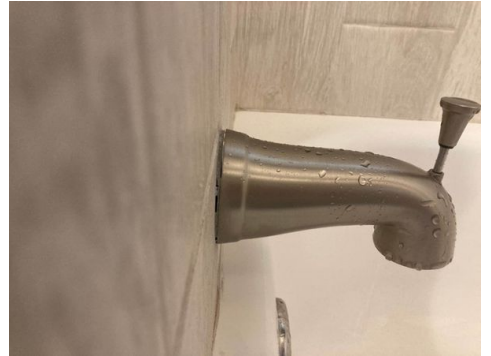
SEAL TUB SPOUT

The tub spout should be sealed at the wall to prevent moisture intrusion in to the wall component. A qualified contractor should evaluate then repair or replace as advised.

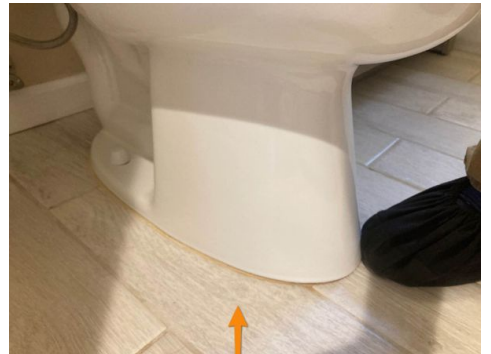
9.13.1 Toilets

LOOSE AT THE FLOOR

The toilet was loose at the floor. This condition typically is caused by loose bolts or nuts and/or missing floor seals. Loose toilet can result in leaks, water damage, and mold, as well as damage to the toilet, water supply lines, bolts, and drainage pipes. A qualified contractor should evaluate and repair or replace as necessary.

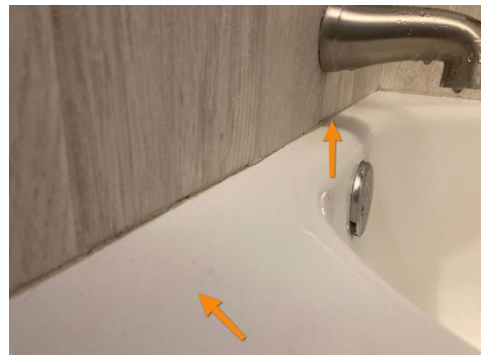
9.14.1 Tub, Shower Area

MISSING/DAMAGED GROUT

Tiles on the wall in the bath/shower area had missing or damaged grout. A qualified contractor should evaluate and repair or replace as necessary.

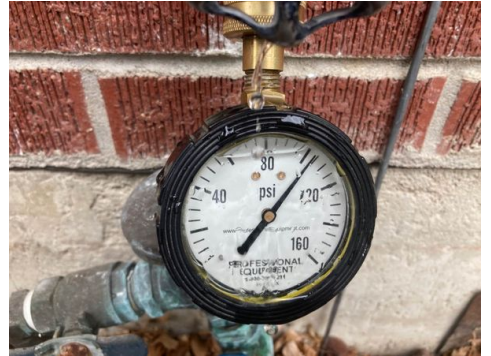
11.4.1 Water Pressure

HIGH WATER PRESSURE

The property water supply pressure measured at the exterior faucet or laundry appliance hose bib. Property water supply pressure exceeded the 80 pounds per square inch (PSI) limit considered the maximum allowable by generally accepted current standards. Excessively high water pressure can stress connections in the plumbing system and appliances is likely to cause leaks.

A qualified contractor should install a pressure regulator or evaluate and repair or replace one as necessary.

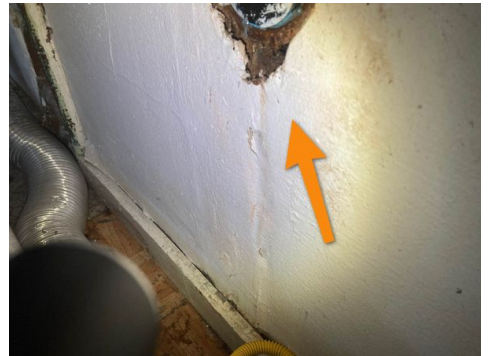
11.5.1 Drain, Waste, & Vent Systems

LEAKING - DRAIN LINE

The drain pipe was actively leaking at the time of inspection. A qualified contractor should evaluate and repair or replace as necessary.

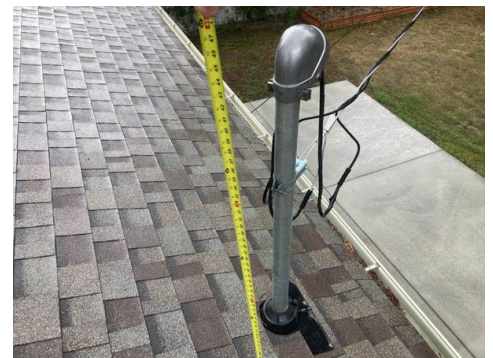
INADEQUATE SUPPORT AT CONDUIT

I observed indications of inadequate support at the electrical conduit.

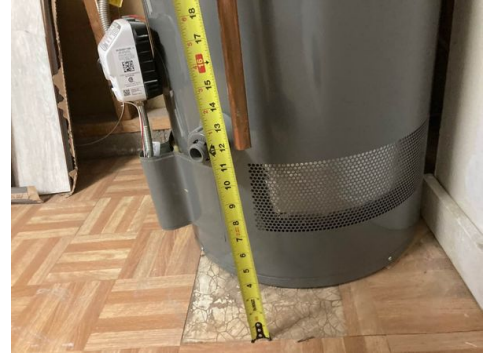
OVER 6" FROM FLOOR

The TPRV pipe did not conspicuously terminate within 6 inches of the floor. This may allow high pressure hot water to cause unnecessary damage. A qualified contractor should evaluate and repair or replace as necessary.

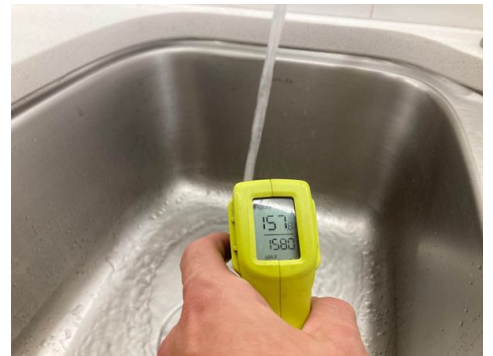
13.13.1 Water Temperature

WATER TEMPERATURE HIGH

The water temperature was higher than the acceptable range of 120-130 degrees. We recommend adjusting the water heater thermostat.

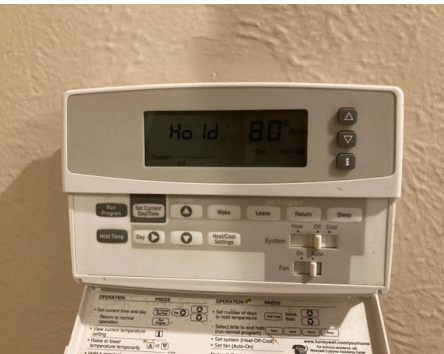
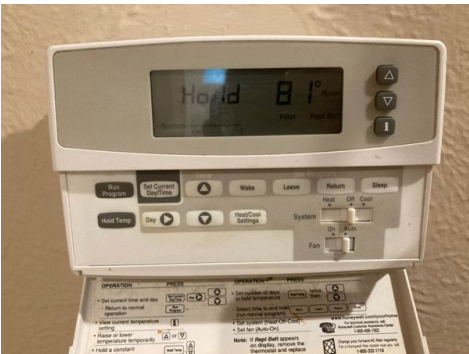
Thermostat & Normal Operating Controls: (P2) Thermostat Location
Hallway

The thermostat(s) was installed at a location in the property, which appears to be adequate to operate the HVAC system efficiently. The thermostat(s) was fastened securely to the wall, activated the HVAC unit, and appeared to be in serviceable condition. The inspector takes two pictures of the thermostat. The first picture is to show all of the settings on the thermostat before the inspector operates it and the second picture shows that the inspector has reset the thermostat back to the original settings after the operation.

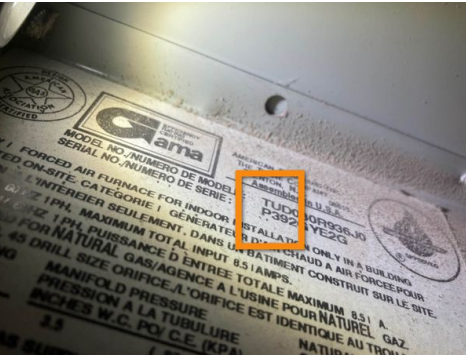
BEYOND TYPICAL LIFE EXPECTANCY

Due to the year of manufacture, the heating system is assumed to be near the end of its expected service life. Regular maintenance and monitoring of its condition is recommended. Budgeting for repairs and future replacement is recommended. A qualified contractor should evaluate to clean, service/repair/replace as necessary, and certify the unit if possible. [InterNACHI's Standard Estimate Life Expectancy Chart for Homes](#)

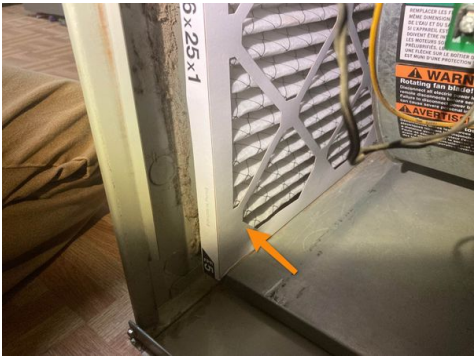
NOT SECURED

The HVAC system air filter was not properly secured. This condition reflects a lack of regular maintenance of the HVAC system. Clogged filters can restrict air flow and increase internal temperatures. A clean air filter will help increase the efficiency and prolong the life expectancy of the heating and cooling system. Due to the damage that can be caused by dirty or clogged coils, recommend replacing filter, as well as cleaning, servicing and evaluating of the HVAC system by a qualified HVAC professional and repair or replace as necessary.

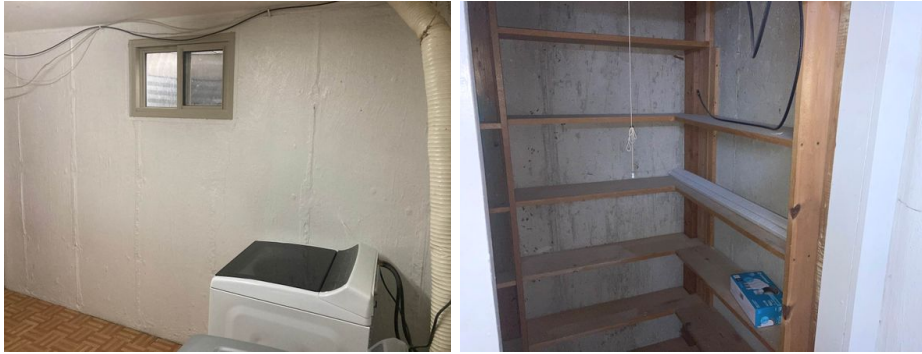
Foundation Wall: (P1) Inspected

The visible portions of the foundation walls were inspected for overall condition at the time of the inspection. Due to expansive soils, and concrete setting conditions, minor cracks are to be expected. Any notable deficiencies or exceptions will be listed in this report.

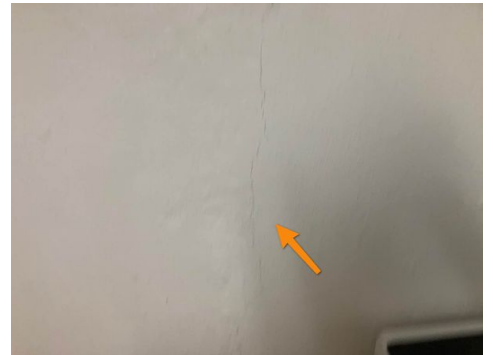
16.3.1 Foundation Wall

MINOR CRACKS

There were minor to moderate cracks in the basement foundation wall. These cracks should be sealed to prevent moisture intrusion and monitored for further movement. Further analysis by a licensed structural engineer is recommended. Axiom recommends our premier partner - Level Engineering. They can be contacted at 720-706-8540 or online at www.axiuminspections.com/structural-engineer.

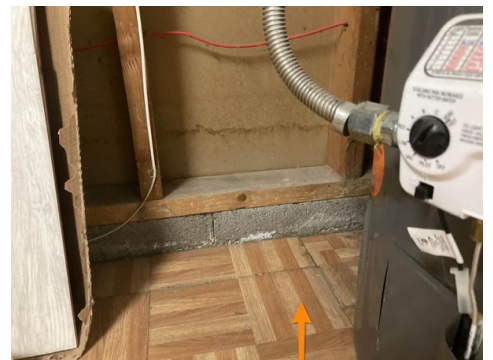
16.4.1 Basement Interior Wall Structure

BASEMENT WALLS NOT FLOATING

Basement walls were not constructed using a method which will allow for soil movement. This method is usually termed "floating" the walls and involves leaving a gap at the bottom of the wall so that vertical movement (heaving) of the concrete slab basement floor will not be transmitted to the rest of the property structure. Colorado has areas with expansive soils. Expansive soils are soils which increase to many times their original volume in response to increases in soil moisture content, creating forces which can easily damage property structural components such as foundations, floor slabs, flat work and interior and exterior wall coverings. Consider consulting with a qualified contractor before the expiration of your Inspection Objection Deadline to discuss options and costs for correction an/ or stabilization.

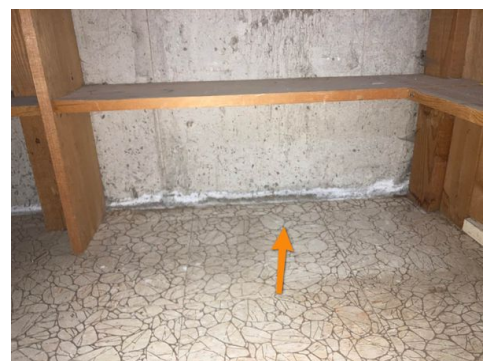
16.5.1 Moisture Intrusion

EFFLORESCENCE

Efflorescence (white powdery substance) on the wall indicates moisture is in contact with the concrete or masonry. This does not necessarily indicate that intrusion will occur. I recommend checking the gutters and the downspout drain lines for proper operation. Also, a water proofing paint could be applied to the interior side of the wall if necessary. Efflorescence is found on many properties without water intrusion occurring inside the property. But, it should alert you to the possibility that future steps may be needed. A qualified contractor should evaluate and repair as necessary.
