CHESTER COUNTY HOME INSPECTIONS

SWIMMING POOL AND SPA

917 Roundelay Dr
West Chester PA 19382

JULY 25, 2018

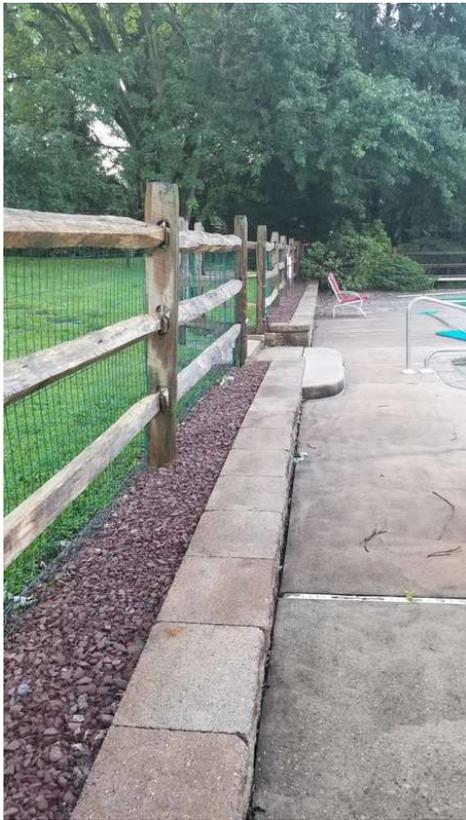
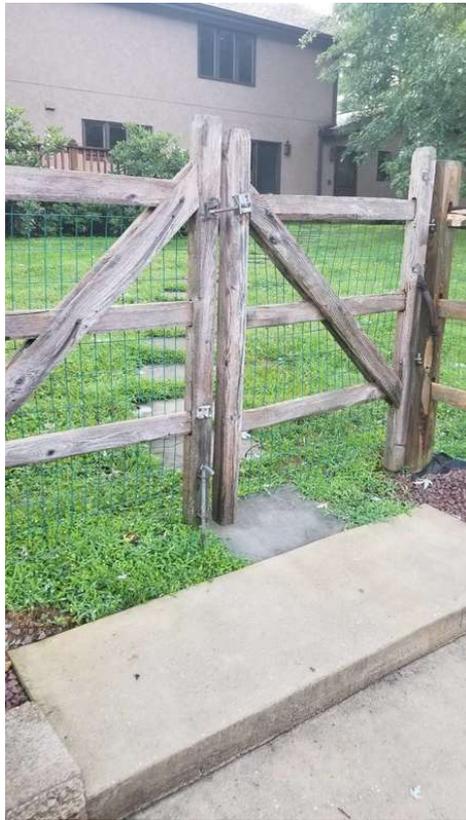
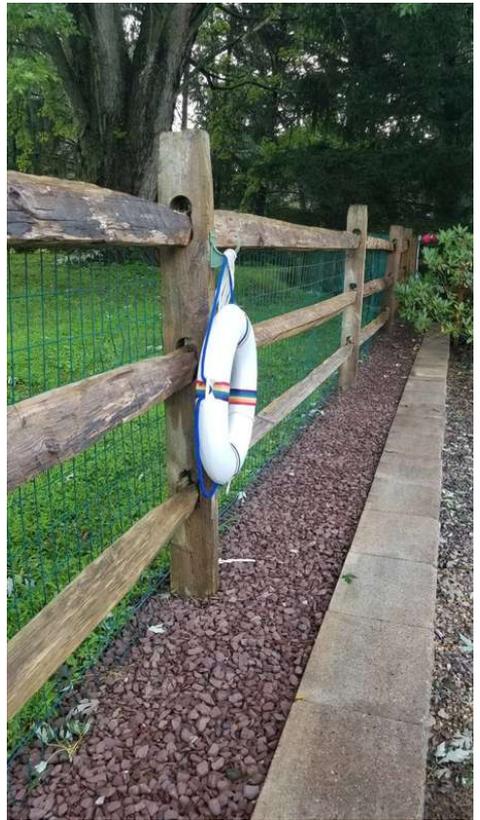
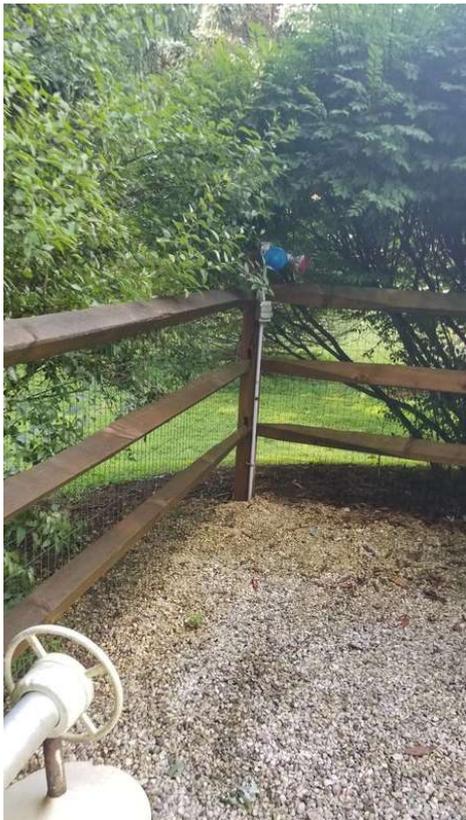
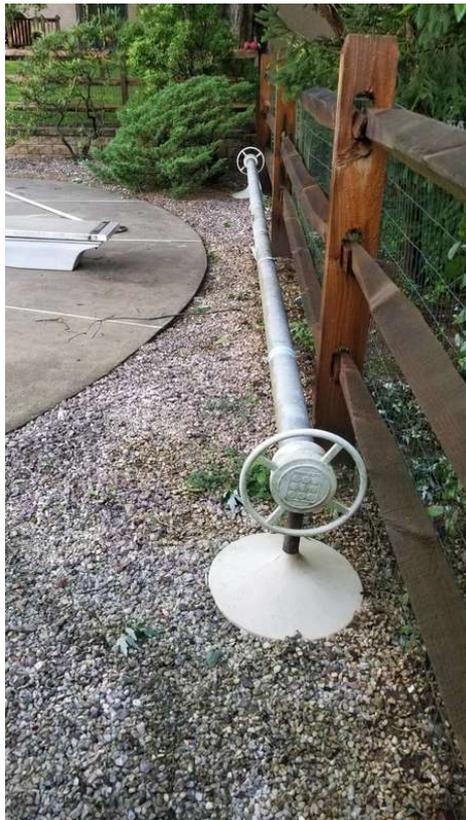
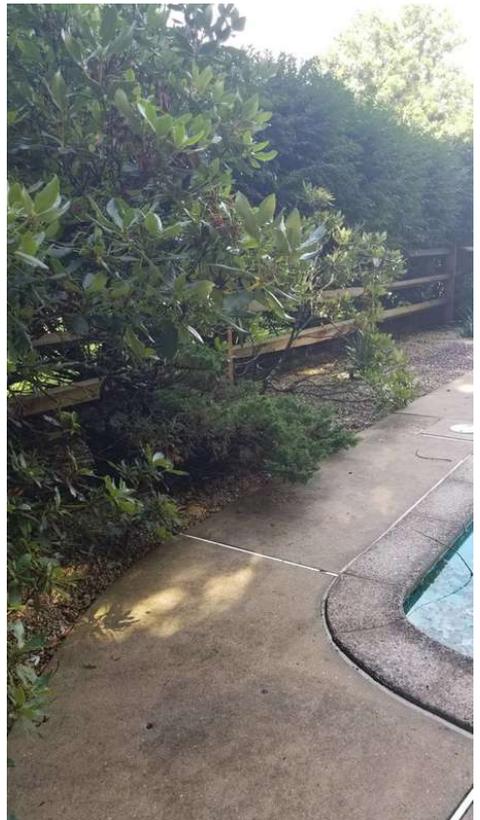
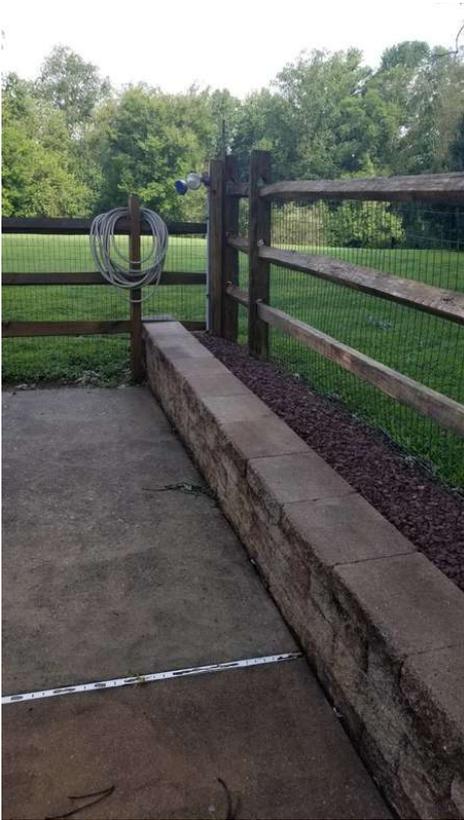
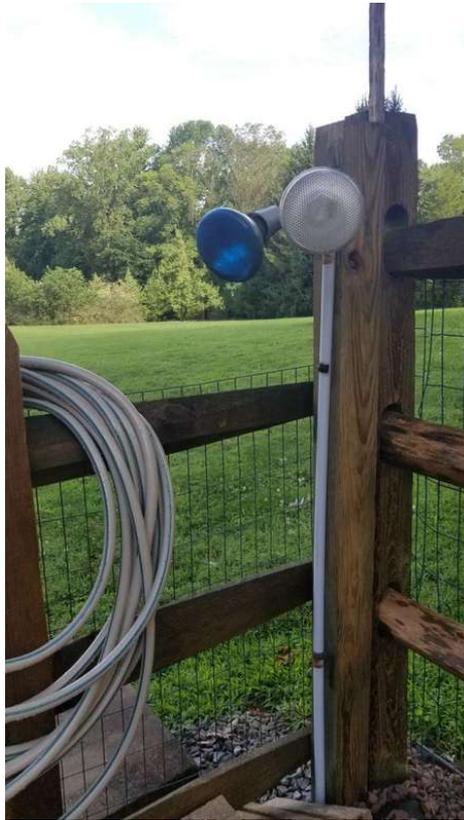
Safety Devices: Fence

Pool fencing code require that pool fencing should be a minimum of 48 inches with the latch a minimum of 54 inches off the grade. Gates should be self-closing and self-latching and open away from the pool/spa area.

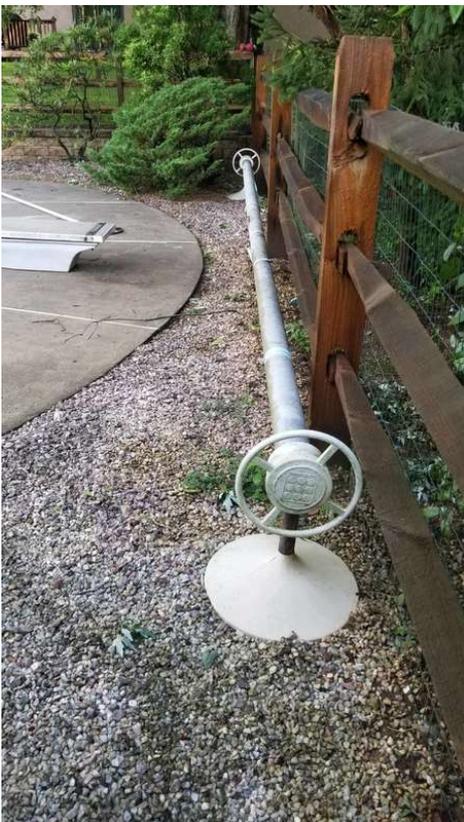
Safety Devices: Safety Cover

The pool decking has mounting holes for pool cover spring attachments, a cover roller is present but no pool cover itself was noted. Covers are helpful to keep leaves out during off-season.

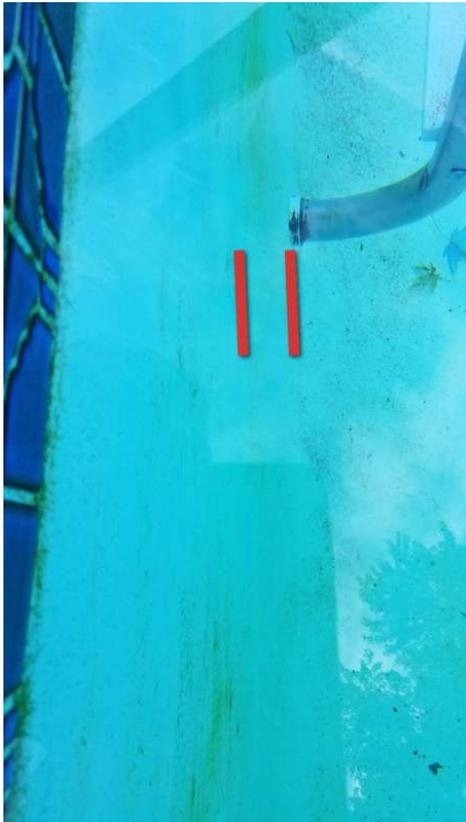
Safety Devices: Ladder

Functional ladder is present at deep end. Typically a pool ladder would be resting against the pool wall to make it sturdy. This ladder was offset from the inside pool wall by about 6" - anyone climbing out at the ladder would experience it is moving or flexing. This is hard to take a picture of due to reflection but the red lines on picture indicate the distance between the bottom of the ladder and the wall.

Ladder not supported against pool wall

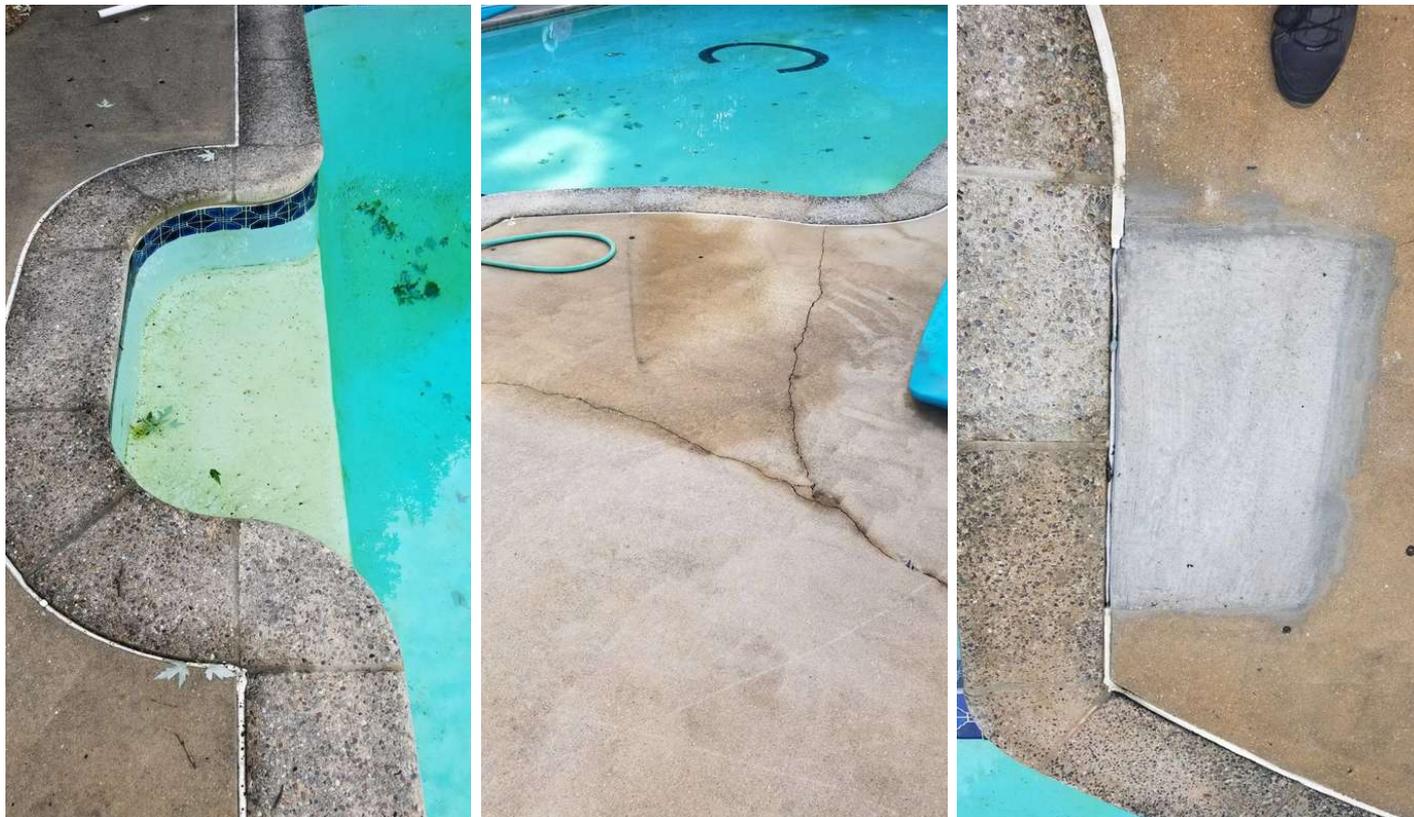
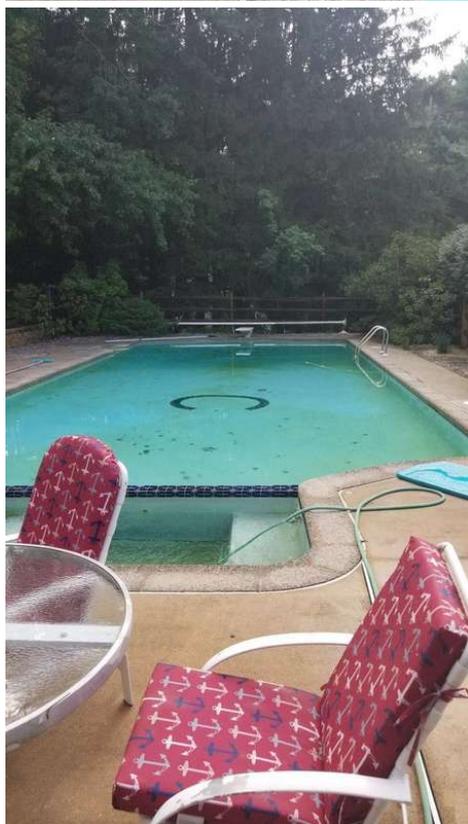
Coping, Tile and Decking: Photos

Coping is generally good but stained. Decking has seen better days. There was recent patchwork at the spa for plumbing repairs.

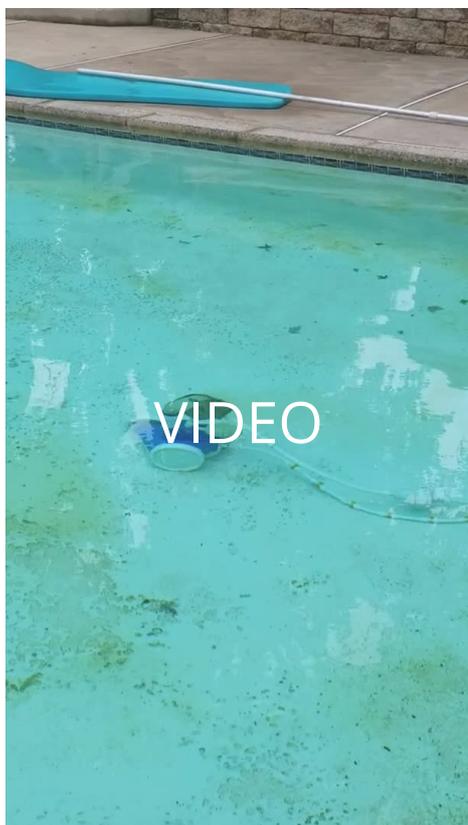
Cleaner: Type

The automatic pool cleaner is of the type that operates by pressure - it has a separate pump that operates it. The pressure out the top of the device causes suction at the bottom which pulls debris into the mesh trap at the exit. This type of device can only capture what it traps in the bag. Any fine particles like sand and dead algae are just stirred up and passes out the mesh. It is effective for picking up leaves and such but does nothing to getting sand or particles into the filter. Other types of cleaners are effective in cleaning up debris as well as particle vacuuming.

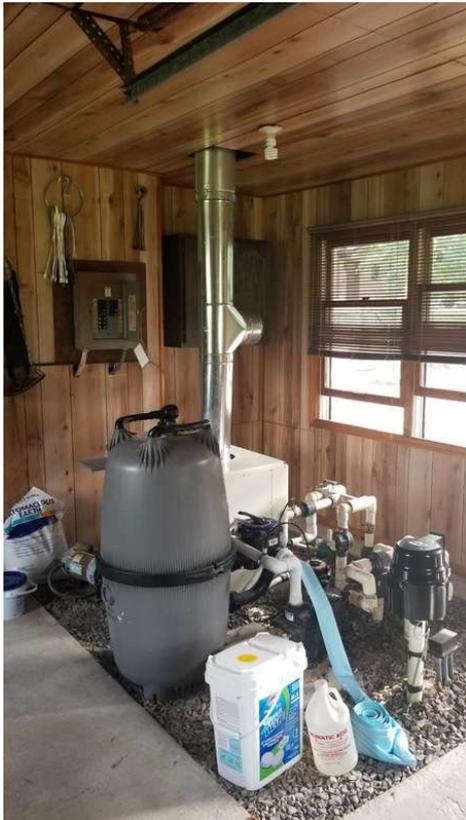
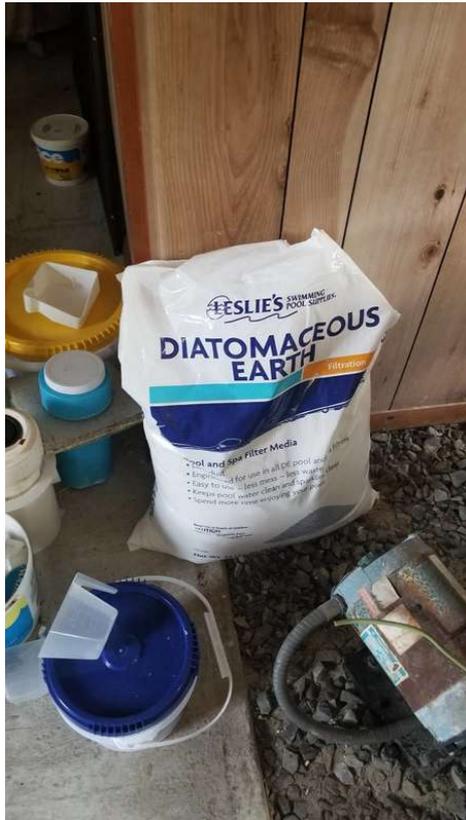
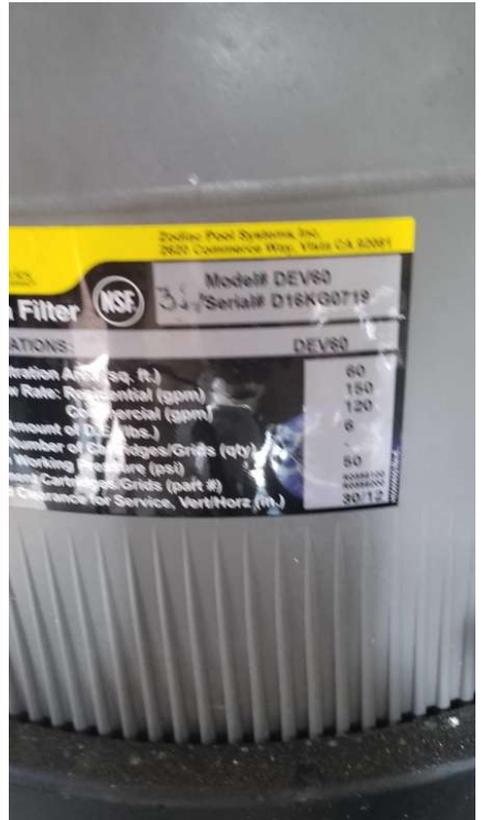
Filtering/Cleaning: Type

Filter: Jandy model DEV60, type Diatomaceous Earth (DE), 150 gallon per minute flow rate. Holds 6 lbs of DE

Starting pressure after back-washing was approximately 8 PSI with water flow set to both skimmers and returns. This is a usable reference pressure point, if it gets about about 16 PSI, it is time to backwash.

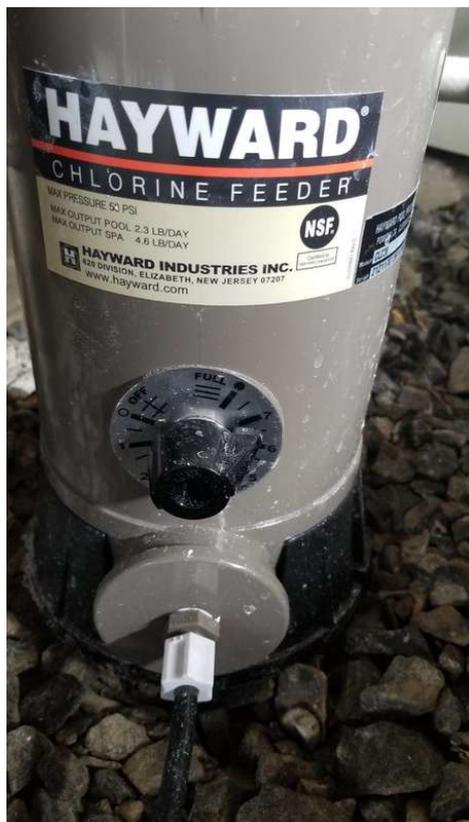
Chlorine Dispenser: Type

The chlorine dispenser is an add-on to the pool system. It taps off the main plumbing with an aftermarket mounting. It holds about half-dozen 3" chlorine tablets. The amount of water that can flow through the unit is controlled by a small valve; set that to change the amount of chlorine introduced into pool. It will be necessary to check the canister about once per week.

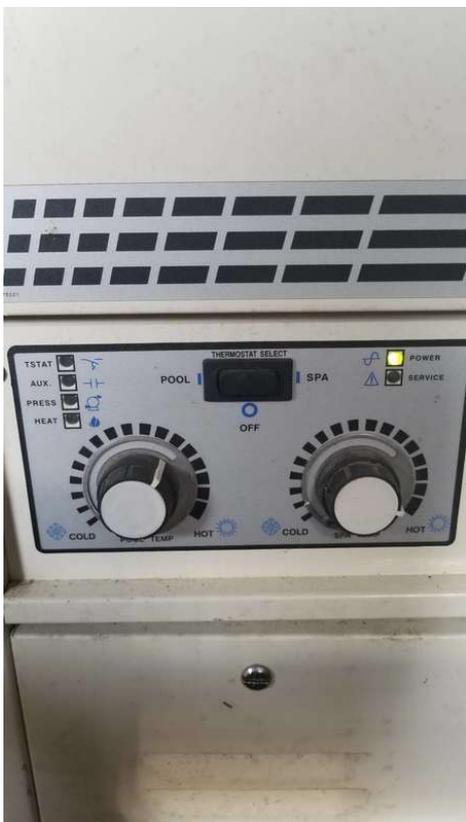
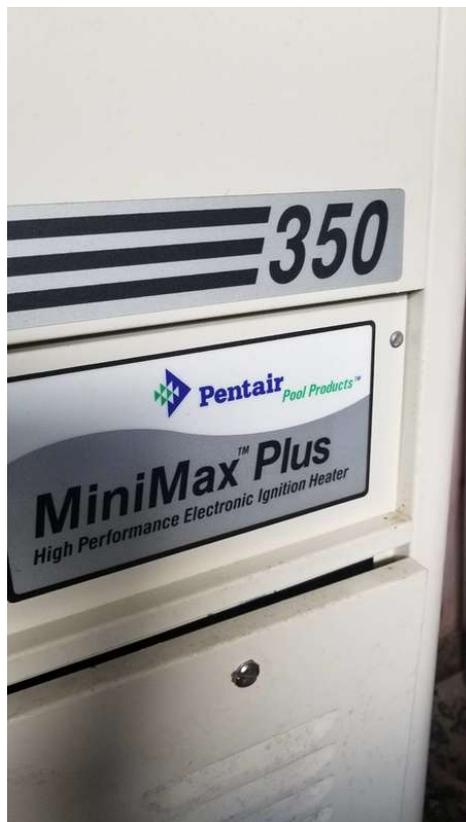
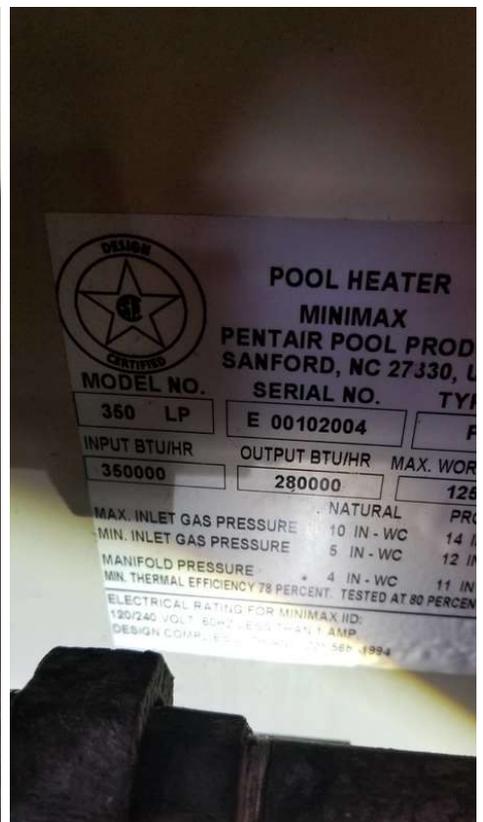
Heating: BTU Rating:

Pentair MiniMax 350 -- 350,000 BTU input, 280,000 BTU output

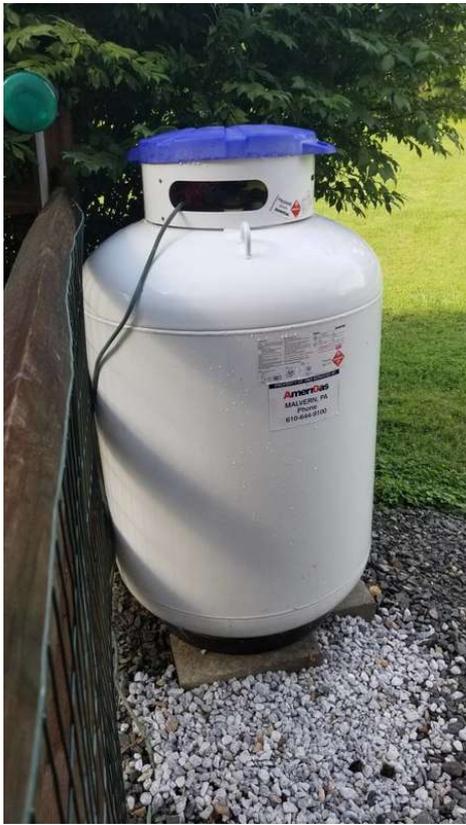
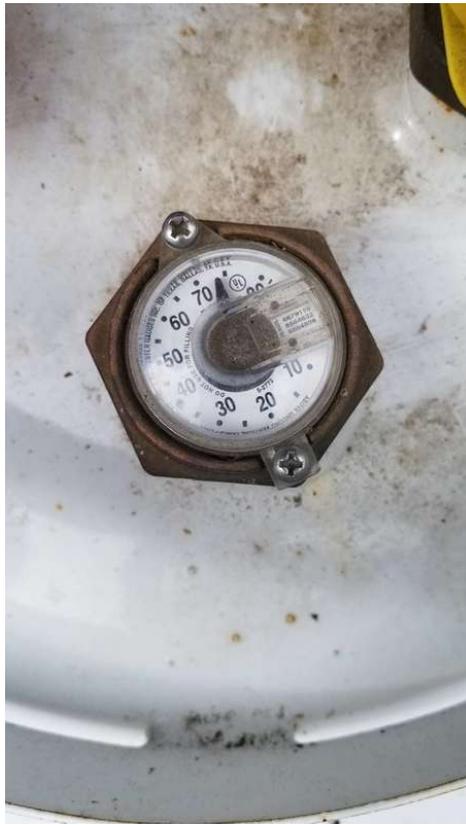
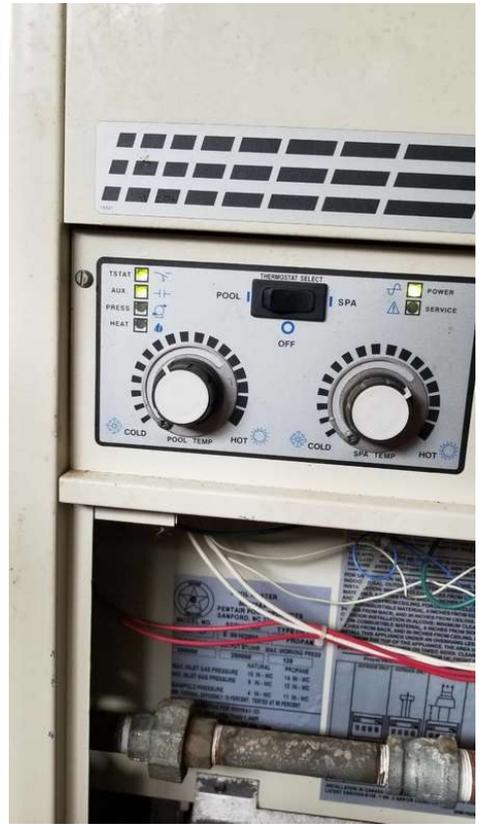
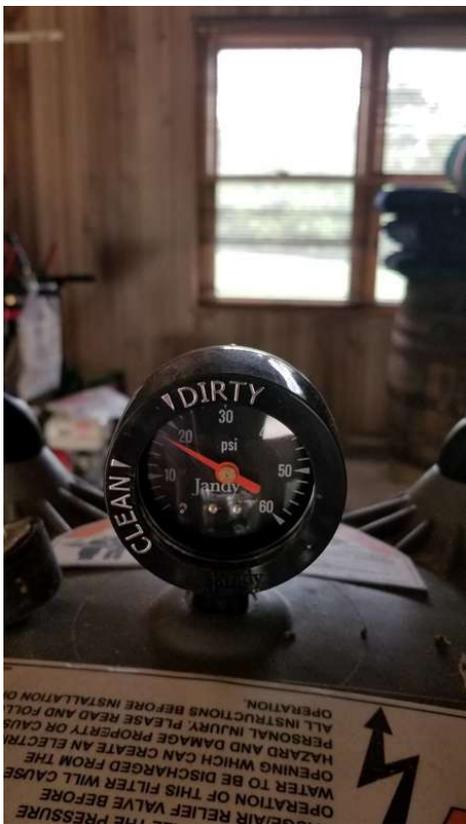
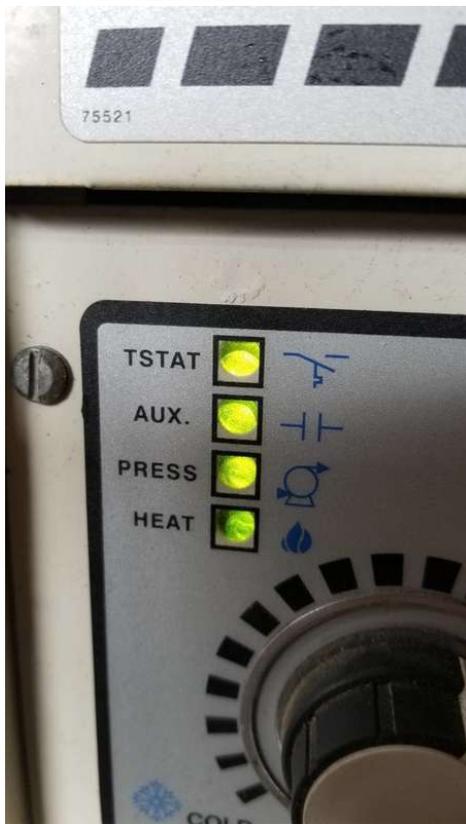
Heating: Serviceable

Heater is older but appears in good serviceable condition. This heater is propane; the tank is readily accessible and was almost full. This tank is only used for the pool heater.

Note that the heater will not fire up when the water filter is dirty. At time of inspection, the filter pressure reading was between clean and dirty on the scale (18 PSI) and the heater would not fire up. After backwashing it started right up at 8 PSI This is a fail-safe mechanism in case the filter is blocked thus restricting water flow.

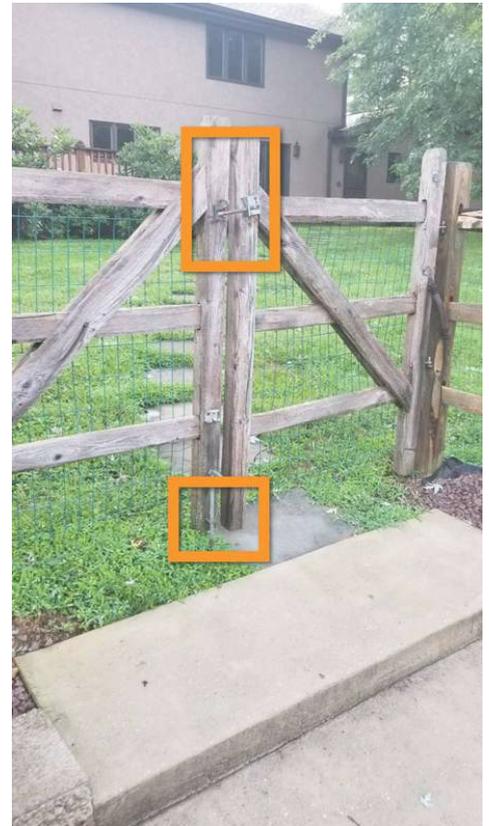
GATE LATCH

The gate does not latch properly. Repairs are needed to the latch itself as well as the gate. Gate should open away from pool only.

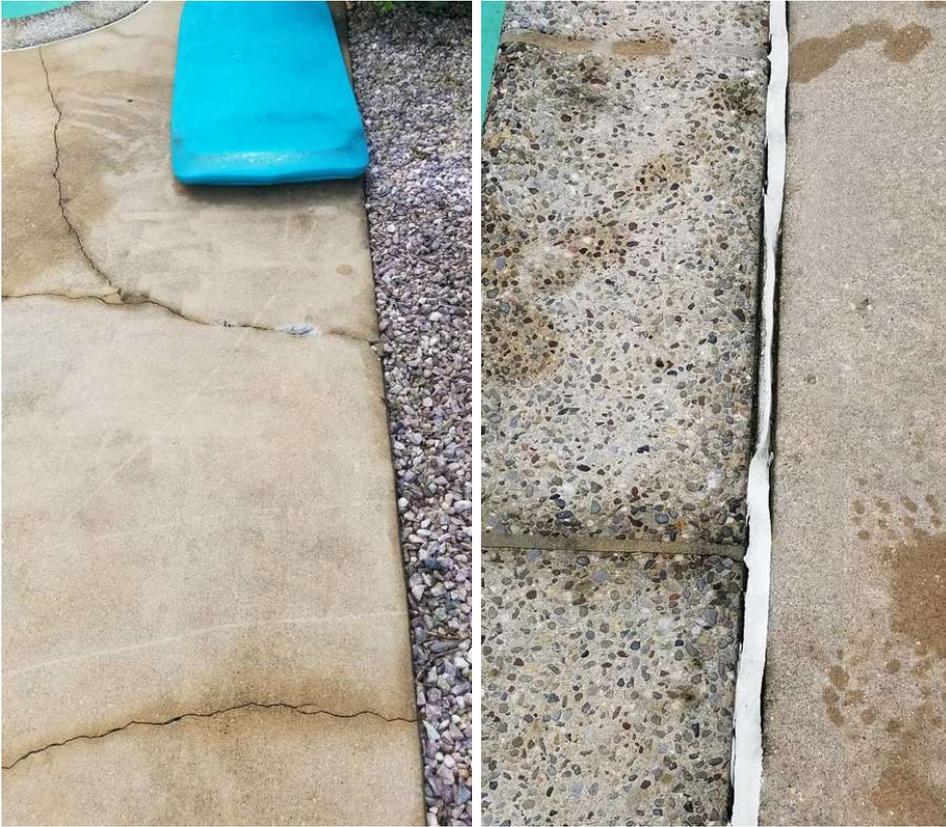
DECK CONDITION

There are several cracks in the decking concrete, some are large and will become trip hazards. The grout line between the coping and deck is failing which allows water to get in under the deck and at pool walls.

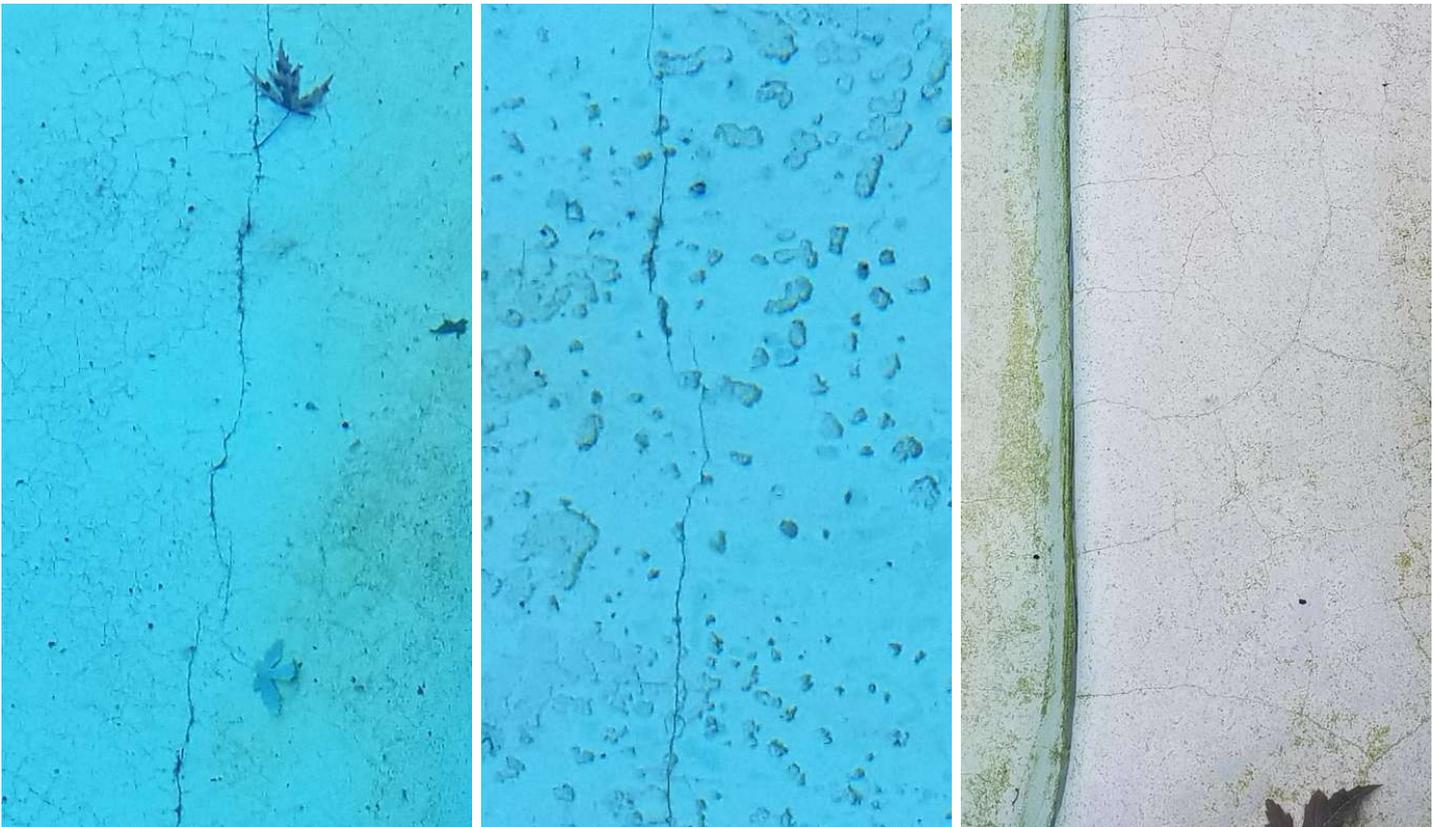
SURFACE DEFECTS NEED LIKELY REPAIR

There are hairline cracks and wider cracks in the plaster all around the pool and spa. The plaster surface is worn.

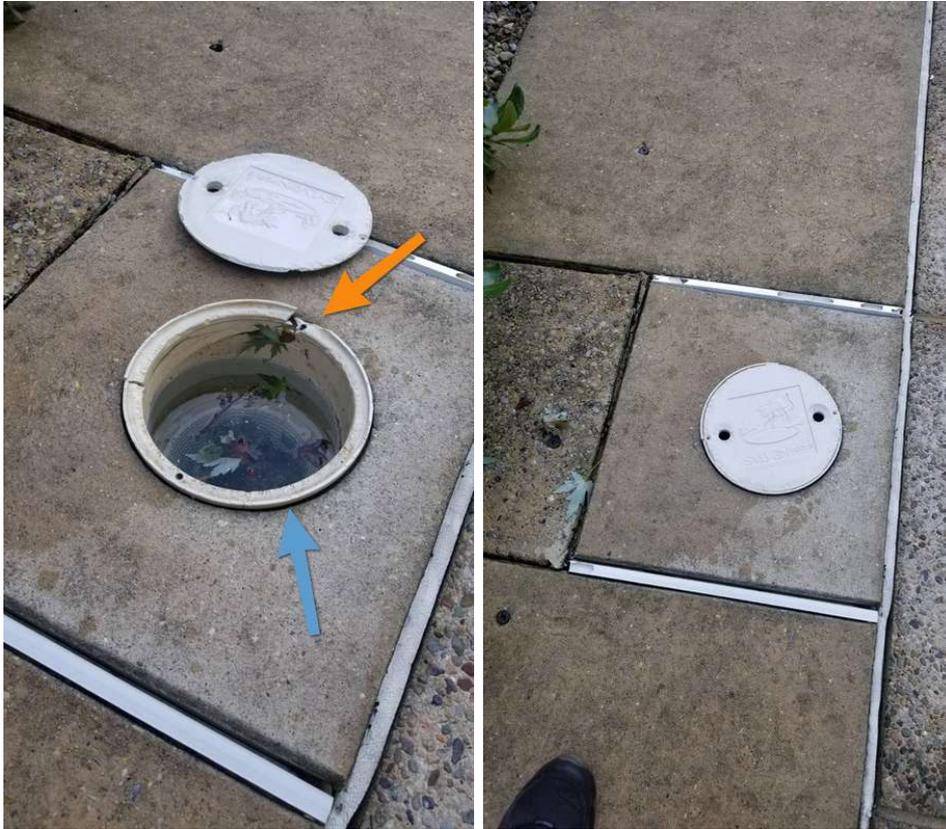
Upgrades/Maintenance Items**SKIMMER FAILING**

One of the skimmers was loose against the decking and cracked at the outer rim. This means the plastic skimmer body did not have the support it should have and is thus prone to more damage. A cracked skimmer will leak below the decking and against the pool wall. (Other skimmer was intact)

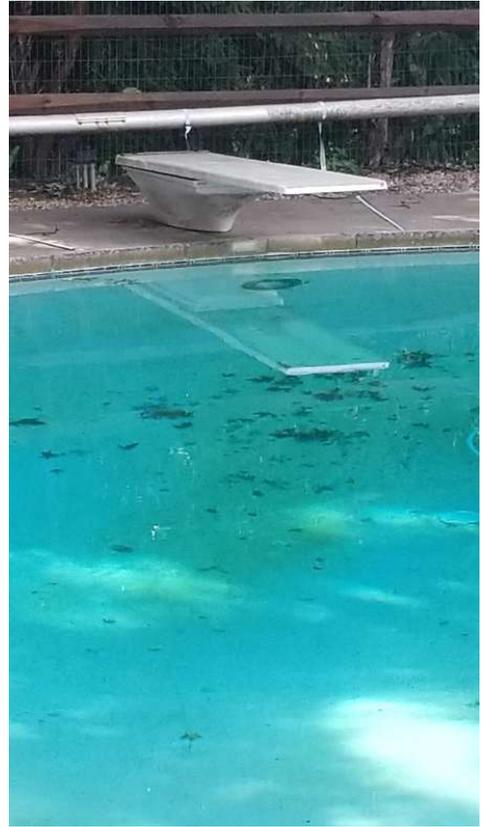
Safety/Major Concerns**DIVING BOARD**

Pool has a diving board. The shape and size of the pool plus the position of the diving board is such that a diver is likely to hit his/her head on the pool floor when diving. This is a huge safety concern. Consider that many insurance companies no longer provide coverage if pools have diving boards. Recommend removing diving board.
