## RESIDENTIAL REPORT

901 15th St. SW  
Sidney MT 59270

MARCH 25, 2018

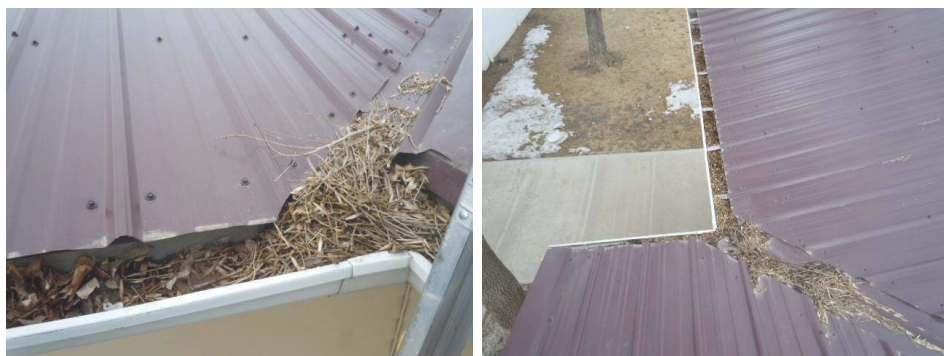
Debris has accumulated in the gutters. Recommend cleaning to facilitate water flow.

Recommendation

Recommended DIY Project

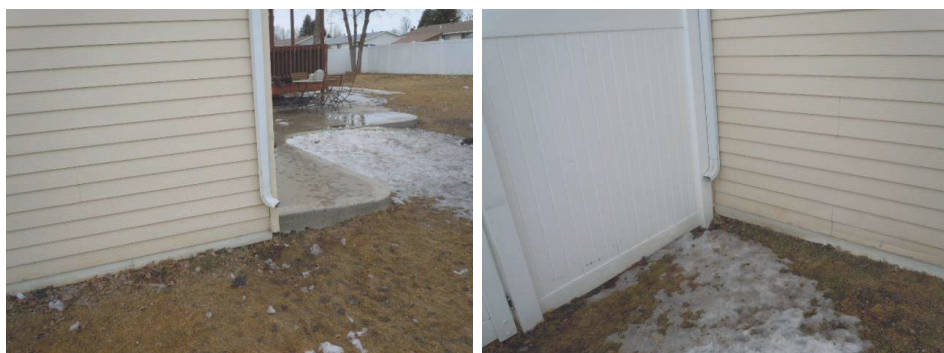
### 2.2.2 Roof Drainage Systems

#### DOWNSPOUTS DRAIN NEAR HOUSE

One or more downspouts drain too close to the home's foundation. This can result in excessive moisture in the soil at the foundation, which can lead to foundation/structural movement. Recommend adjusting downspout extensions to drain at least 10 feet from the foundation. The west side may need a qualified contractor to redesign and direct water away from the home.

Recommendation

Recommended DIY Project

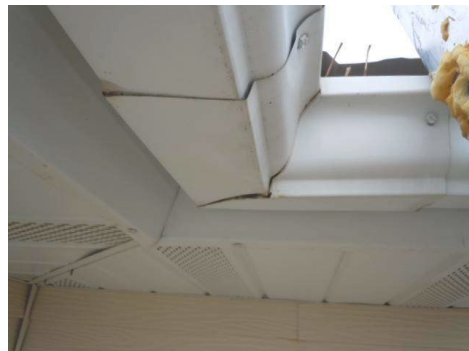
### 2.2.3 Roof Drainage Systems

#### GUTTER LEAKAGE

Gutters were observed to be leaking in one or more areas. This can result in excessive moisture in the soil at the foundation, which can lead to foundation/structural movement. Recommend a qualified contractor evaluate and repair gutters to proper functionality.

Contact a qualified roofing professional.

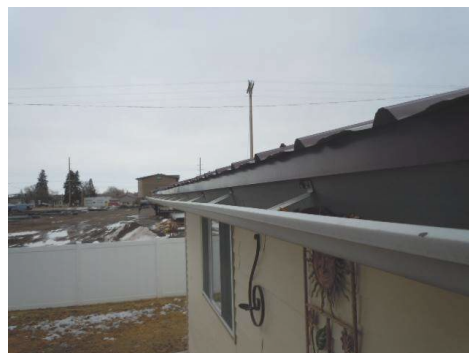
#### 2.2.4 Roof Drainage Systems

### **GUTTER LOOSE**

The gutter on the rear of the house is loose and needs to be re-fastened to fascia and pitched properly.

Contact a qualified handyman.

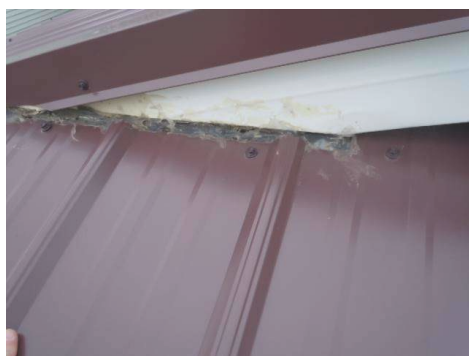
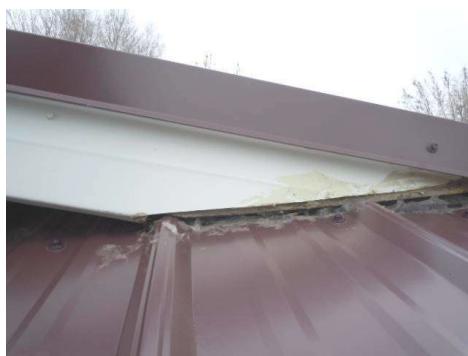
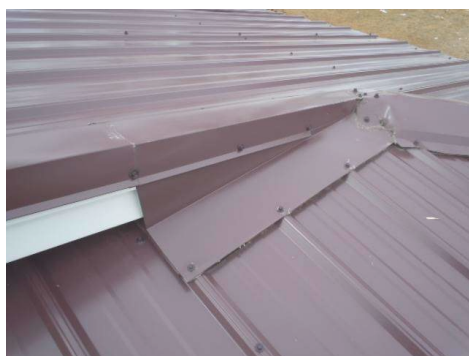
#### 2.3.1 Flashings

### **MISSING FLASHING**

Flashings were missing above the garage at time of inspection. Flashings provide protection against moisture intrusion. Recommend a qualified roofing contractor evaluate and remedy to match the east side (3rd image).

Contact a qualified roofing professional.

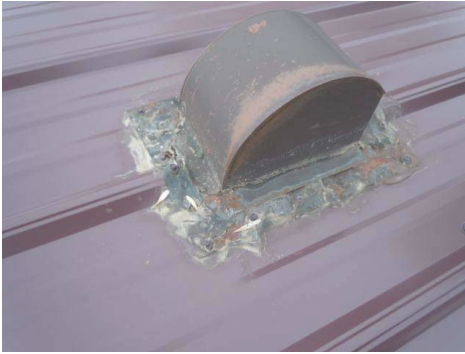
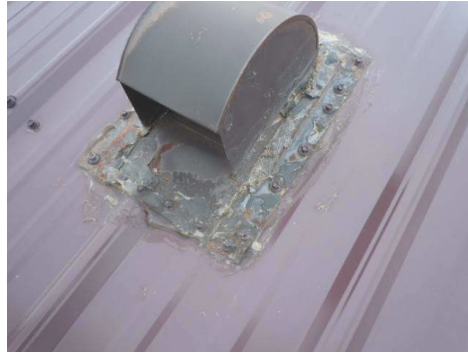
#### 2.4.1 Skylights, Chimneys & Other Roof Penetrations

### **BATHROOM VENT DETERIORATED AND RUSTING**

The bathroom vent was deteriorated and rusting with areas of caulking that were failing, allowing possible water intrusion damage. Recommend a qualified professional evaluate and repair to prevent water intrusion.

Contact a qualified professional.

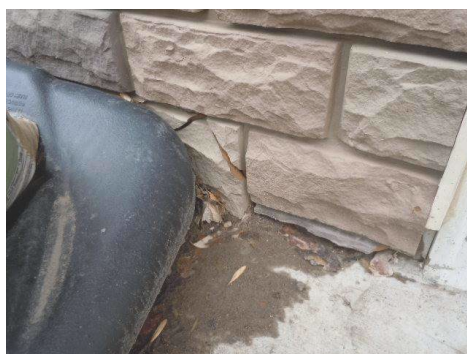
#### SIDING DAMAGE AND POSSIBLE WATER INTRUSION

Decorative rock siding was damaged and showed signs of possible water intrusion. This could lead to further siding deterioration and/or mold. Recommend a qualified siding contractor evaluate and repair.

Contact a qualified professional.

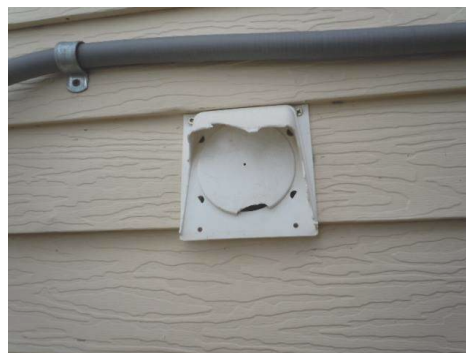
### 3.1.2 Siding, Flashing & Trim

#### **BASEMENT BATHROOM VENT DAMAGED**

I observed a damaged vent on the north side of the home that is believed to be the basement bathroom vent. The dryer vent location was not identified but is believed to be under the deck that had visibility restrictions.

Contact a qualified appliance repair professional.

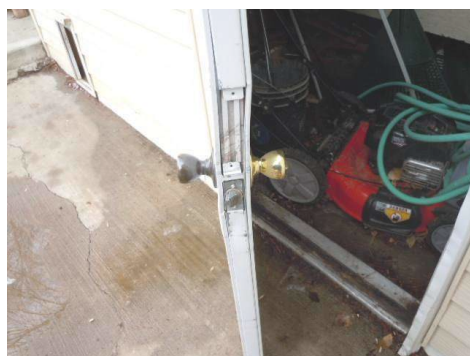
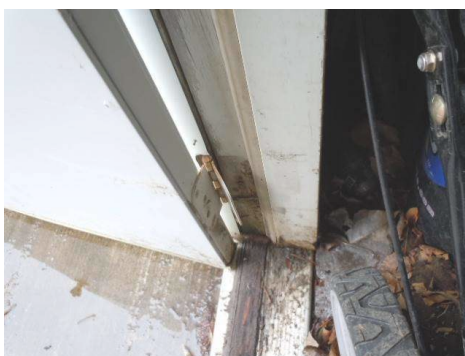
### 3.2.1 Exterior Doors

#### **HARDWARE DAMAGED**

One or more pieces of door hardware were damaged. Recommend repair or replace.

Contact a qualified professional.

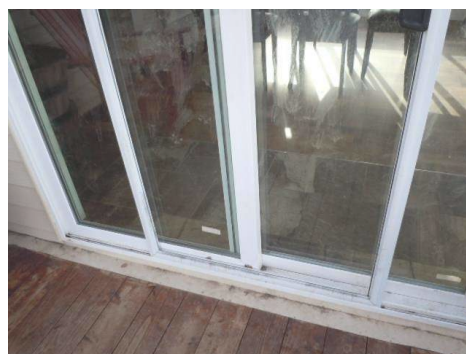
### 3.2.2 Exterior Doors

#### **SLIDING GLASS DOOR - MISSING SCREEN**

The sliding glass door had a sliding screen door that was missing the screen. The screen should be repaired or replaced as necessary by a qualified contractor. Replacement is more typical.

Contact a qualified door repair/installation contractor.

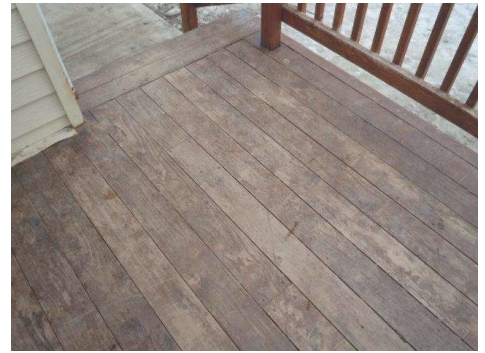
### 3.5.1 Porches, Patios, Decks, Balconies and Carports

#### **DECK - WATER SEALANT REQUIRED**

Deck is showing signs of weathering and/or water damage. Recommend water sealant/weatherproofing be applied.

Recommendation  
Recommended DIY Project

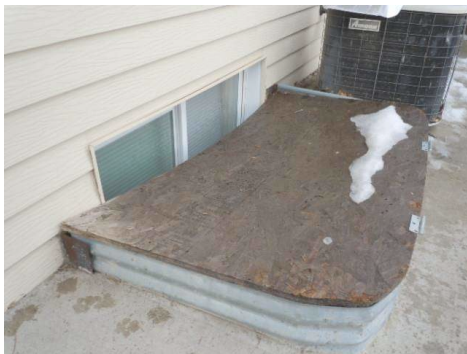
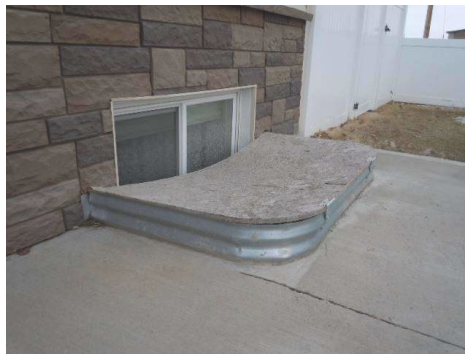
### 3.8.1 Representative Number of Windows

#### **EGRESS WINDOW COVER MISSING/INADEQUATE**

Two egress windows had inadequate window covers that would allow rain and snow to enter the window well. Recommend a qualified professional install proper egress window covers to prevent water and snow intrusion.

Contact a qualified professional.

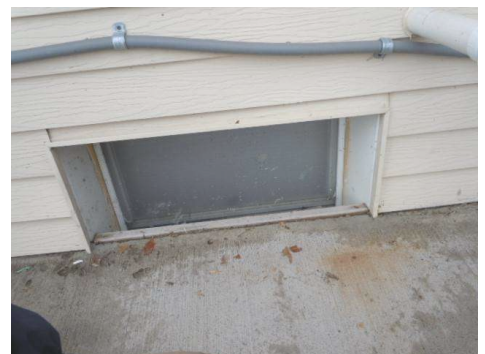
### 3.8.2 Representative Number of Windows

#### **WINDOW COVER MISSING**

A basement window on the north side of the house would benefit from a window cover to prevent prevailing wind driven rain and snow from entering the window well. Recommend a qualified contractor install a basement window cover.

Contact a qualified professional.

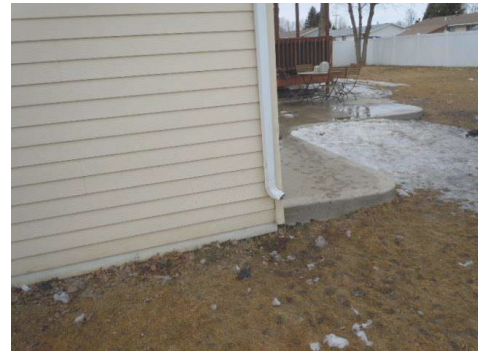
### 3.9.1 Vegetation, Grading, Drainage & Retaining Walls

#### **INADEQUATE GRADING**

I observed what was in my opinion inadequate grading of the property that may adversely affect the structure due to moisture intrusion. Recommend extending downspouts and removing snow from around the home in the winter to reduce chances of water intrusion.

Recommended DIY Project

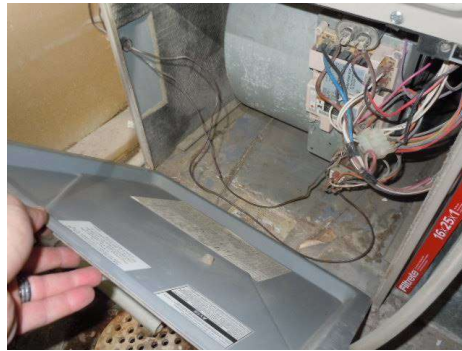
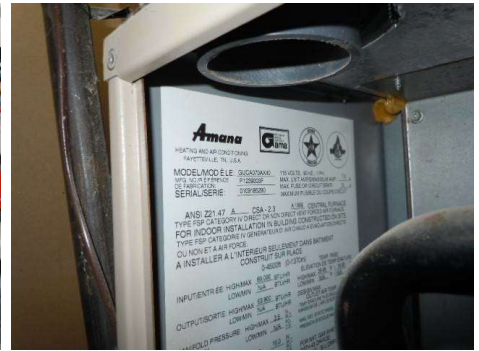
Basement

The furnace serial number #0109185290 indicates that the furnace was manufactured in 2001. The black marker on the furnace indicates that it was installed in March of 2002.

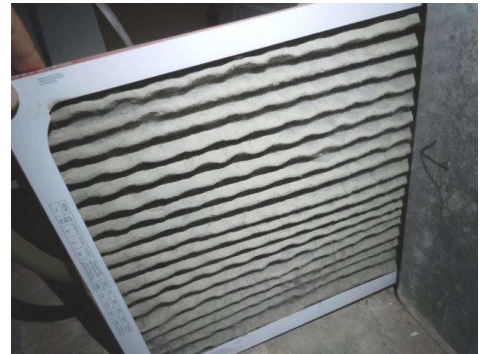
### 5.1.1 Equipment

The furnace filter is dirty and needs to be replaced every 6 months.

Contact a qualified HVAC professional.

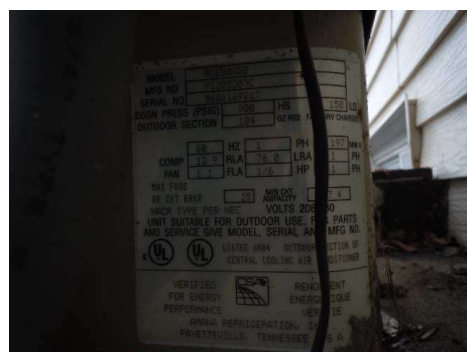
#### Cooling Equipment: A/C Unit

The serial number on the A/C unit (9601169217) indicated that the unit was manufactured in 1996 with an estimated SEER (Seasonal Energy Efficiency Rating) of 10.

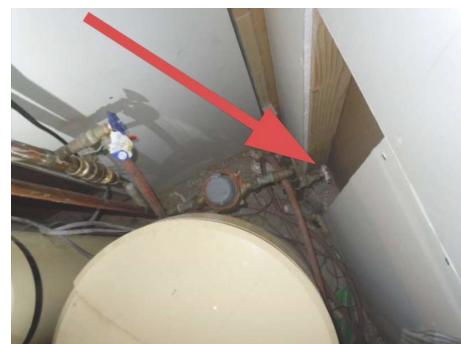
Basement, Furnace Room

Water shut off is located behind the water softener.

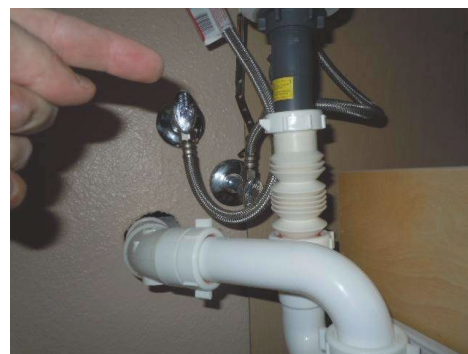
### 7.2.1 Drain, Waste, & Vent Systems

The plumbing below a sink had flexible pipe installed. Flexible pipe ages, dries, cracks and is prone to leaking especially if disturbed by homeowner belongings stored under the sink. Recommend full hard PVC plumbing be installed by a qualified professional.

Contact a qualified professional.

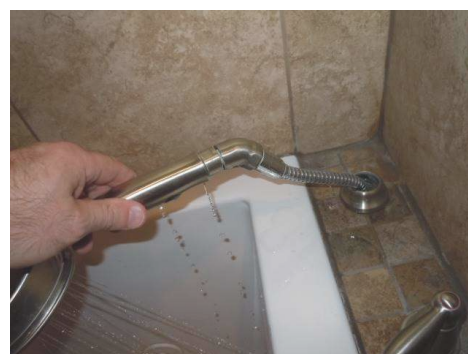
### 7.3.1 Water Distribution Systems, Fixtures, Faucets and Toilets

#### TUB/SHOWER FAUCET LEAKING

The shower head installed in the whirlpool tub was leaking. Recommend repair to prevent water damage to an inaccessible space around the tub.

Recommended DIY Project

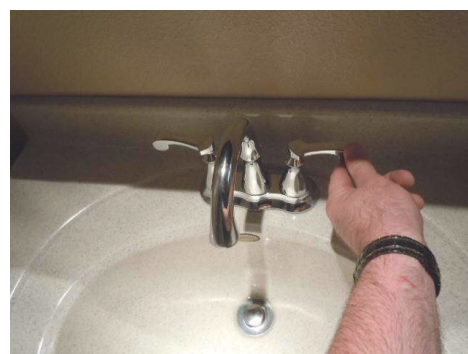
### 7.3.2 Water Distribution Systems, Fixtures, Faucets and Toilets

#### LOOSE FAUCET HANDLE

I observed a loose faucet handle in the basement bathroom. This should be corrected to prevent further damage to the fixture.

Recommended DIY Project

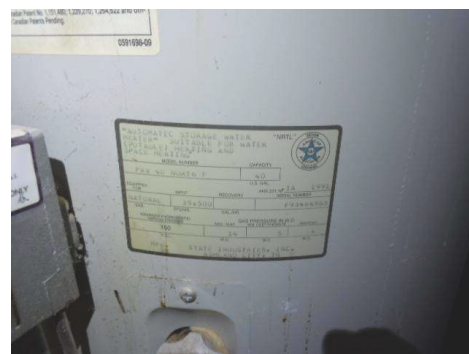
The serial number (F93464563) indicated that the water heater was manufactured in 1993. Water heater showed normal signs of wear and tear and was still functioning properly at the time of the inspection. Recommend monitoring it's effectiveness and replacing in the near future.

Contact a qualified plumbing contractor.

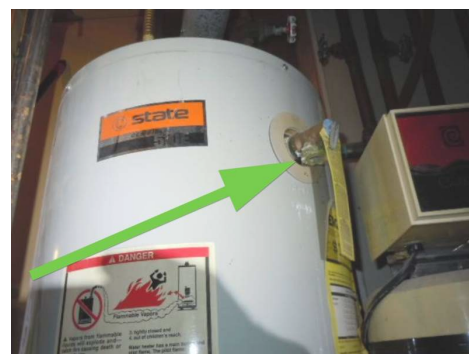
## 7.4.4 Hot Water Systems, Controls, Flues &amp; Vents

**TPR VALVE EXTENSION MISSING**

The Hot water heater was missing the TPR (Temperature Pressure Relief) valve extension. To prevent injury from super heated water/steam the TPR Valve should be extended to with in six inches of the floor.

Contact a qualified appliance repair professional.

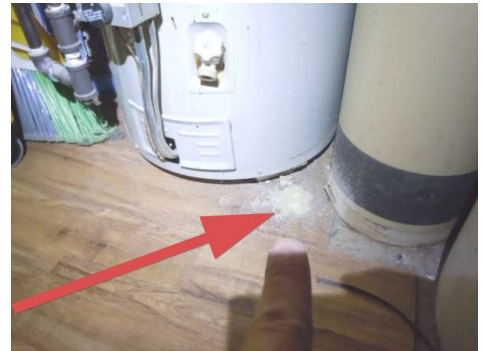
## 7.4.5 Hot Water Systems, Controls, Flues &amp; Vents

**WATER STAINS - LEAKAGE**

Water stains were observed beneath water heater, indicating a past or present leak coming from the TPR valve. Recommend further evaluation and repair by a qualified plumber.

Contact a qualified plumbing contractor.

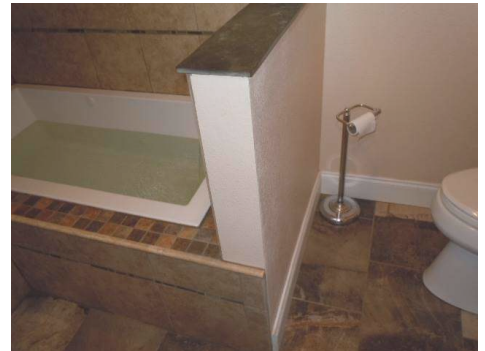
## 7.7.1 Functional Drainage of Sinks, Tubs and Showers

**INACCESSIBLE WHIRLPOOL TUB COMPONENTS**

The Pump and other components of the whirlpool jet tub were inaccessible for inspection for leakage. Recommend installing an access panel to allow for easy inspection and repair of components.

Contact a qualified professional.

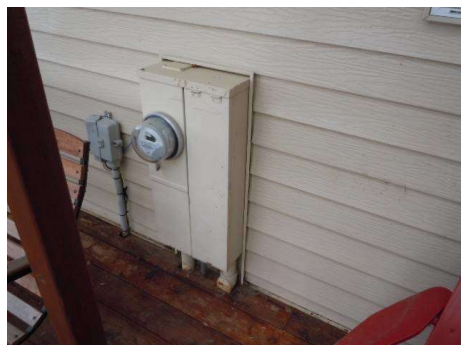
#### Main Service Disconnect, Main & Subpanels, Breakers and Fuses: Panel Capacity

200 AMP

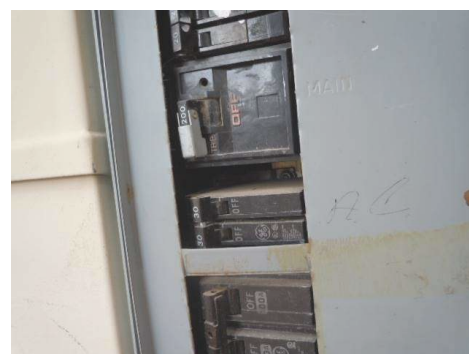
### 8.4.1 Main Service Disconnect, Main & Subpanels, Breakers and Fuses

#### **KNOCKOUTS MISSING**

"Knockouts" are missing on the electric panel. This poses a safety hazard and it is recommended that the opening in the panel caused by the missing knockout(s) be properly sealed by a licensed electrician.

Contact a qualified electrical contractor.

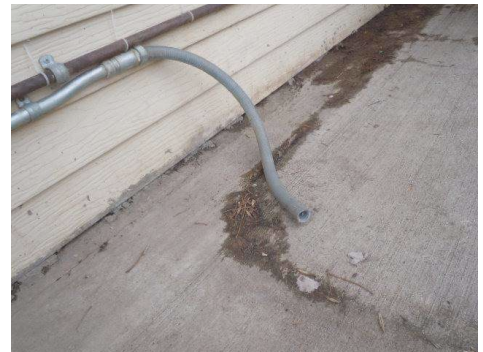
### 8.5.2 Branch Wiring Circuits, Grounding and Bonding

Observed exposed wires in the end of conduit on the west exterior of the home that used to feed a hot tub. Due to the lack of proper labeling of the electric panel it is not known if the wires are hot.

Recommend a qualified electrical contractor evaluate and label the wiring/breakers.

Contact a qualified electrical contractor.

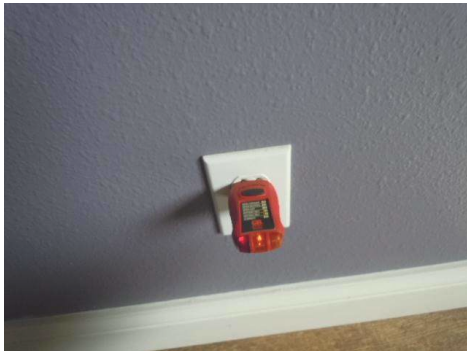
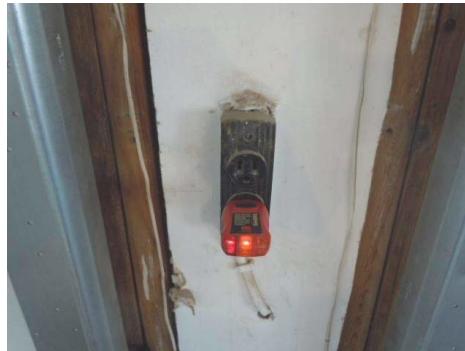
#### 8.6.1 Lighting Fixtures, Switches & Receptacles

##### **REVERSE POLARITY**

One or more receptacles have been wired with reverse polarity. This can create a shock hazard. Recommend licensed electrician evaluate & repair.

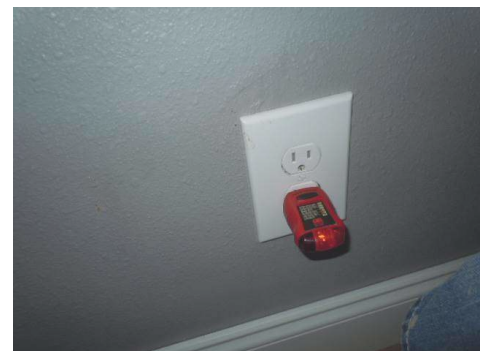
#### 8.6.2 Lighting Fixtures, Switches & Receptacles

##### **UNGROUND RECEPTACLE**

One or more receptacles are ungrounded. To eliminate safety hazards, all receptacles in kitchen, bathrooms, garage & exterior should be grounded.

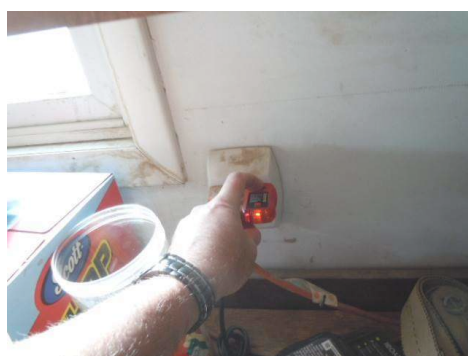
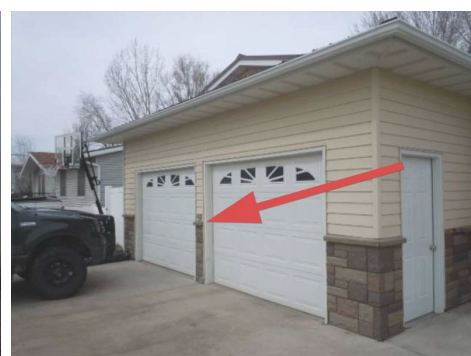
## 8.7.1 GFCI &amp; AFCI Protection

**NO GFCI PROTECTION INSTALLED**

No GFCI protection present at location. Receptacles near water should all be GFCI Protected. Recommend licensed electrician upgrade by installing ground fault receptacles at location.

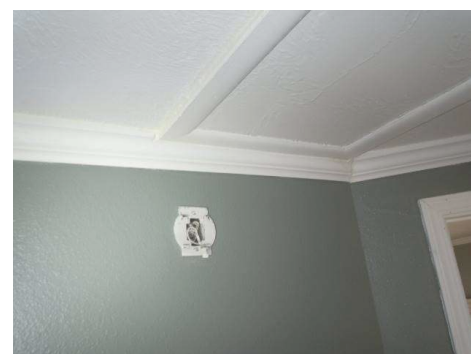
## 8.8.1 Smoke Detectors

**MISSING SMOKE DETECTOR**

I observed an area that in my opinion should have a smoke detector. Here are two helpful articles about smoke detectors.

Contact a qualified appliance repair professional.

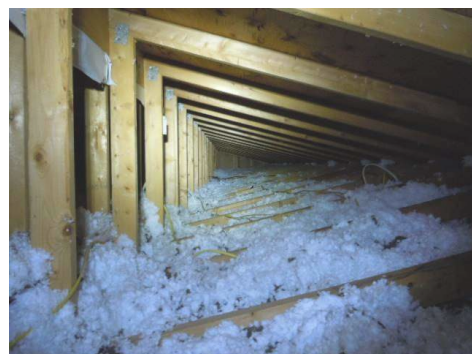
Insulation depth was inadequate in many areas. Recommend a qualified attic insulation contractor install additional insulation up to our zone recommendation of R49.

Contact a qualified insulation contractor.

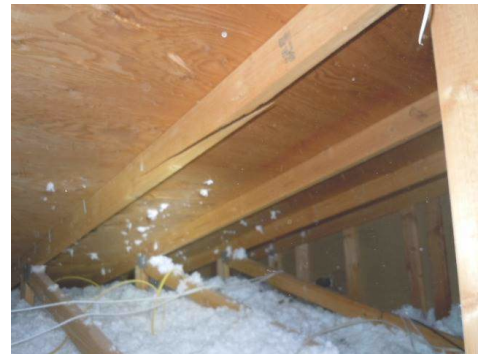
#### 9.5.1 Roof Structure & Attic

##### **CRACKED RAFTER**

Observed a cracked rafter in the attic. Recommend a qualified carpenter to evaluate/repair to maintain the roof's ability to hold up to snow loads and foot traffic.

Contact a qualified carpenter.

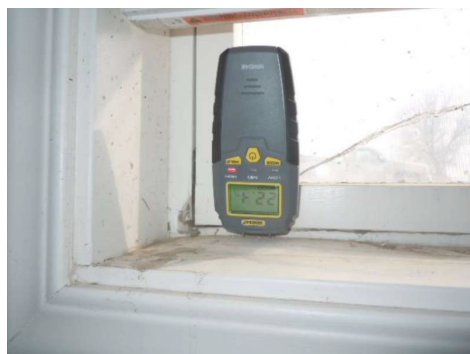
#### WINDOW SILL MOISTURE INTRUSION

One or more window sills showed elevated moisture readings indicating moisture intrusion from an unknown source. Moisture levels above 20% in building materials promote mold growth and material decay. Recommend a qualified professional evaluate/repair/make recommendations to reduce moisture intrusion.

Contact a qualified professional.

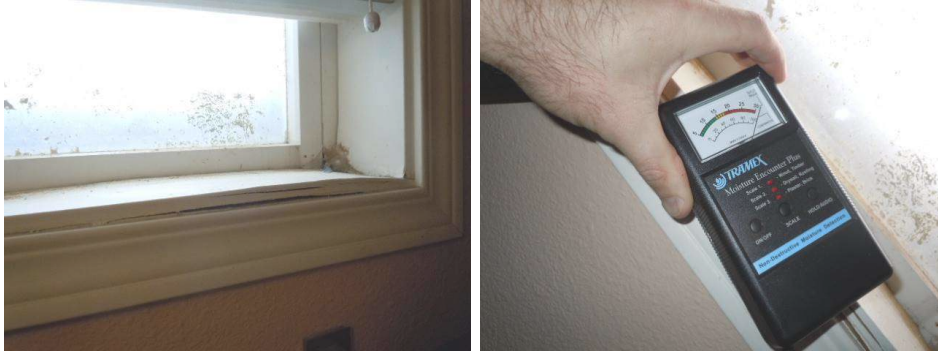
## 10.2.2 Windows

**WINDOW WILL NOT OPEN**

A window in the basement bathroom would not open due to a wet and swollen window sill as indicated by the moistuer meter. Recommend evaluation/repair by a qualified professional.

Contact a qualified professional.

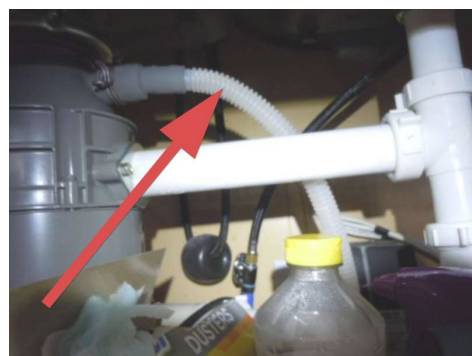
#### IMPROPERLY INSTALLED HIGH-LOOP IN DRAIN PIPE

Dishwasher drain pipe was installed improperly. The drain pipe should have a high-loop or air gap to reduce the possibility of contaminated water backflow due to a clogged drain. Recommend a qualified plumber evaluate and repair.

Contact a qualified plumbing contractor.

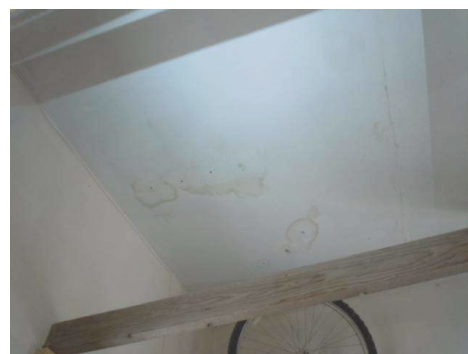
#### STAIN(S) ON CEILING

There is a stain on ceiling/wall that requires repair/paint. Source of staining could be old or active, the area was dry at the time of the inspection. Recommend painting with oil based primer and monitoring.

Recommended DIY Project

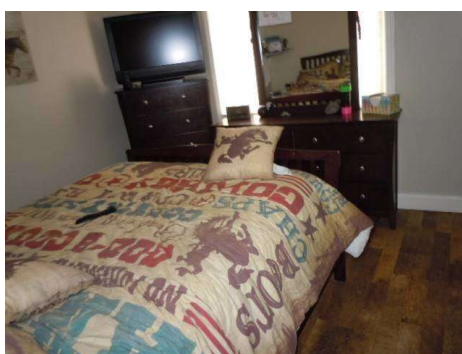
#### Homeowner Belongings

Homeowner belongings were an inspection restriction in some areas such as closets. The flooring and walls were not inspected for defects in the closets and under/behind furniture for example. Recommend doing a thorough walk through before the closing date to check for any hidden damage or water intrusion.
