# PROTECT PROPERTY INSPECTIONS

## HOME INSPECTION REPORT

44743 Alamendras St  
Maricopa, AZ 85139

Larry Mesler  
MAY 10, 2021

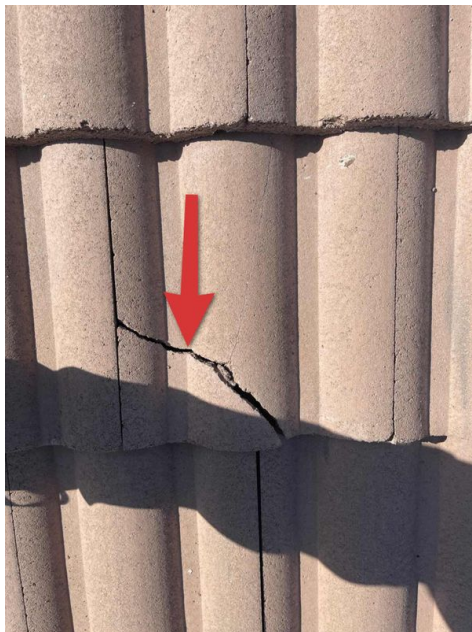
Northwest

#### Concrete Tile: Condition

Significant and/or Safety Concern

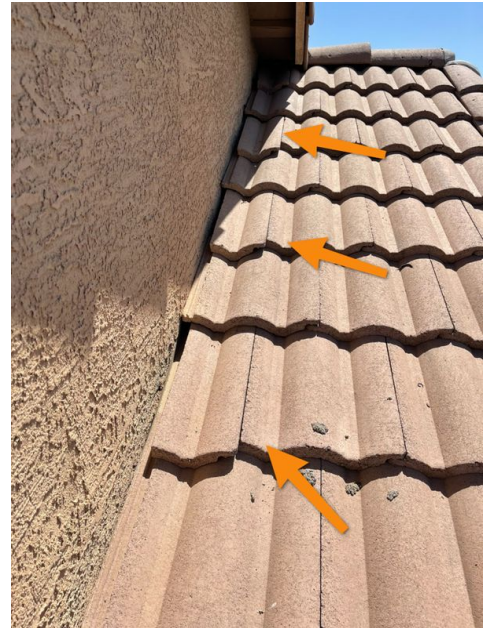
North-Sidewall

Roof tiles that had been inadequately fastened have been displaced. The tiles should be replaced by a qualified roofing contractor in a manner that will hold them securely in place.

Contact a qualified roofing professional.

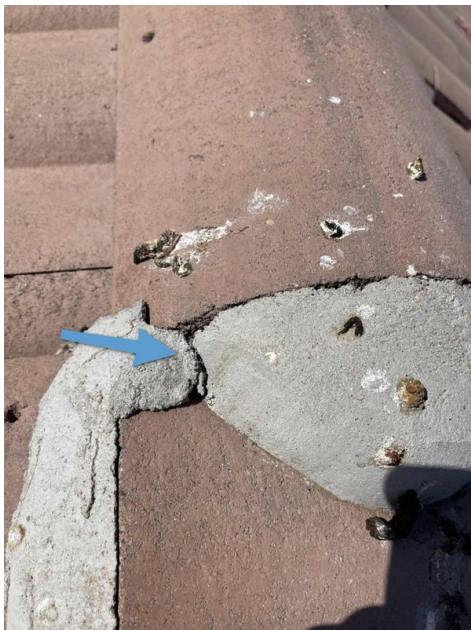
North

**MORTAR CAP- CRACKED**

Minor cracking was observed at one or more mortar joints on the roof. Recommend sealing to prevent further deterioration.

Contact a qualified roofing professional.

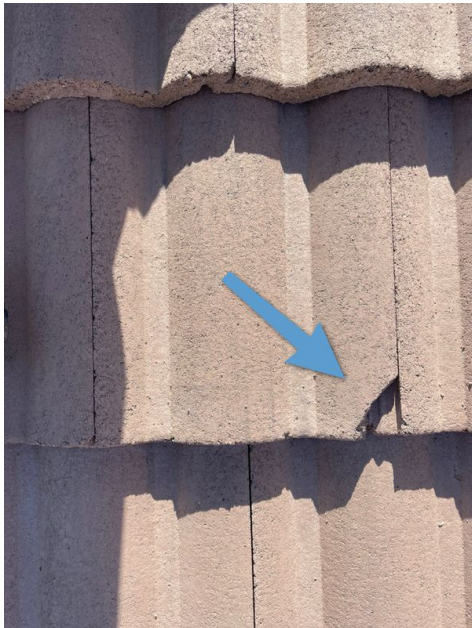
North

**TILES- RIGHT CORNER DAMAGE**

The interlocking concrete tile roof had a number of broken lower right corners. Tiles are thinnest at their edges where they interlock and lower corners are the weakest part of these thin areas. Tiles with broken sections that do not exceed the overlap (typically 3 inches) can be repaired. Tiles with broken sections that exceed the overlap should be replaced. All work should be performed by a qualified roofing contractor.

Contact a qualified roofing professional.

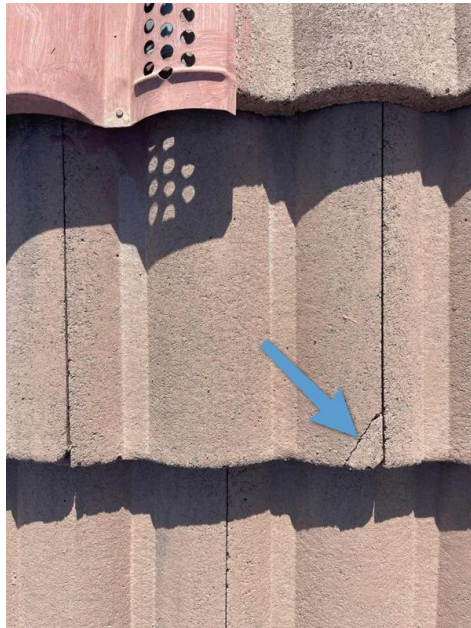
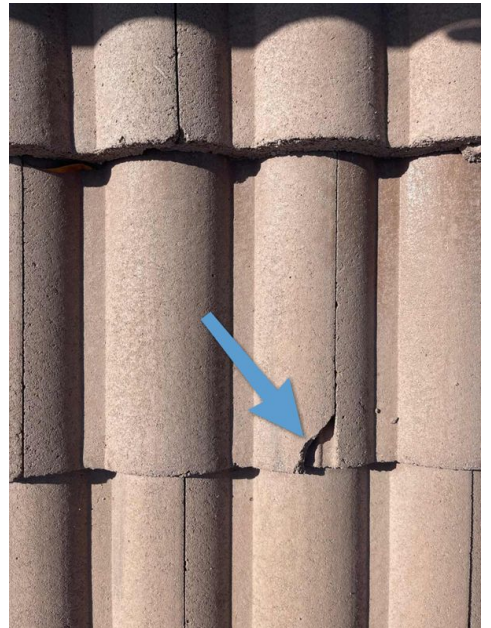
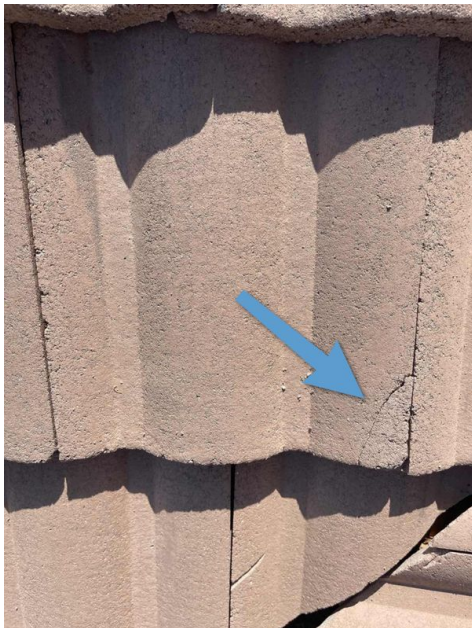
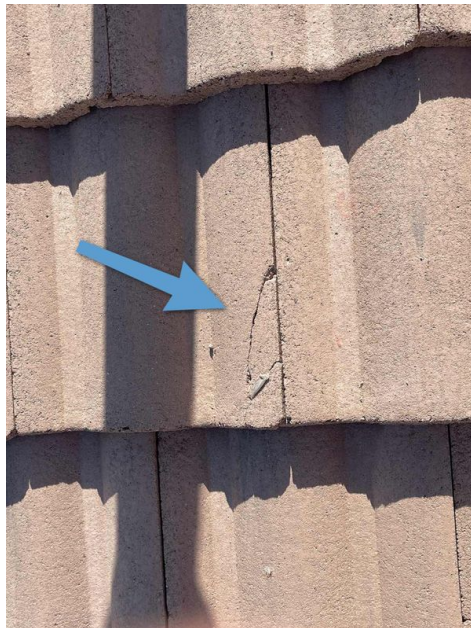
🔧 2.1.5 Roofing System - Concrete Tile: Tiles- Right corner damage

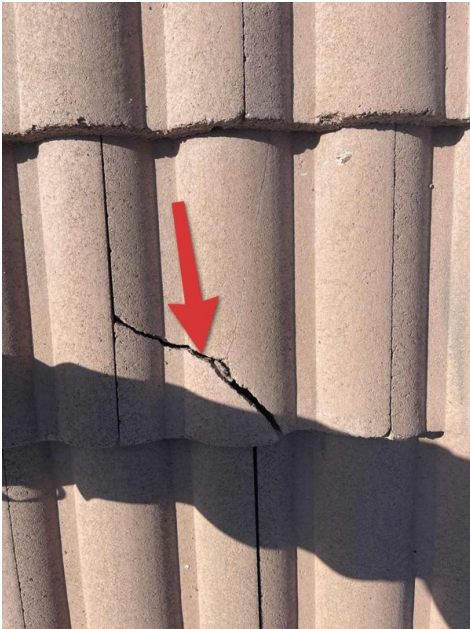
Northwest

Significant and/or Safety Concern

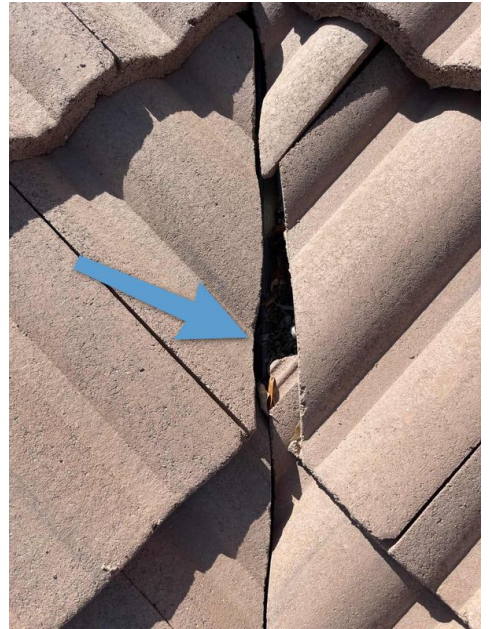
Northwest

**DEBRIS OBSERVED IN FLASHING**

Debris was observed in one or more flashing details, Recommend cleaning and evaluating to ensure this has not caused any moisture back up.

Contact a handyman or DIY project

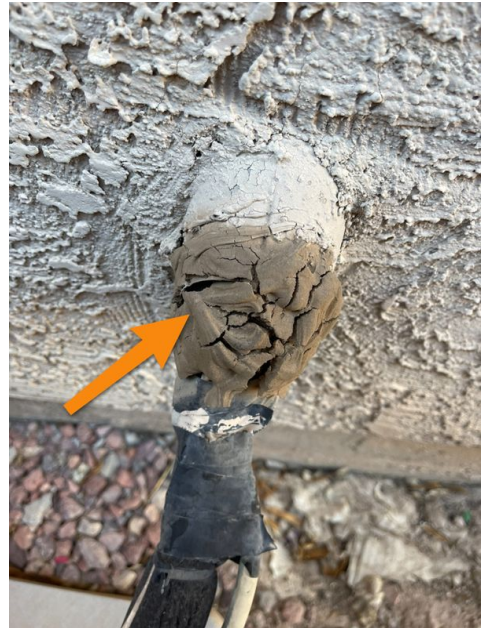
Refrigerant lines -sealant disintegrating

Contact a handyman or DIY project

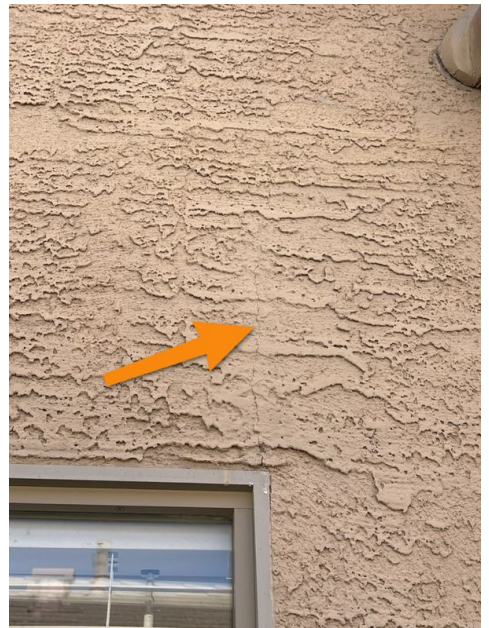
## 3.3.2 Wall Cladding

Moderate Item**GENERAL- CRACKING, VOIDS AND IMPERFECTIONS**

Recommended DIY Project

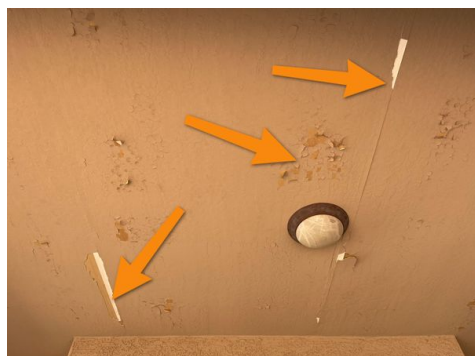
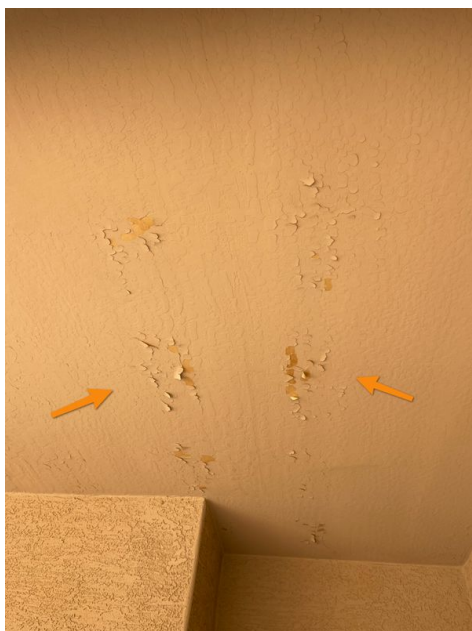
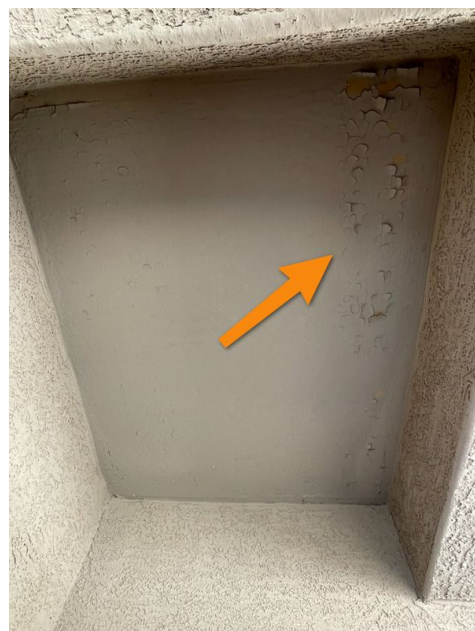
⚠ 3.8.1 Exterior - Patios, Decks, Porches, Balconies, Covers, Areaways, Railings & Stairs\*: Patio/Porch - Ceiling cracked, separations, voids, imperfections

Contact a qualified professional.

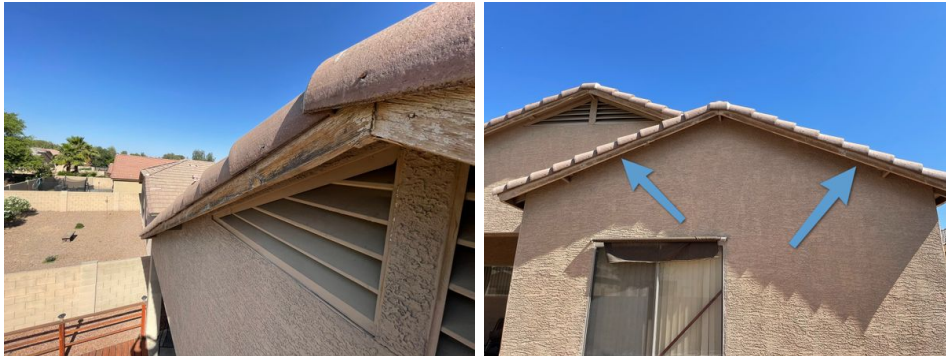
Southwest

🔧 3.9.1 Exterior - Trim, Eaves, Soffits, flashing & Fascia\*: General- Minor wear and tear

3.9.1 Trim, Eaves, Soffits, flashing & Fascia\*

### GENERAL- MINOR WEAR AND TEAR

Contact a qualified painting contractor.

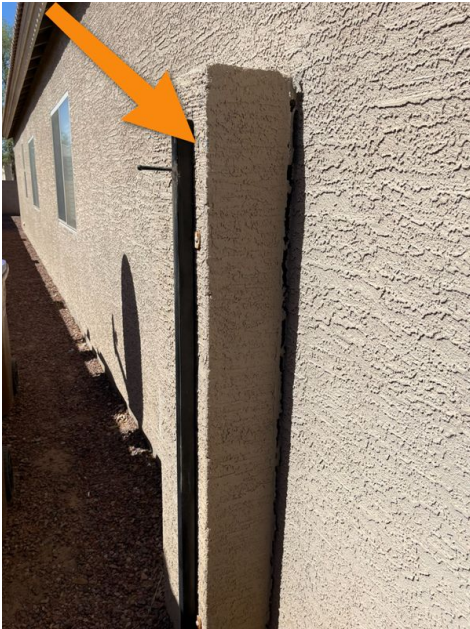
Moderate Item

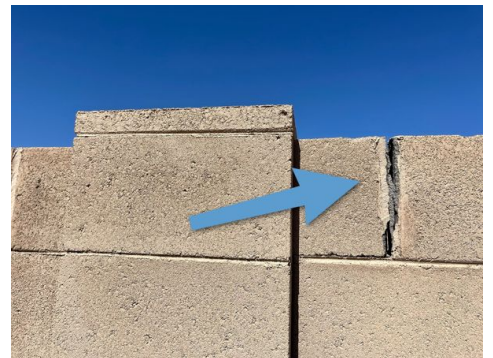
West

- 🔧 3.10.3 Exterior - Fencing, Gates, and Retaining walls: Block Wall- Cracking or Movement Stable
- 🔧 3.10.4 Exterior - Fencing, Gates, and Retaining walls: Rain caps loose

### 3.10.3 Fencing, Gates, and Retaining walls

Contact a qualified masonry professional.

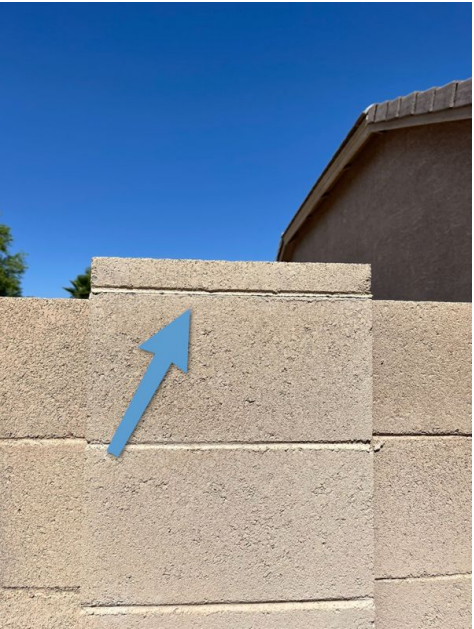
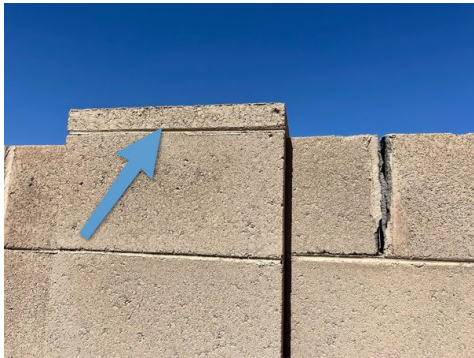
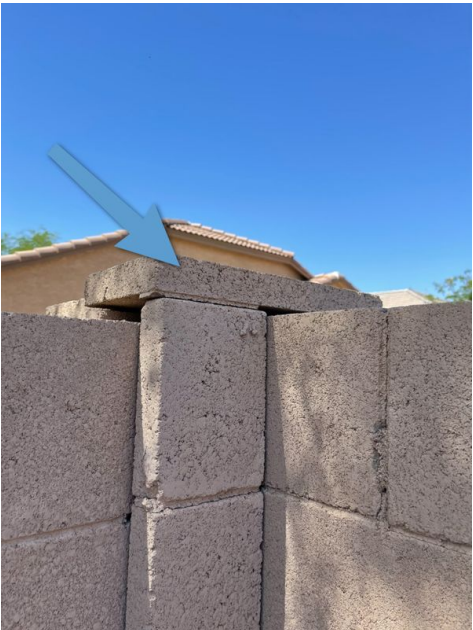
### 3.10.4 Fencing, Gates, and Retaining walls

Contact a qualified professional.

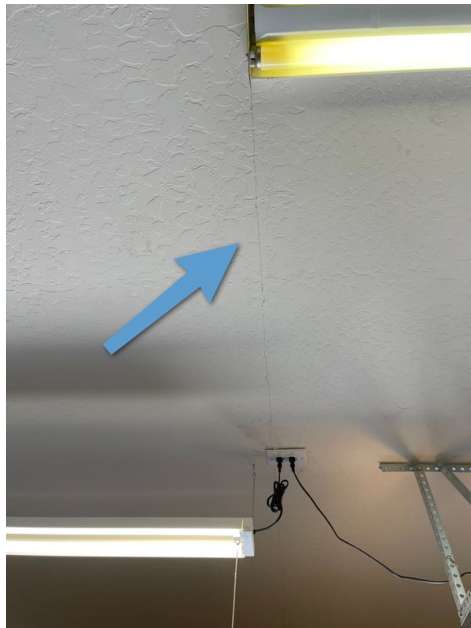
- 🔧 4.1.1 Garage - Ceilings: General- Common Cracks, imperfections and nail pops
- 🔧 5.1.1 Interiors - Ceilings: General- Common Imperfections
- ⊖ 5.1.2 Interiors - Ceilings: Moisture Staining- Possible Roof Leak

### 4.1.1 Ceilings

Contact a qualified drywall contractor.

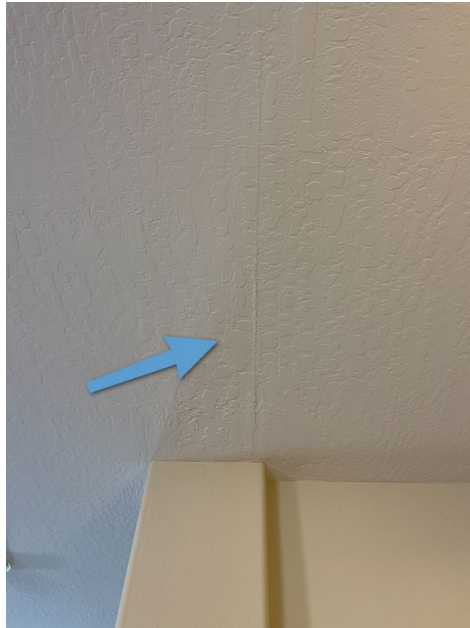
Living Room

I observed common cracking, openings, chips, nail pops, prior repairs and imperfections on the ceiling in the home. This condition is observed in most homes and should be maintained and monitored.

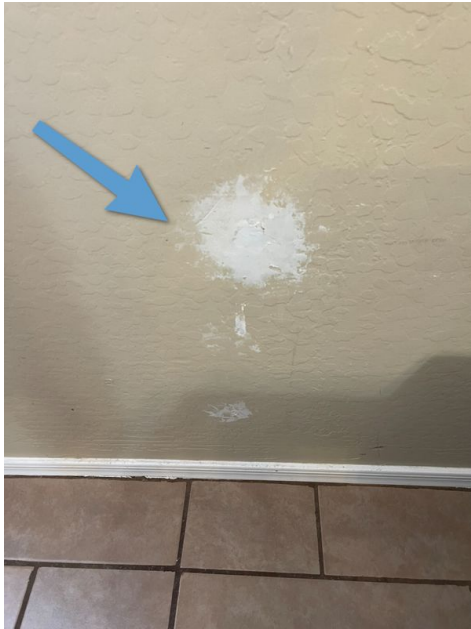
Dining Room

Imperfections were observed on the interior walls. Recommend corrections were needed.

Contact a qualified professional.

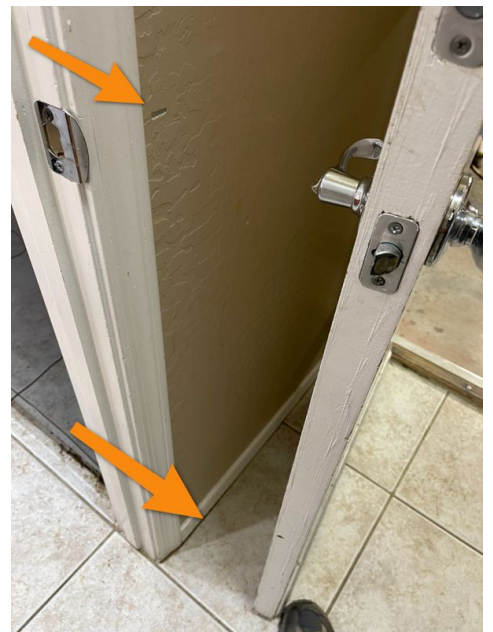
Laundry room

One or more doors had no stops or were damaged. The Inspector recommends that stops be installed throughout the home to protect the walls and cabinets.

Contact a qualified handyman.

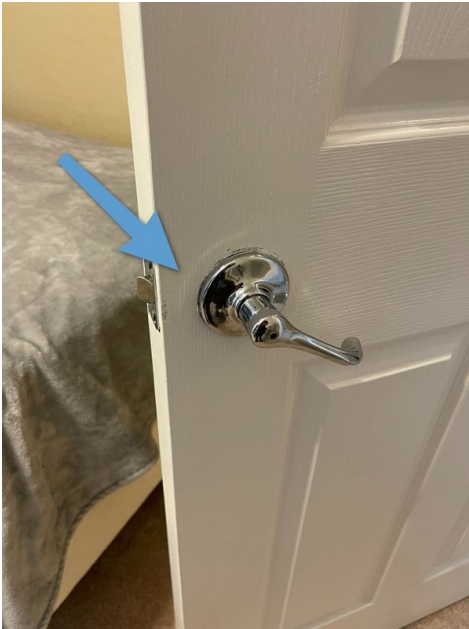
East Bedroom

Door hardware was loose or inoperable at time of inspection. The Inspector recommends repair, adjustment or replacement as necessary by a qualified specialist.

Contact a qualified handyman.

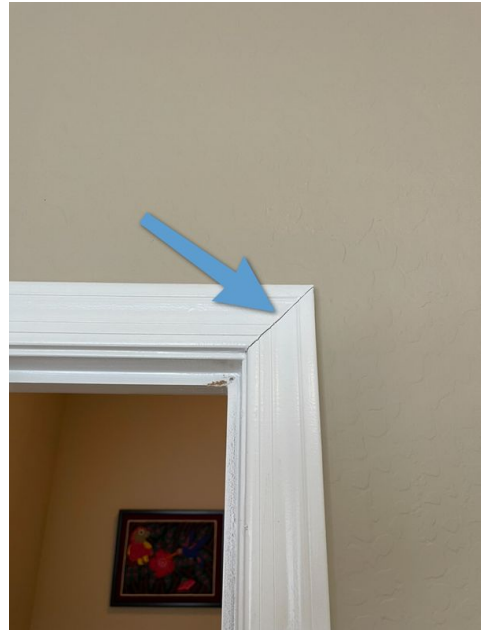
Bedroom

**TRIM- AROUND DOOR SEPARATION, VOIDS AND/OR DAMAGE**

I observed trim separation/cracking/voids/ chipped, recommend repairs and/or replacement as needed.

Contact a qualified professional.

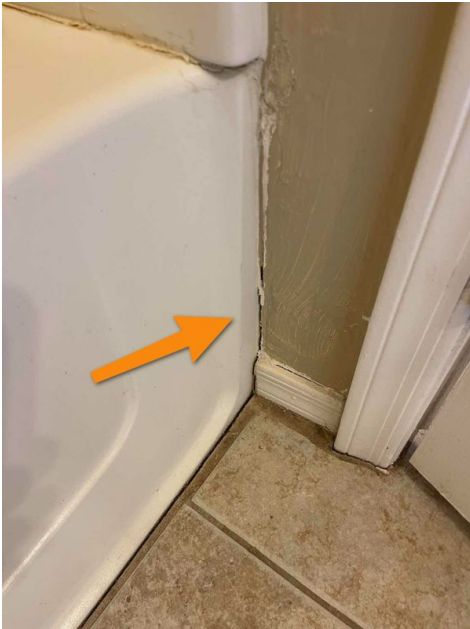
Guest bathroom

Wall separation was observed near the shower/tub enclosure and wall transition. Recommend sealing this to prevent moisture intrusion.

Contact a handyman or DIY project

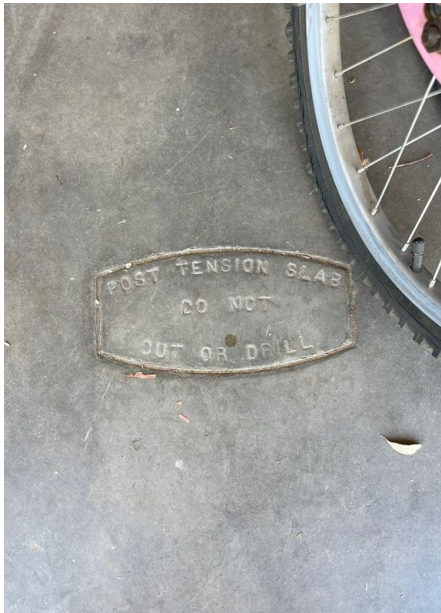
#### Foundation Type

Post-Tensioned Slab

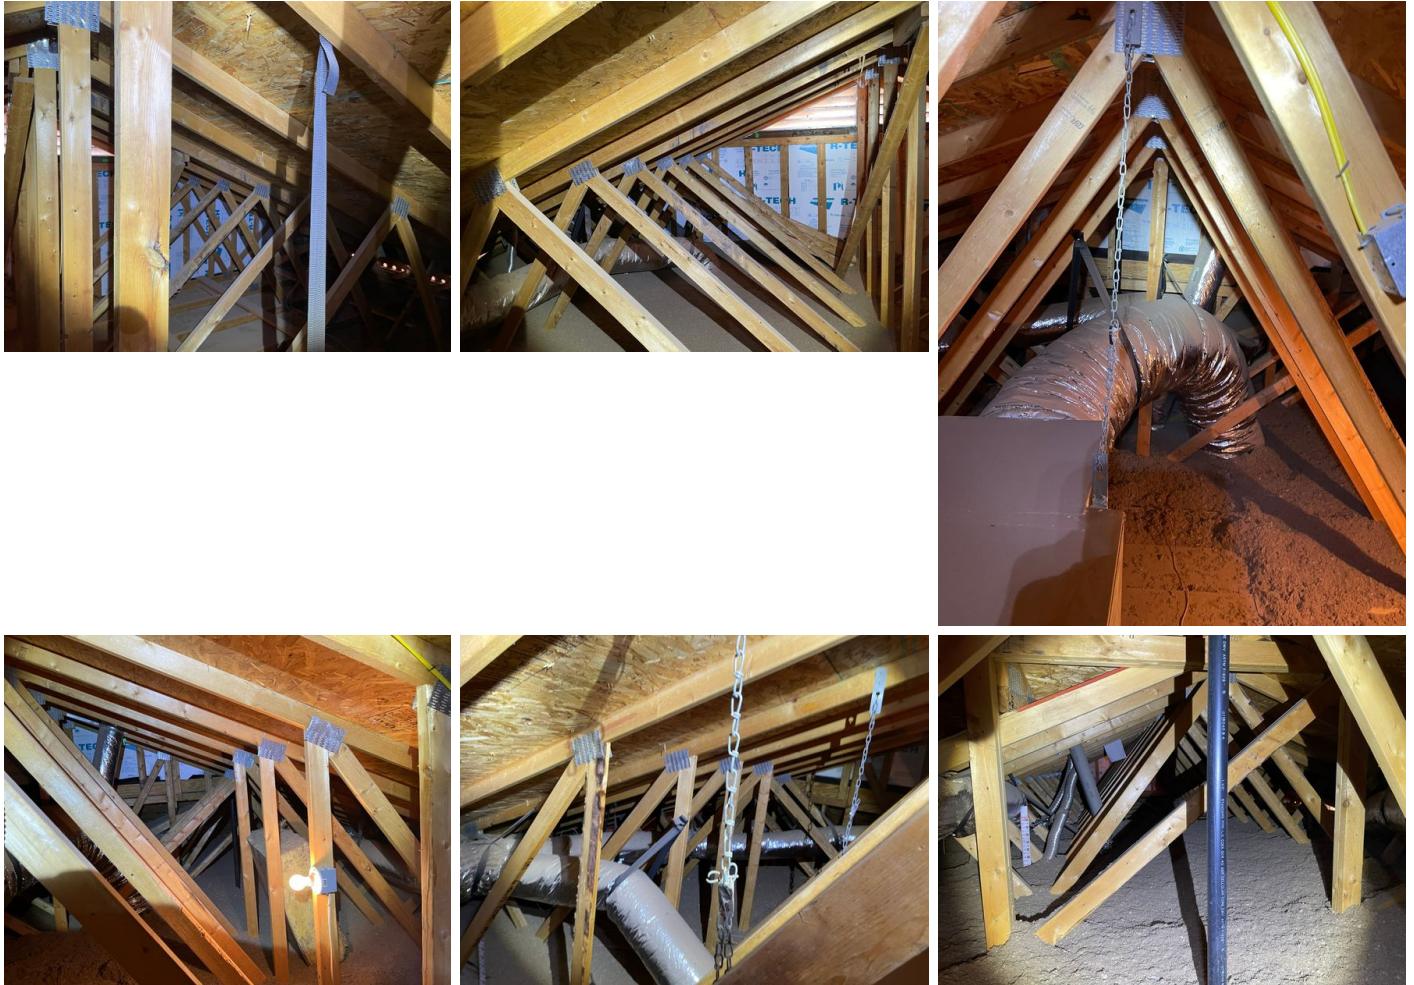
## Roof Structure Type

Wood, Trusses, Oriented Strand Board

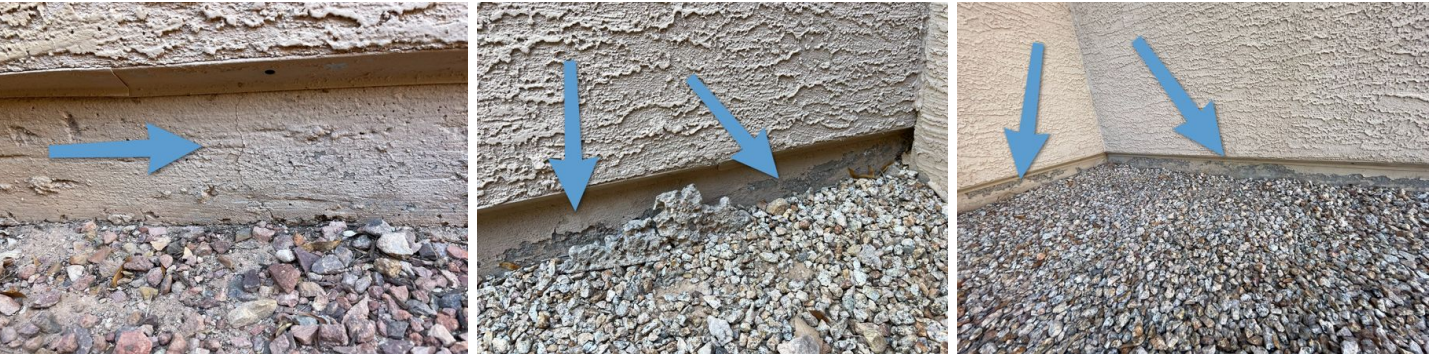
We noted minor cracks, voids and deterioration, within normal tolerances, at one or more areas throughout the exposed foundation stem wall. Unless noted otherwise, this type of cracking is often a result of shrinkage and/or minor settlement and usually does not affect the strength of the foundation. We still recommend further evaluation. Recommend sealing these areas as preventative maintenance.

Recommendation  
Contact a qualified masonry professional.

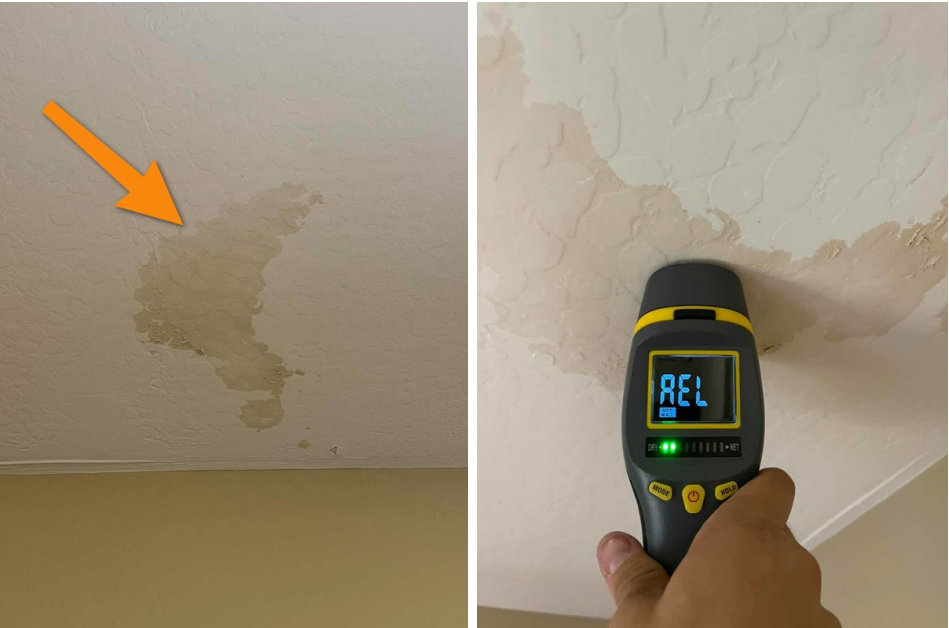
Master bedroom

6.5.1 Ceiling Structure

Ceiling structure showed signs of water intrusion, which could lead to more serious structural damage. Recommend a qualified contractor identify source or moisture and remedy.

Currently dry

Recommendation  
Contact a qualified professional.

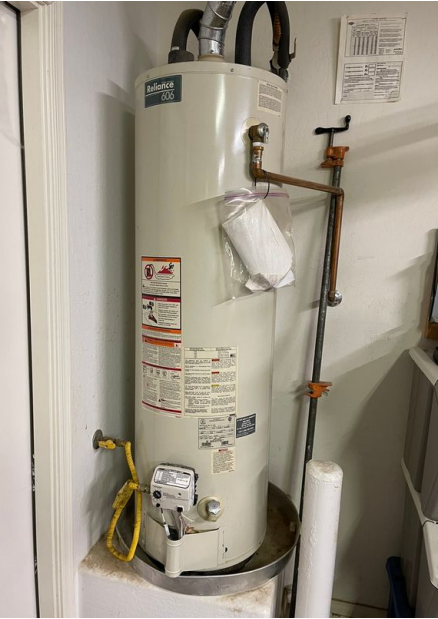
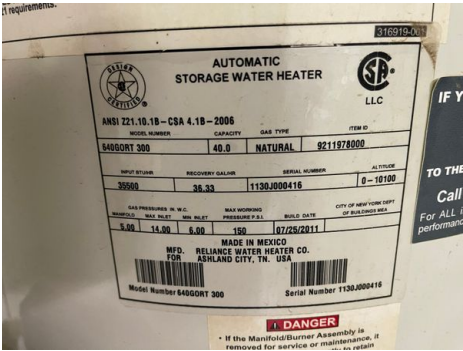
Hot Water Equipment and  
Operating Controls-Unit 1: Data  
Plate Photo(s)

Hot Water Equipment and  
Operating Controls-Unit 1:  
Location  
Garage

Hot Water Equipment and  
Operating Controls-Unit 1:  
Capacity  
40gal

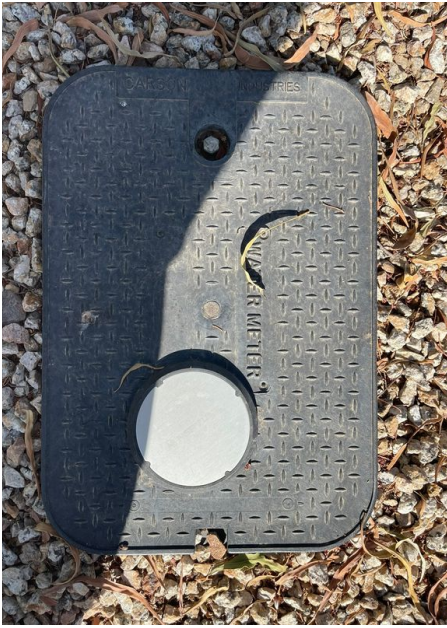
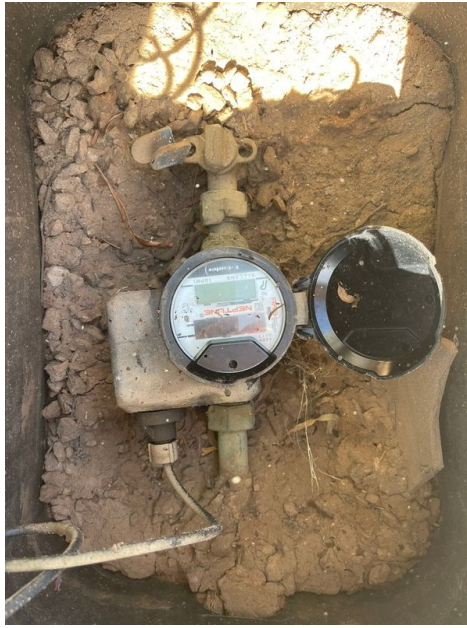
## Water Meter

The water meter was observed for a period of time to find that it was not spinning. When no fixtures are running at this home, the water meter should be still.

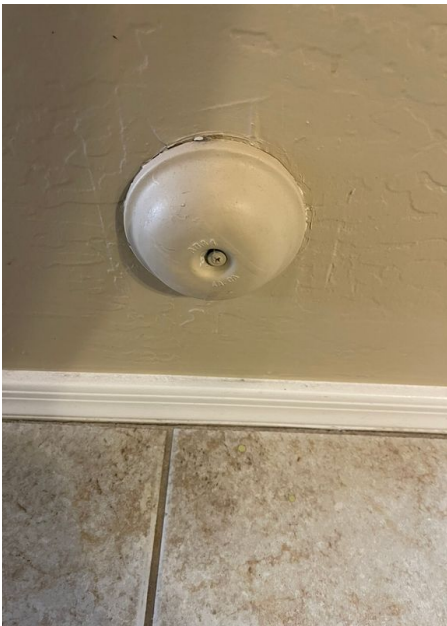
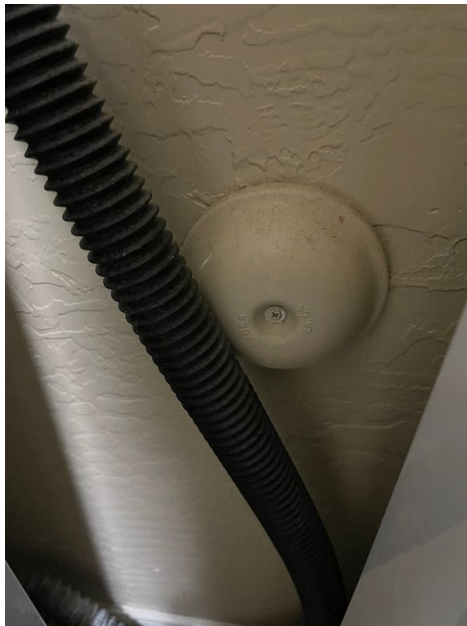
## Waste Clean-outs Observed?

Yes

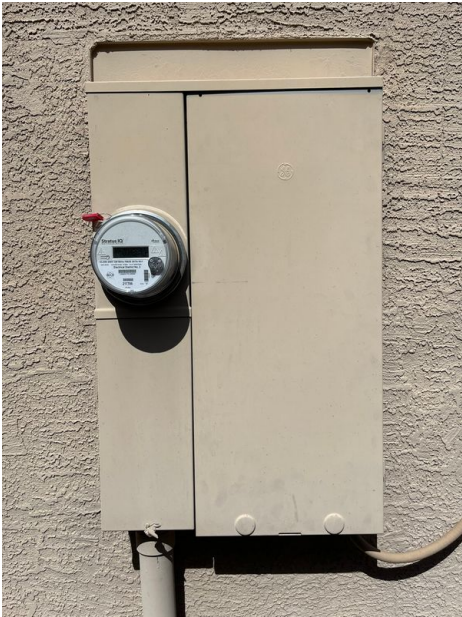
Manufacturer Data Plate Photo

Serviceable

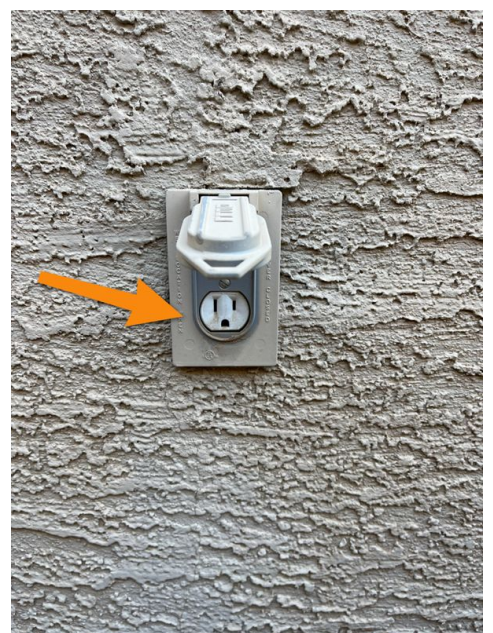
Next to condenser-West

### 8.6.1 Receptacles, Polarity, Ground

#### **RECEPTACLE- DAMAGED**

Contact a qualified electrical contractor.

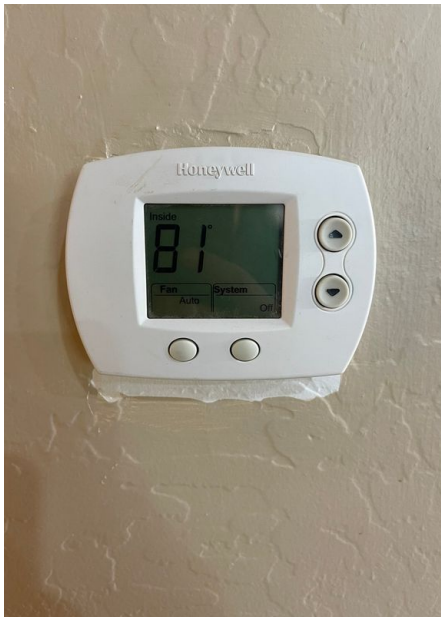
#### Thermostat(s) Location

Hall

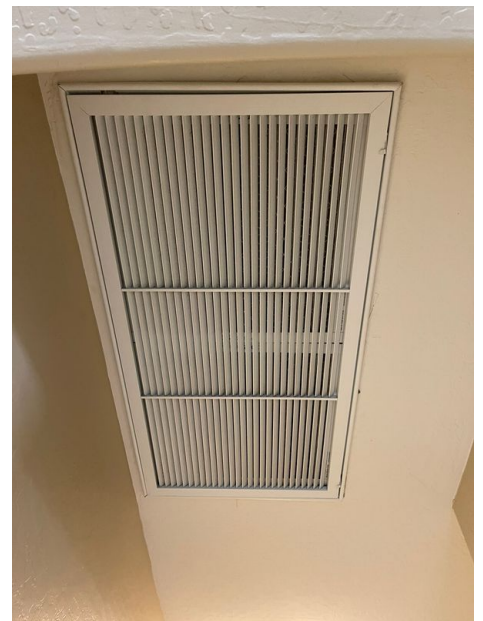
#### Air Filters

Disposable - Clean - Replace every 30 days, 2

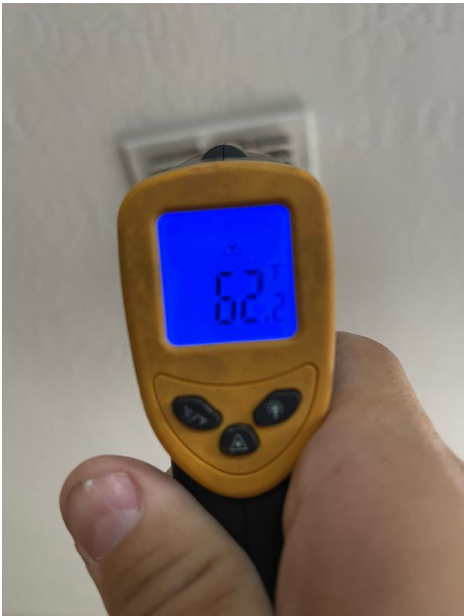
**Equipment 1: Cool Temperature - Air Return\***

62 F (Fahrenheit)

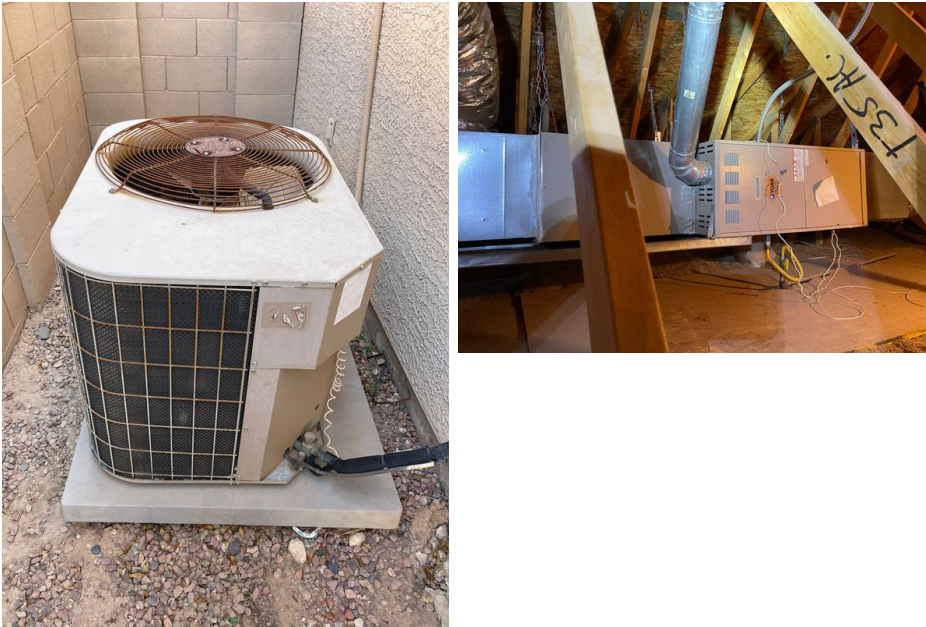
Equipment 1: Brand(s)

The air conditioning system was a split system in which the cabinet housing the compressor, cooling fan and condensing coils was located physically apart from the evaporator coils. As is typical with split systems, the compressor/condenser cabinet was located at the home's exterior so that the heat collected inside the home could be released to the outside air. Evaporator coils designed to collect heat from the home interior were located inside a duct at the furnace and were not directly visible.

York

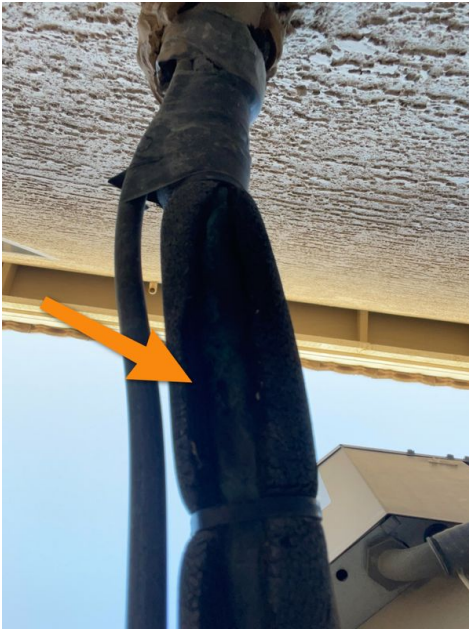
Refrigerant lines

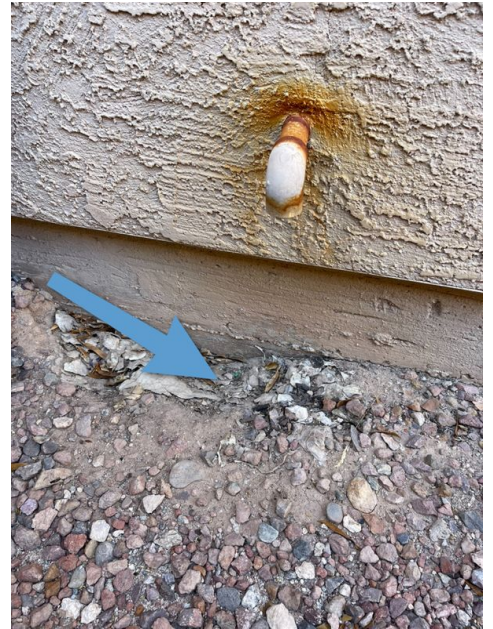
### 9.3.2 Condensation System

#### **RUST IN PAN**

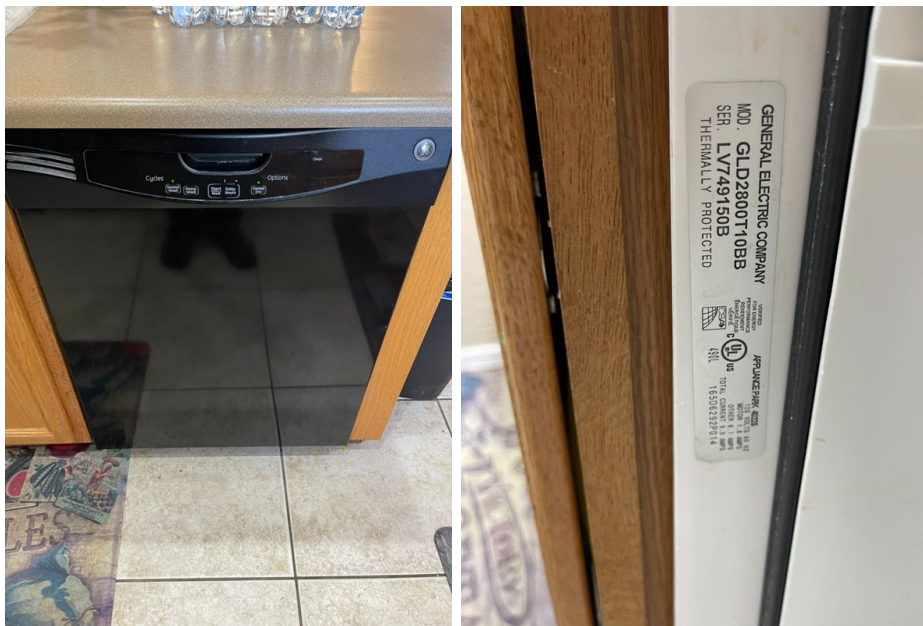
**Dishwasher: Brand**

GE

Unless otherwise noted: At the time of the inspection, the Inspector observed no deficiencies in the condition and operation of the dishwasher. It was operated through a cycle.

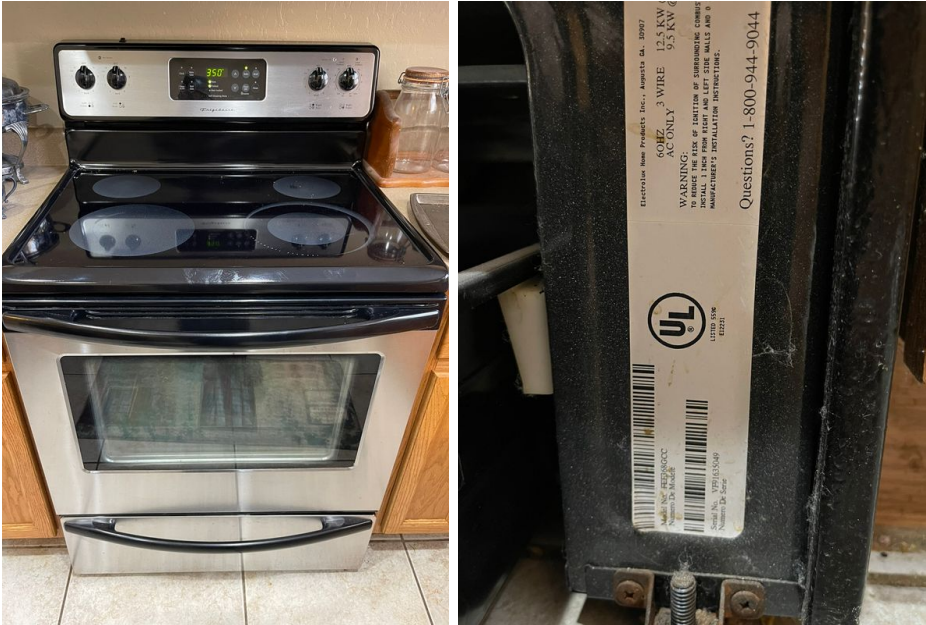
Oven(s): Oven Type

Range

The oven was turned on in bake and in boil. The light was also tested and unless otherwise noted in this report, the oven was found to be functional.

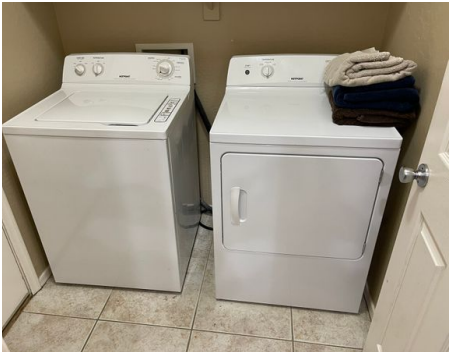
Laundry equipment was observed in the laundry room. Full testing and inspection of these units is beyond the scope of a General Home Inspection. When occupants belongs aren't in the units, we will turn them on for a short cycle to test the hookups for function. The washer filled, spun, and drained. The dryer heated. If a more thorough inspection is desired, recommend contacting an appliance specialist.

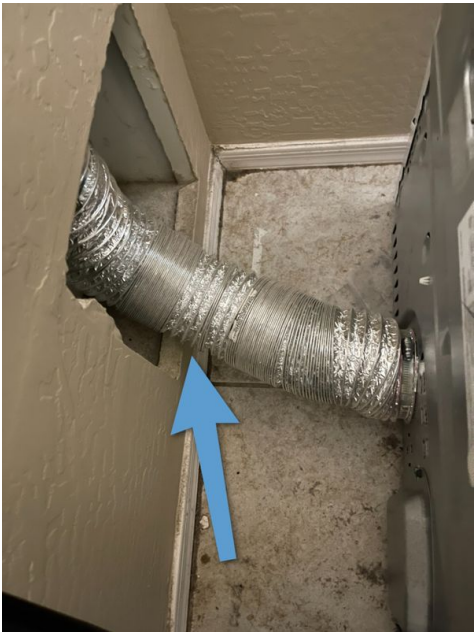
**DRYER VENT- CLEAN**  
We always recommend cleaning the dryer vent upon moving in and at least once annually (more depending on usage).  
Recommendation  
Contact a qualified professional.
