HOME INSPECTION REPORT COPY

1234 Home Inspection Report
Hanover MD 21076

AUGUST 12, 2018

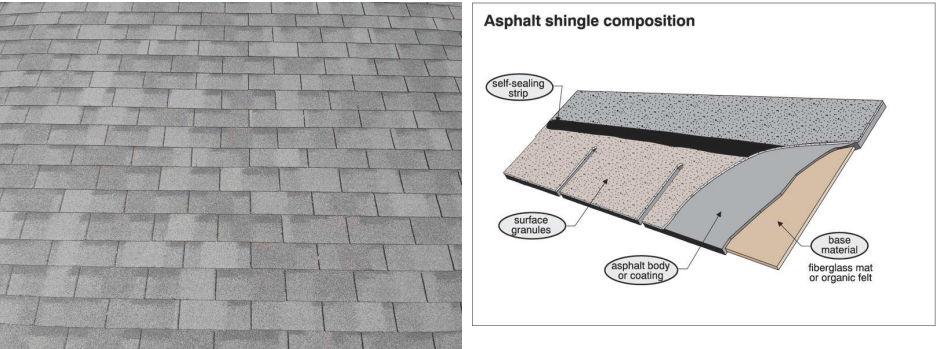
Roof Covering: 3 Tab Asphalt Composition Shingles

The roof was covered with 3-tab fiberglass asphalt shingles. These shingles are composed of a fiberglass mat embedded in asphalt and covered with ceramic-coated mineral granules.

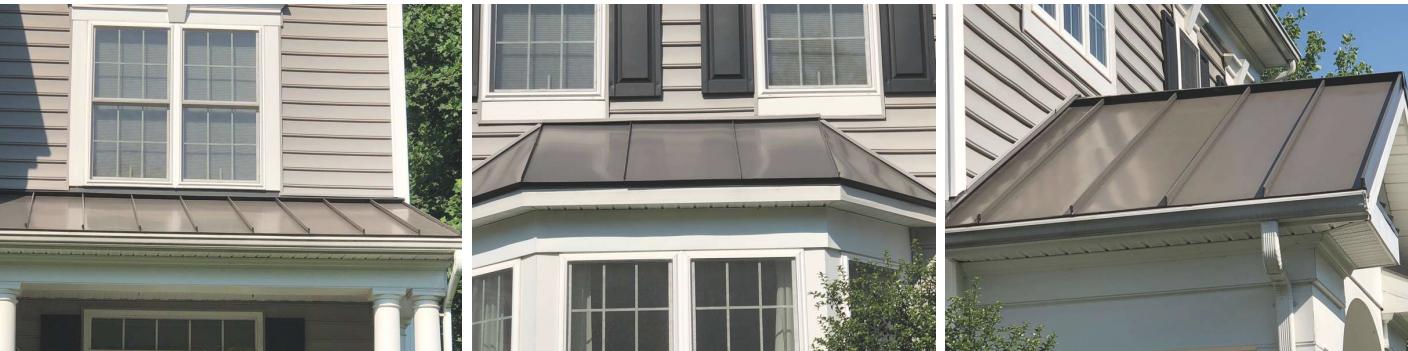
Roof Covering: Standing Seam Metal Roof

This roof, or portions of the roof is covered with standing seam metal roofing. This roof covering is long lasting but the useful lifespan of the materials is dependent on the quality, and maintenance of the coating that protects the metal from corrosion.

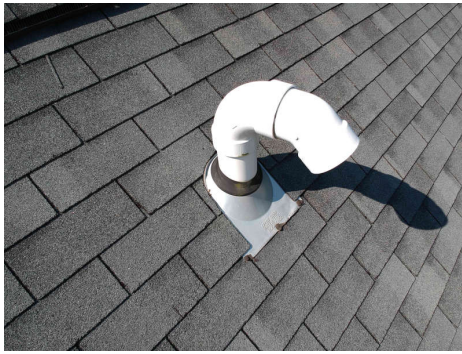
The photo shows examples of where roof flashing might be found under ideal conditions.

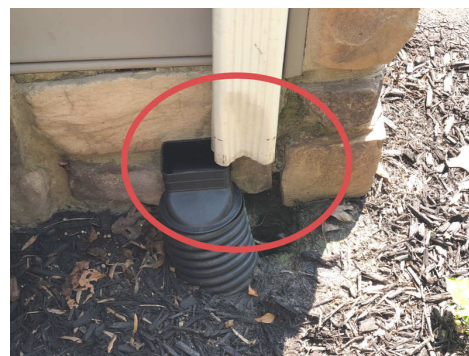
The downspout has separated where it meets the drain tile and may discharge at the foundation. This condition may cause leakage into the basement and possibly damage the foundation if not corrected.

Recommended Repairs

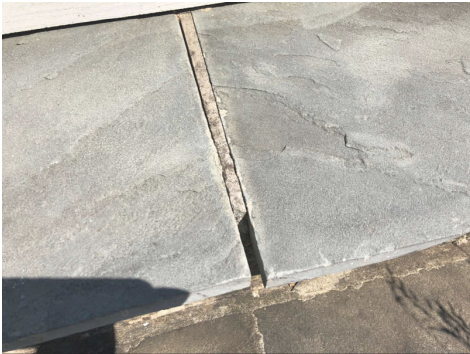
DETERIORATED MORTAR IN STAIRWAY

Mortar is deteriorated and requires maintenance to prevent more expensive repairs.

Maintenance Issues

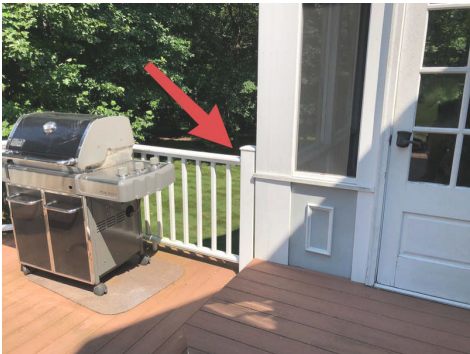
LOOSE GUARDRAIL

This guardrail is loose and should be secured to prevent failure and personal injury.

Safety Issue

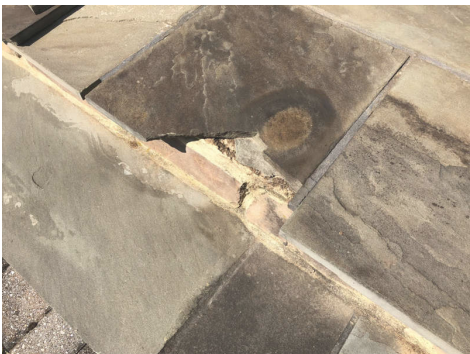
BROKEN STONE ON PORCH

The nosing has broken off of a piece of a stone installed on the front porch. This may be a trip fall hazard.

Recommended Repairs

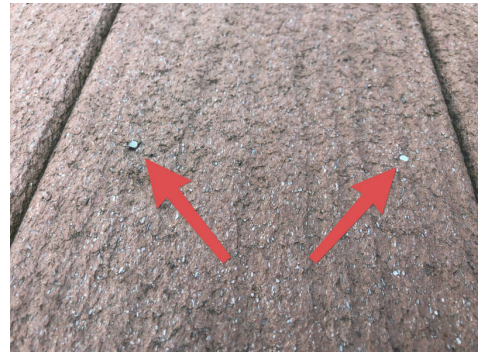
DECK PLANKING IMPROPERLY FASTENED

The deck planking has been nailed down with finish nails and is starting to come loose.

Recommended Repairs

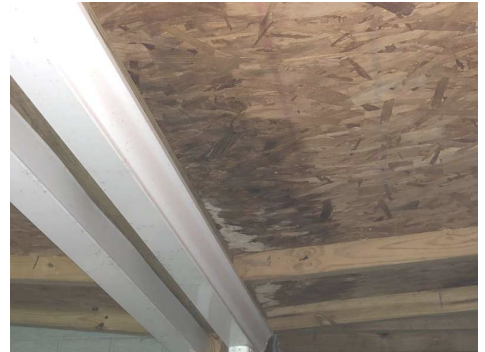
CEILING UNDERNEATH OF DECK IS WATER DAMAGED

The ceiling installed underneath of the screened porch (deck) that channels water into the rain gutters is water damaged.

Recommended Repairs

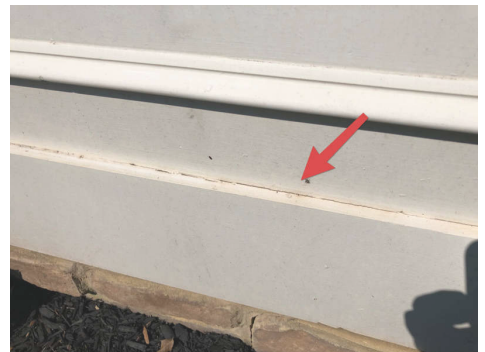
MINOR GAPS IN TRIM

There are minor gaps between the pieces of trim and/or between the trim and siding. This condition may allow moisture into the structure and premature deterioration of the trim.

Maintenance Issues

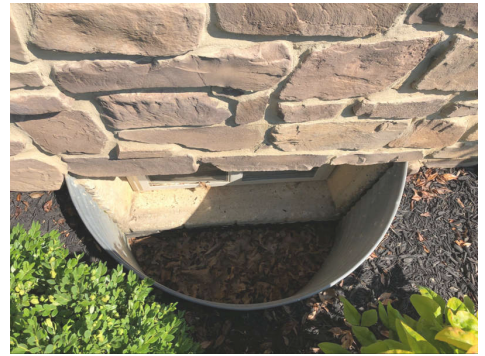
3.4.1 Doors / Windows

WINDOW WELLS UNCOVERED

Window wells should be covered to keep water, children, and pests, such as foxes or skunks out of the window well.

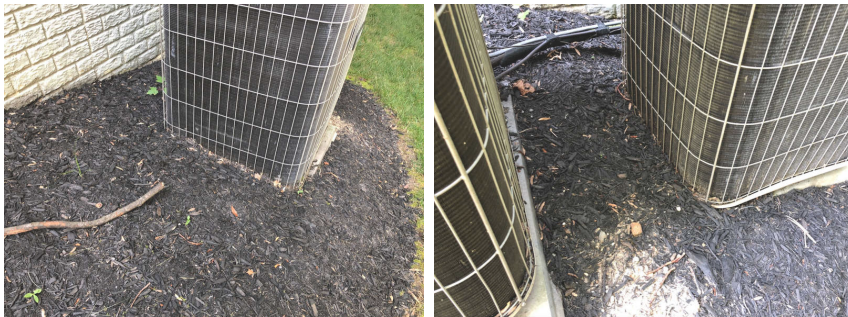
SOIL OR MULCH BUILT UP ON CONDENSER

Soil or mulch has built up on the condensing coil for the air-conditioning system. This may reduce overall efficiency.

Contact a qualified lawn care professional.

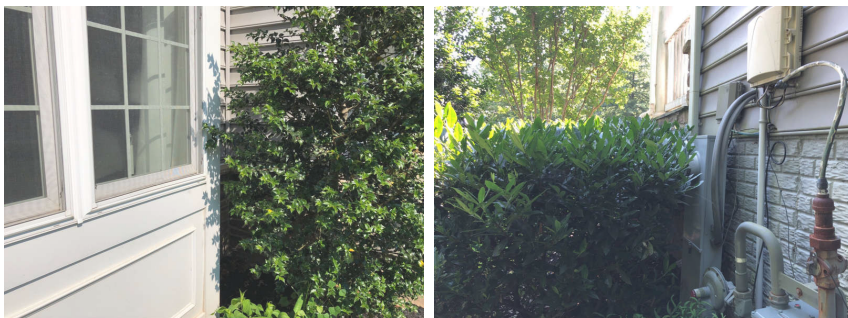
SHRUBS NEED TRIMMING

Shrubs should be trimmed away from the home to keep moisture and pests out.

Contact a qualified landscaping contractor

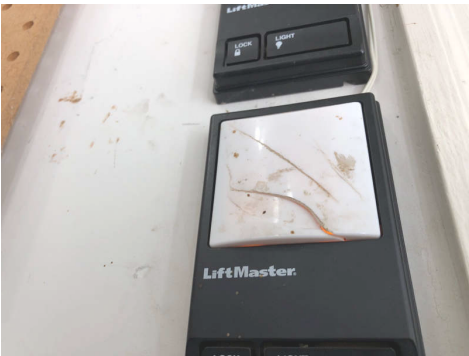
DOOR OPENER SWITCH
DAMAGED

This garage door opener switch is damaged but functional.

Recommendation
Contact a qualified garage door contractor.

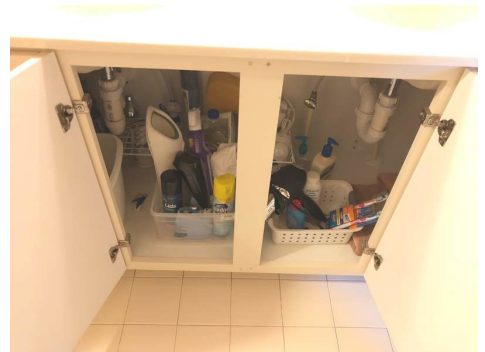
Inspection of the cabinets was limited by the items stored inside of or on top of the cabinets and countertops.

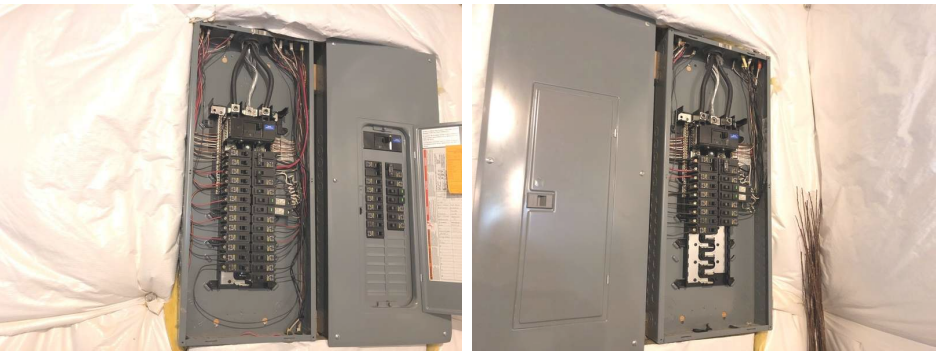
Service Panel / Main Disconnect: Cover Removed For Inspection

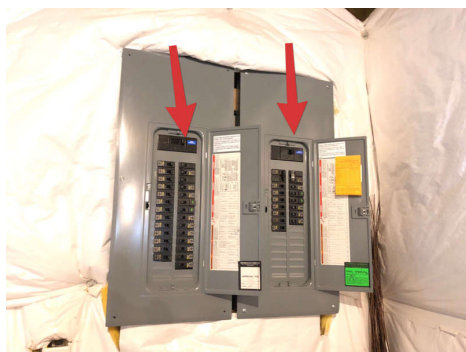
Service Panel / Main Disconnect: Main Disconnect / Panel in Basement

The main electrical shutoff (disconnect) is located in the basement. It is important to maintain easy access to the main service panel so that power can be turned off or back on in the event of an emergency. This is a very good place to keep a flashlight.

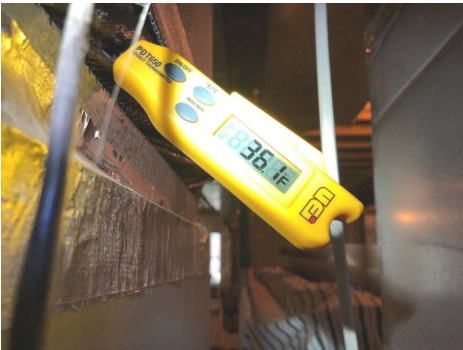
Cooling System: System Cooling Adequately

The air is being cooled adequately. The temperature was checked at the air handler.

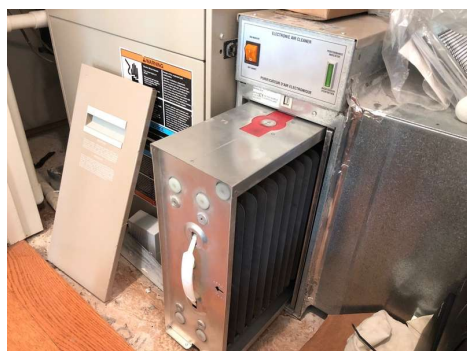
Distribution of Heating / Cooling: Forced Air Distribution

Once the temperature is set at the thermostat, cold air from the home is pulled into the system where it passes through the air filter, removing allergens like pollen and dust. It then blows the air through the air handler where it is warmed via the furnace's heat source and spread to the home through the ducts via the blower motor.

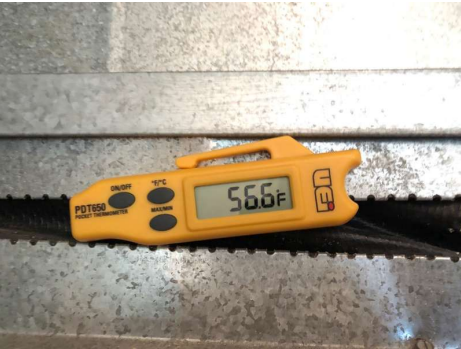
Cooling System: Split System Installed

The air conditioning system is a split system in which the cabinet housing the compressor, cooling fan and condensing coils was located physically apart from the evaporator coils. As is typical with split systems, the compressor/condenser cabinet was located at the home's exterior so that the heat collected inside the home could be released to the outside air.

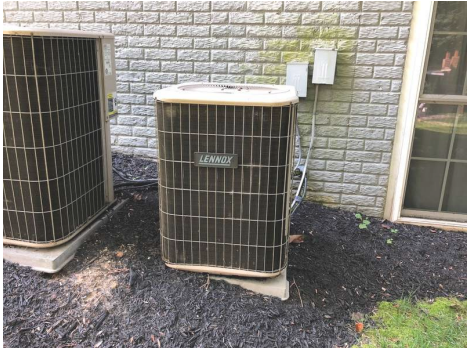
10.1.1 Heating Equipment

CORROSION INSIDE FURNACE

Corrosion inside of the furnace may indicate that there is a condensate leak from the evaporator coil above or gas exhaust pipe. This condition may affect the operational lifespan of the equipment.

Recommendation

Contact a qualified heating and cooling contractor

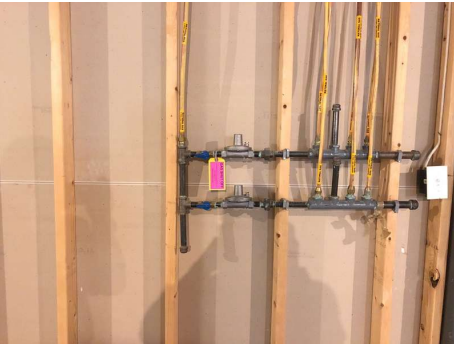
Gas System: Type of Gas Piping
Black Steel, Copper Tubing

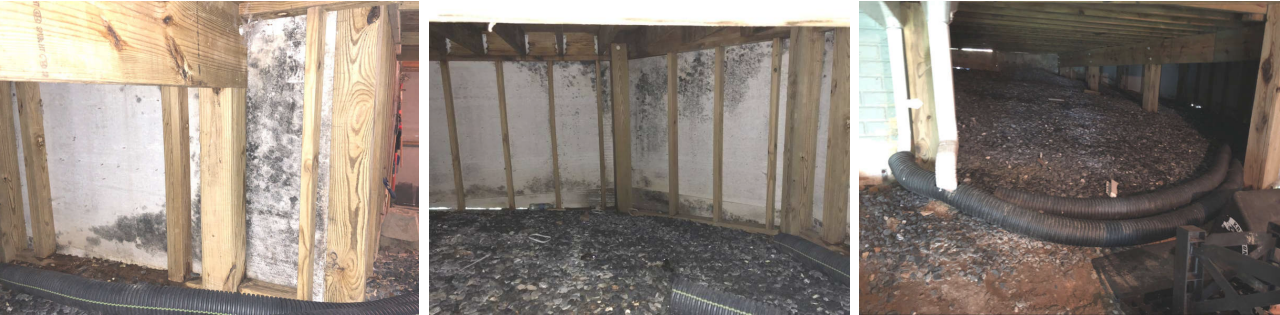
MOLD GROWTH UNDER DECK

What may be mold is present on the Hardie Backer walls underneath of the deck. This may be due to the minimal ventilation underneath of the deck and the water that drains into the space. It is very unlikely that this would affect the living space.
