HOME INSPECTION REPORT

123 Main Street, Philadelphia pa
Philadelphia, PA 19125

FEBRUARY 28, 2023

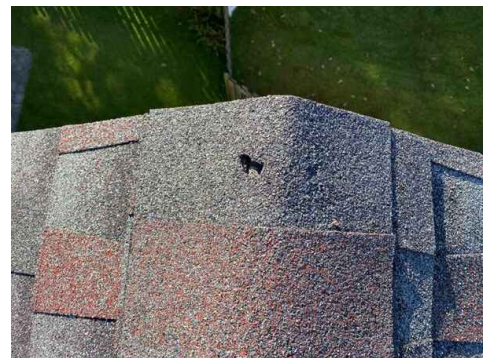
DAMAGED SHINGLE

Cap shingles were noted to be damaged at the upper peak. Replacement by a licensed roofing contractor is needed.

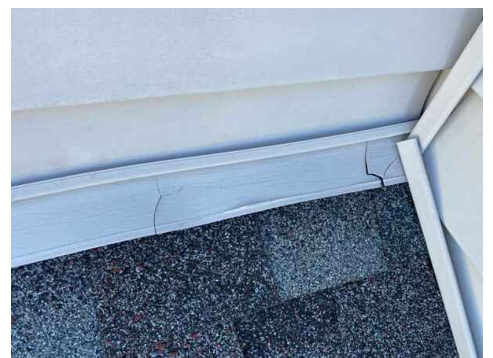
2.4.1 Flashings

FLASHING DAMAGED

The flashing was cracked and damaged at the lower roof. Repairs and sealing of the area are needed to prevent water intrusion.

Contact a qualified handyman.

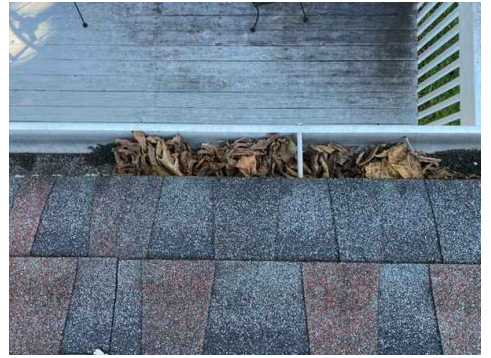
Debris was noted in the gutters. Cleaning the gutters out is recommended to ensure proper drainage.

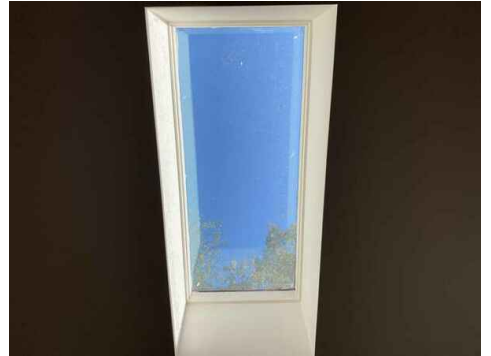
2.8.1 Skylight(s)

MONITOR SKYLIGHT

Skylights are notorious for leaking. Because of this, the skylight should be regularly monitored for any signs of water intrusion including dripping and staining.

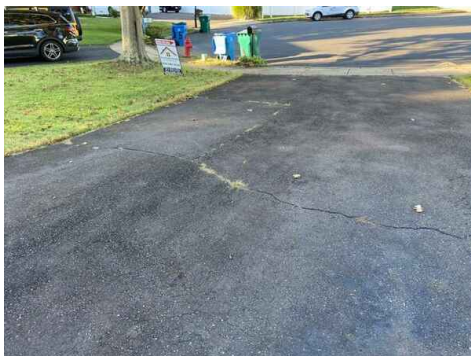
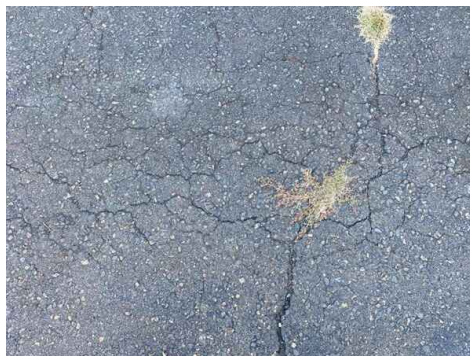
DRIVEWAY WORN OUT

The driveway needs attention and minor repair to prevent further deterioration. The entire asphalt driveway should be seal coated every three years to extend the life of the surface, protecting it from the sun's ultraviolet rays, which can deteriorate the binder and expose the aggregate. Seal coating will prevent water and ice from getting into the pavement and causing it to crumble prematurely.

Contact a qualified professional.

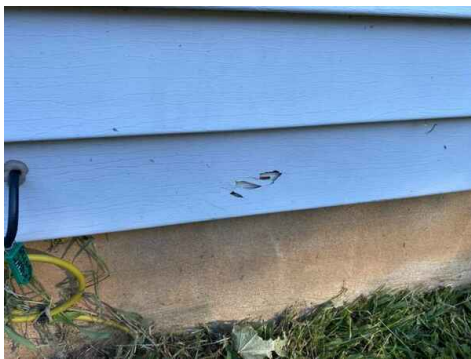
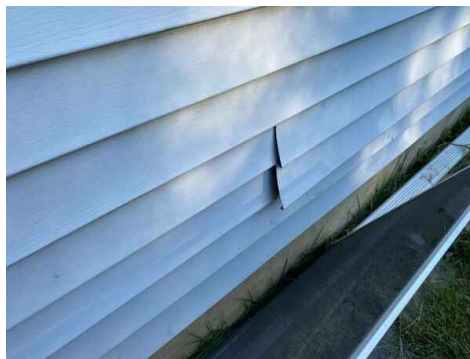
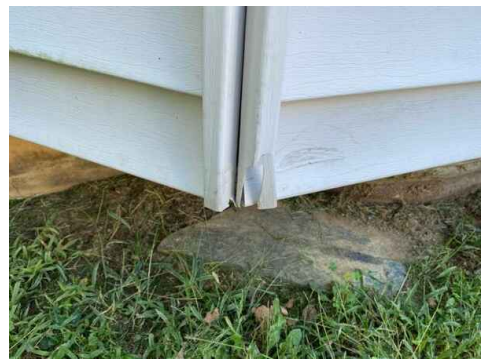
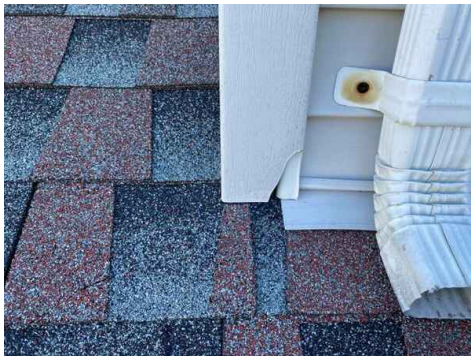
**SIDING - DAMAGE**

The siding was noted to be loose and damaged at multiple areas around the house. Repair or replacement is needed.

Contact a qualified professional.

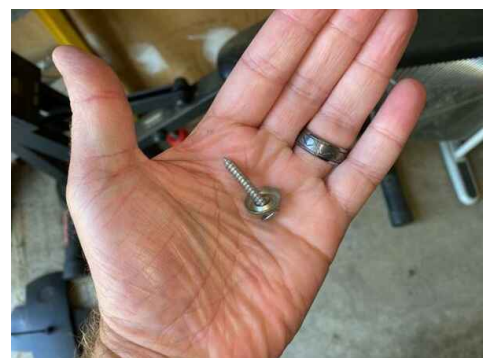
Sharp screws were noted at the dead front of the panel. These can potentially pierce wire sheathing in the interior of the panel and create a safety hazard. Replacement with proper screws is needed.

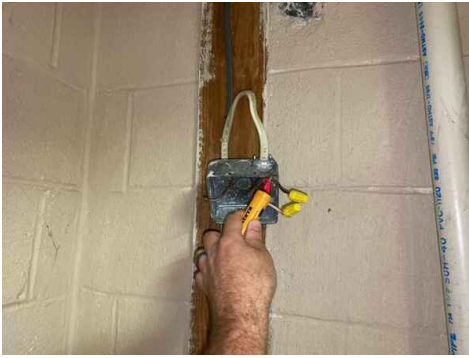
5.4.1 Wiring and Fixtures

OPEN JUNCTION BOX

Junction boxes were noted without covers. The covers should be installed.

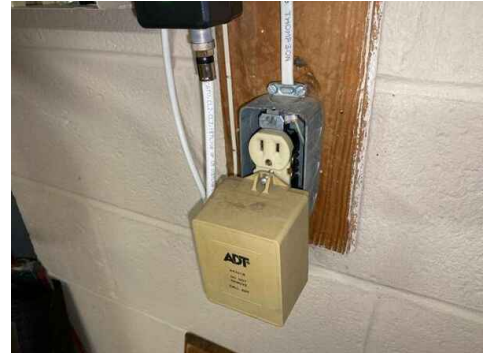
5.5.1 Receptacles

MISSING FACE PLATE

A receptacle face plate was missing. This is a safety concern. Installation of the face plate is needed.

Contact a qualified professional.

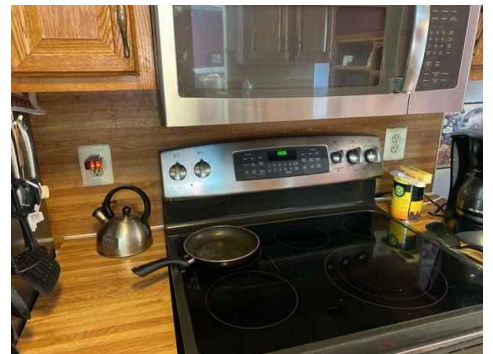
5.7.1 Operation of GFCI (Ground Fault Circuit Interrupters)

**Safety Hazard****KITCHEN**

Contact a qualified professional.

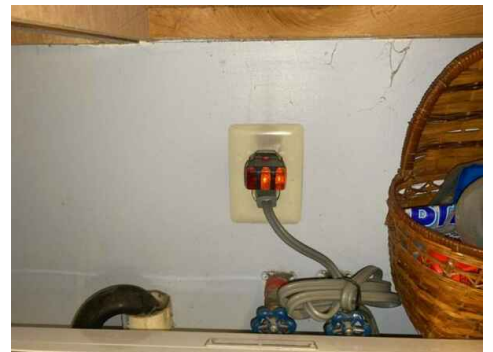
5.7.2 Operation of GFCI (Ground Fault Circuit Interrupters)

**Safety Hazard****LAUNDRY**

Contact a qualified professional.

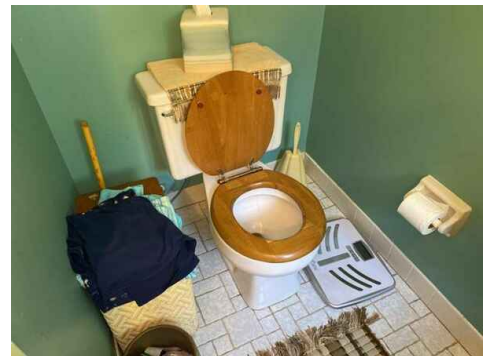
TOILET - LOOSE

The toilet was loose which can put stress on the plumbing and waste line connections. This could ultimately result in waste and water spills. Fully securing the toilet is needed.

Contact a qualified professional.

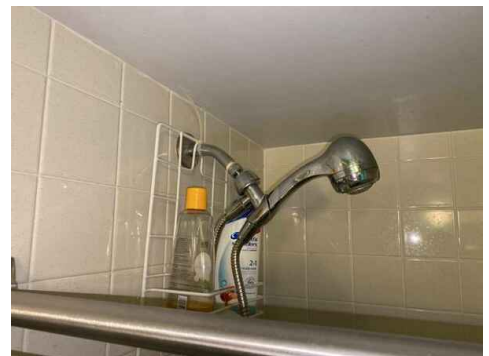
6.8.2 Bathroom(s)

SHOWER - LOOSE HEAD/MAST

The shower head/mast was loose. Securing and sealing is recommended.

Contact a qualified professional.

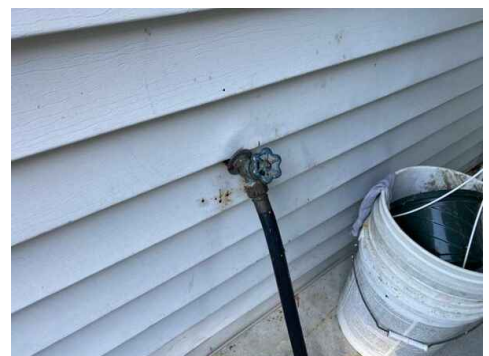
6.12.1 Hose Bibbs

FROST FREE REPLACE

The hose bibb was not frost free. Frost free replacement is recommended.

Contact a qualified professional.

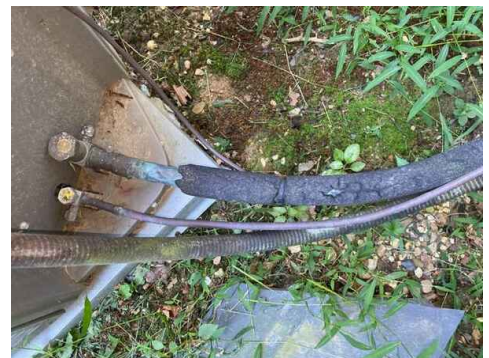
CONDENSER - INSULATION DAMAGE

The condenser suction line insulation was damaged/missing. Replacement of the insulation is suggested to control condensation buildup.

Contact a qualified professional.

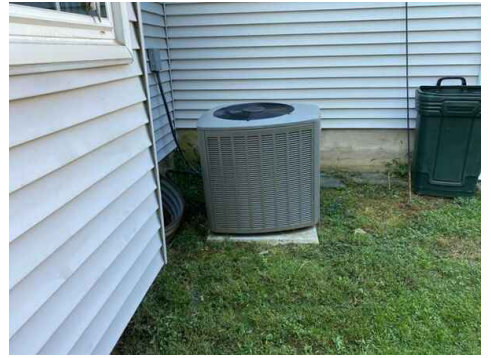
7.6.2 Cooling and Air Handler Equipment

CONDENSER - NOT LEVEL

The condensing unit was out of level. Corrections should be made to prevent undue stress or damage to the unit which could shorten its lifespan.

Contact a qualified professional.

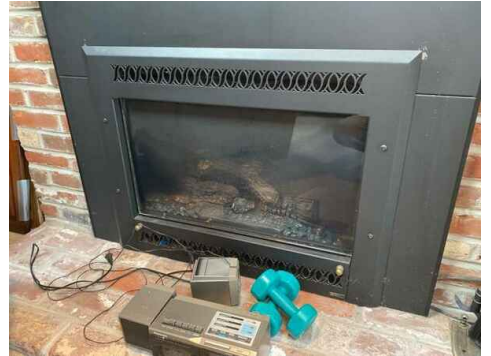
7.8.1 Gas/LP Firelogs and Fireplaces

NON OPERATIONAL

The gas fireplace did not function under normal operating conditions. It should be evaluated, serviced and confirmed operational.

Contact a qualified professional.

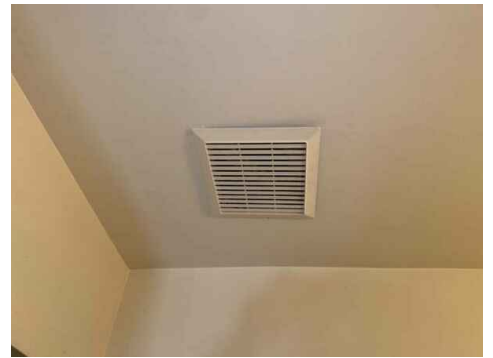
8.5.1 Bathroom(s)

EXHAUST FAN - TERMINATION NOT FOUND

The termination point of the bathroom exhaust fan was not found. Exhaust fans should exhaust/terminate to the exterior. This should be discussed with the seller or qualified contractor.

Contact a qualified professional.

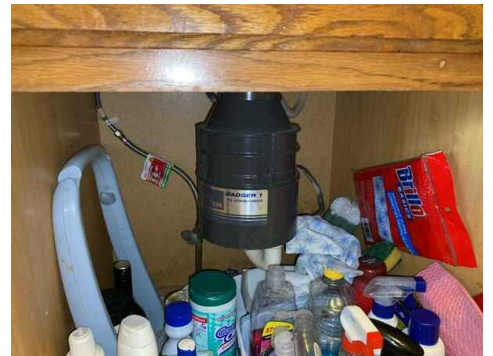
8.6.1 Kitchen Appliances/cabinets

APPLIANCE NOT FUNCTIONING

The garbage disposal was not operational at the time of inspection. Repair or replacement is needed.

Contact a qualified professional.

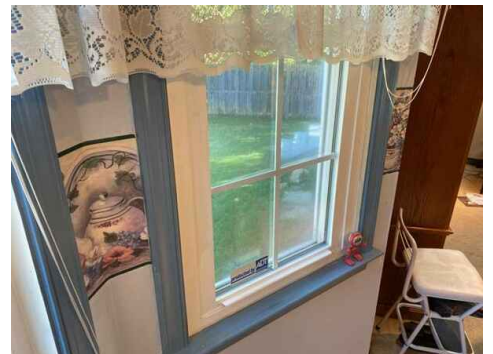
8.8.1 Windows

WINDOWS - FOGGED GLASS

Multi-pane window was fogged between the panes. Fogging or moisture between the panes indicates a poorly insulated pane seal. Replacement is needed.

Contact a qualified professional.

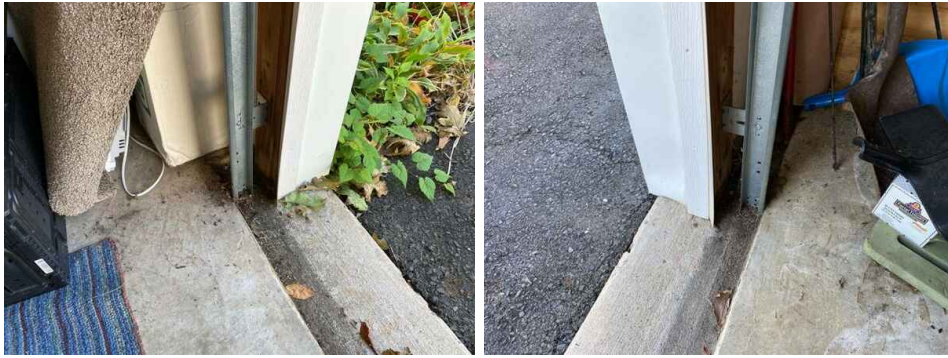
Safety Hazard

Contact a qualified professional.

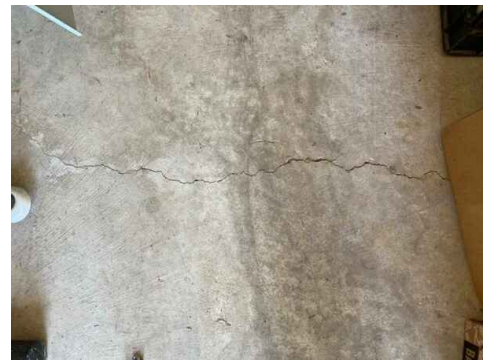
9.5.1 Garage Floor

TYPICAL CRACKING

The garage floor had typical cracking which is usually the result of shrinkage or settlement of the slab. The garage floor slab is not considered structurally integral to the home. Sealing the cracks is suggested.
