### YOU'RE HOME INSPECTION

1995 house  
Mckinney , TX 76082

# PROPERTY INSPECTION REPORT FORM

1995 house, McKinney, TX 76082

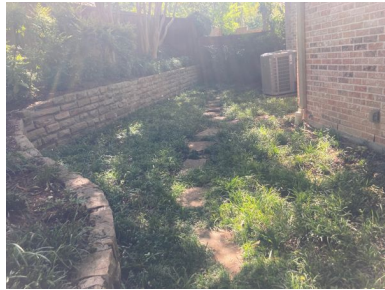
## 2: High Soil

☹️Minor or Cosmetic Deficiencies  
front & rear & right side

- The soil line is too high at one or more locations around the home. Under current building standards there should be at least 2-inches of foundation visible below masonry veneer and 4-inches of foundation visible below wood type veneer. High soils can lead to moisture problems in the wall cavities of a home. The soils need to be lowered so that at least two inches of foundation is visible under the first course of brick.

Recommendation: Contact a qualified grading contractor.

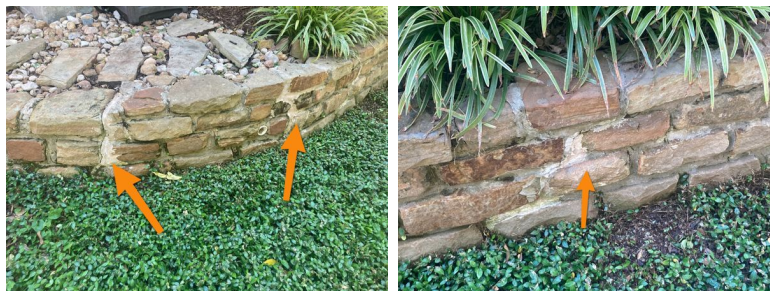
## 3: Retaining wall Mortar Cracks

☹️Minor or Cosmetic Deficiencies

- The mortar cracks observed on the retaining wall appear to be a minor and typical sign of seasonal movement. It is recommended that the cracks be repaired as necessary or as desired

Recommendation: Contact a qualified masonry professional.

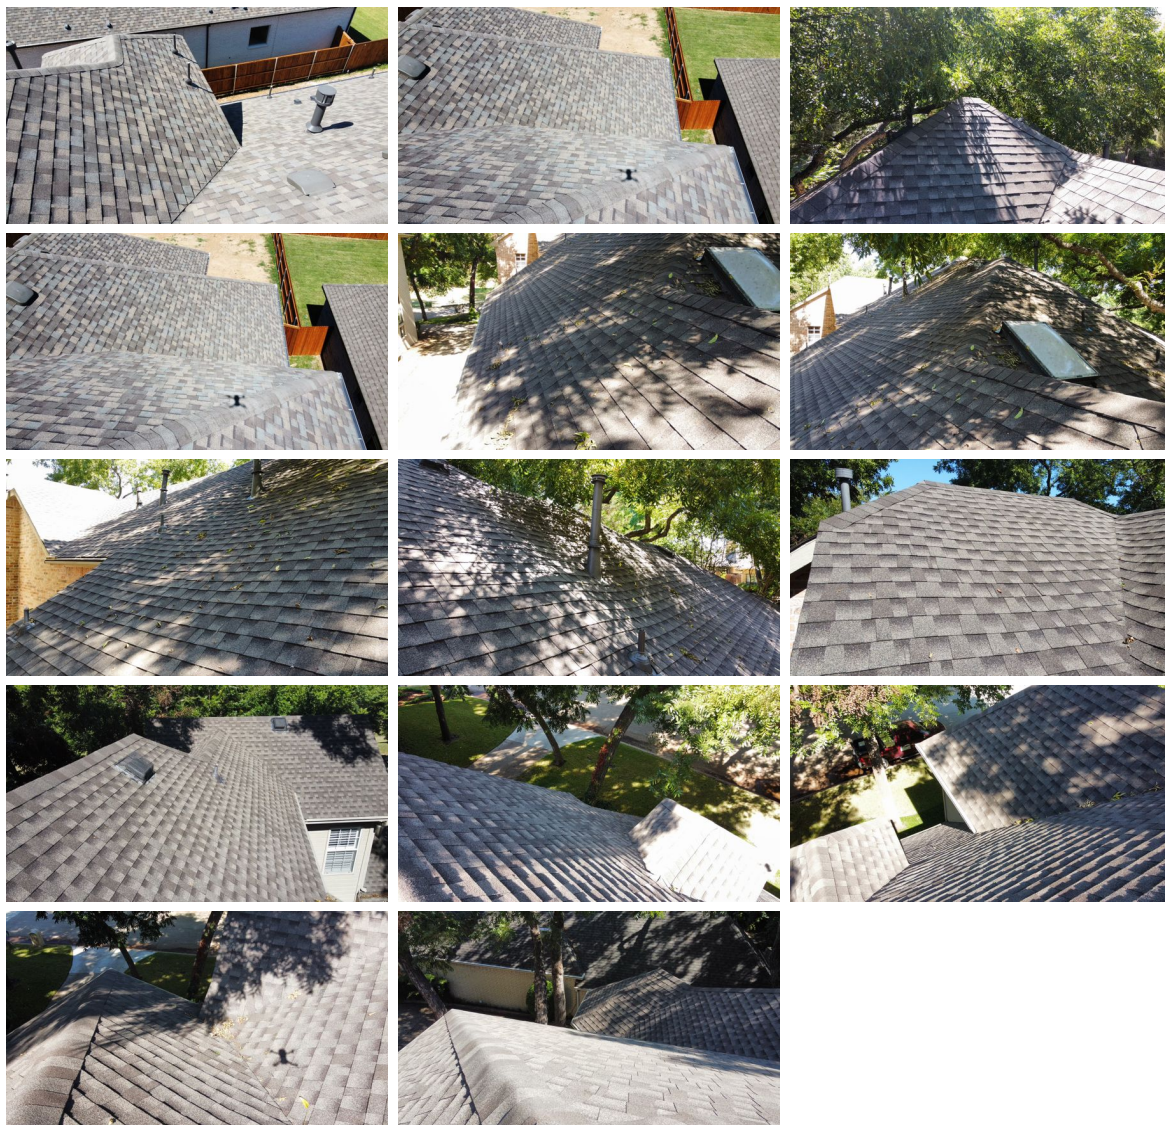
- Pictures if the roof covering for reference.

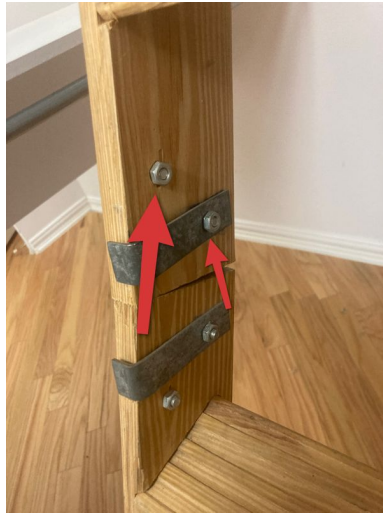
### 2: Nuts Loose or missing

Some of the attic ladder nuts and bolts were observed to be loose and/or missing. Minor improvements to the attic ladder are recommended for reasons of safety.

Recommendation: Contact a qualified handyman.

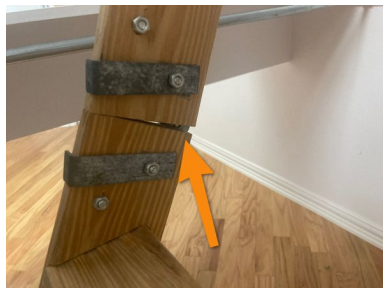
⚠️ Minor or Cosmetic Deficiencies

There was observed to be a gap between the ladder rungs. Over time this can cause damage to the rungs. The ladder was also observed to be wobbly. It is recommended that the ladder be adjusted.

Recommendation: Contact a qualified carpenter.

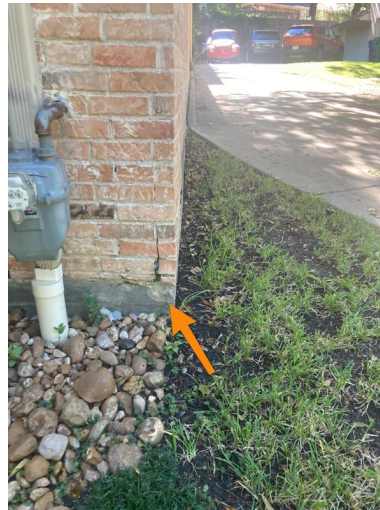
🟡 Minor or Cosmetic Deficiencies

- 1 Corner pops were observed at the corner of the slab. Corner pops on the slab are cosmetic in nature and Not a sign of foundation problems.

Recommendation: Contact a qualified professional.

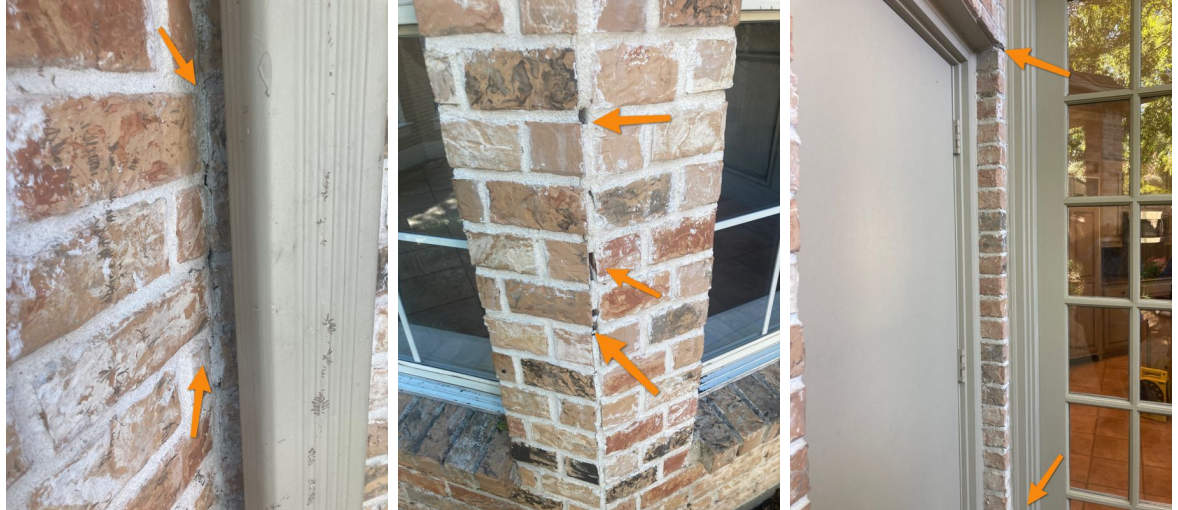
🟡Minor or Cosmetic Deficiencies

- Mortar improvements are recommended for the masonry veneer.

Recommendation: Contact a qualified masonry professional.

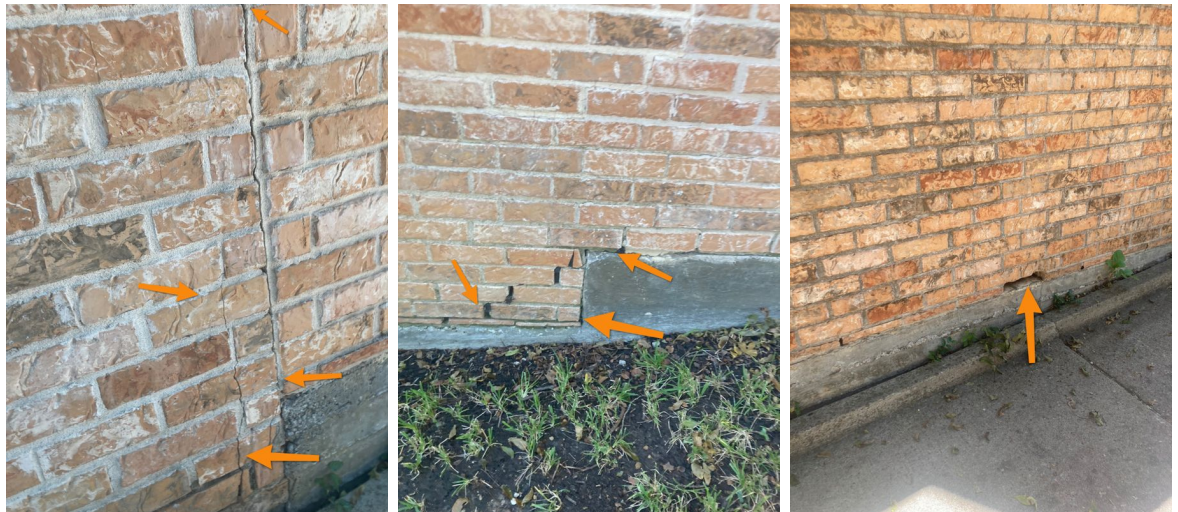
## 3: Masonry Crack or damage

🟡Minor or Cosmetic Deficiencies

- Brick and or mortar cracks were observed at the property. The crack should be repaired by a qualified mason.

Recommendation: Contact a qualified masonry professional.

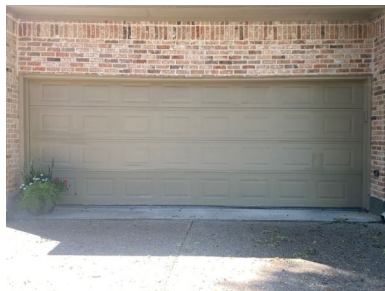
#### 4: Garage Door Sags

⚠️ Minor or Cosmetic Deficiencies

- Some sagging of the garage brick / lintel was observed. This condition should be further evaluated and corrected as necessary.

Recommendation: Contact a qualified professional engineer

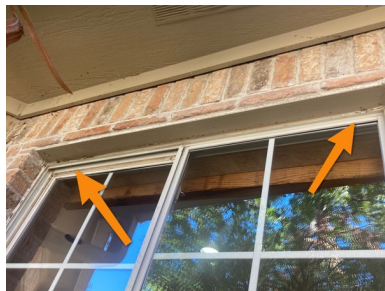
#### 6: Rusted Lintel

🟡 Minor or Cosmetic Deficiencies

- Lintels above one or more exterior doors or windows were visibly rusted at the time of the inspection. Rust should be cleaned off and the lintels painted as part of normal home maintenance.

Recommendation: Contact a handyman or DIY project

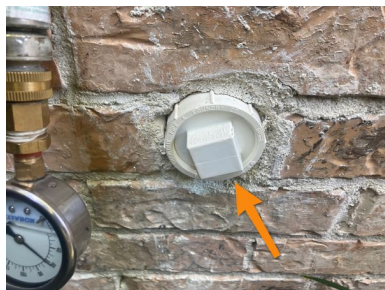
#### 7: Paint exposed PVC

🟡 Minor or Cosmetic Deficiencies

- Exposed PVC drain pipes should be painted to help protect them from UV light.

Recommendation: Contact a qualified painting contractor.

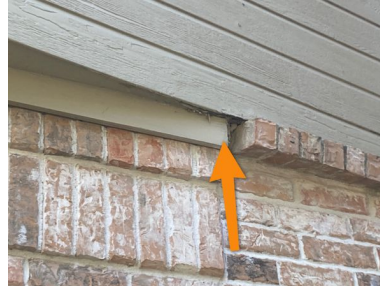
- Wood rot / deterioration was observed at the exterior of the home. All deteriorated or damaged wood should be replaced, resealed and properly painted with a sound coat of paint.

Recommendation: Contact a qualified professional.

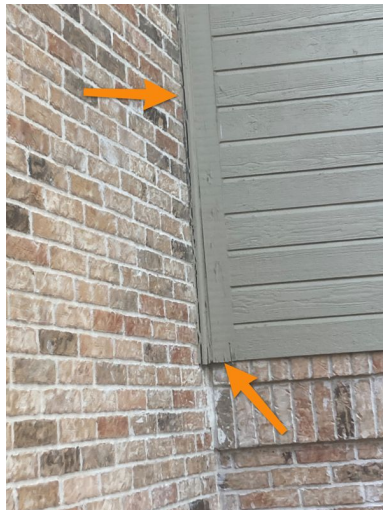
#### 8: Wood rot

⚠️Minor or Cosmetic Deficiencies

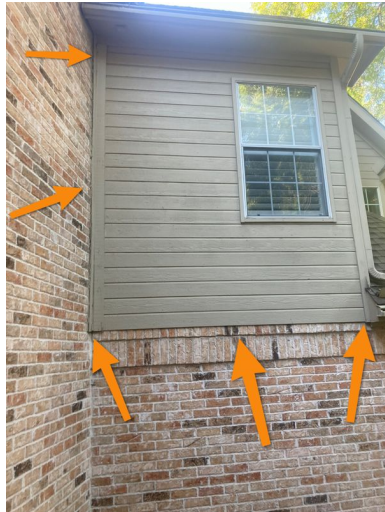
#### 10: Seal exterior Interfaces

⚠️ Minor or Cosmetic Deficiencies

- The interfaces where the siding meets the brick or masonry veneer needs to be sealed with a good sealant. Interfaces between two types of exterior veneer also need to be sealed or touched up

Recommendation: Contact a handyman or DIY project

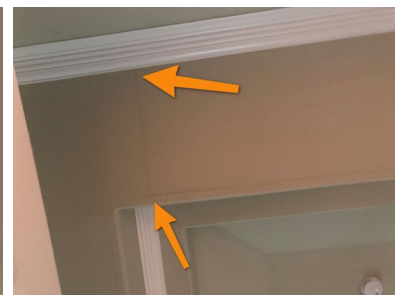
**1: Ceiling Cracks**

☹️ **Minor or Cosmetic Deficiencies**

Ceiling cracks were observed. It is recommended that the cracks be repaired.

Recommendation: Contact a qualified drywall contractor.

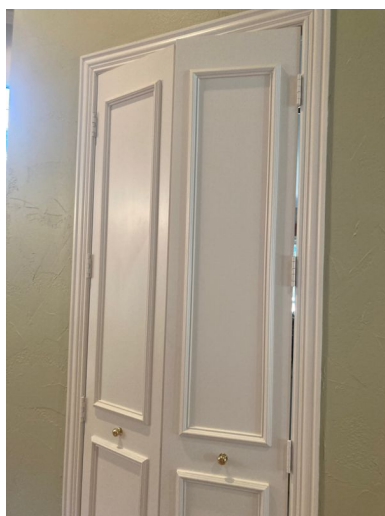
🟡 Minor or Cosmetic Deficiencies

The bullet catch assembly needs to be adjusted so the door opens and closes easily.

Recommendation: Contact a qualified professional.

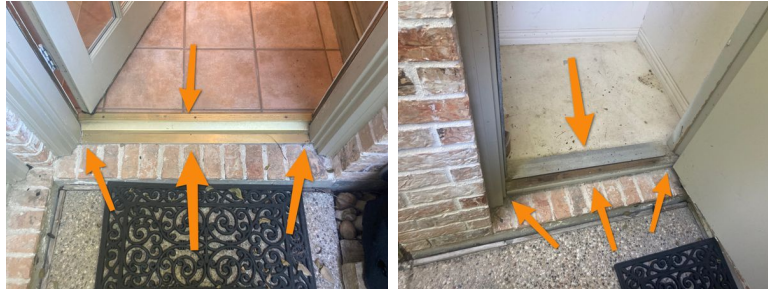
⚠️Minor or Cosmetic Deficiencies

All exterior door thresholds should be sealed around edges.

Recommendation: Contact a qualified professional.

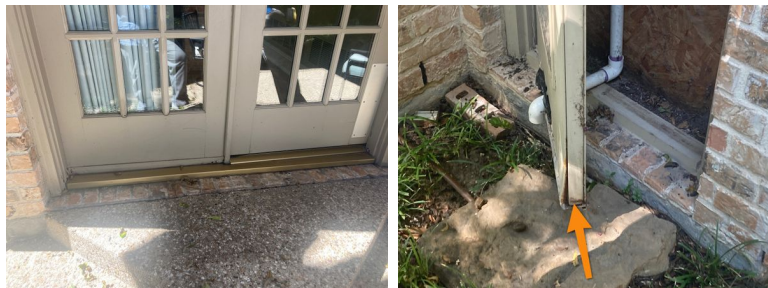
#### 5: Wood rot

⚠️Minor or Cosmetic Deficiencies

Wood rot observed at one of the exterior doors. All deteriorated components should be replaced.

Recommendation: Contact a qualified professional.

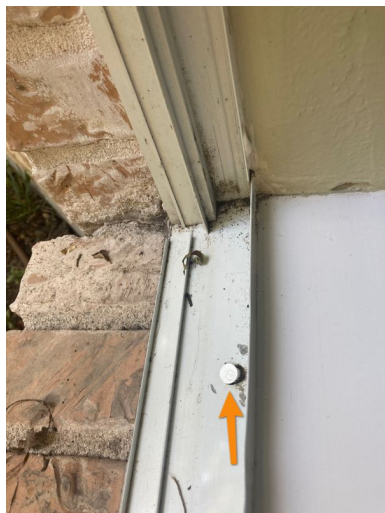
🟡 Minor or Cosmetic Deficiencies

The security contacts in the base of the window frames need to be properly sealed so to help prevent possible water intrusion.

Recommendation: Contact a qualified professional.

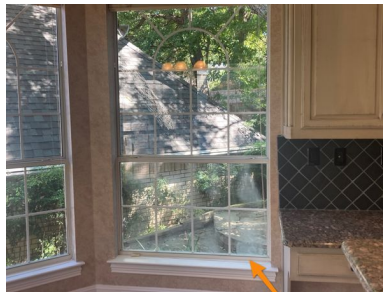
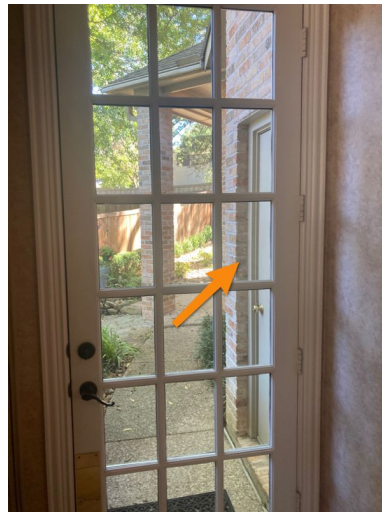
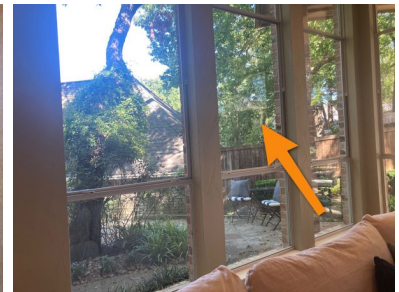
### 🟡Minor or Cosmetic Deficiencies

Important: This is not likely all of the fogged windows. I did my best but I cant find them all for the reasons listed above.

Recommendation: Contact a qualified window repair/installation contractor.

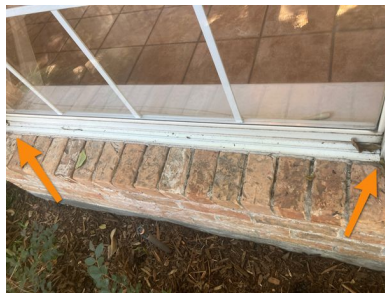
#### 4: Caulking touchups are needed

Minor or Cosmetic Deficiencies

Caulking touch ups are needed around the windows of the home inside and outside.

Recommendation: Contact a handyman or DIY project

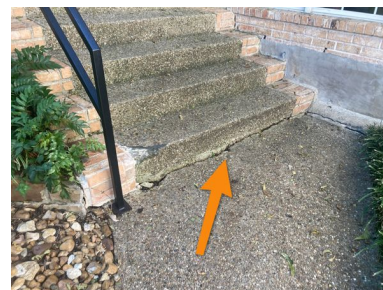
### 1: Risers Uneven

Minor or Cosmetic Deficiencies

Steps are also supposed to be no more than 7 3/4" in height.

Recommendation: Contact a qualified handyman.

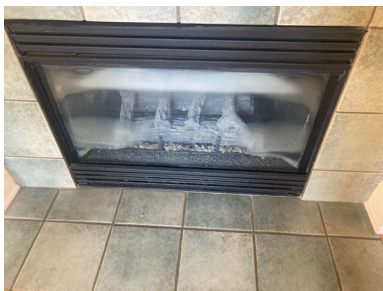
Pic during operation:

Picture of the gas kit during operation.

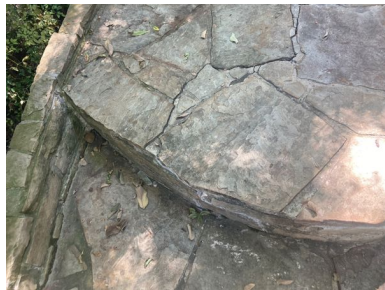
- The stairway treads were observed to be loose in one or more locations and need to be re-secured for safety reasons.

Recommendation: Contact a handyman or DIY project

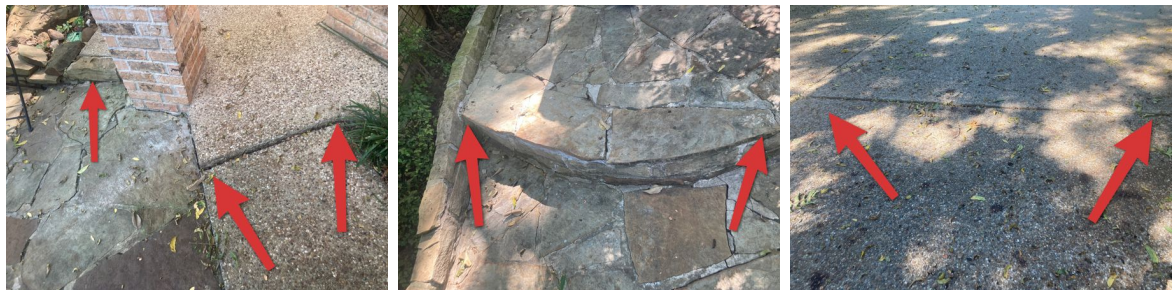
### 3: Trip Hazard

▲Essential Items (Licensed Professionals & Safety)

Some of the front sidewalks are uneven. This condition presents a possible trip hazard or hazards to people entering or leaving.

Recommendation: Contact a qualified concrete contractor.

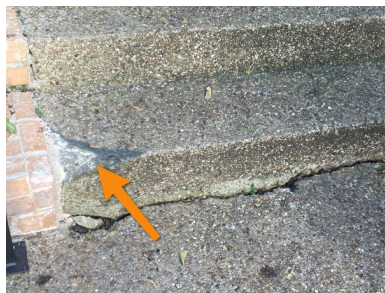
A masonry step is damaged and should be repaired as necessary.

Recommendation: Contact a qualified masonry professional.

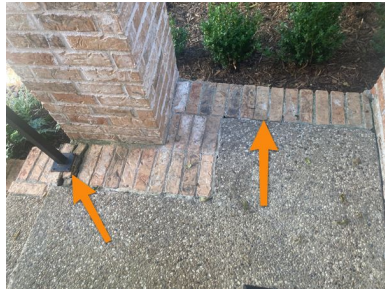
Mortar touchups are needed at the porch area.

Recommendation: Contact a qualified masonry professional.

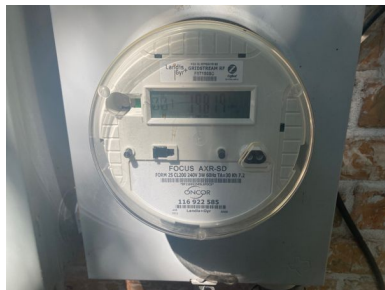
### *Pictures Electrical Meters:*

Pictures of the electrical meters for reference.

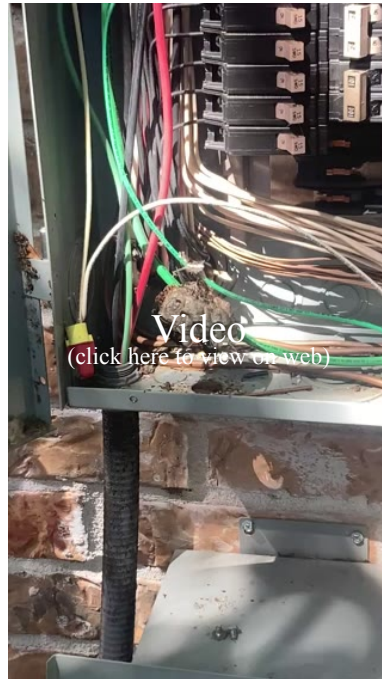
Wasp were observed inside the service panel at the time of inspection. it is recommended that they be removed.

Recommendation: Contact a qualified professional.

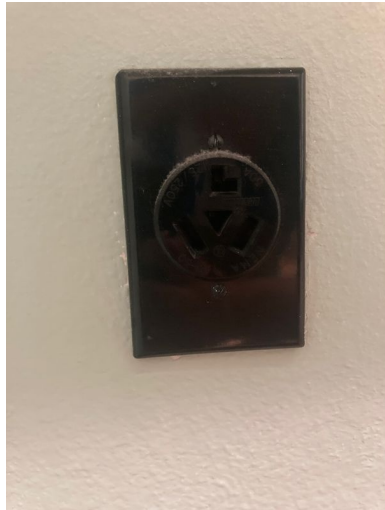
The buyer should be aware that the dryer vent plug is a 3 prong style. If the buyers dryer has a 4 prong pig tail the plug will need to be replaced with a 4 prong outlet.

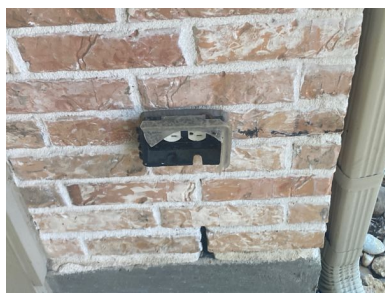
One or more of the receptacles was noted to have missing or damaged cover plate.

Recommendation: Contact a qualified electrical contractor.

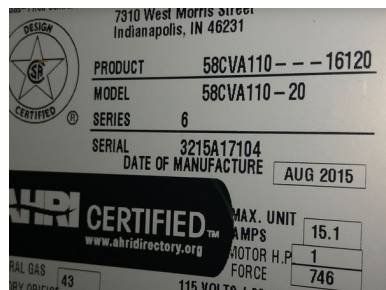
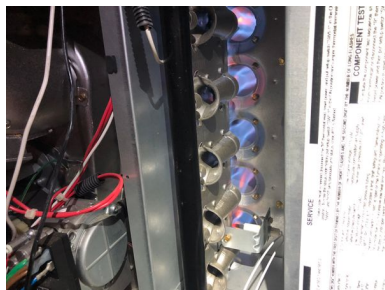
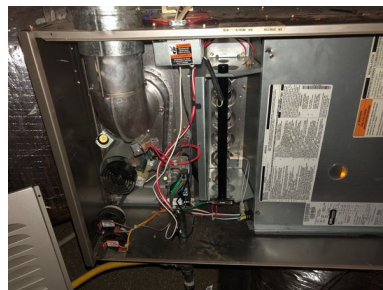
*(GAS) PICS of Furnace, Comb Chamber:* Downstairs unit -

- Picture of the furnace/heater for reference.
- Picture of the combustion chamber during operation.

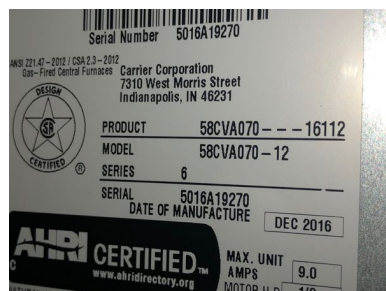
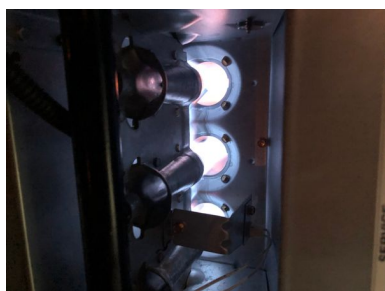
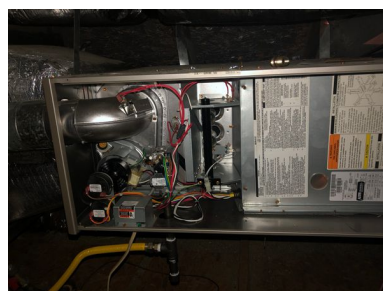
*(GAS) PICS of Furnace, Comb Chamber:* Upstairs unit -

- Picture of the furnace/heater for reference.
- Picture of the combustion chamber during operation.

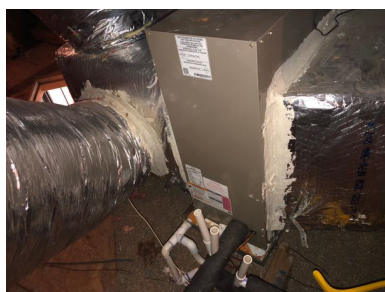
- Image taken of the supply and return air with the IR camera of the HVAC grills during operation of the cooling system.

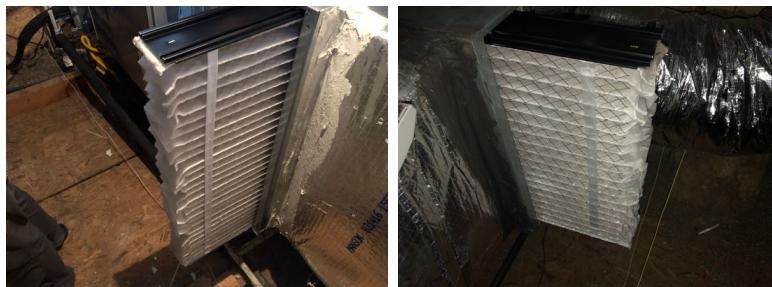
*Picture of the Filter(s):*

- Picture(s) of the HVAC filter(s) for reference. **FYI: 1 inch filters should be changed Every month and 4 inch filters should be changed every three months as part of regular home maintenance.**

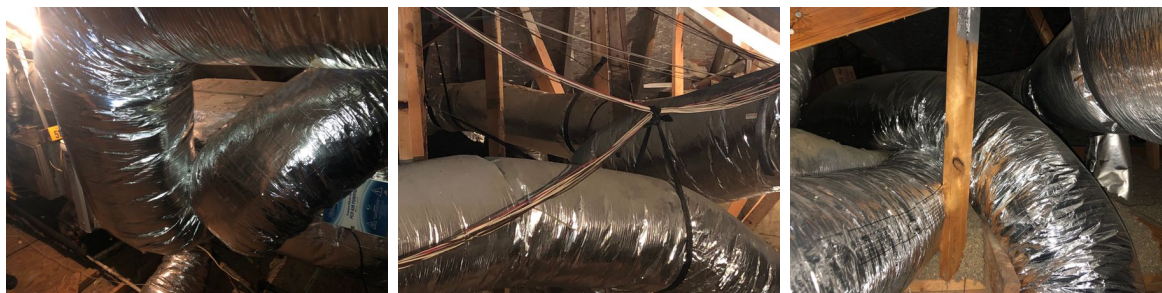
*Ductwork ok:*

- All visible ducts appeared to be in satisfactory condition at the time of this inspection.

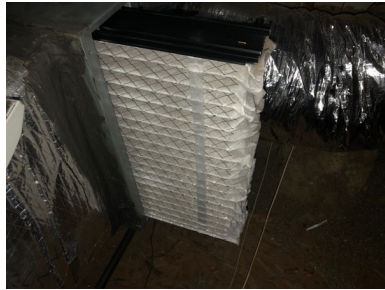
- The filters were dirty at the time of inspection and should be replaced as necessary. **1 inch filters** should be replaced **monthly** and **4 inch filters** should be replaced **every 4 months**.

Recommendation: Contact a handyman or DIY project

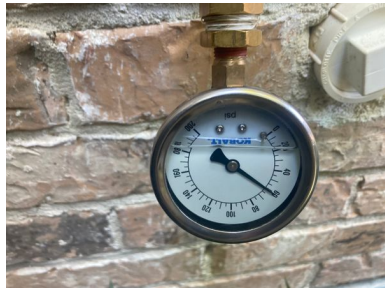
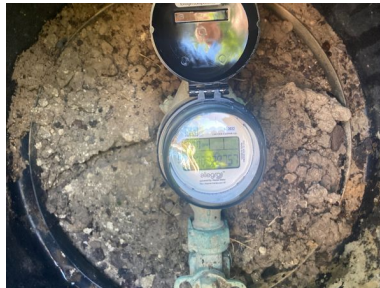
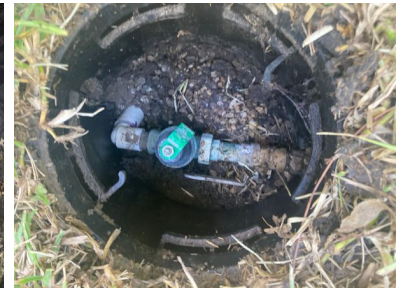
*PICS Water Pressure, (meter or well equipment) & Customer Shutoff:*

- Picture of the pressure gauge at the time of inspection.
- Picture of the water meter at the time of inspection. (Or well equipment)
- Picture of the customer shutoff valve (If visible).

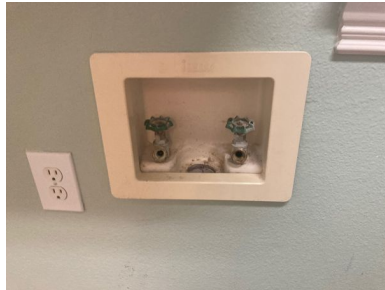
*Pic of the laundry connections:*

- Picture of the laundry room washer box connections. No rust or leaks were found at the time of this inspection.

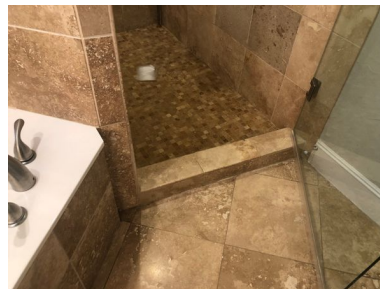
*IR tested shower OK:*

- The shower drain was blocked and about of water was held in the pan area for a period of time to see if the shower pan leaked. I checked the outside edges of the shower pan with the IR camera and with my eyes for leaks and found No leaks at the time of this inspection. It is important to maintain the grout and caulking in shower enclosures to help prevent leaks. Cleaning products that contain bleach can cause deterioration of caulking.

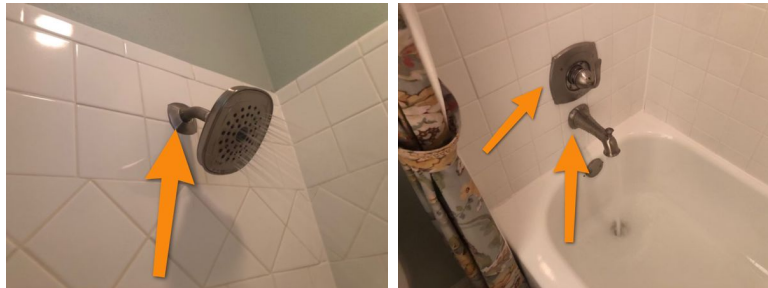
- Tub spout should be sealed to avoid water intrusion in the wall. [FYI: Cleaning products that contain bleach can cause deterioration of caulking.](#)

Recommendation: Contact a handyman or DIY project

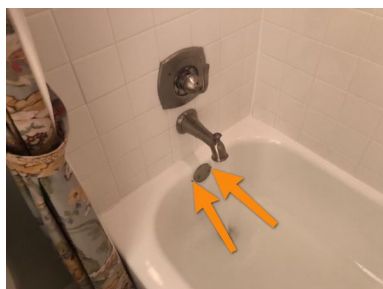
### 2: Surface damage

Minor or Cosmetic Deficiencies

- Bathtub has some surface damage and should be repaired as necessary.

Recommendation: Contact a qualified professional.

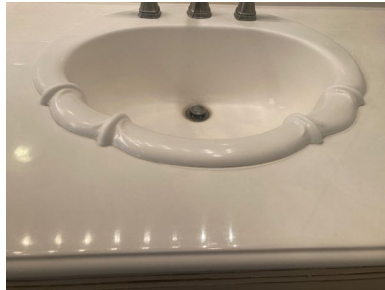
The sink needs to be resealed to the countertop.

Recommendation: Contact a handyman or DIY project

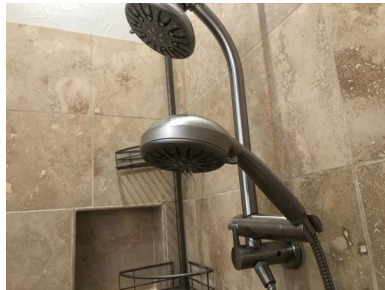
Low water pressure was observed at the shower.

Recommendation: Contact a qualified plumbing contractor.

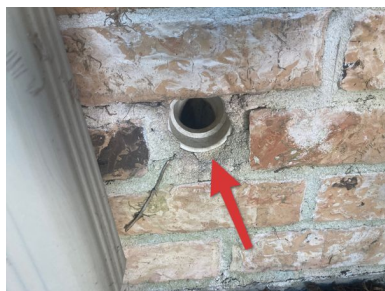
### 1: Missing Cap on cleanout

One or more of the drain line clean out caps was missing at the time of inspection.

Recommendation: Contact a qualified plumbing contractor.

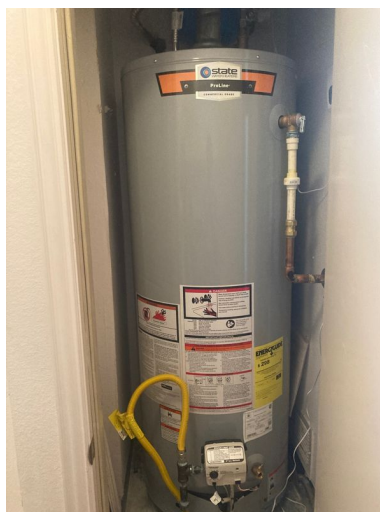
*Water Heater:* Energy Type:, Capacity:, Brand:, Manufacture Date:, Location, Max Energy rating:, Gas, State, 40000 BTU, 50 gallons, Manufacture year 2020, Located in Interior Closet

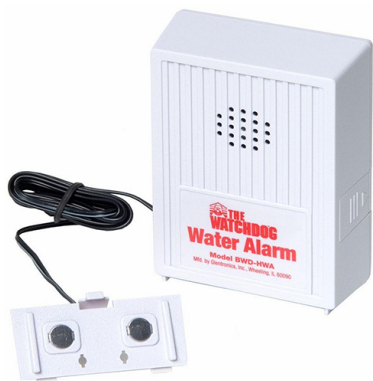
We highly recommend the use of a water alarm at the water heater. This alarm will sound at the presence of any water leaks and could help prevent major water intrusion events due to failure of the water heater. These units are available online or at major home improvement centers for about \$10 each.

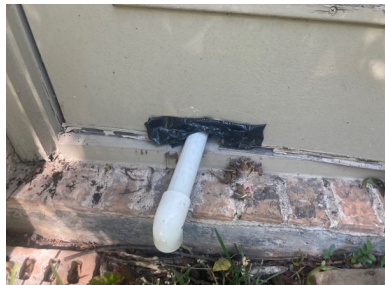
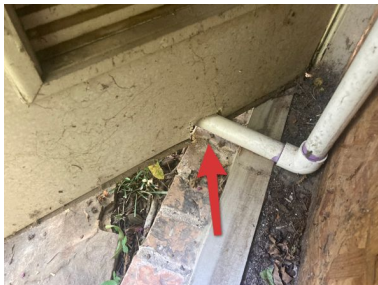
The drain pipe for the emergency drain pan restricts the operation of the door.

Recommendation: Contact a qualified plumbing contractor.

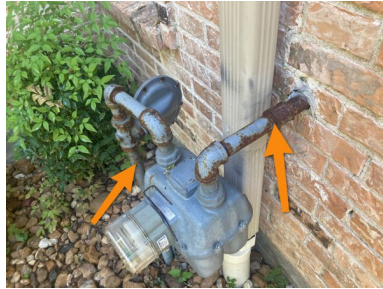
**1: Rust**

Should be cleaned off and the exterior gas pipes painted with a good exterior paint to help prevent further rusting and possible future leaks

Recommendation: Contact a qualified painting contractor.

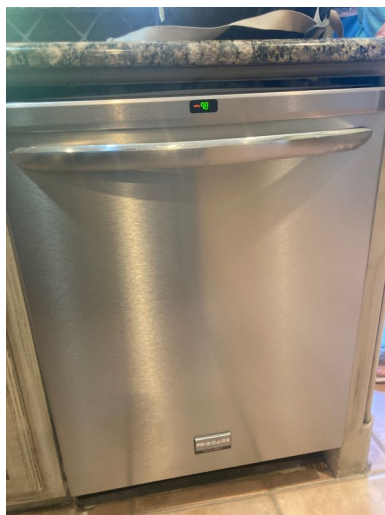
Picture of the dishwasher for reference. The dishwasher appeared to be working at the time of inspection.

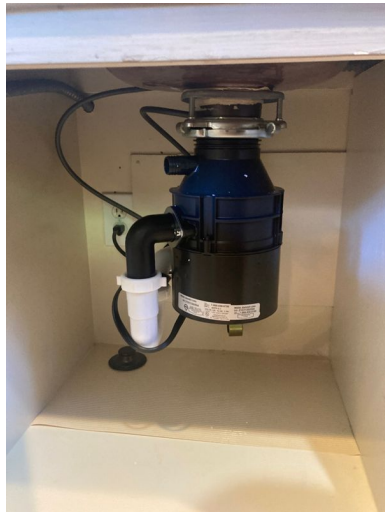
**1: Inop**

The food waste disposer is inoperative. Further evaluation and repair or replacement may be necessary.

Recommendation: Contact a handyman or DIY project

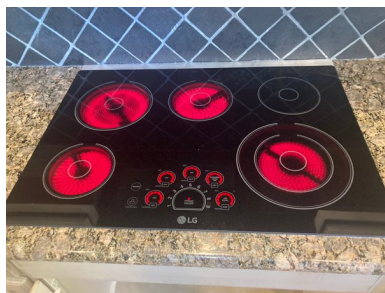
The cooktop burners appeared to be performing properly at the time of this inspection.

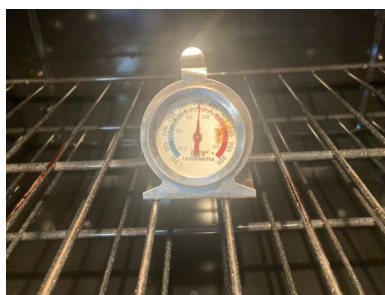
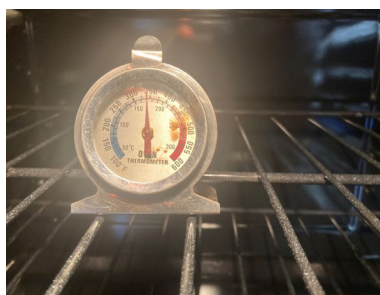
*Oven OK:*

The oven was tested ant 350 degrees and appeared to be working properly at the time of inspection.

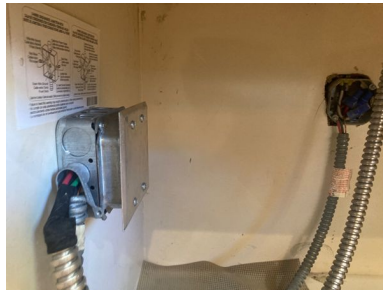
**1: Conduit loose****▲Essential Items (Licensed Professionals & Safety)**

The electrician cal conduit was loose at the appliance and or junction box. The conduit should be better secured.

Recommendation: Contact a qualified electrical contractor.

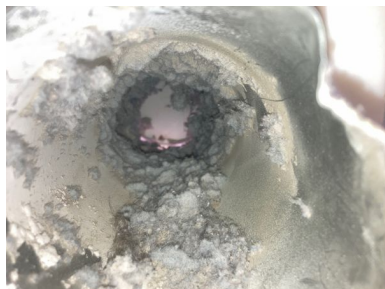
- The visible portion of the dryer duct was observed to be dirty with lint and debris. The inside of the dryer vent should be cleaned before use. Dryer vents should be cleaned regularly as part of normal home maintenance as often as necessary depending on use for reasons of energy efficiency and **fire safety**.

Recommendation: Contact a qualified professional.

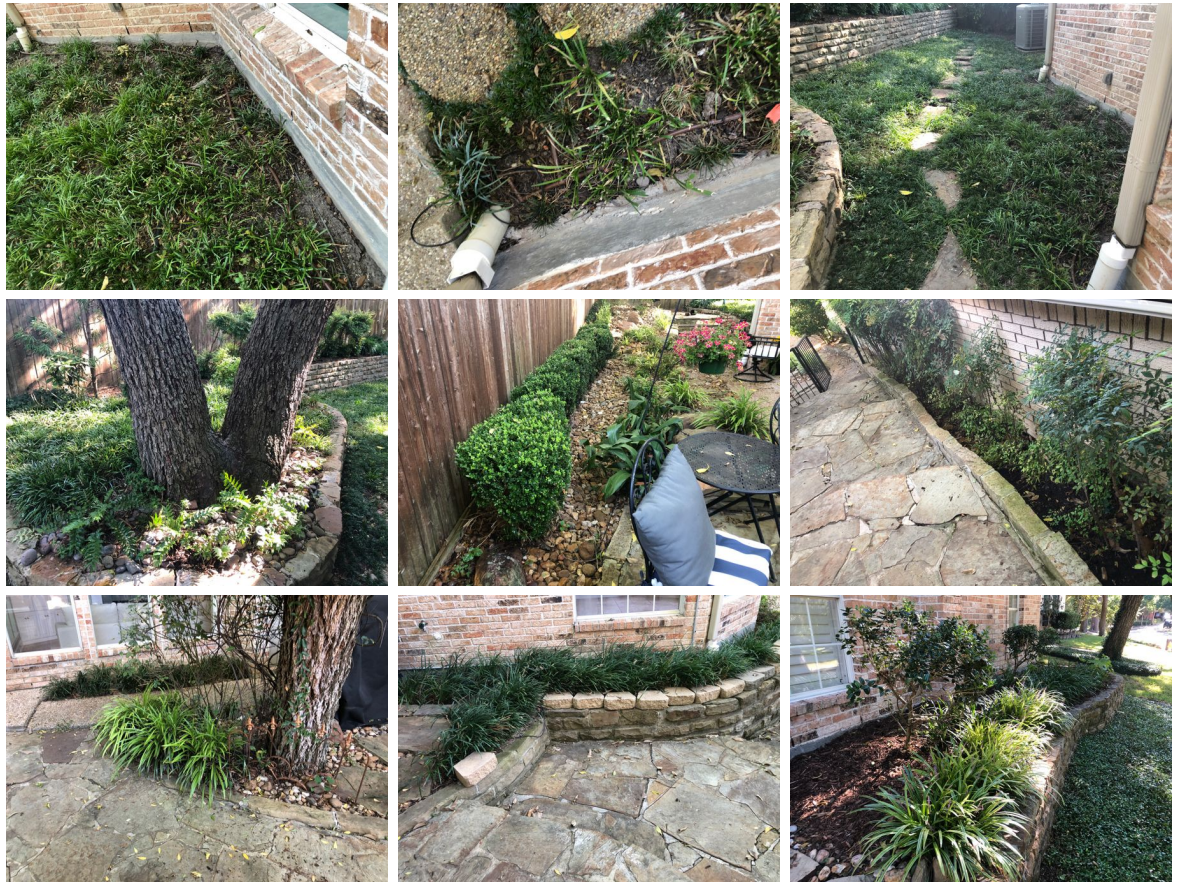
Some zones of the sprinkler system have buried drip lines that cannot be seen. It is difficult to tell when this type of system has a problem unless the foliage starts to die.

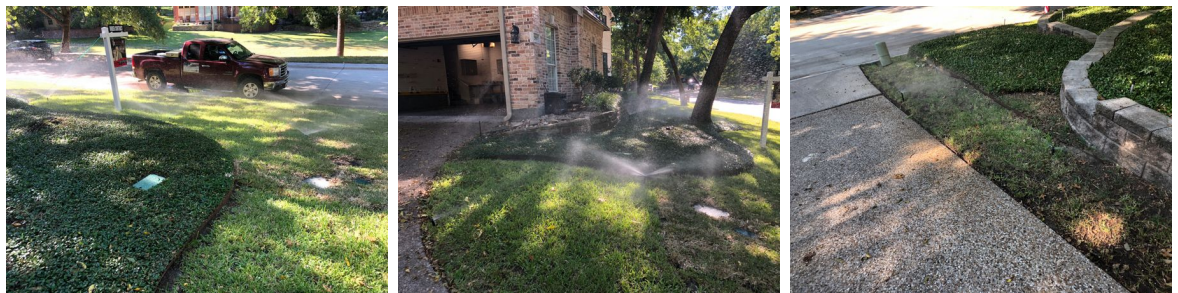
Pictures of the sprinklers during operation.

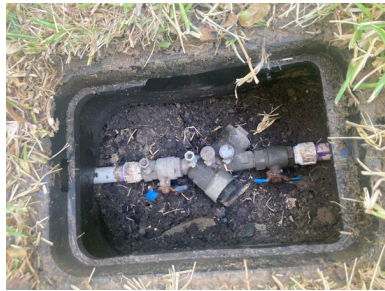
Picture of double check and sprinkler controller for reference.
