MOUNTAINS TO SOUND HOME INSPECTION LLC

HOME INSPECTION REPORT

2734 Garlough Ave SW
Seattle WA 98116

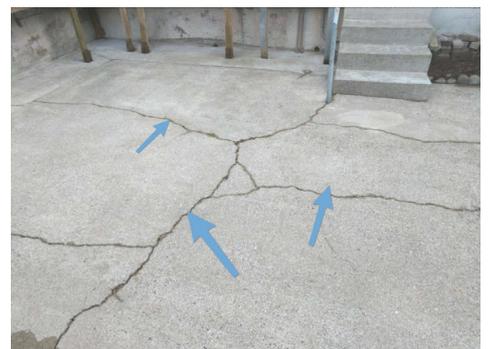
PATIO FLOOR CRACKS

There are cracks in the rear patio floor that you should view for yourself and correct as desired.

Recommendation

Contact a qualified concrete contractor.

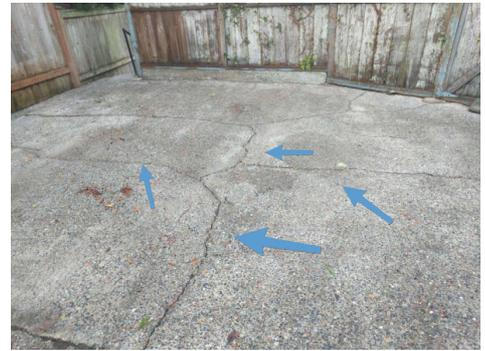
3.2.2 Driveway, Walkways & Patio

SMALL CRACKS IN DRIVEWAY

There are common cracks in the driveway that would not necessarily need to be serviced.

Recommendation

Recommend monitoring.

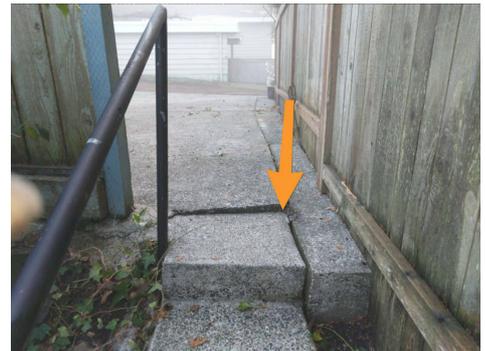
3.2.3 Driveway, Walkways & Patio

WALKWAY-TRIP HAZARD

There is an offset in a walkway that could prove to be a trip-hazard. I recommend using caution when walking in this area.

Recommendation

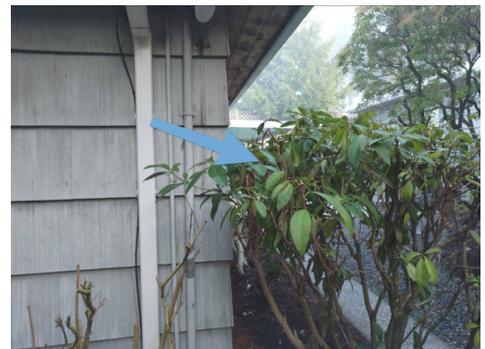
3.5.1 Exterior Siding Notes

VEGETATION IS ENCROACHING

Vegetation is encroaching on the structure, and should be kept a minimum of twelve inches away for the general welfare of the walls and foundation.

Recommendation

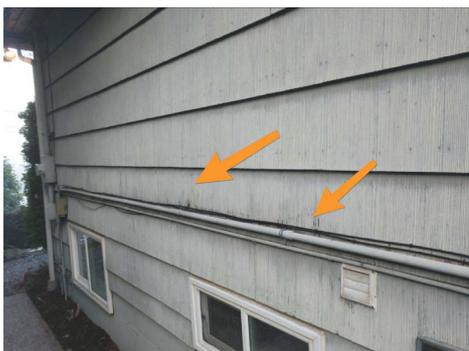
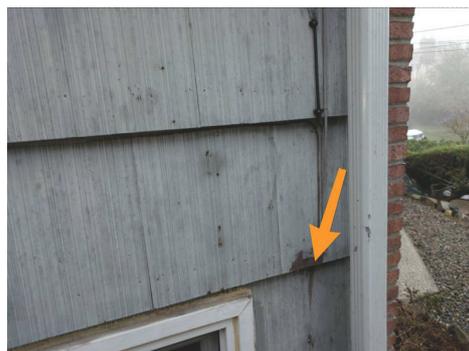
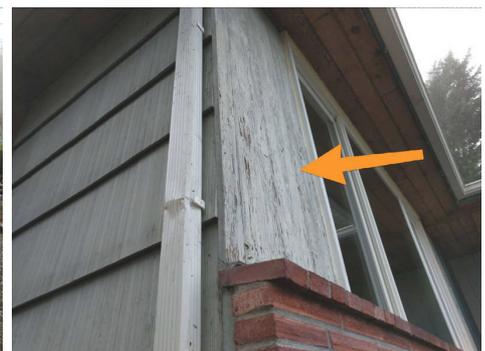
3.5.2 Exterior Siding Notes

WEATHERED SIDING

The exterior siding is weathered. Maintenance and minor repairs are recommended.

Recommendation

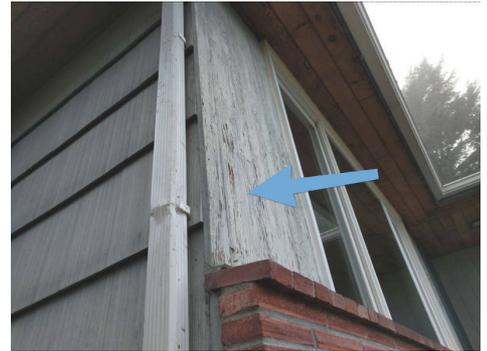
3.5.3 Exterior Siding Notes

The siding needs service at some locations to prevent moisture intrusion.

Recommendation

Contact a qualified handyman.

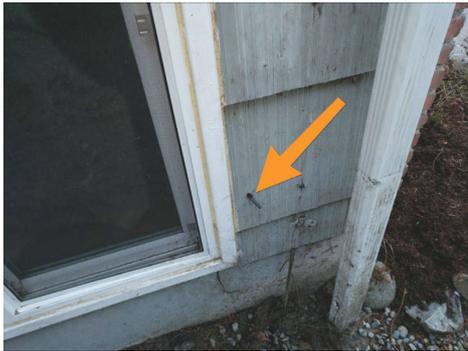
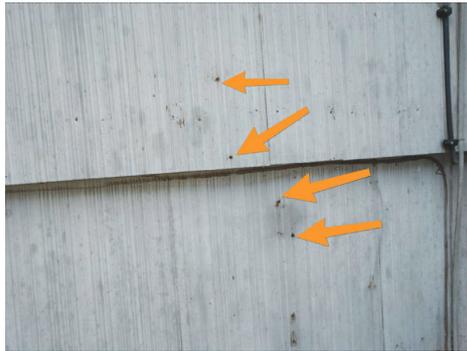
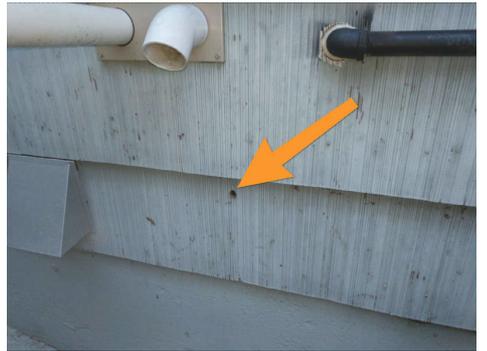
3.5.4 Exterior Siding Notes

Gaps and/or holes were observed on one or more sides in the siding around plumbing, gas, cable, wiring and/or other penetrations. We advise that all the holes and the gaps be caulked and/or sealed to prevent moisture and/or pest intrusion.

Recommendation

Contact a qualified professional.

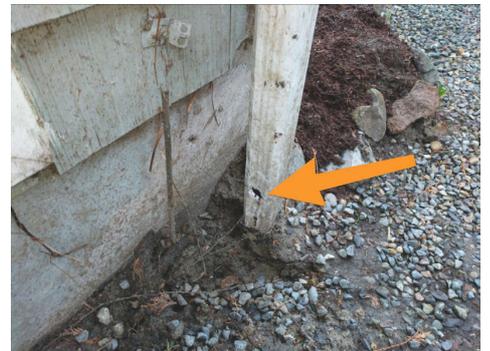
3.9.1 Downspouts

DOWNSPOUTS MISSING COMPONENTS

The downspout are missing parts. Recommend repairs to allow for proper drainage away from the structure.

Recommendation

Contact a qualified professional.

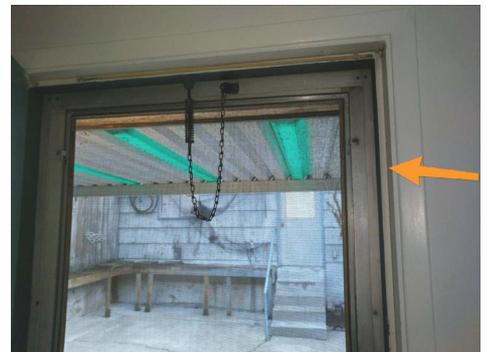
3.10.1 Exterior Doors

EXTERIOR DOOR NOT WEATHER SEALED

Recommendation

Contact a qualified handyman.

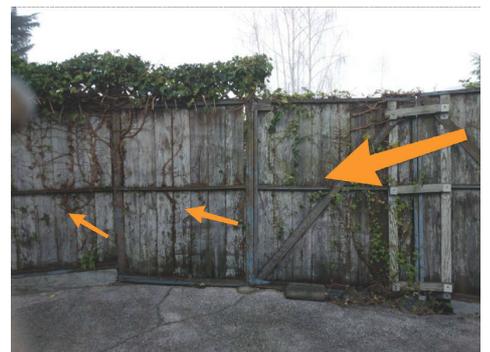
3.13.1 Fences & Gates

FENCES WEATHERED

The fences are weathered. Recommend maintenance and repairs.

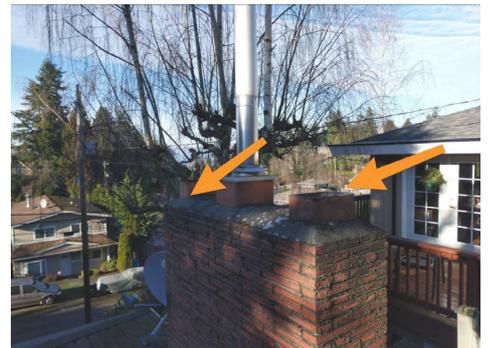
The chimney does not have a spark arrestor or rain cap as recommended. This will help prevent pests or debris from falling into the flue and causing an obstruction or damage.

Recommendation

Contact a qualified handyman.

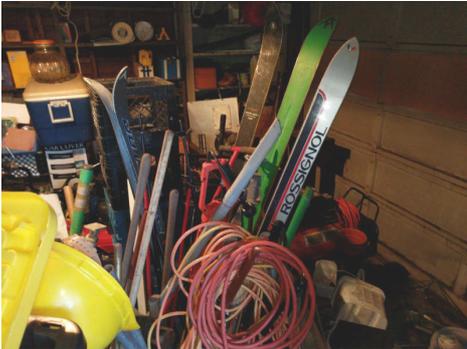
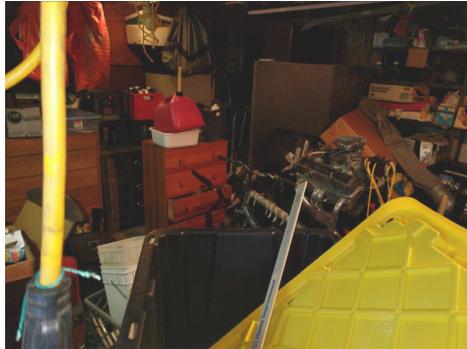
5.4.1 Slab Floor

FULL OF STORAGE SLAB BLOCKED

The garage is too full of storage to permit a clear view of the entire slab. I recommend evaluating the floor yourself once the storage is removed.

Recommendation

Recommended DIY Project

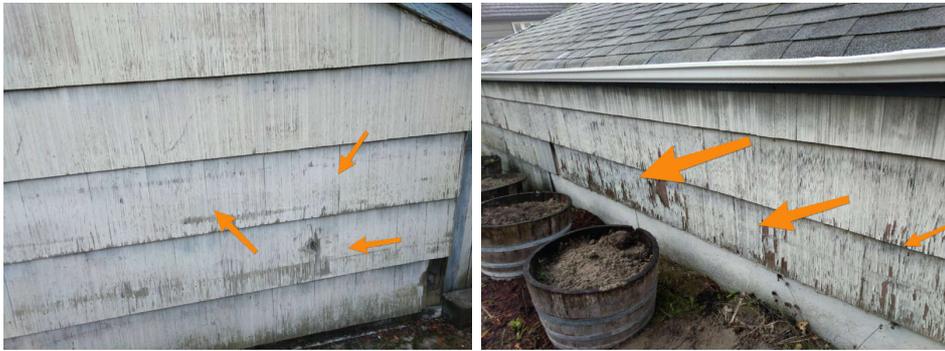
5.7.1 Exterior Siding Notes

WEATHERED SIDING

The exterior siding is weathered. Maintenance and minor repairs are recommended.

Recommendation

Contact a qualified professional.

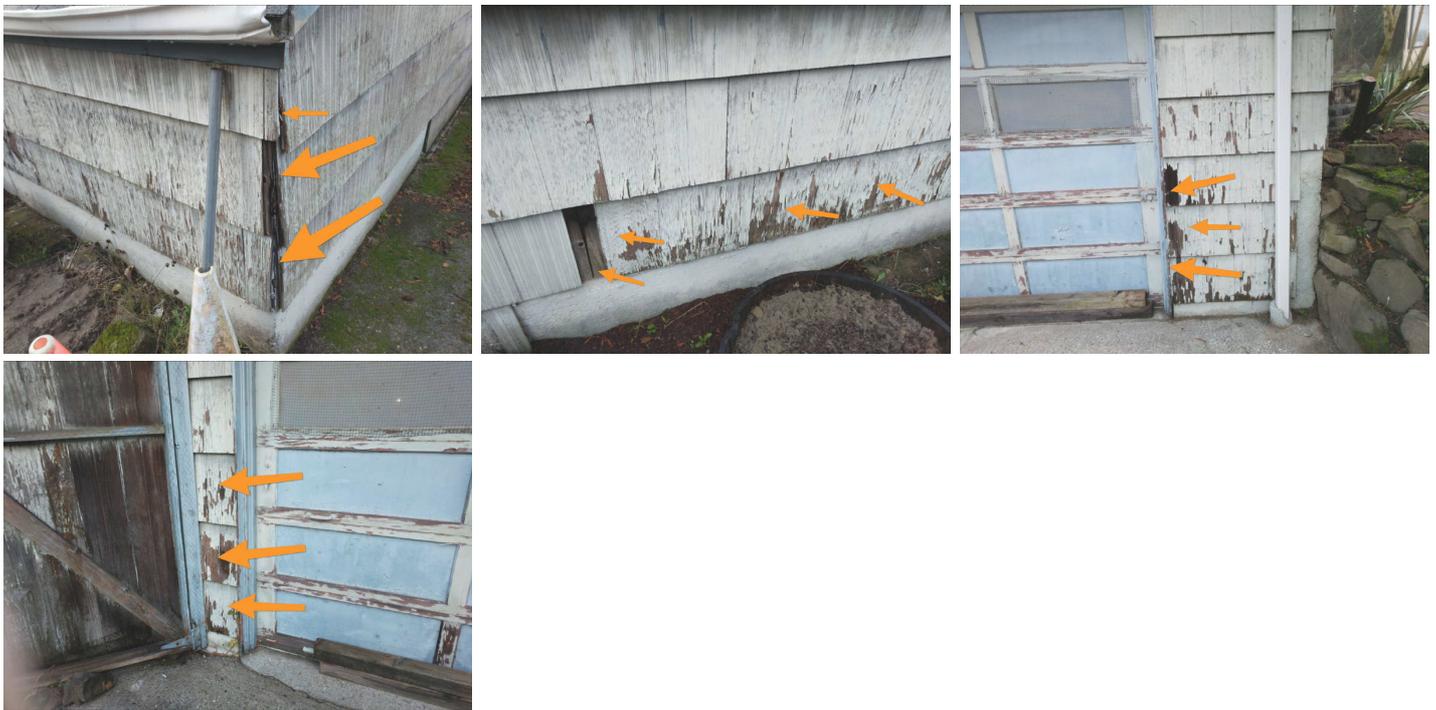
5.7.2 Exterior Siding Notes

WOOD SIDING ARE MOISTURE DAMAGED

Portions of the add-on wood siding are moisture damaged and should be further evaluated by a contractor

Recommendation

Contact a qualified professional.

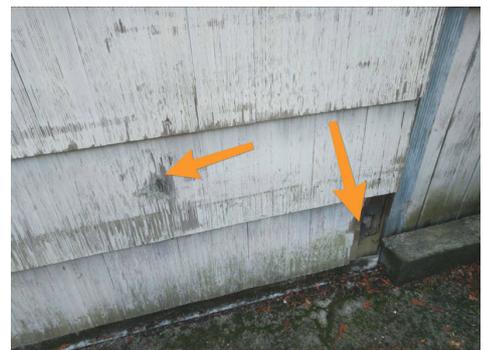
5.7.3 Exterior Siding Notes

DAMAGED SIDING

Observed areas of damaged siding around the residence that should be repaired to help prevent moisture intrusion issues. These damaged areas can allow moisture to penetrate the walls if not properly repaired.

Recommendation

Contact a qualified handyman.

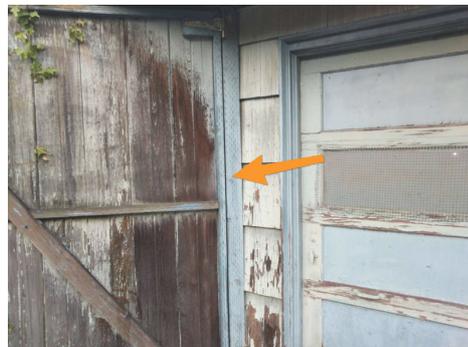
5.7.4 Exterior Siding Notes

Fence(s) were attached to or in contact with the building exterior. Such attachments can serve as a pathway for wood-destroying insects and can retain moisture against the exterior after it rains. We recommend repairs as necessary so there is at least a 2-inch gap between rails and building exteriors.

Recommendation

Contact a qualified professional.

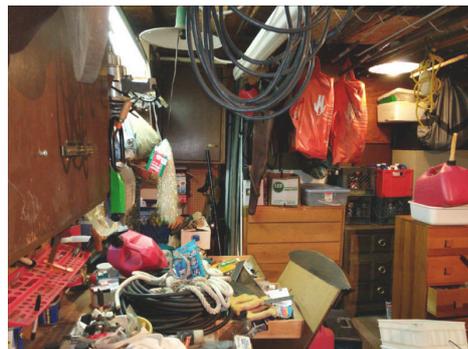
5.8.1 Walls and Ceiling

The stored item in the garage blocked the view of multiple walls. I recommend further evaluation after the storage items have been removed.

Recommendation

Contact a qualified professional.

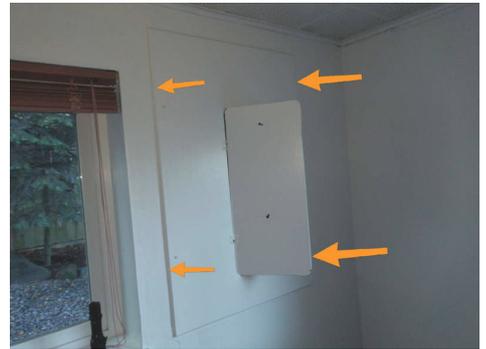
Medium Priority**PANEL COVER PAINTED SHUT**

The panel access cover is painted shut and therefore not accessible. To access would likely cause cosmetic damage to the access cover and wall surround. Therefore the interior components could not be thoroughly evaluated at the time of the inspection.

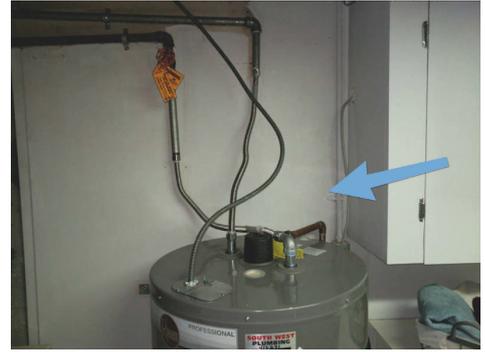
A thermal expansion tank was not installed. We recommend installation

Recommendation

Contact a qualified professional.

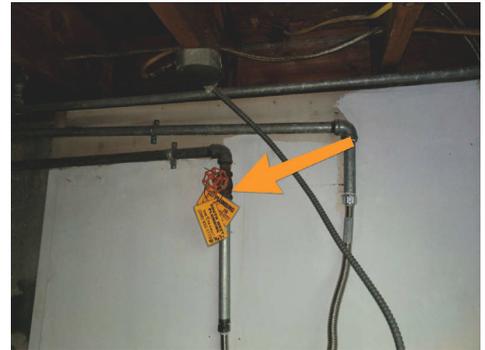
8.1.2 Water Heating System

VALVE IS GATE VALVE

The water heater shut off valve is an older style and less reliable gate type valve. These valves are known to get stuck in place from lack of use and can eventually stop working or begin leaking over time. I recommend evaluating this valve and having it serviced or replaced as you feel necessary.

Recommendation

Contact a qualified plumbing contractor.

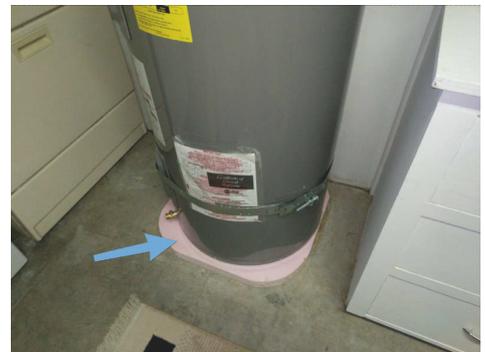
8.1.3 Water Heating System

NO DRIP PAN

No drip pan was present to prevent small leaks from causing moisture damage to surrounding area. Recommend installing a drain pan, at least when getting a new water heater.

Recommendation

Contact a qualified plumbing contractor.

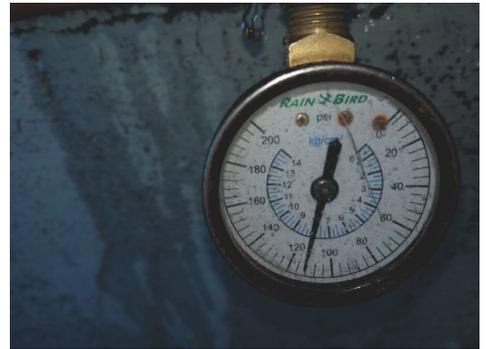
The water pressure inside the residence exceeds 80 psi and will stress components of the system. Appliances and components such as water heaters, dishwashers, washing machines and most water using appliances will function better and last longer under lower water pressure (usually 40-80 psi). You may want a licensed plumber to evaluate this and adjust the water pressure. This evaluation and service is recommended before the close of escrow.

Recommendation

Contact a qualified plumbing contractor.

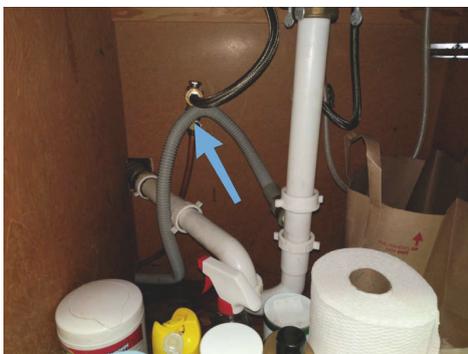
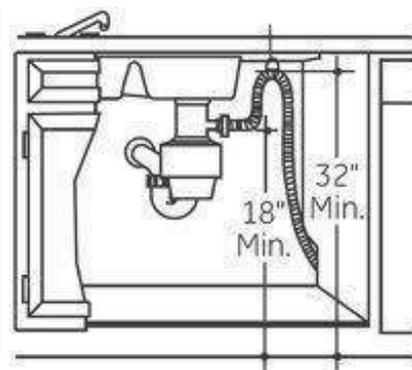
Dishwasher drain pipe was installed without an air gap/high loop to prevent cross contamination. Recommend a qualified licensed professional evaluate and or repair.

Recommendation

Recommended DIY Project

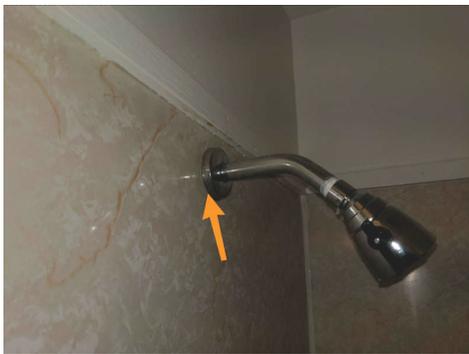
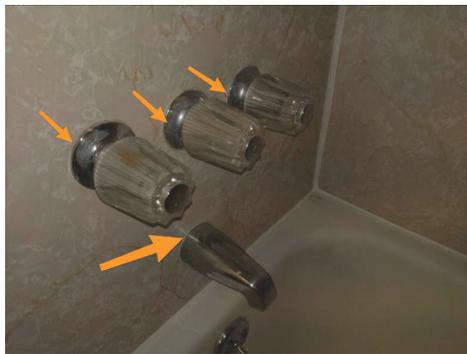
I recommend caulking or sealing around shower valves and faucets etc to help prevent moisture intrusion behind or into the walls. Monitoring these areas is also recommended to help ensure an adequate seal is in place.

Recommendation

Contact a qualified handyman.

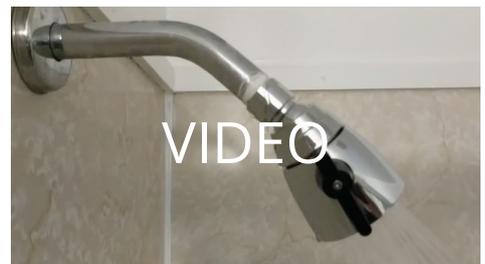
11.4.2 Tub-Shower

SHOWER HEAD LEAK

The shower head leaked at the base of the head or hose. The joint should be tightened or sealed to prevent leakage.

Recommendation

Contact a qualified professional.

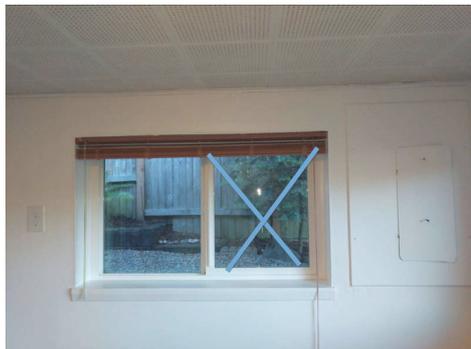
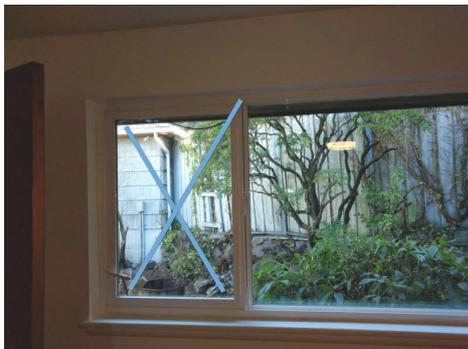
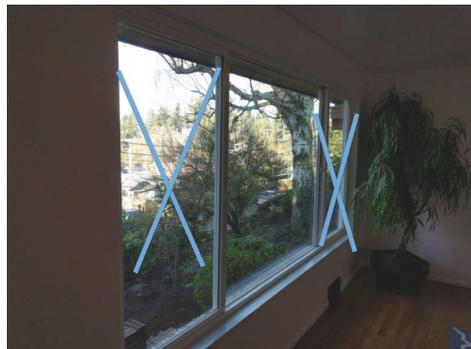
SCREENS DAMAGED/MISSING

Window screens were missing or damaged in one or more areas. We recommend repair or replacement as needed.

Recommendation

Contact a qualified professional.

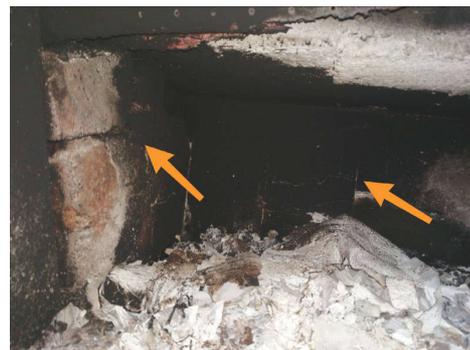
13.9.1 Fireplace Notes

MINOR FIREPLACE CRACKING

Minor cracking was observed in the fireplace bricks. These should be monitored and repaired as needed.

Recommendation

Contact a qualified professional.

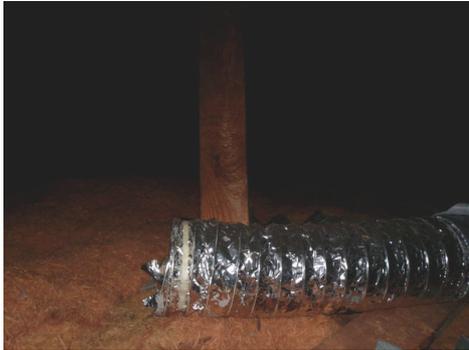
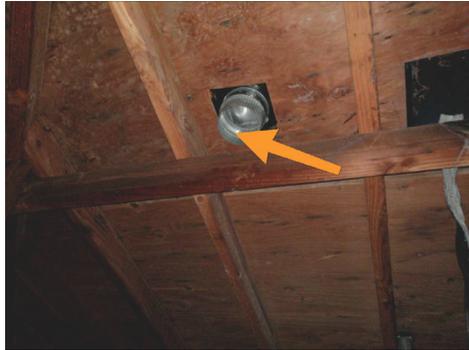
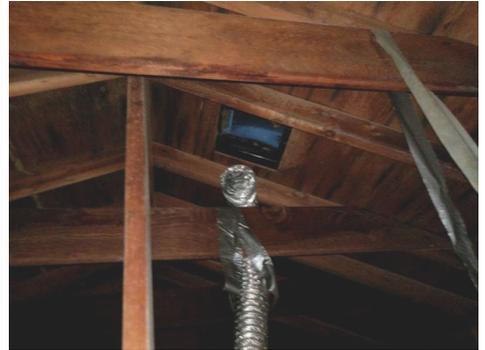
The bathroom exhaust duct is separated, and should be repaired.
