SAMPLE TOWNHOUSE REPORT

1234 Townhouse Terr.
Hanover MD 21076

Sarah Sample
AUGUST 12, 2018

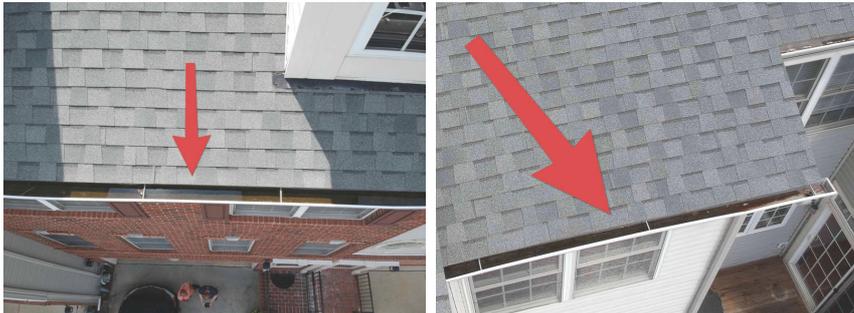
Rain Gutters are blocked, holding water and overflowing. This condition can cause water damage in the home if not corrected.

Contact a qualified roofing professional.

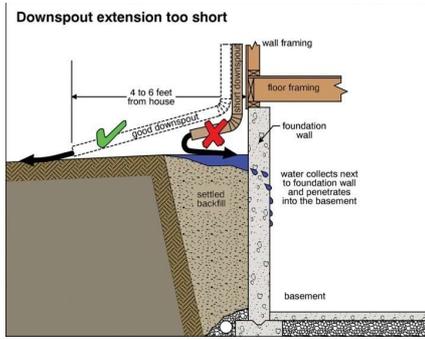
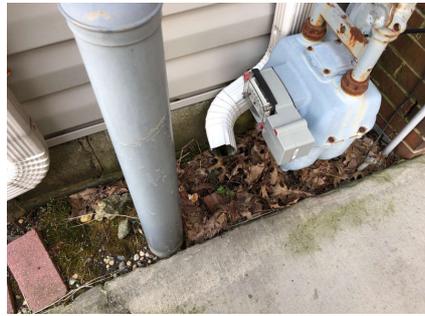
2.3.2 Drainage System

DISCHARGES TO FOUNDATION

Downspouts discharge next to the foundation and should take water at least several feet away from the home. This is the most common cause of foundation damage and wet basements.

Contact a qualified handyman.

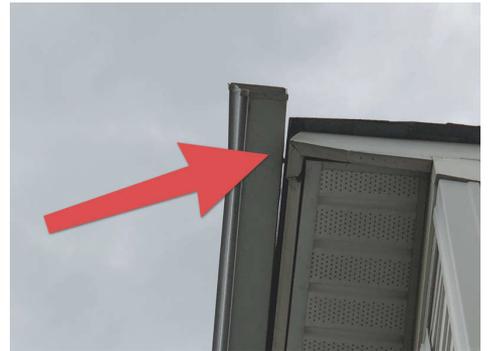
2.3.3 Drainage System

LOOSE RAIN GUTTERS

This condition may allow the gutters to fall off or cause water to overflow the gutters and collect near the foundation. This is a primary cause of wet basements and foundation damage.

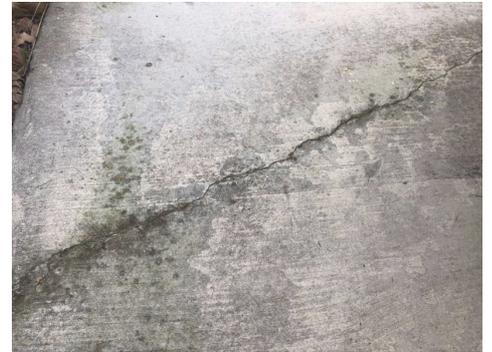
REPAIR CONCRETE CRACKS

There are normal cracks in the concrete which should be filled with an appropriate material to slow the rate of deterioration caused by the freeze/thaw cycle.

Contact a qualified handyman.

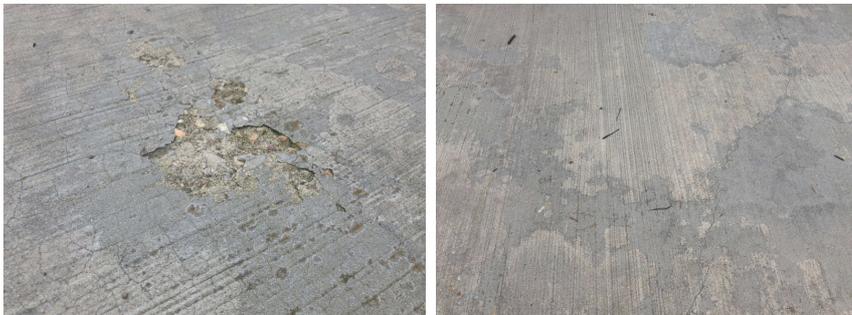
3.1.2 Driveway / Sidewalk / Patio

DETERIORATED TOP-COAT

The driveway appears to have been top-coated or resurfaced and the top coat is coming off. The surface underneath will be irregular and the concrete may deteriorate more rapidly.

Contact a qualified concrete contractor.

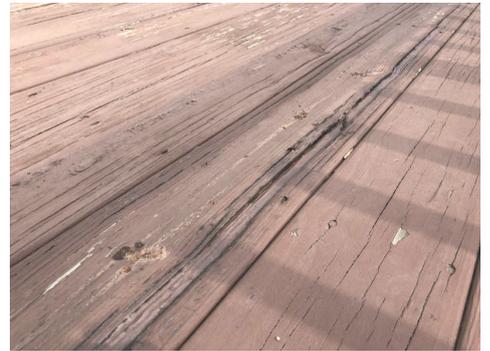
3.2.2 Steps / Porch / Deck

DETERIORATED PLANKING

Planking is deteriorated and should be replaced.

Contact a qualified handyman.

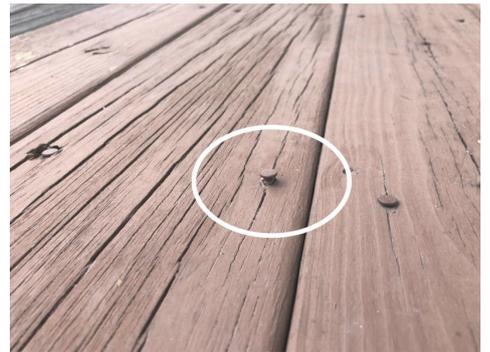
3.2.3 Steps / Porch / Deck

PROTRUDING NAILS OR SCREWS

Protruding nails or screws should be set to prevent personal injury and/or eliminate a trip hazard.

Contact a handyman or DIY project

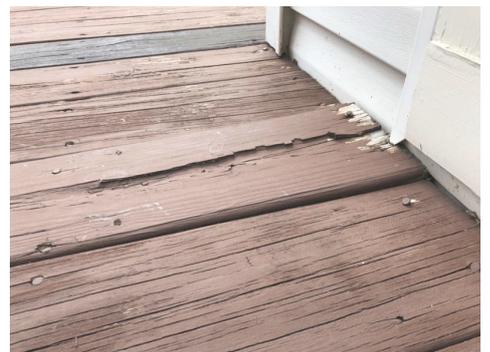
3.2.4 Steps / Porch / Deck

RAISED PLANKING TRIP HAZARD

Loose or raised planks should be secured to eliminate a trip hazard.

Contact a handyman or DIY project

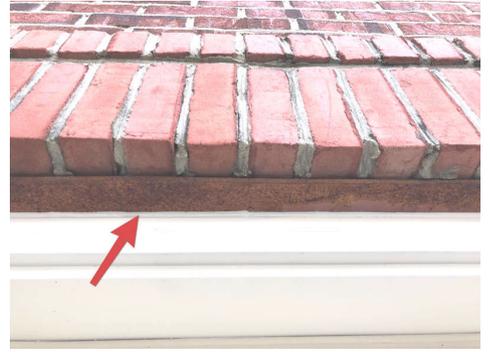
RUSTED LINTEL ABOVE DOOR

The lintel above this door in the brick wall is rusted. This condition may damage the brick and will eventually structurally weaken the lintel.

Contact a qualified painting contractor.

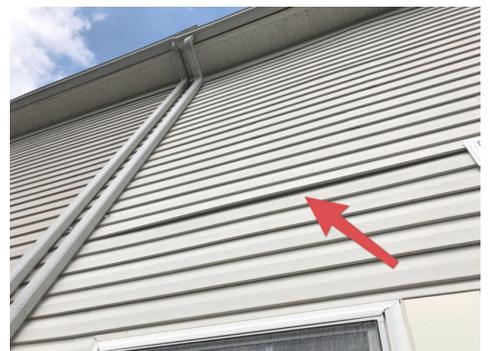
LOOSE SIDING

Portions of the siding is loose and should be secured to prevent wind damage and more expensive repairs.

Contact a qualified siding specialist.

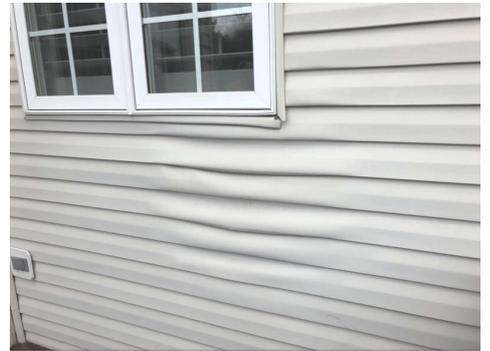
3.4.2 Siding / Trim / Flashing

SIDING WARPED BY GRILL OF SUNLIGHT

Siding is warped. This is possibly caused by a grill or light reflecting from the patio door. This appears to be cosmetic.

Contact a qualified siding specialist.

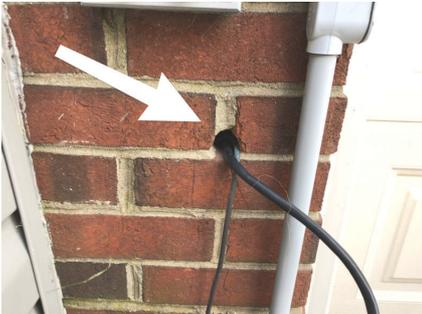
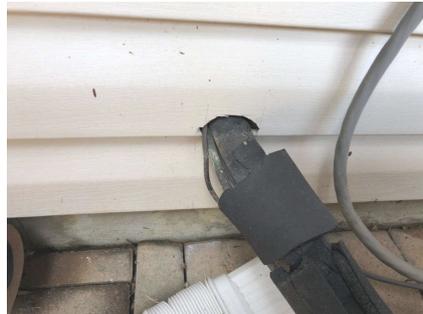
3.4.3 Siding / Trim / Flashing

GAPS AT PENETRATIONS

There are gaps at wires, pipes or other penetrations. This condition may allow water into the structure, water damage and possibly mold growth if not corrected.

Contact a handyman or DIY project

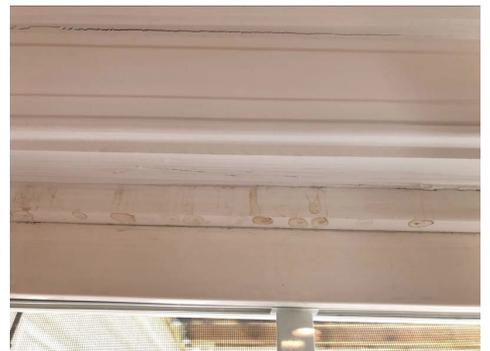
3.4.4 Siding / Trim / Flashing

NO FLASHING ABOVE LEDGER

The ledger attaching the deck structure to the home structure interrupted the exterior wall covering and was inadequately flashed. No flashing was installed above the ledger. Flashing is designed to protect the wall assembly from moisture intrusion where the deck attaches to the home. There are water stains above the door beneath the deck.

Water spots below ledger in basement

Contact a qualified deck contractor.
