ROOM BY ROOM HOME INSPECTION SERVICES LLC

ROOM BY ROOM TEMPLATE FOR HOME INSPECTIONS

31015 SW Riverwood Dr West Linn, OR 97068

Mike Smith AUGUST 18, 2022

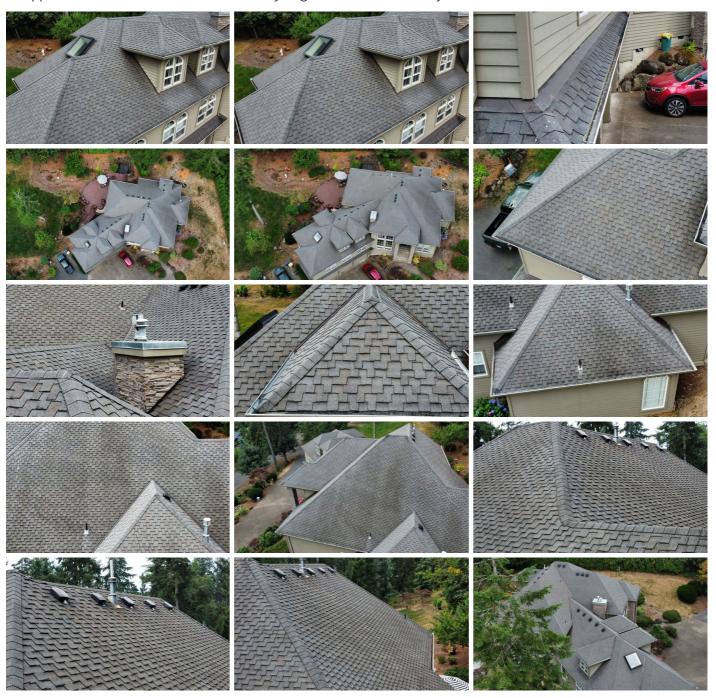
Roof Covering: Roof Was Inspected

Drone

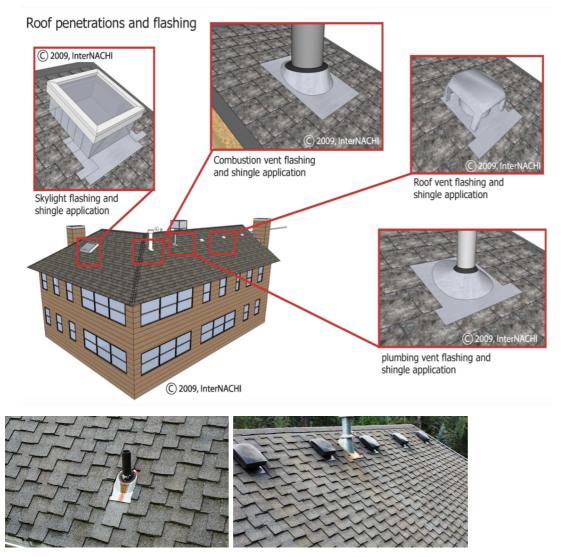
Plumbing Vent Pipes: Plumbing Vent Pipes Inspected

I looked at DWV (drain, waste and vent) pipes that pass through the roof covering. There should be watertight flashing (often black rubber material) installed around the vent pipes. These plumbing vent pipes should extend far enough above the roof surface.

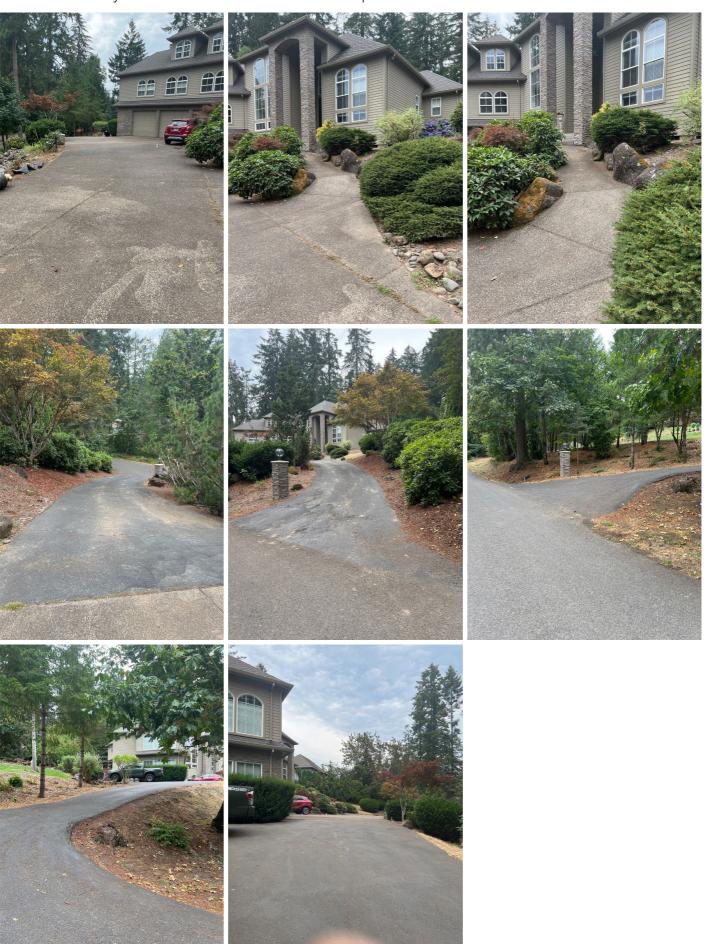
Walkways & Driveways: Walkways & Driveways Were Inspected

I inspected the walkways and driveways that were adjacent to the house. The walkways, driveways, and parking areas that were far away from the house foundation were not inspected.

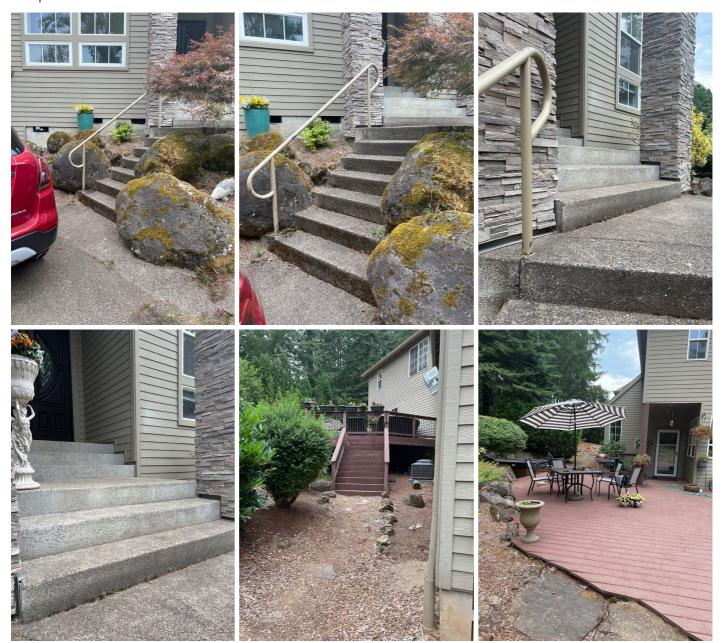
Porches, Patios, Decks, Balconies & Carports: Porches, Patios, Decks, Balconies & Carports Were Inspected

I inspected the porches, patios, decks, balconies and carports at the house that were within the scope of the home inspection.

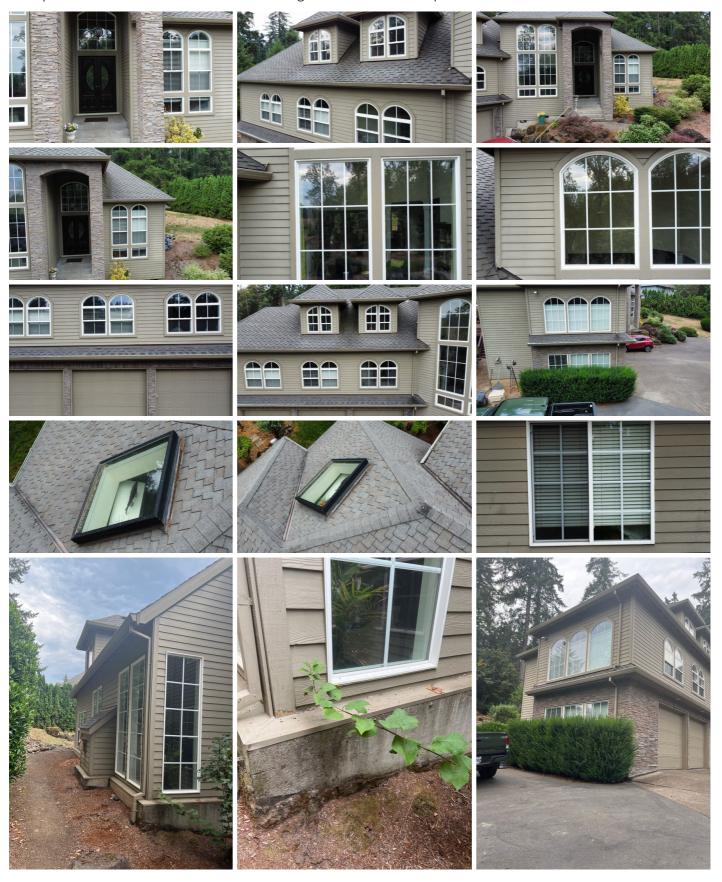
Windows: Windows Inspected

A representative number of windows from the ground surface was inspected.

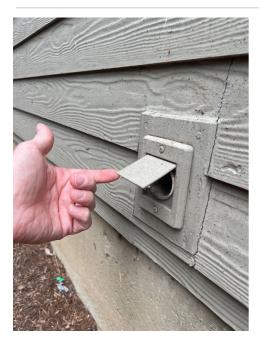
UNIDENTIFIED HOODS

I observed some exterior exhaust hoods, but I was unable to identify them as to what their purpose was.

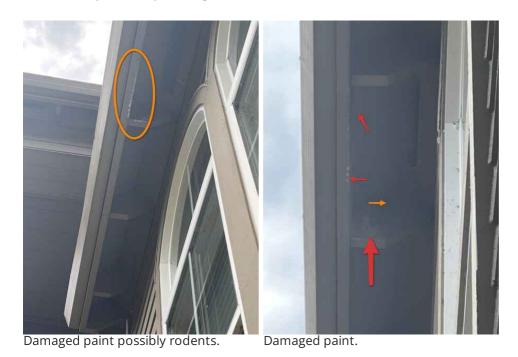
3.2.1 Eaves, Soffits & Fascia

PAINT SURFACE IN POOR CONDITION

I observed indications of paint or staining in poor condition. Flaking, cracking, and worn areas. Correction and further evaluation is recommended.

Contact a qualified painting contractor.

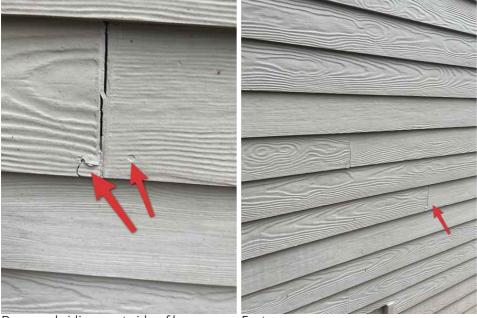
3.3.1 Wall-Covering, Flashing & Trim

CRACKING - MINOR

Siding showed cracking in one or more places. Recommend monitoring.

Damaged siding, east side of home.

Recommended DIY Project

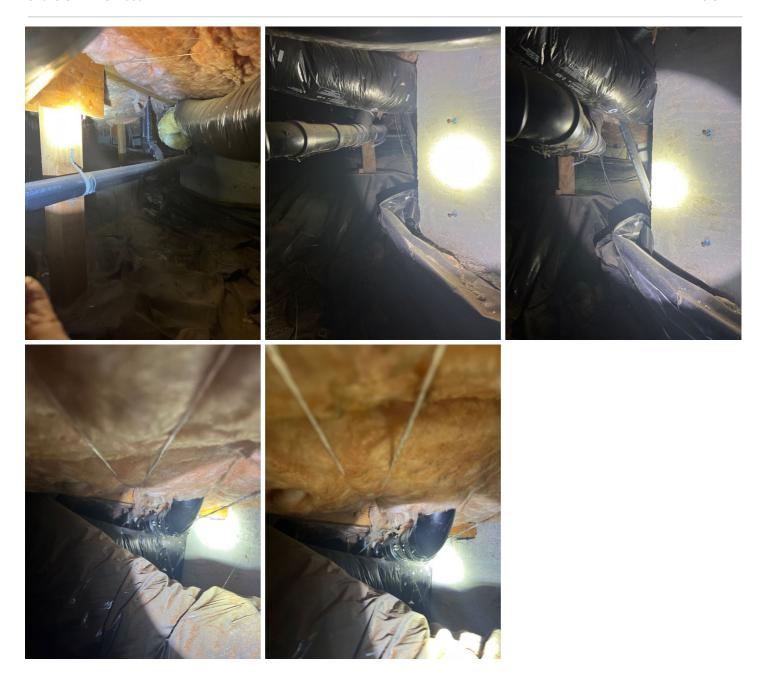
NOT ALL PIPES WERE INSPECTED

The inspection was restricted because not all of the pipes were exposed, readily accessible, and observed. For example, most of the drainage pipes were hidden within the walls.

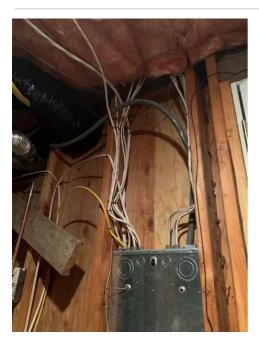
UNABLE TO INSPECT ALL OF THE WIRING

I was unable to inspect all of the electrical wiring. Obviously, most of the wiring is hidden from view within walls. Beyond the scope of a visual home inspection.

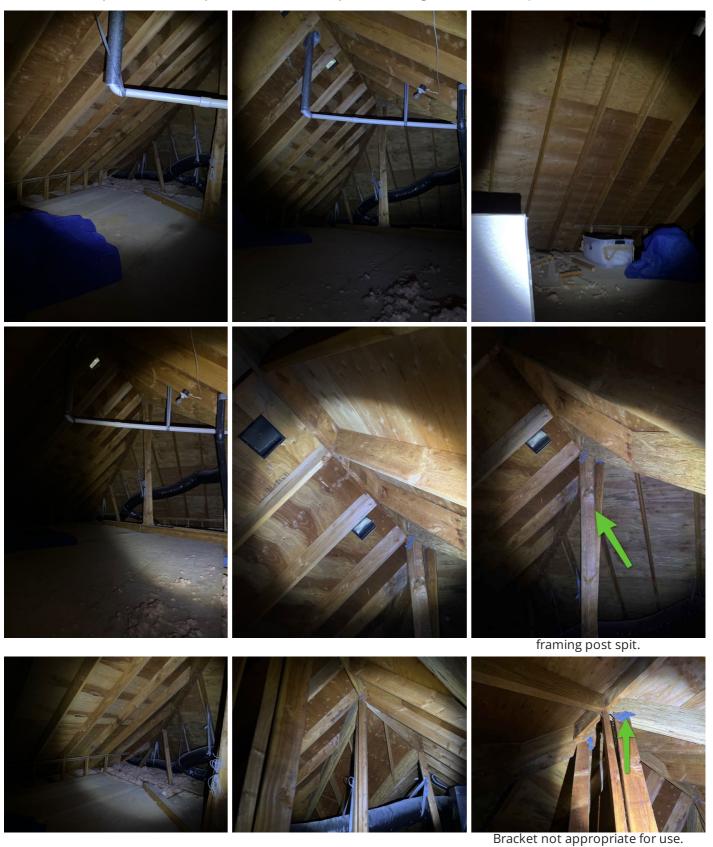
Broken roof rafter.

I observed a major structural defect in the attic.

Broken rafter.

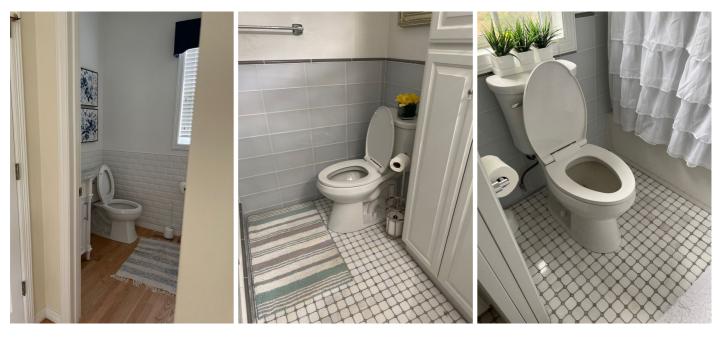
Bathroom Toilets: Toilets Inspected

I flushed all of the toilets.

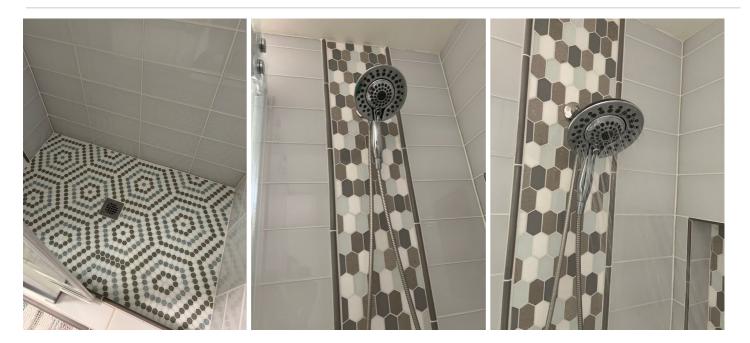
Sinks, Tubs & Showers: Ran Water at Sinks, Tubs & Showers

I ran water at all bathroom sinks, bathtubs, and showers. I inspected for deficiencies in the water supply by viewing the functional flow in two fixtures operated simultaneously.

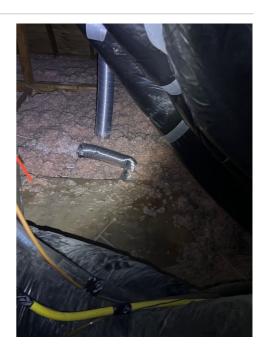
IMPROPERLY EXHAUSTING

I observed that the bathroom fan is improperly exhausting air from the bathroom.

Contact a qualified general contractor.

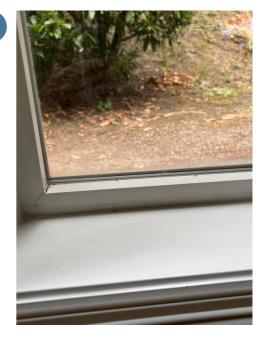
FOGGED / BROKEN SEAL

Contact a qualified window repair/installation contractor.
