HOME INSPECTION REPORT

14140 SE 17th Pl #A1

Bellevue WA 98007

APRIL 24, 2019

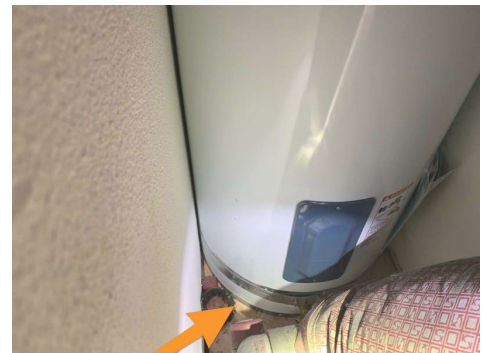
No drip pan was present to prevent small leaks from causing moisture damage to surrounding area. Recommend installing a drain pan, at least when getting a new water heater.

Contact a qualified plumbing contractor.

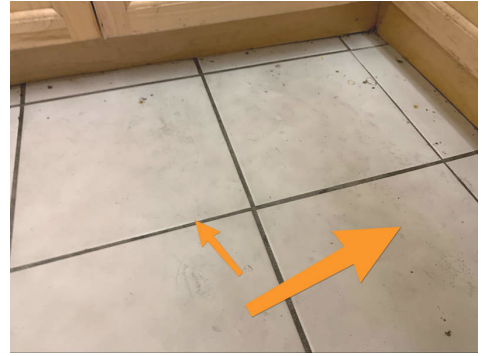
FLOOR WORN OR COSMETICALLY DAMAGED

The floor is worn or cosmetically damaged, which you should view for yourself and correct as desired.

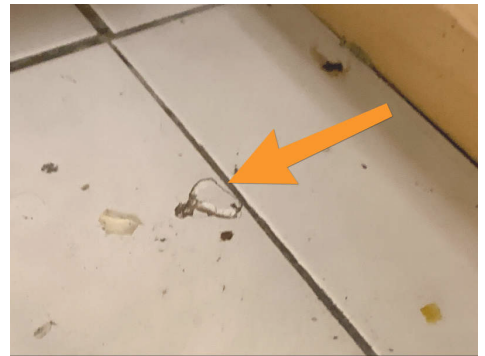
6.6.2 Flooring

MINOR CRACKS IN FLOOR TILES OR GROUT LINES

There are minor and typical cracks in the floor tiles or grout lines, which you should view for yourself. They are likely to have been caused by normal settlement, but you may wish to seek the opinion of a specialist; especially if you are concerned or desire more information.

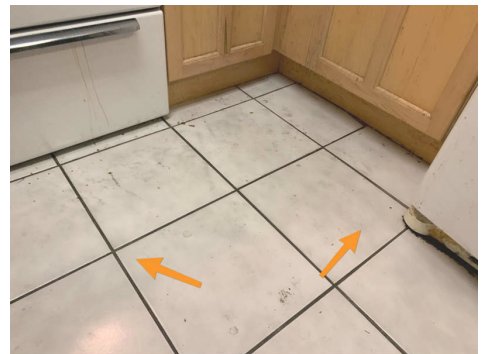
6.6.3 Flooring

TYPICAL WEAR AND TEAR

The kitchen floor has typical wear and tear.

Recommend monitoring.

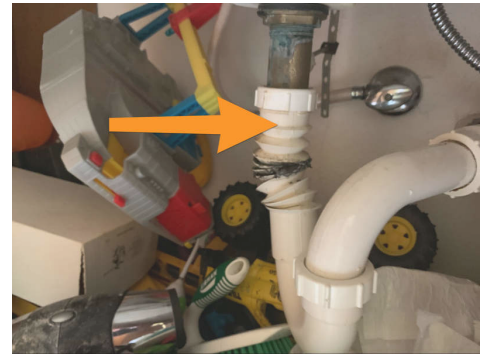
Flexible drainpipes clog more often than traditional rigid piping. I recommend monitoring and repairing as needed.

Contact a qualified professional.

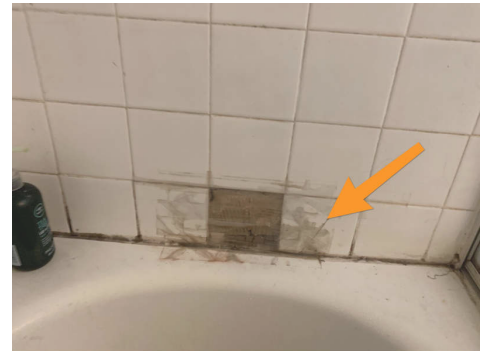
8.4.1 Tub-Shower

TUB AREA COSMETIC DAMAGE

The tub area has some cosmetic damage that you should view for yourself and repair as necessary.

Contact a qualified handyman.

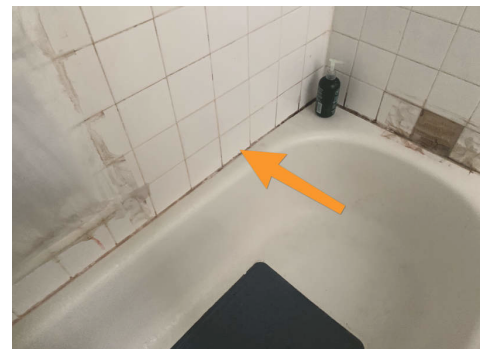
8.4.2 Tub-Shower

CLEANED AND CAULKED

The enclosure needs to be cleaned and caulked, to forestall moisture damage.

Contact a qualified handyman.

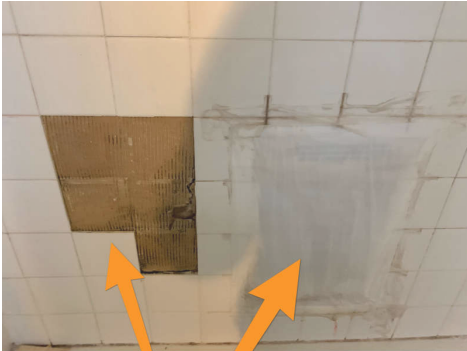
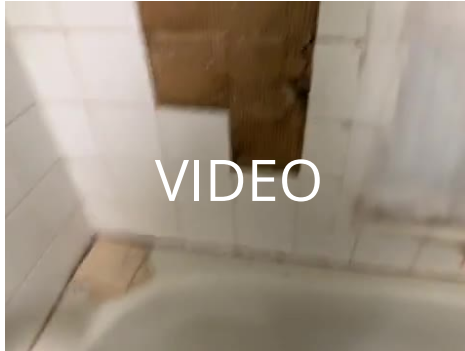
8.4.3 Tub-Shower

Medium Priority**TUB/SHOWER WALL SURROUND DAMAGE**

The shower or tub wall surround is damaged. Recommend further evaluation and repair.

Contact a qualified professional.

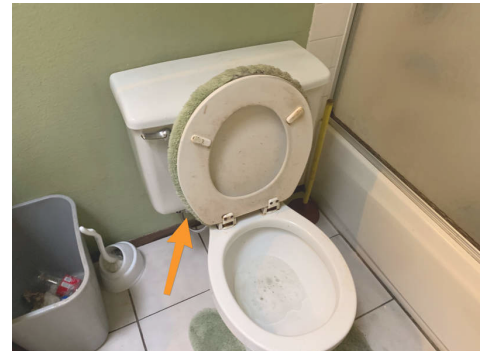
8.5.1 Toilet

The toilet shut off valve was turned off. Washington State law prohibits us from turning the valve on to test the the toilet. Ask the seller about this condition.

Contact a qualified professional.

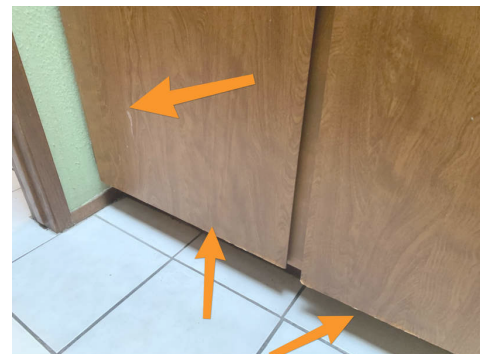
8.7.1 Cabinets

Medium Priority**THE CABINETS HAVE TYPICAL COSMETIC DAMAGE**

The cabinets have typical and minor cosmetic damage, often consistent with time and use. I recommend you should view these areas for yourself and correct as desired.

Recommended DIY Project

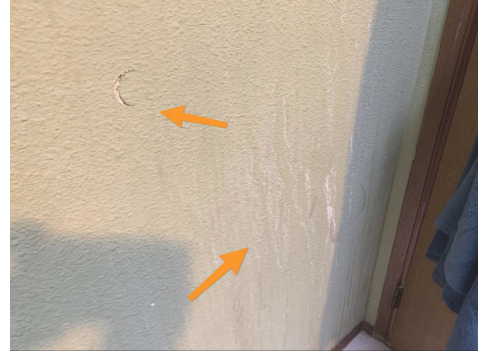
8.11.1 Walls and Ceiling

NORMAL WEAR AND TEAR

The walls or ceiling have minor cosmetic damage (scuffs, scrapes, nail holes etc) that you should view yourself and correct as desired.

Recommended DIY Project

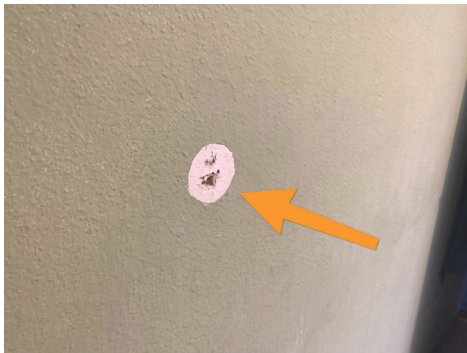
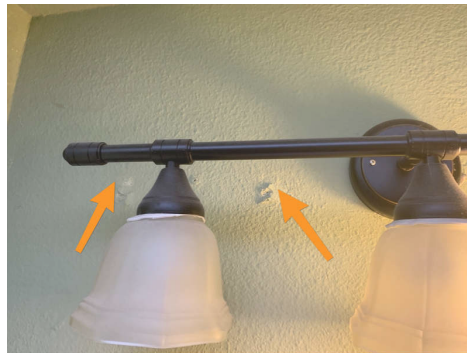
8.11.2 Walls and Ceiling

WALLS HAVE DAMAGE

The walls have some damage and repair is recommended

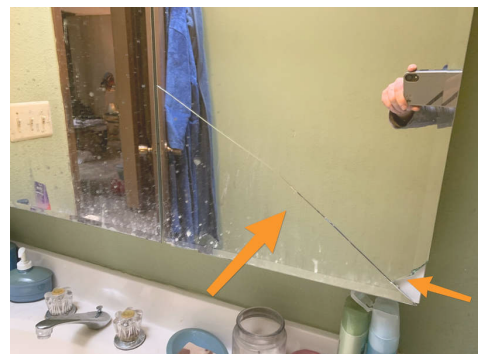
8.11.3 Walls and Ceiling

MIRROR MISSING/DAMAGED

A mirror was broken, missing or not installed. Recommend repairing or replacing as needed.

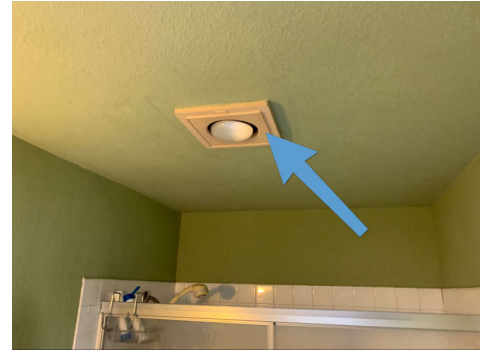
8.12.1 Lights, Wall Switches

CEILING LIGHT NOT WORKING

A light fixture did not have light bulbs or the bulbs were burnt out. Recommend replacing bulbs and testing.

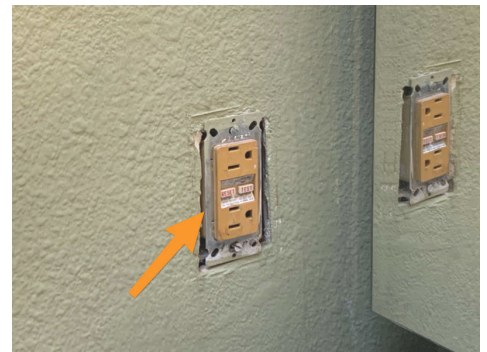
8.13.1 Outlets, Electrical Observations

The GFCI outlet was wired properly and functioned, but it didn't trip when tested. Recommend repair or replacement of the outlet.

Contact a qualified professional.

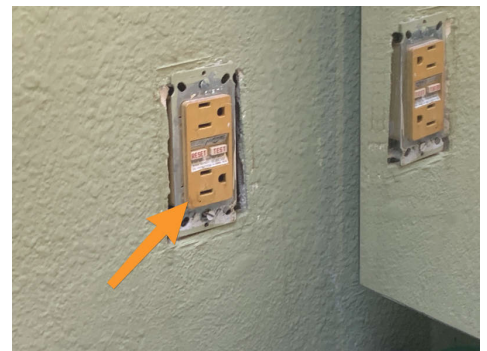
8.13.2 Outlets, Electrical Observations

MISSING OR DAMAGED COVER PLATE

There was a missing or damaged cover plate that should be repaired or replaced as needed.

Contact a qualified professional.

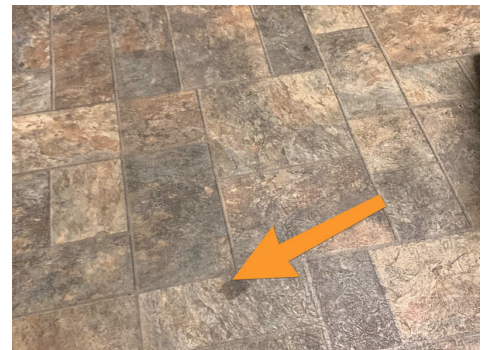
10.3.1 Flooring

FLOOR WORN OR COSMETICALLY DAMAGED

The floor is worn or cosmetically damaged, which you should view for yourself and correct as desired.

Contact a qualified flooring contractor

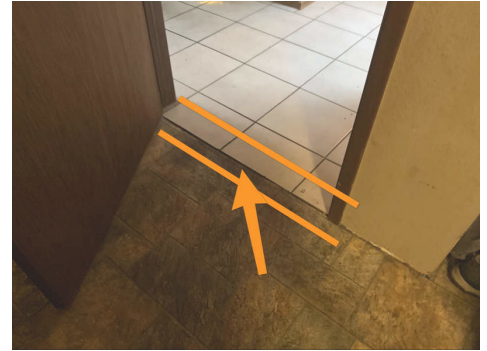
10.3.2 Flooring

TRANSITION STRIPS MISSING

Transition strips were missing or damaged between one surface to another. Recommend installing as needed.

Contact a qualified professional.

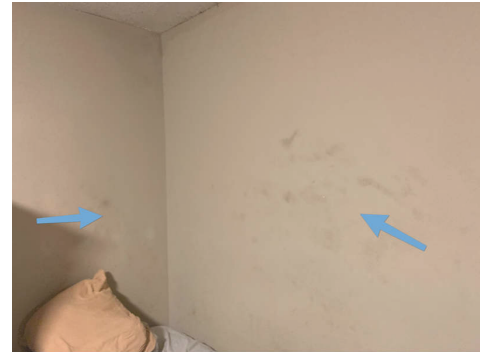
10.4.1 Walls and Ceiling

NORMAL WEAR AND TEAR

The walls or ceiling have minor cosmetic damage (scuffs, scrapes, nail holes etc) that you should view yourself and correct as desired.

Recommended DIY Project

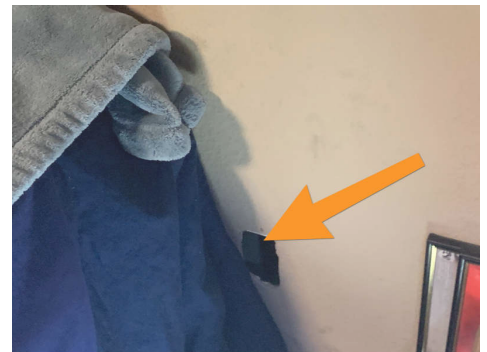
10.4.2 Walls and Ceiling

WALL/CEILING DAMAGED

The wall/ceiling has some damage and repair is recommended.

Contact a qualified drywall contractor.

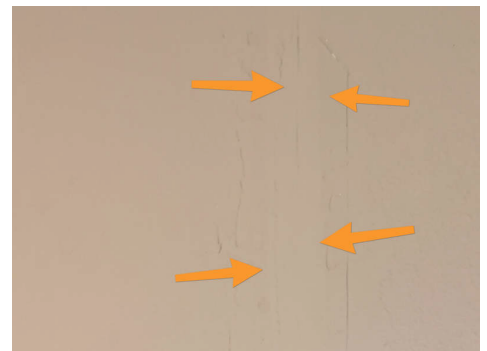
10.4.3 Walls and Ceiling

PATCH/PAST REPAIR

Patches or repairs were observed in the wall or ceiling. We could not determine the reason for the repairs. Recommend monitoring.

Contact a qualified professional.

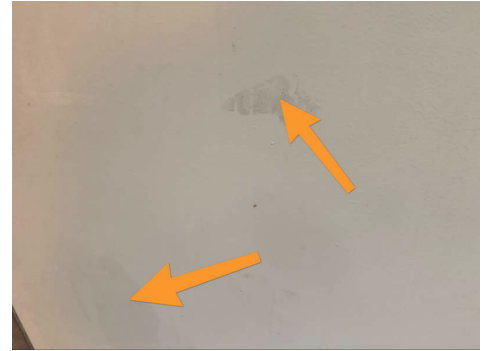
10.4.4 Walls and Ceiling

The walls and ceilings throughout the home are cosmetically worn and damaged. We recommend repairing as needed.

Contact a qualified professional.

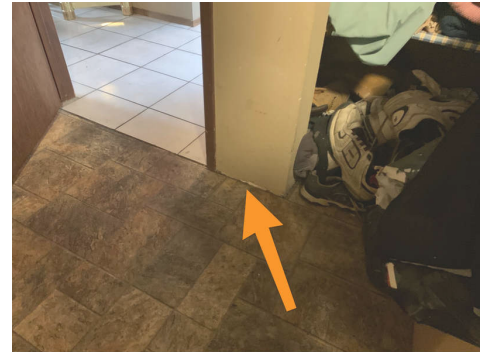
10.4.5 Walls and Ceiling

MISSING/DAMAGED WALL BASE

Wall base is missing or damaged. Recommend repair or replacement as needed.

Contact a qualified professional.

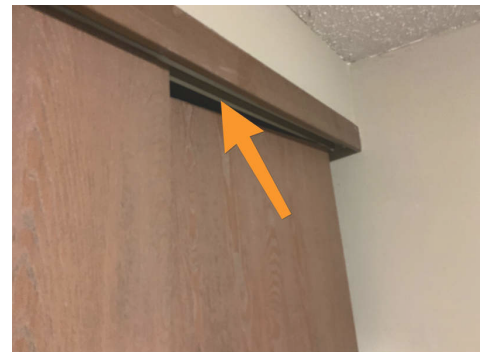
10.6.1 Closet

CLOSET DOOR OFF TRACK

The closet door is off the track. Recommend repair as needed.

Contact a qualified professional.

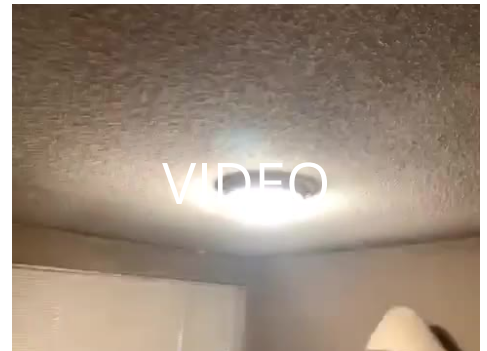
10.9.1 Lights, Wall Switches

A ceiling light in the bedroom is not functioning may not be wired correctly or is otherwise generally malfunctioning. This should be evaluated by a qualified electrician and repaired or replaced as needed

Contact a qualified professional.
