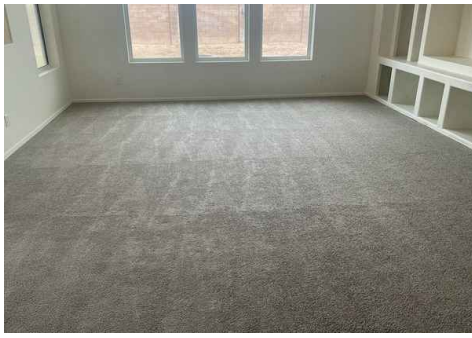
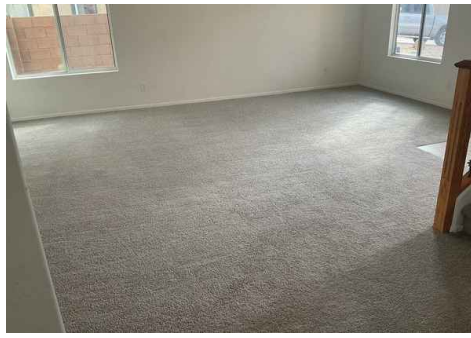
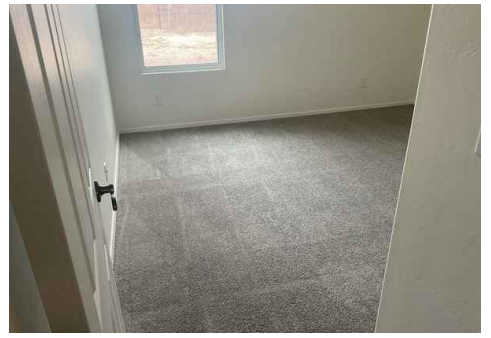
BEDROOM 4 & LIVING ROOM

MISSING FLOORING

What the independent inspector noted:

The downstairs is missing flooring material. Recommend repair.

What Opendoor did

A professional installed new carpet & pad throughout the entire home.

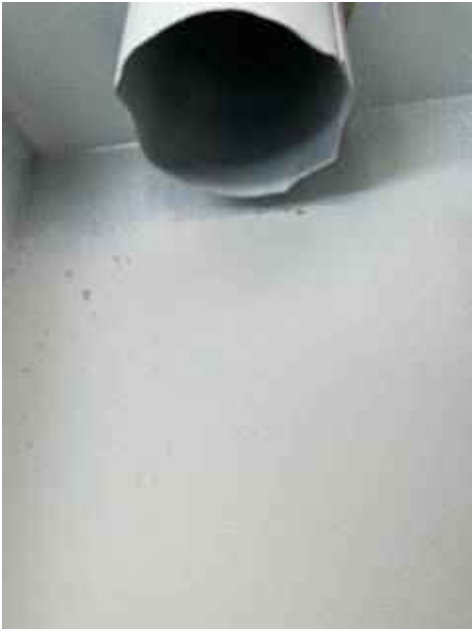
LINT BUILDUP AT DRYER VENT

What the independent inspector noted:

Opendoor standards issue

Lint buildup is observed at the exterior dryer vent exhaust. This can create a fire hazard. Having the vent flue professionally cleaned and/or repaired is recommended.

What Opendoor did

A professional cleaned this duct.
