HOME INSPECTION REPORT

12336 SE 310th Ln Unit 61
Auburn WA 98092

OCTOBER 22, 2020

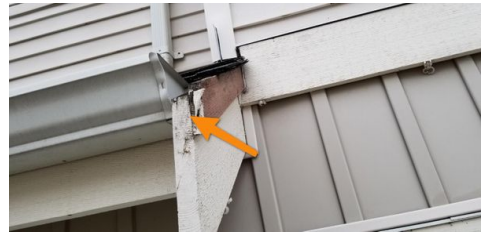
**Medium Priority****FASCIA AND TRIM NEED TYPICAL MAINTENANCE****FRONT**

Sections of the fascia and trim need maintenance type service, paint etc.

Contact a qualified handyman.

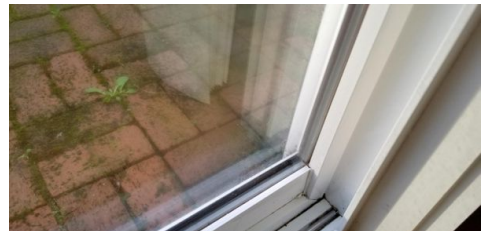
**Medium Priority****BROKEN HERMETIC SEAL****REAR**

A panel in the dual-glazed slide door has a broken hermetic seal, and should be serviced as necessary by a licensed window person.

Contact a qualified professional.

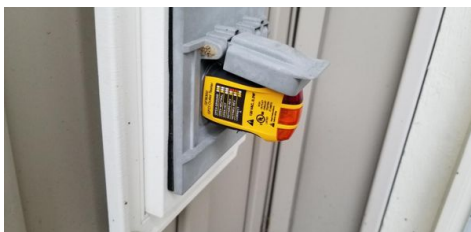
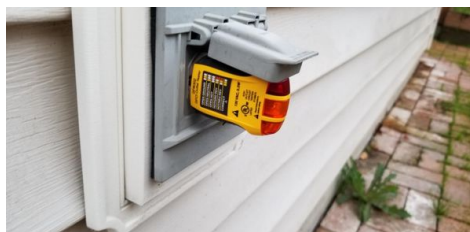
3.14.1 Outlets, Electrical Observations

A outlet does not have power and should be demonstrated or repaired.

Contact a qualified electrical contractor.

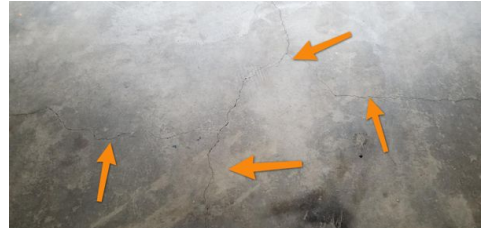
5.5.1 Slab Floor

SMALL CRACKS

The garage slab floor is structurally integral, and has some typical and moderately small cracks that are probably as a consequence of curing, but could indicate the presence of expansive soils. We do not regard these as being structurally threatening, but the slab is integral and you may wish to have an engineer confirm this.

Contact a qualified concrete contractor.

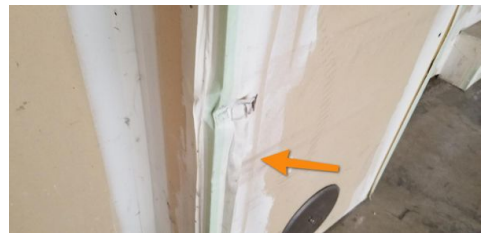
5.8.1 Walls and Ceiling

WALLS/CEILING HAVE DAMAGE

The walls/ceiling have some damage and repair is recommended.

Contact a qualified drywall contractor.

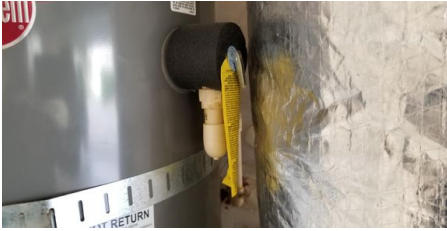
**Water Heating System: Thermal Expansion Tank**

This water heater includes a safety feature known as a thermal expansion tank or potable water expansion tank that appears acceptable.

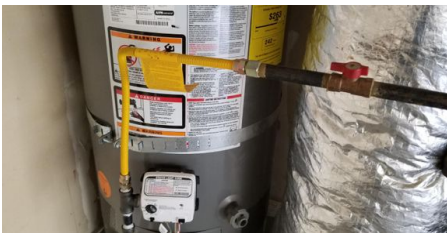
**Water Heating System: Vent Flue-Acceptable**

The vent/flue was in good repair and was mechanically fastened and met proper clearances at the time of the inspection.

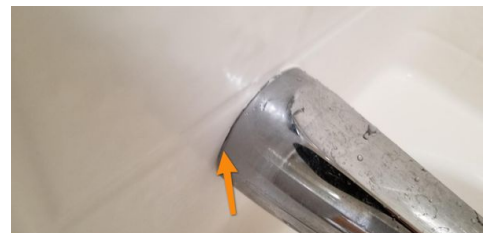
I recommend caulking or sealing around shower valves and faucets etc to help prevent moisture intrusion behind or into the walls.

Monitoring these areas is also recommended to help ensure an adequate seal is in place.

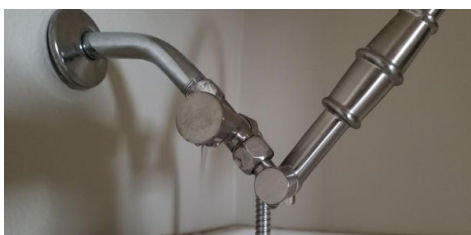
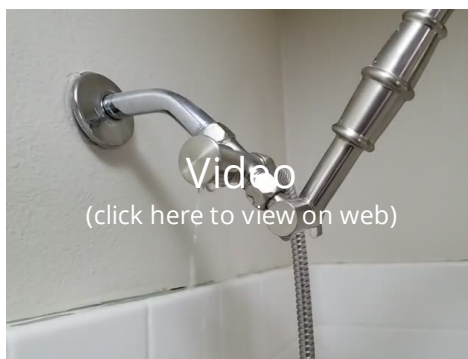
12.4.2 Tub-Shower

SHOWER HEAD LEAKING, NOT WORKING PROPERLY

The shower head is leaking or not working properly and should be serviced or replaced as necessary by a licensed professional.

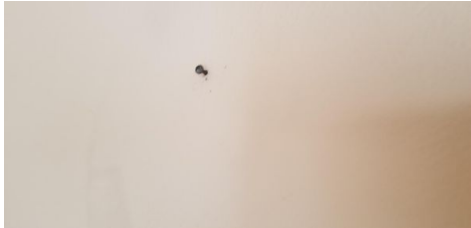
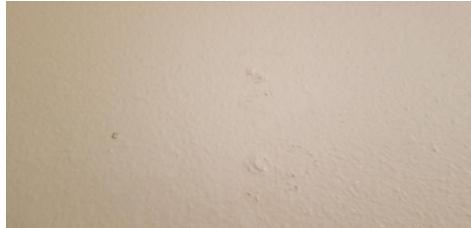
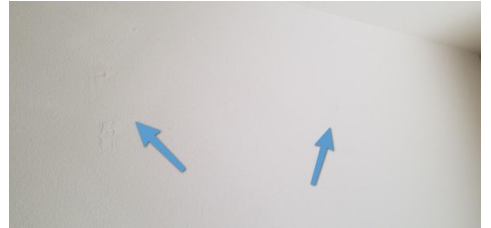
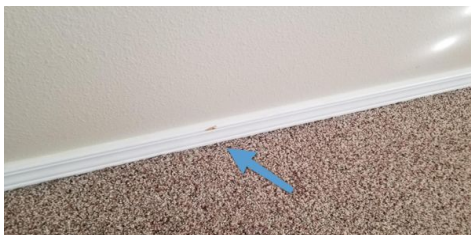
NORMAL WEAR AND TEAR

The walls or ceiling have minor cosmetic damage (scuffs, scrapes, nail holes etc) that you should view yourself and correct as desired.

Recommended DIY Project

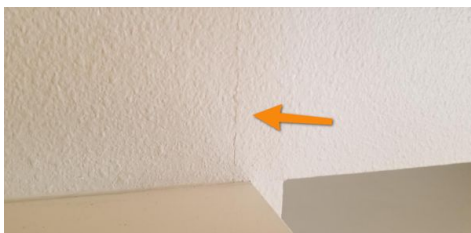
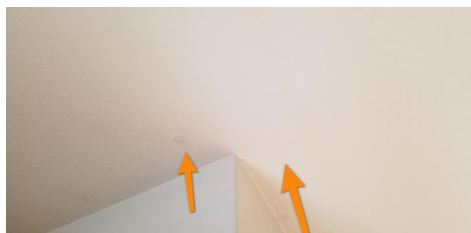
14.4.2 Walls and Ceiling

COMMON WALL/CEILING CRACKS (WARRANTY)

Observed typical settlement type cracking and nail pops on walls and ceilings. Recommend repairs as needed. Home owner to identify all areas for repair.

Contact a qualified professional.

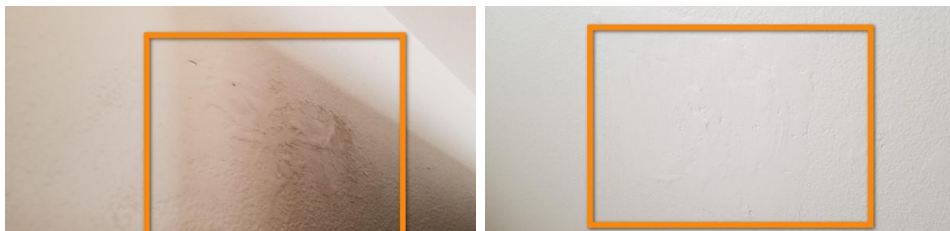
14.4.3 Walls and Ceiling

PATCH/PAST REPAIR

Patches or repairs were observed in the wall or ceiling. We could not determine the reason for the repairs. Recommend monitoring.

Contact a qualified professional.

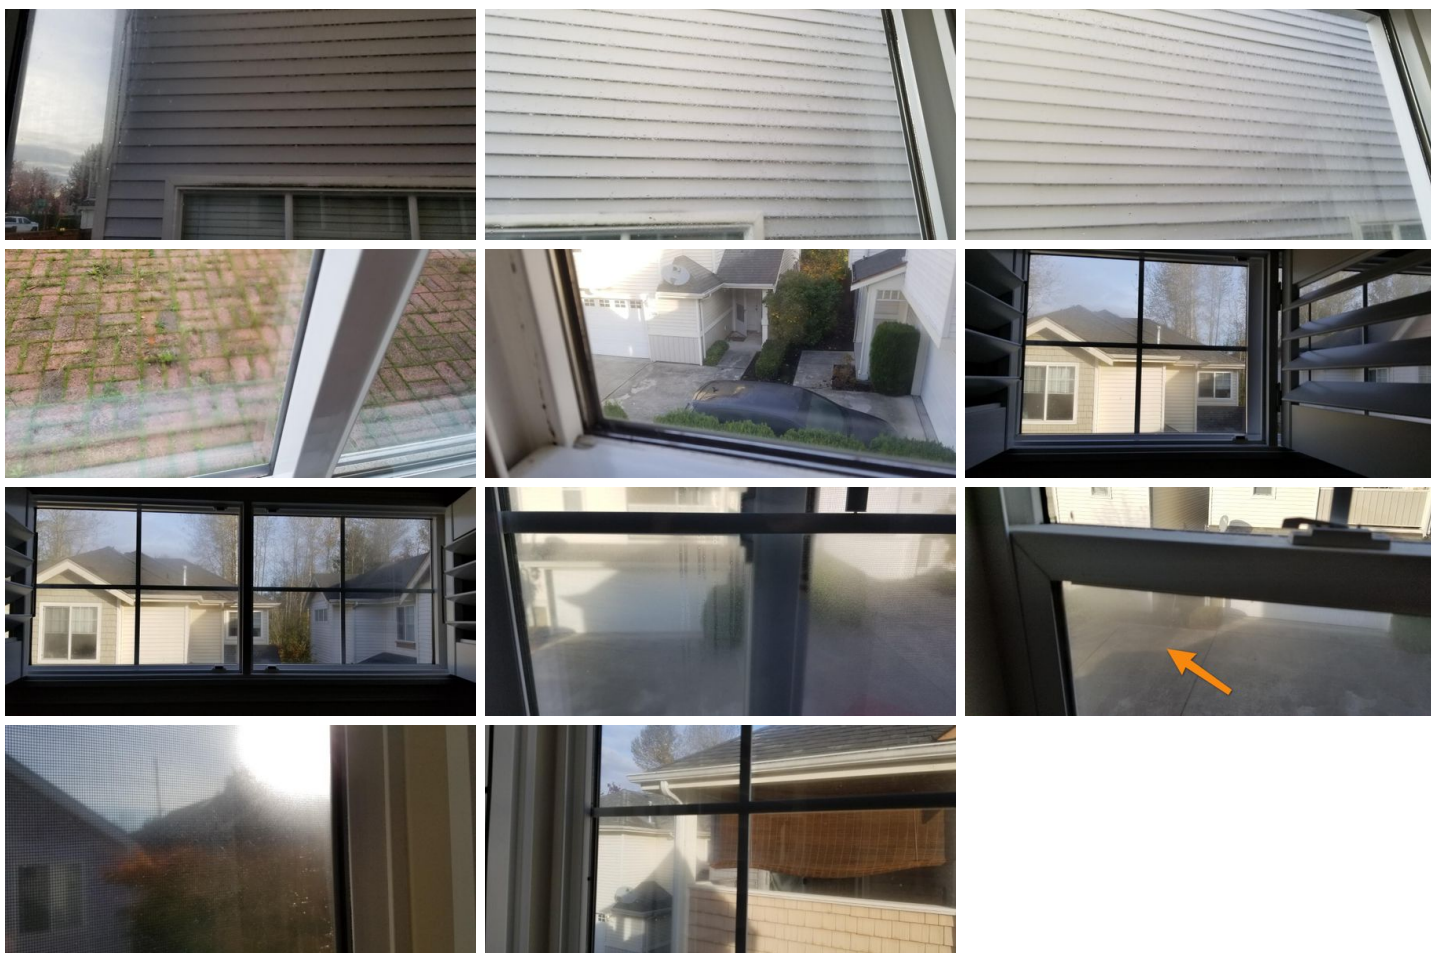
14.5.1 Windows

BROKEN SEALS

A window(s) has broken hermetic seals, and should be replaced. This is evident from fogging, or condensation forming between the panes of glass, that confirm that the seal has failed. If you are concerned we recommend that you have a professional check out all the windows within the residence.

Contact a qualified window repair/installation contractor.

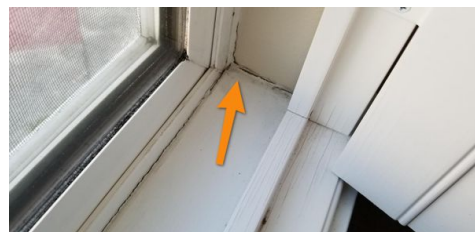
14.5.2 Windows

WINDOW SILL DAMAGED/MISSING

The window sill is missing or damaged. Recommend repair or replacement as needed.

Contact a qualified professional.

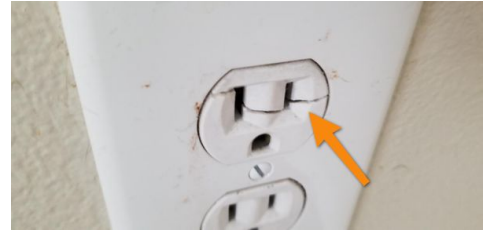
DAMAGED OUTLET

A damaged Outlet was observed. Recommend replacement.

Contact a qualified professional.

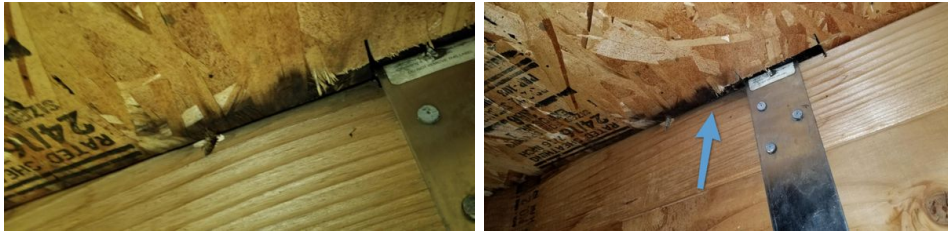
MOISTURE STAINS ON THE UNDERSIDE DECKING.

There are obvious moisture stains on the underside of some wood decking, which is predictable and would not necessarily confirm an active roof leak. However, the possibility of an active leak could not be ruled out either. Therefore, you are recommended to have a qualified roof specialist evaluate further, before the close of escrow.
