## HOME INSPECTION REPORT

4447 28th PI W  
Seattle, WA 98199

Jason Fields  
MAY 6, 2022

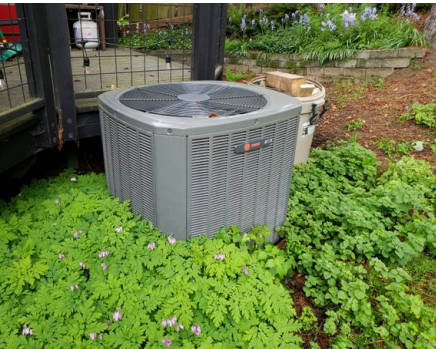
**Air Conditioning/Heat Pump:**  
**Equipment Photo**

Because outside temperature was below 60 degrees, we are unable to test the unit. Most manufacturers recommended temperatures be at 60 degrees or above for 48 hours prior to running air conditioners. I recommend servicing.

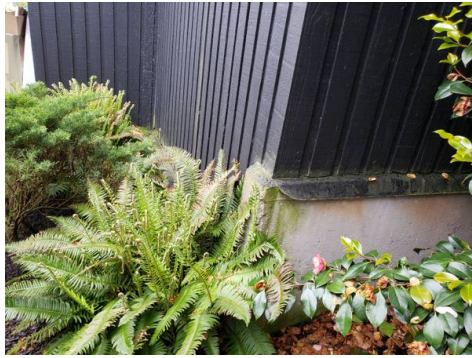
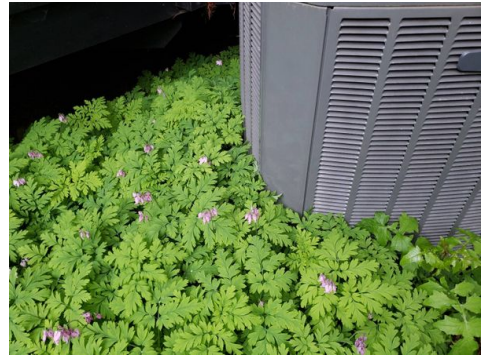
Vegetation is encroaching on the structure, and should be kept a minimum of twelve inches away for the general welfare of the walls and foundation.

Recommendation

Contact a qualified landscaping contractor

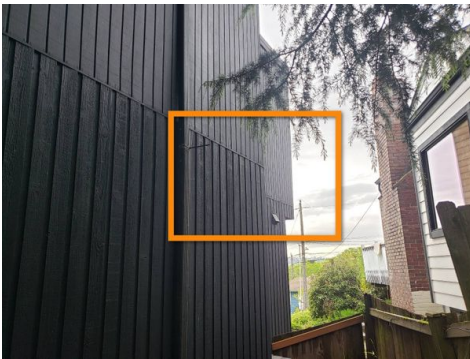
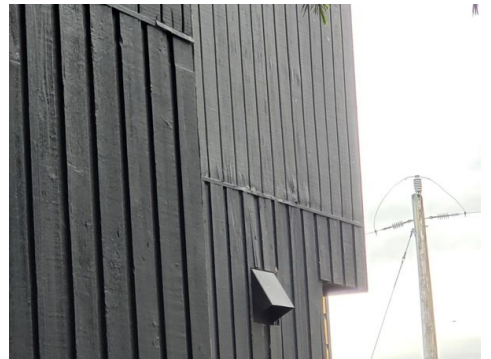
### 3.5.2 Exterior Siding Notes

#### **MOISTURE DAMAGE**

Portions of the siding were previously moisture damaged and should be further evaluated by a contractor.

##### Recommendation

Contact a qualified siding specialist.

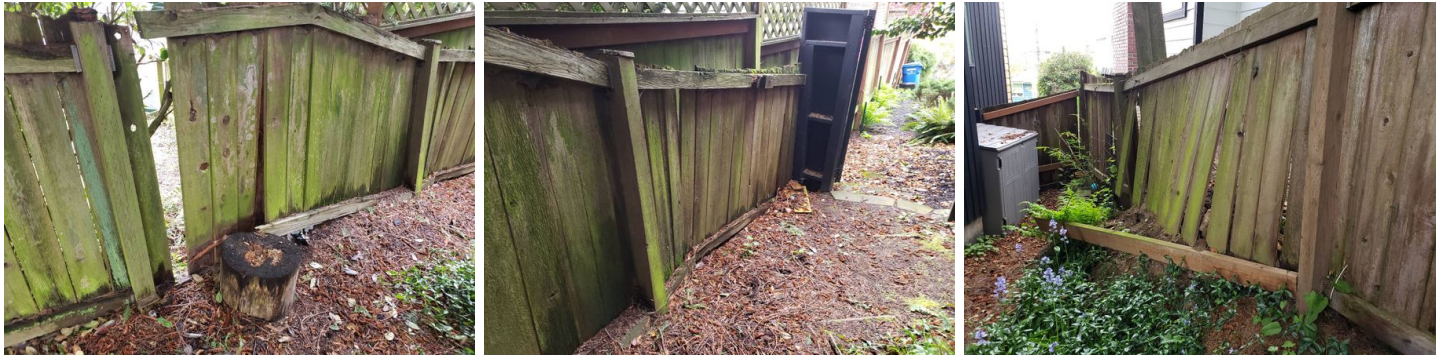
### 3.14.1 Fences & Gates

#### **DAMAGED FENCING**

Observed some damaged fencing on the property that will need to either be repaired or replaced.

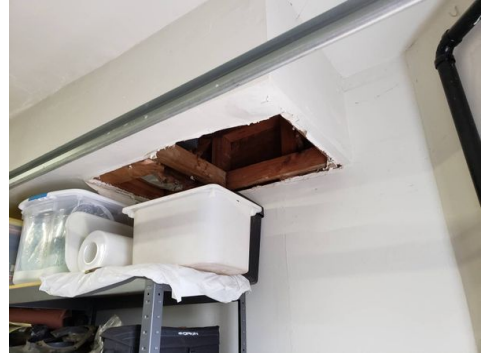
**THE VOIDS IN THE CEILING FIREWALL SHOULD BE REPAIRED**

The voids in the ceiling firewall should be repaired, in order to maintain the necessary firewall separation between the garage and the residence.

Recommendation

Contact a qualified handyman.

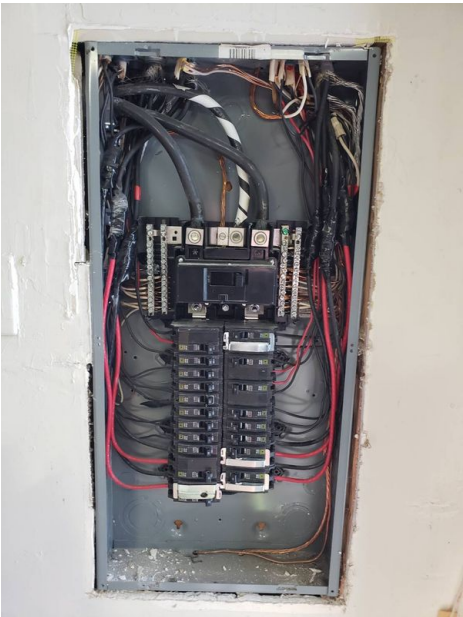
**Panel Size, Location & Photo:**  
**Panel Amps, Location and Picture**  
200 AMP, Garage

**Panel Cover Condition:**  
**Acceptable**  
The electrical panel cover is in acceptable condition.

**Main Panel Notes: Acceptable**  
The panel and its components have no visible deficiencies. Any exceptions will be noted below.

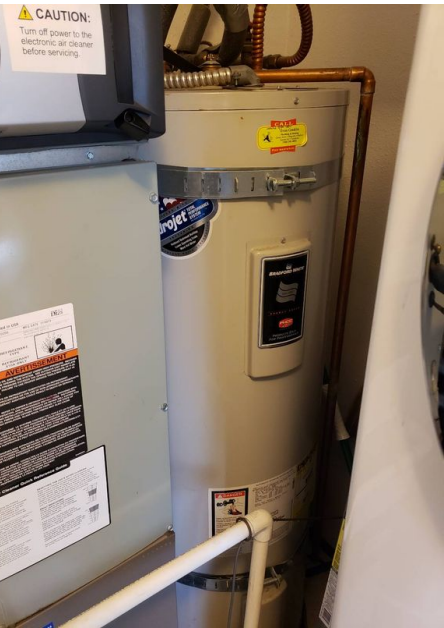
**Water Heating System: Manufacturer and picture**  
Bradford & White

I recommend flushing & servicing your water heater tank annually for optimal performance. Water temperature should be set to at least 120 degrees F to kill microbes and no higher than 130 degrees F to prevent scalding.  
[Here is a nice maintenance guide from Lowe's to help.](#)

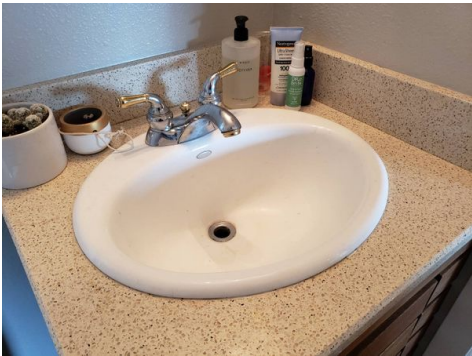
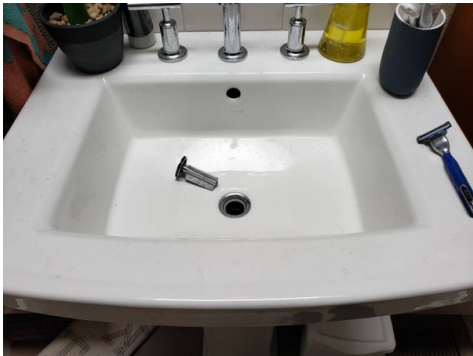
The sink stopper does not work properly and repair is recommended.

Recommendation

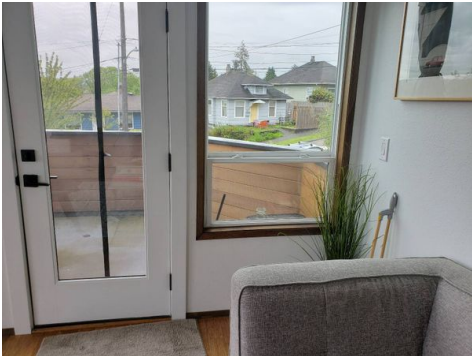
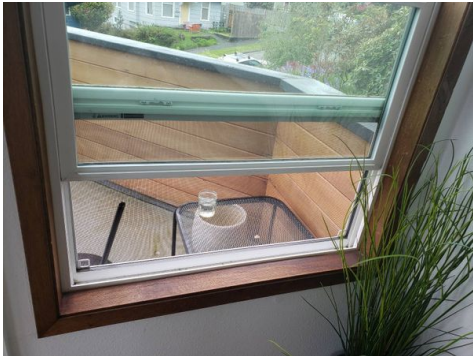
13.5.1 Windows

**WINDOW DOES NOT STAY OPEN**

At least 1 window does not stay open and service is recommended.

Recommendation  
Contact a qualified window repair/installation contractor.

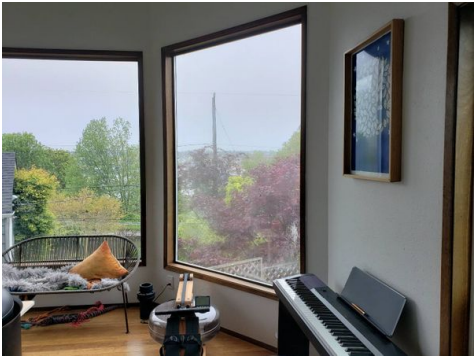
13.5.2 Windows

**HERMETIC SEALS**

One or more windows have broken hermetic seals. This is evident from fogging, or condensation forming between the panes of glass that confirm that the seal has failed. If you are concerned we recommend that you have a professional check out all the windows within the residence and repair or replace as needed.

Recommendation  
Contact a qualified professional.

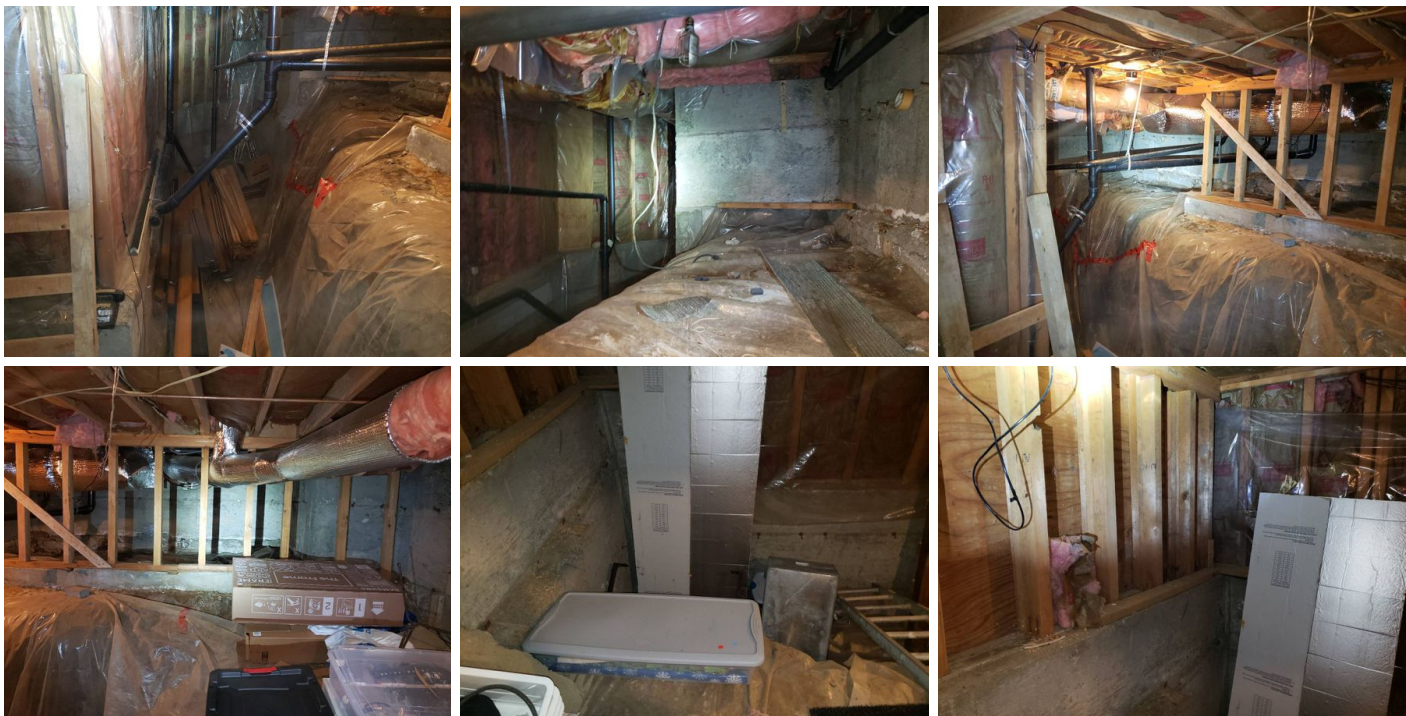
**Crawlspace Notes: Crawlspace Photos**

At the time of the inspection, the vapor barriers were in good condition with only minor visible defects normal to the age of the home.

The foundation showed only the normal signs of weathering and or cracking at the time of the inspection.
