## RESIDENTIAL HOME INSPECTION REPORT

1180 Bridgeway Ct  
Clermont FL 34711

JULY 16, 2021

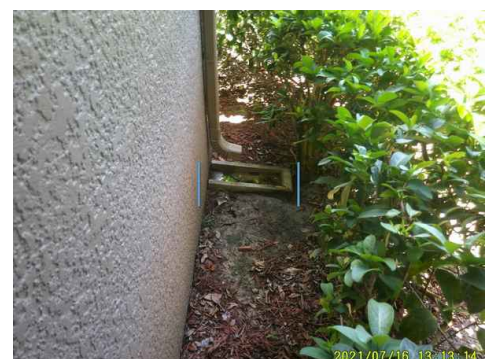
One or more downspouts drain too close to the home's foundation. This can result in excessive moisture in the soil at the foundation, which can lead to foundation/structural movement. Recommend adjusting and/or extending downspout to ensure the water drains away from the foundation.

Contact a handyman or DIY project

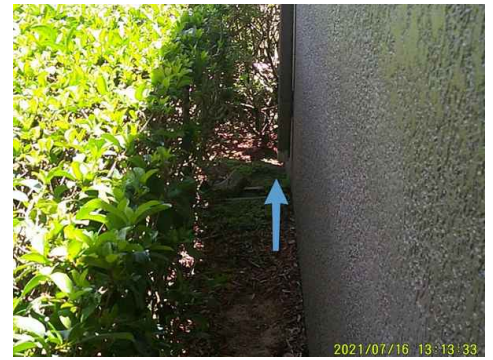
## 2.4.2 Gutters &amp; Downspouts

**DOWNSPOUT DETACHED**

I observed indications of a disconnected and detached downspout pipe fitting. Reattach and divert away from foundation.

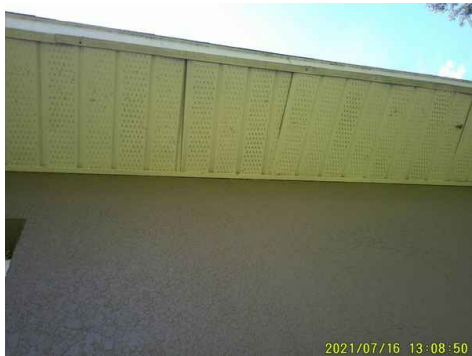
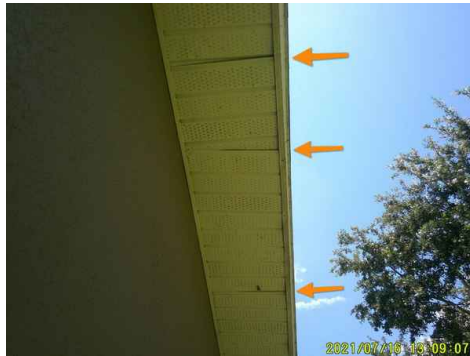
Soffit was observed to be out of place leaving gaps between panels. Recommend correction to prevent pests or rodents getting into the soffits.

Contact a handyman or DIY project

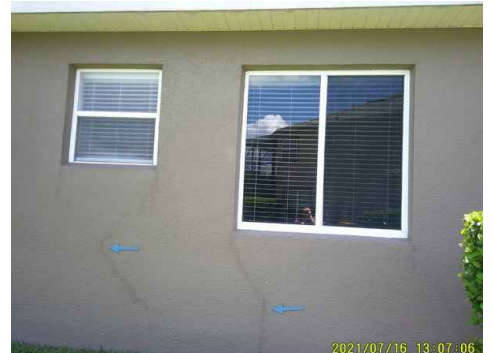
## 3.3.1 Wall-Covering, Flashing &amp; Trim

**PRIOR SETTLEMENT**

Prior settlement cracks appear to have been repaired and painted. Monitor for any changes.

Contact a qualified professional.

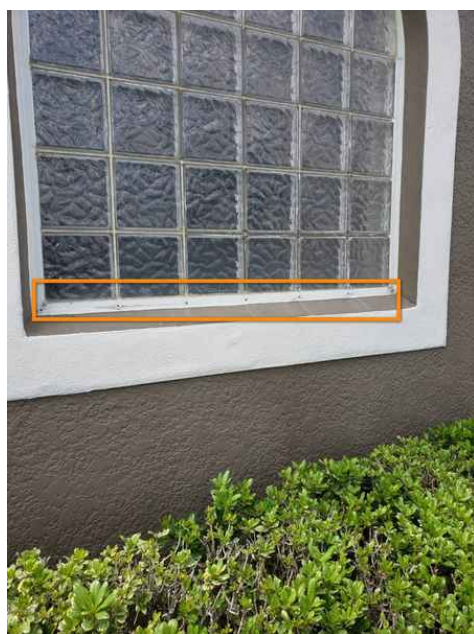
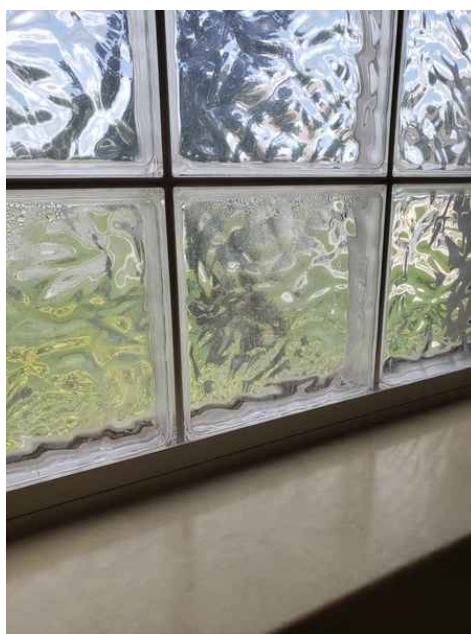
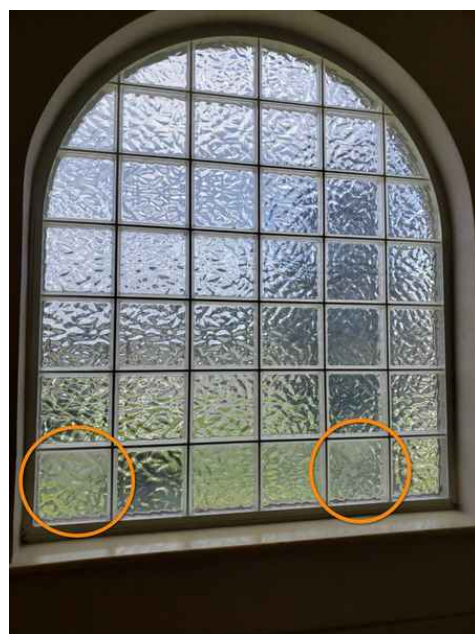
## 3.8.1 Windows

**CONDENSATION WITHIN GLASS BLOCK**

I observed condensation in glass block window to Master Bathroom. Intrusion holes were noticed on exterior frame of glass block window. Recommend further evaluation.

Contact a qualified window repair/installation contractor.

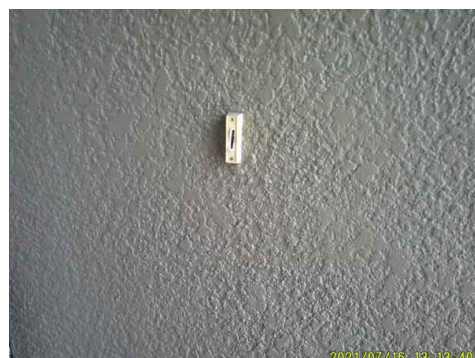
**DOORBELL BUTTON CRACKED**

I observed cracked doorbell button. Recommend replacement.

Contact a handyman or DIY project

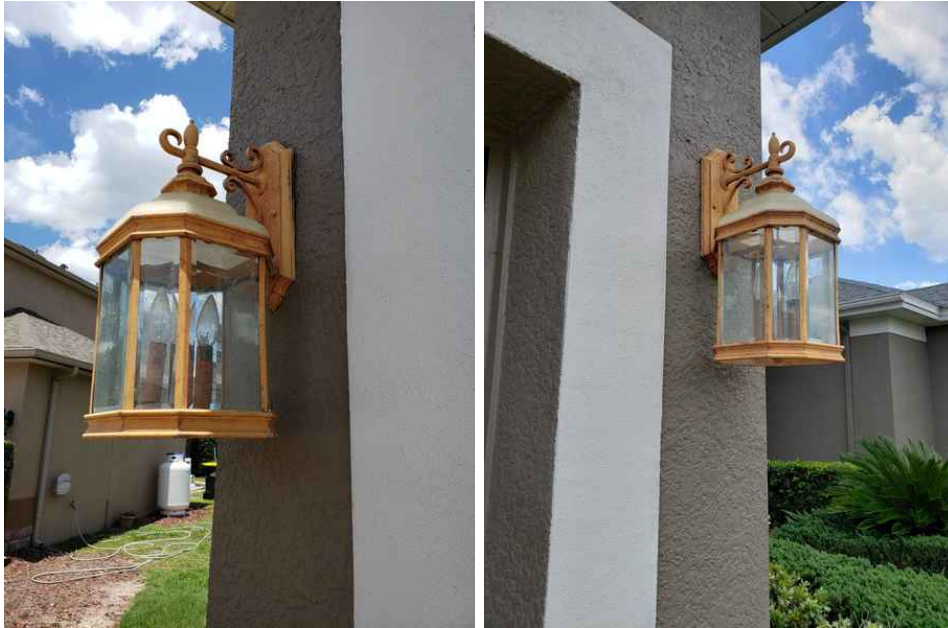
## 3.12.1 Exterior Lighting

**LOOSE FIXTURES**

I observed the light fixtures at the sides of garage to be loose. This may allow moisture to get behind the fixture. Recommend repairing or replacing.

Contact a handyman or DIY project

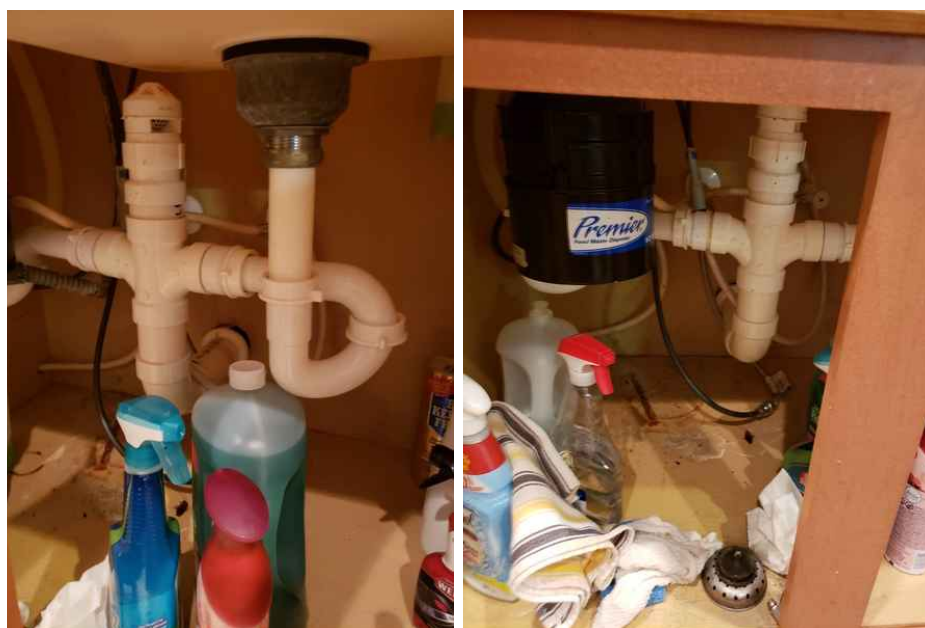
**Kitchen Sink: Plumbing Inspection Method**

Supply and drain pipes were inspected looking for leaks, improper installation, proper trap setup and other deficiencies. No deficiencies observed at inspection time unless noted in this report.

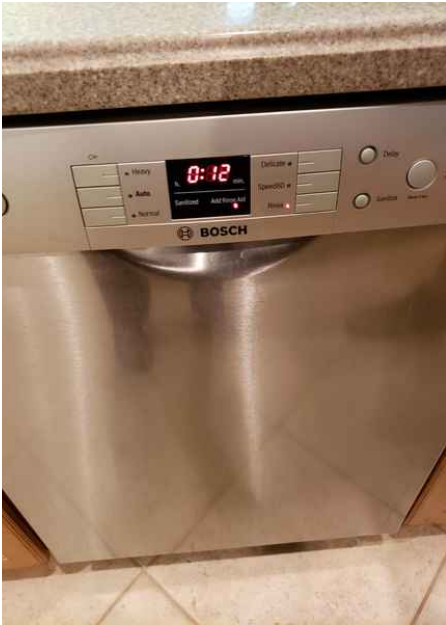
**Dishwasher: Dishwasher Inspection Method**

The dishwasher was operated by running a wash cycle and looking for leaks. The units efficiency of cleaning dishes is not tested. No deficiencies observed at inspection time unless noted in this report.

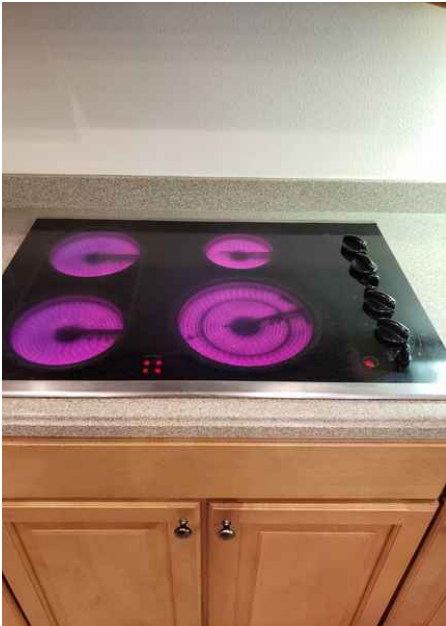
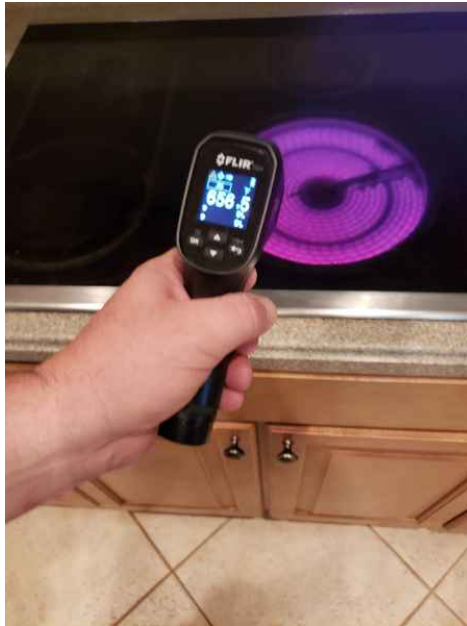
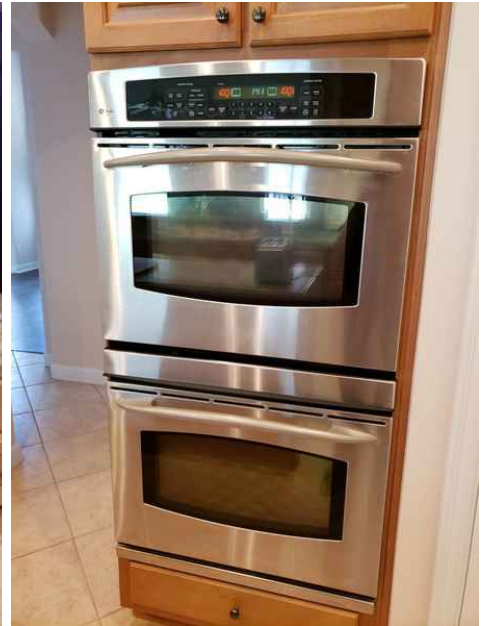
### Range/Oven/Cooktop: Oven/Range Inspection Method

All of the heating elements on the range were turned to High and the oven set to 350 degrees in Bake mode. No other stove/oven functions are tested. No deficiencies observed at inspection time unless noted in this report.

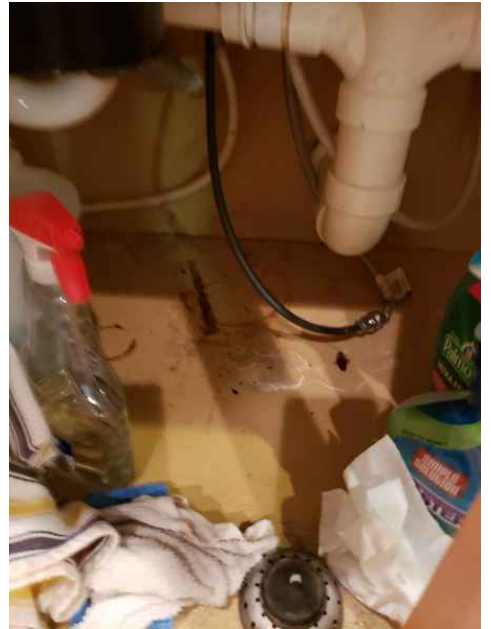
Cabinet floor seems to be sunken, possible prior leak. No active leak was observed when running water. Recommend monitoring.

Recommend monitoring.

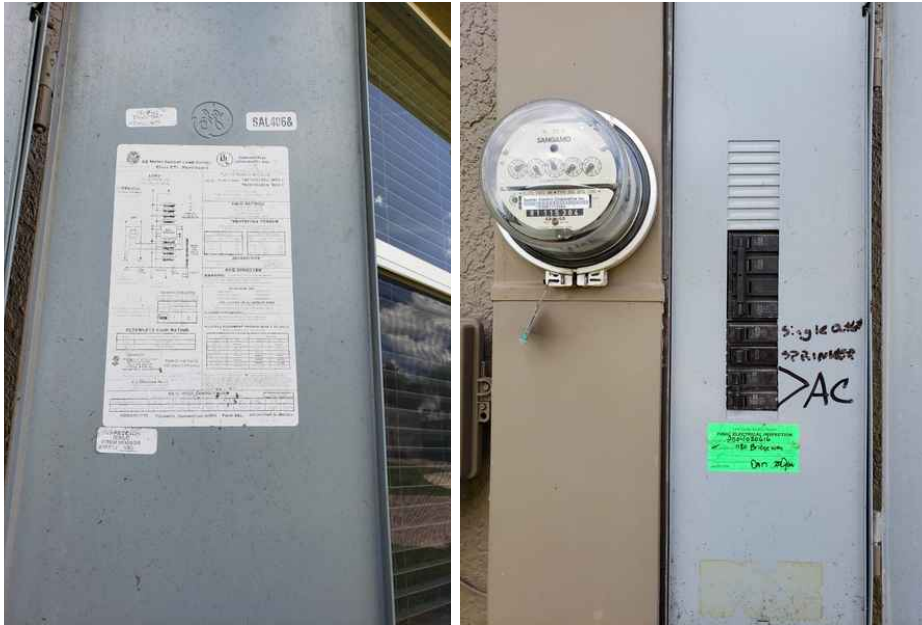
**Main Service Disconnect: Inspected Main Service Disconnect**

The service disconnect or main OCPD (over current protection device) was inspected looking for any deficiencies and reporting on its location. This disconnect can be a breaker, fuse block or kill switch. This is the means of shutting off all electricity entering the home. No deficiencies observed at inspection time unless noted in this report.

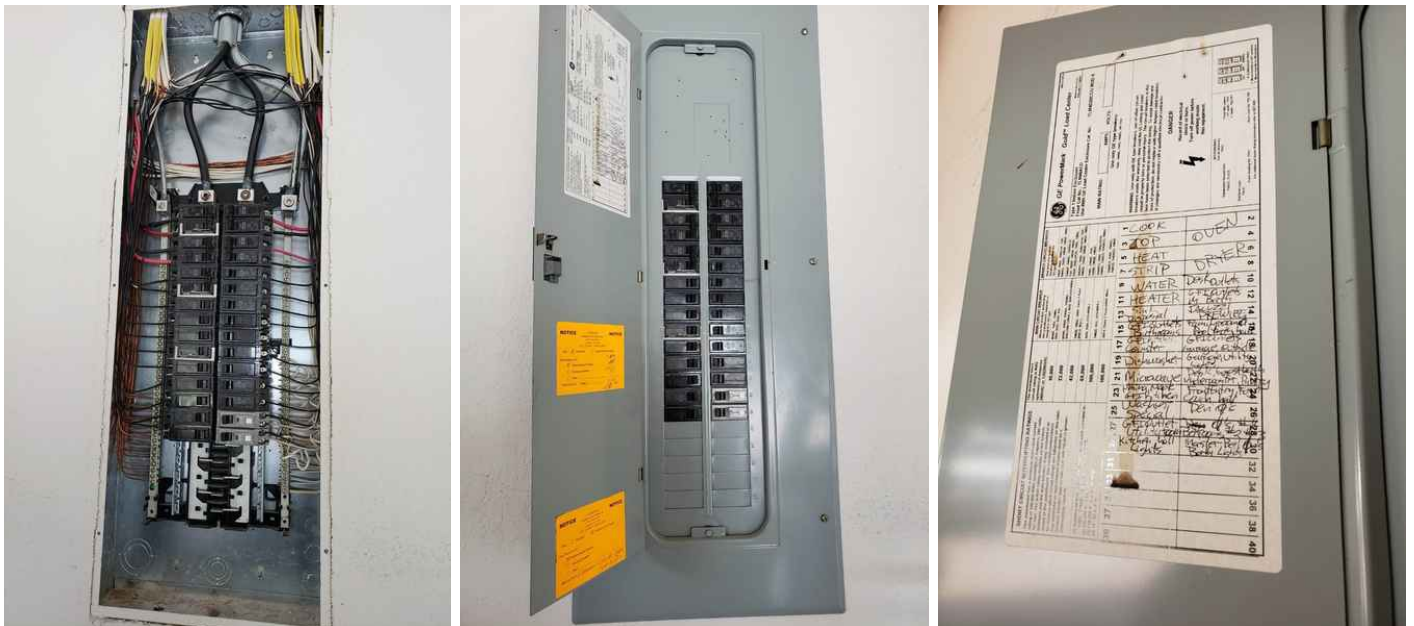
### Panelboards & Breakers: Inspected Main Panelboard & Breakers

I inspected the electrical panelboards and over-current protection devices (circuit breakers and fuses) looking for any wiring deficiencies or damage. No deficiencies observed at inspection time unless noted in this report.

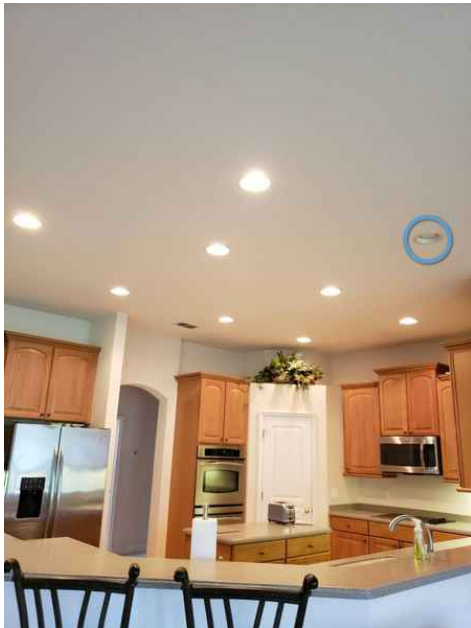
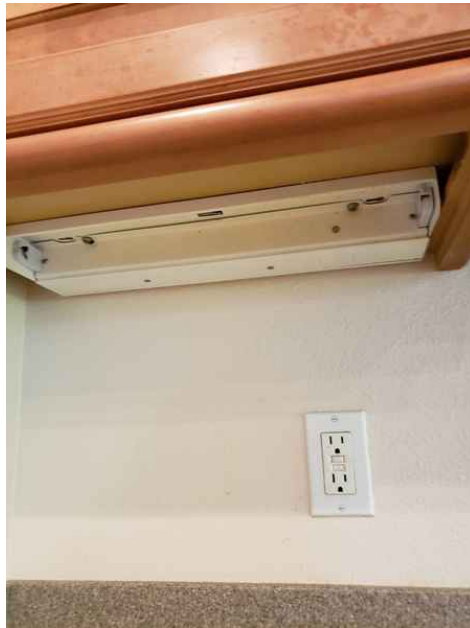
No lightbulb installed

Contact a qualified electrical contractor.

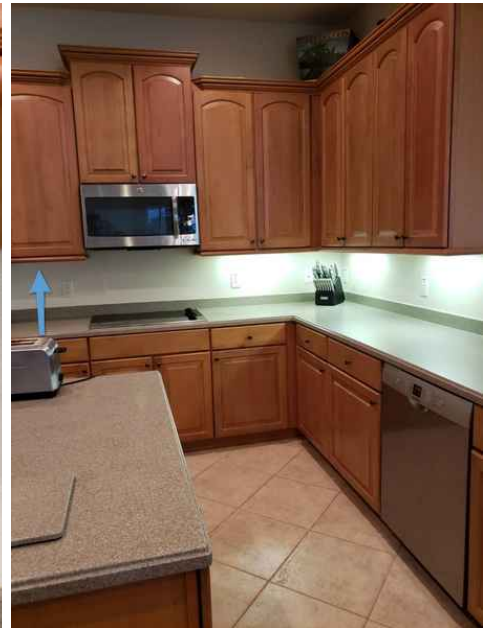
Missing lightbulb location

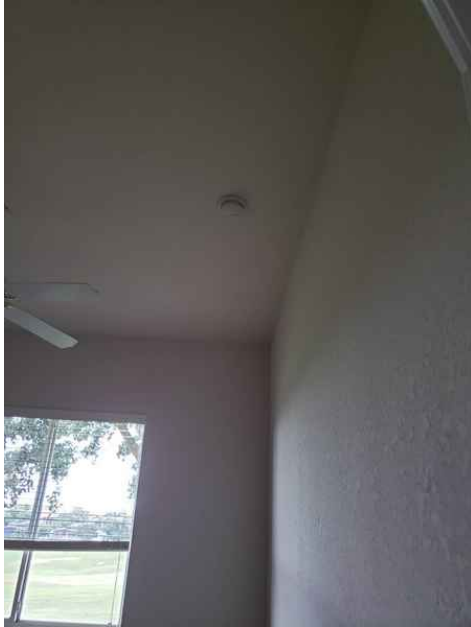
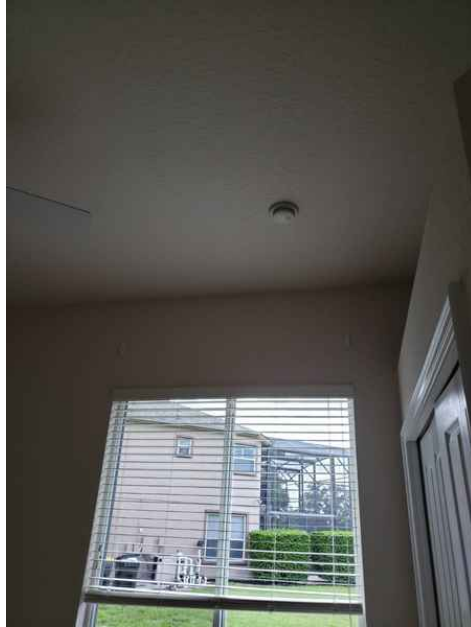
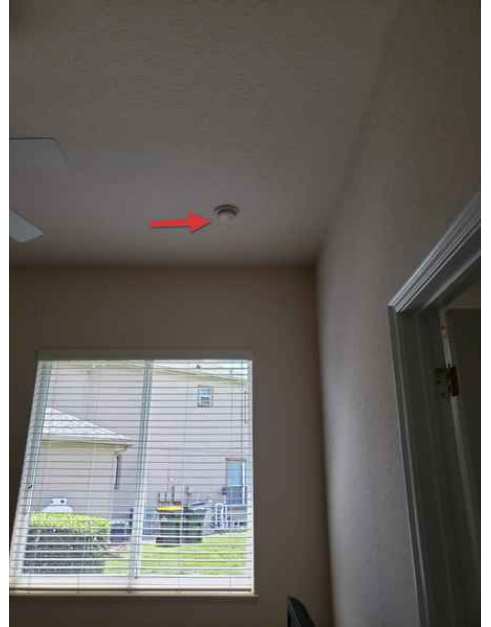
Did not test correctly when pressed. In front left bedroom.

Contact a qualified professional.

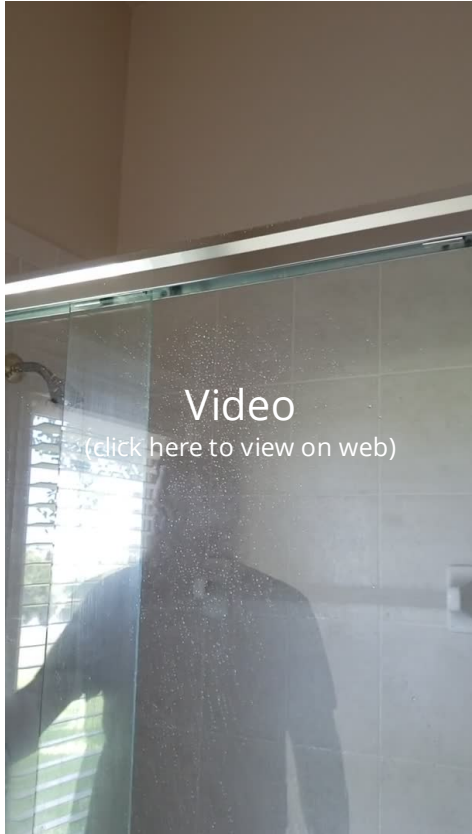
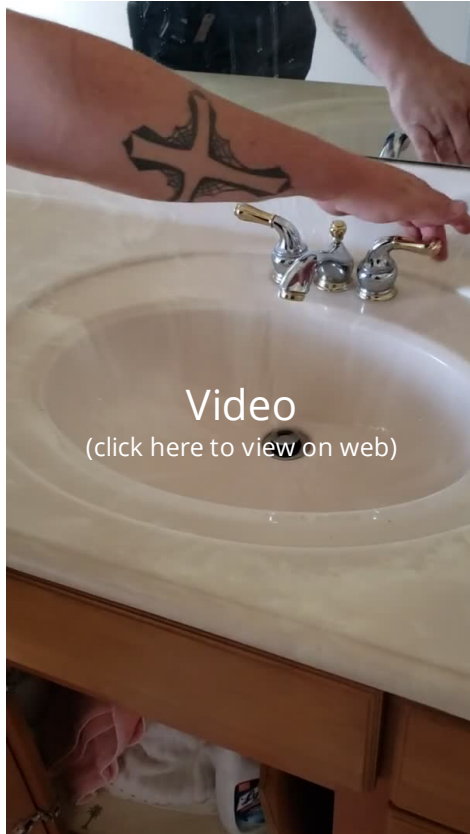
## 7.2.2 Sinks, Tubs &amp; Showers

**REDUCED WATER PRESSURE**

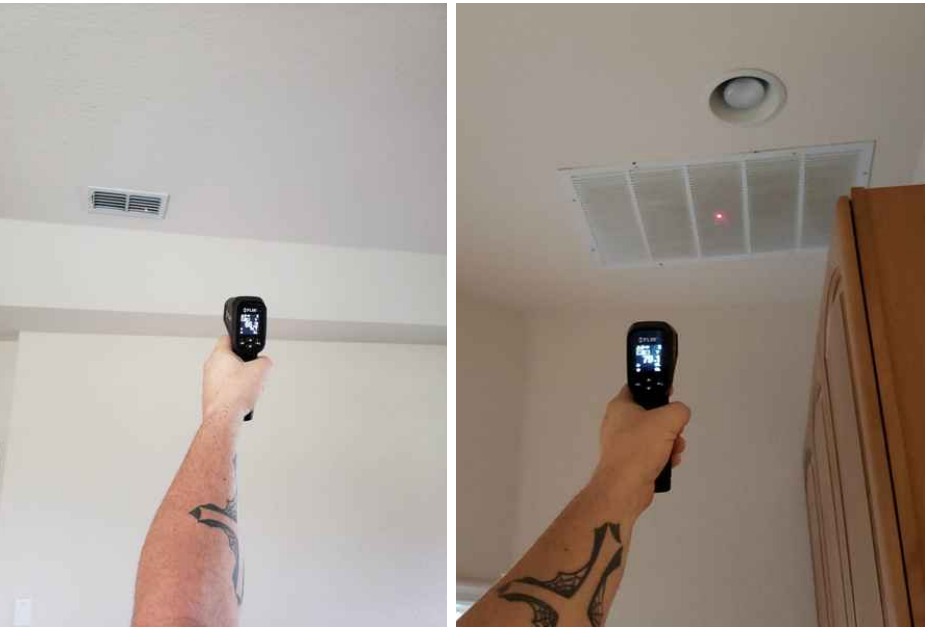
The typical temperature differential between return and supply air is 10 - 20 degrees in cooling mode and 16 - 25 degrees in heating mode. Several factors can affect these numbers, such as, but not limited to: indoor ambient air temperature, exterior ambient air temperature, humidity, cleanliness of the air filter and evaporator, etc.

These readings are shown to show the system responded to normal operating controls at the time of the inspection and not to show the exact temperature differential produced by the system, the efficiency or performance of the system which lies beyond the scope of a home inspection.

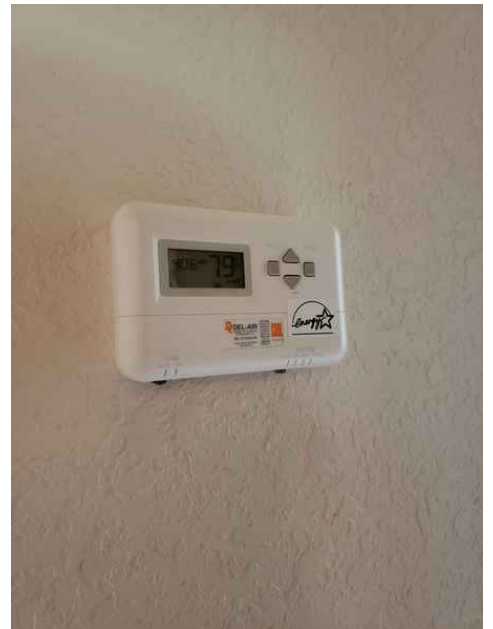
## 9.3.1 Condensate

**COOLANT LINE INSULATION WORN**

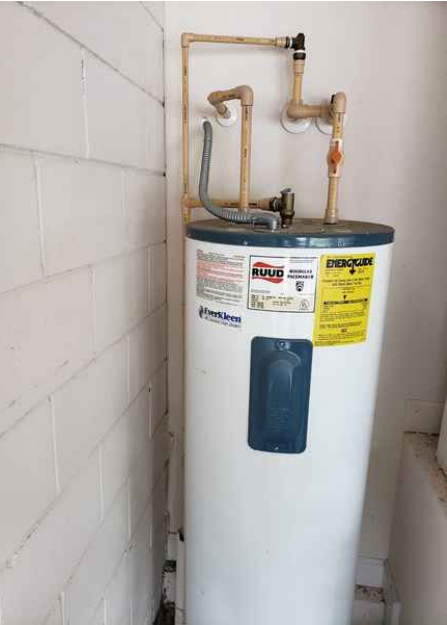
**Hot Water Source: Inspected Hot Water Source**

The water heater was tested to see if it produced hot water at the time of inspection. Visible portions were inspected looking for signs of leaking, corrosion and/or proper setup. No deficiencies observed at inspection time unless noted in this report.

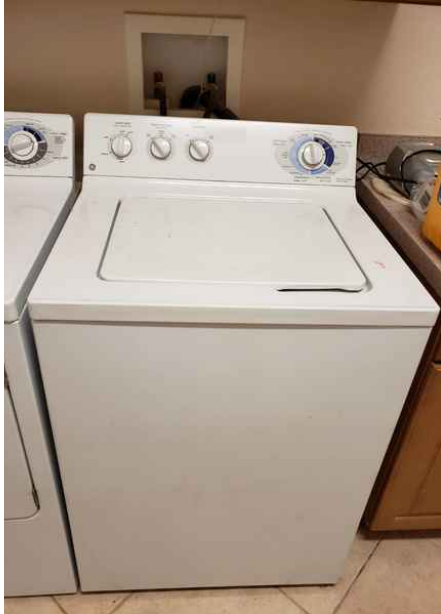
**Clothes Washer: Washer Present**  
Laundry Room

**Clothes Washer: Brand**  
GE

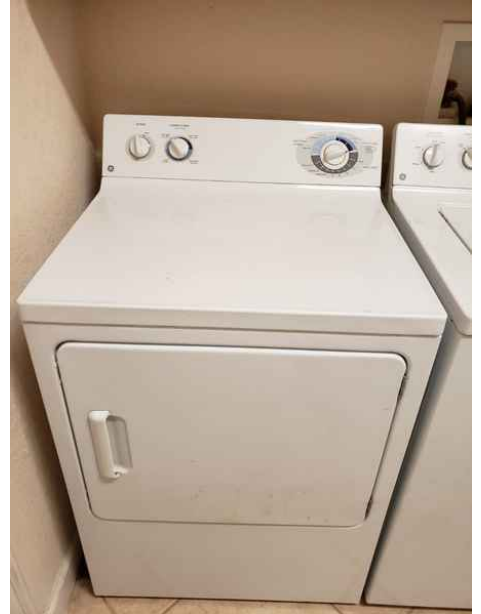
**Clothes Dryer: Dryer Present**  
Laundry Room

**Clothes Dryer: Brand**  
GE

**Clothes Dryer: Dryer Vent**  
**Material**  
Metal (Flex)
