MICHAEL TOFANO PROPERTY AND HOME INSPECTIONS

INTERNACHI RESIDENTIAL

34 Madoc Drive
Brampton Ontario L6V 1Z9

Domenic Castiello
JULY 30, 2018

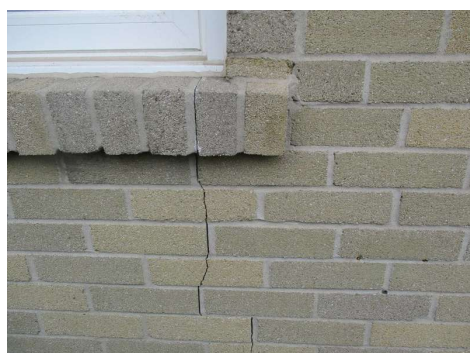
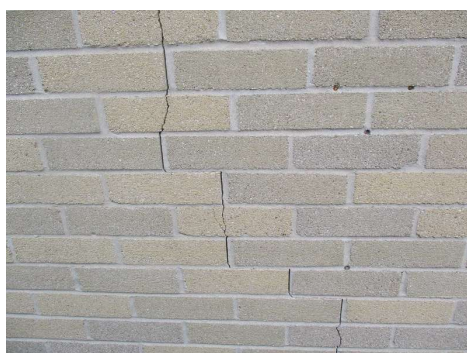
3.1.1 Siding, Flashing & Trim

CRACKING - MINOR

Brick Siding showed cracking in one or more places. This is a result of temperature changes and previous water damage. This is typical as homes age. Recommend monitoring.

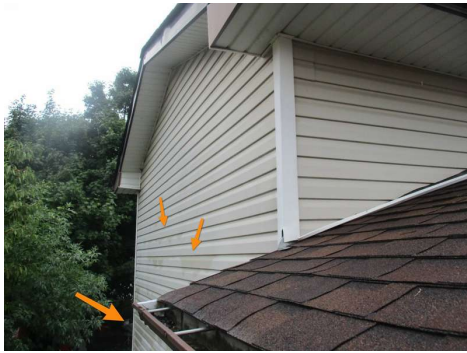
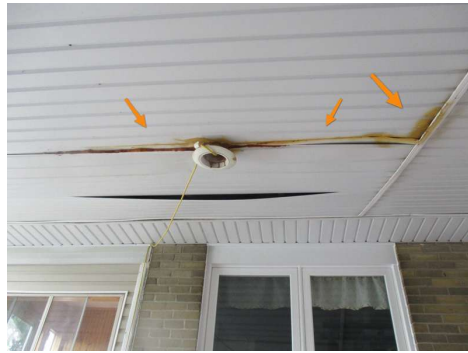
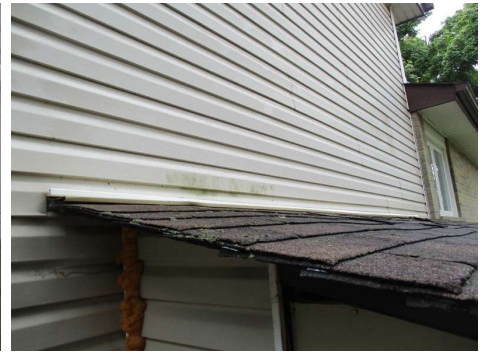
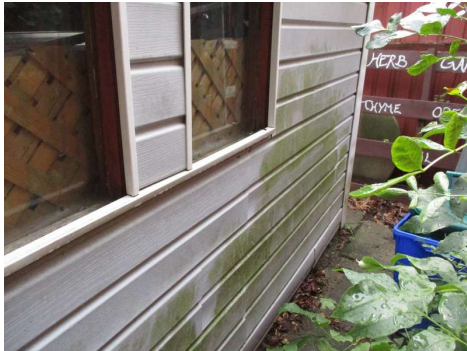
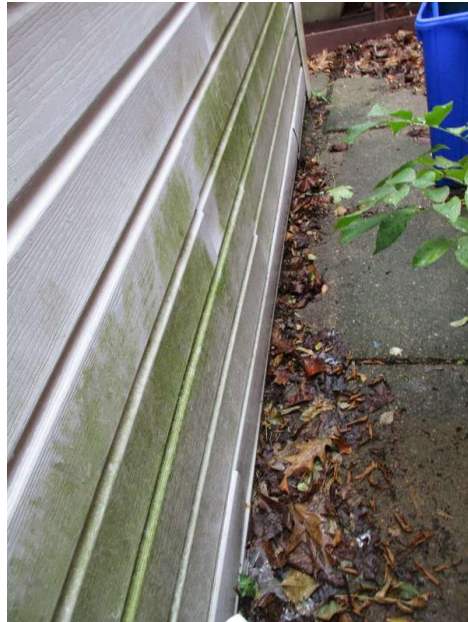
3.1.2 Siding, Flashing & Trim

EVIDENCE OF WATER INTRUSION

Siding showed signs of water intrusion. This could lead to further siding deterioration and/or mold. Recommend a qualified siding contractor evaluate and repair.

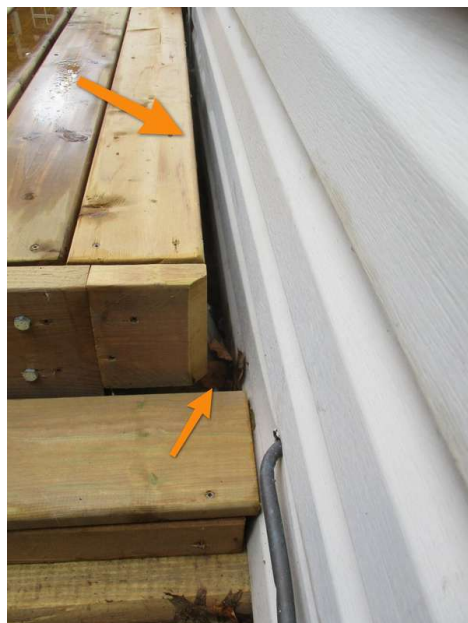
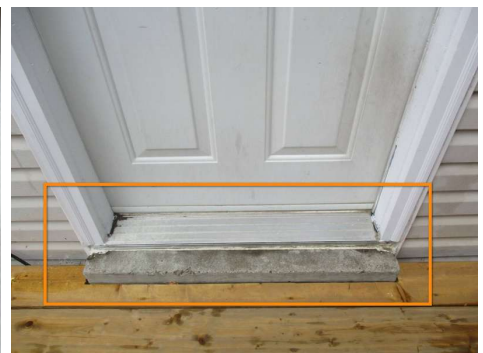
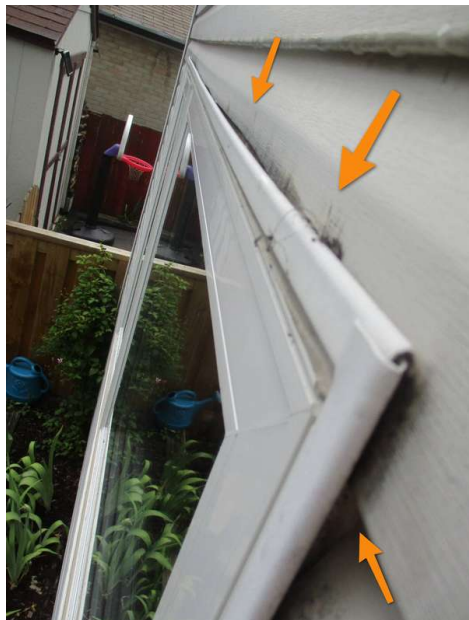
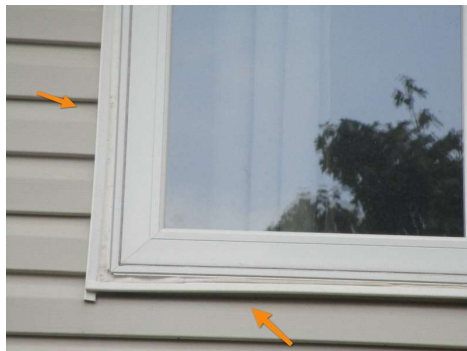
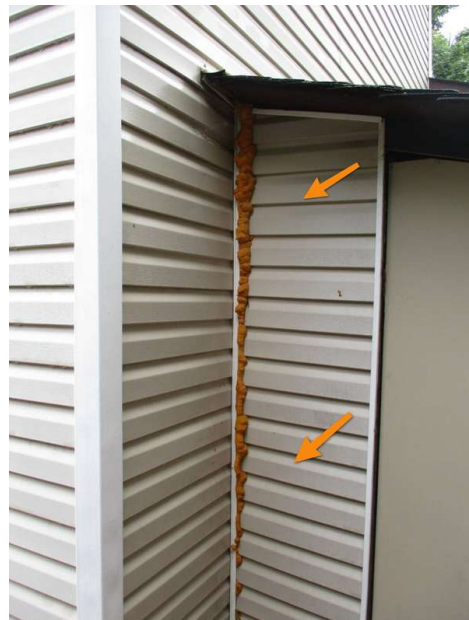
3.1.3 Siding, Flashing & Trim

FLASHING/TRIM IMPROPERLY INSTALLED

Flashing & trim pieces were improperly installed, which could result in moisture intrusion and damaging leaks. Recommend a qualified siding contractor evaluate and repair.

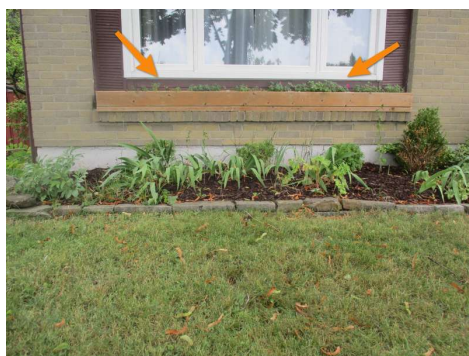
3.1.4 Siding, Flashing & Trim

GROUND CLEARANCE

Inadequate clearance between siding/wood and ground. Recommend a minimum ground clearance between bottom of siding and ground of 4". Siding in contact with the ground or soil is a serious concern because that condition can provide direct access for wood destroying insects.

Remove to prevent further moisture damage.

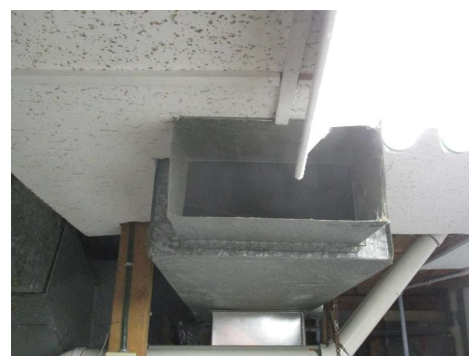
DUCT LEAKING

Air supply duct was leaking air. Recommend a qualified HVAC technician or vents & ducts contractor repair.

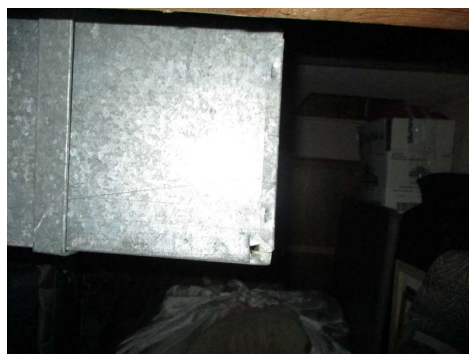
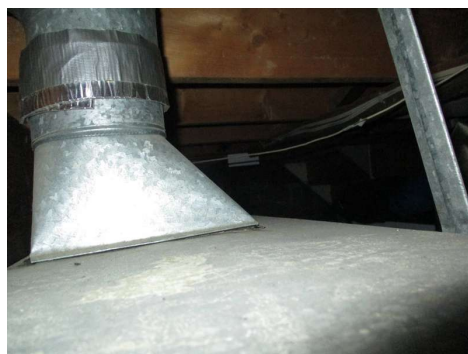
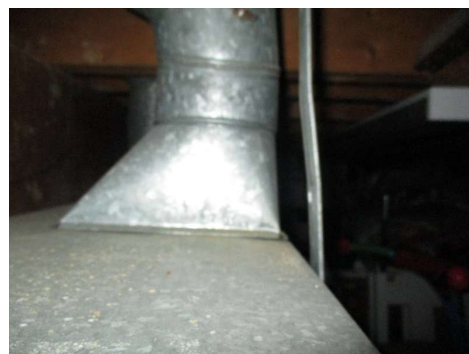
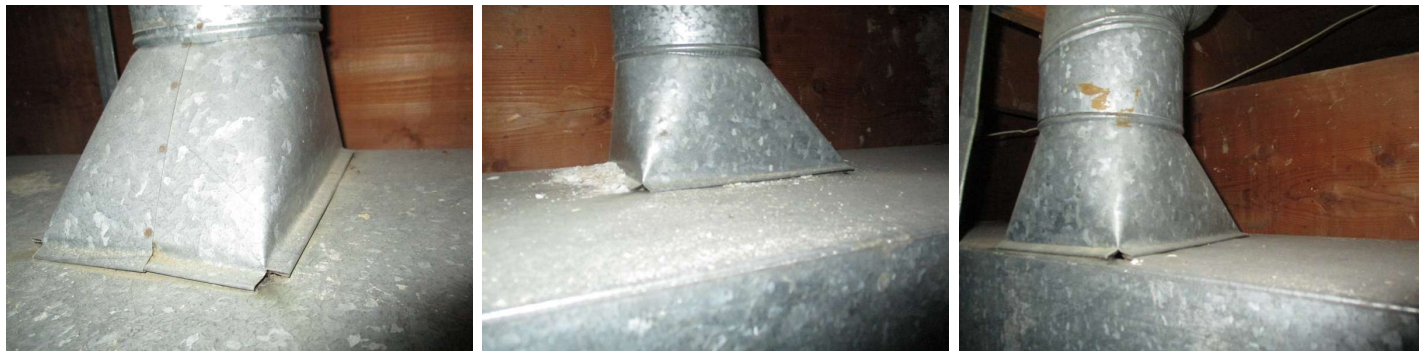
5.3.2 Distribution Systems

DUCTS NOT SEALED

Air supply ducts were not properly sealed. Recommend a qualified HVAC contractor seal supply and return ducts for maximum efficiency.

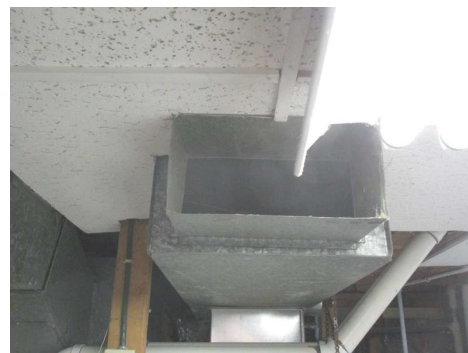
5.3.3 Distribution Systems

RETURN AIR SYSTEM MISSING/INSUFFICIENT

Return air registers were missing or insufficient. This can result in poor heating efficiency. Recommend a qualified HVAC contractor evaluate and remedy.

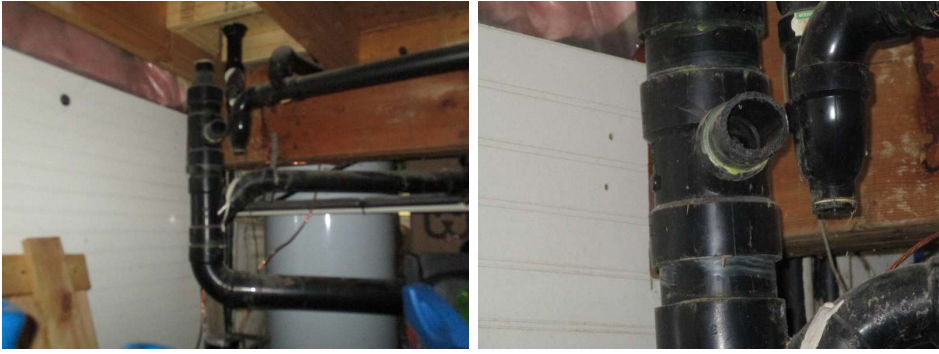
IMPROPER CONNECTION

An improper connection was observed at a drain, waste or vent pipe. Recommend a qualified plumber evaluate and repair.

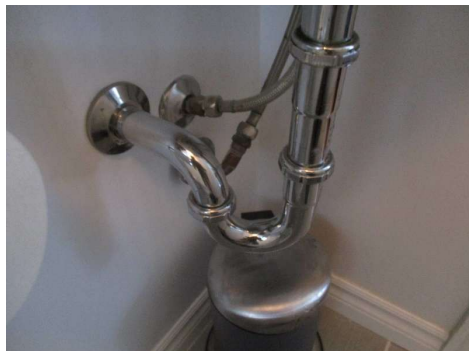
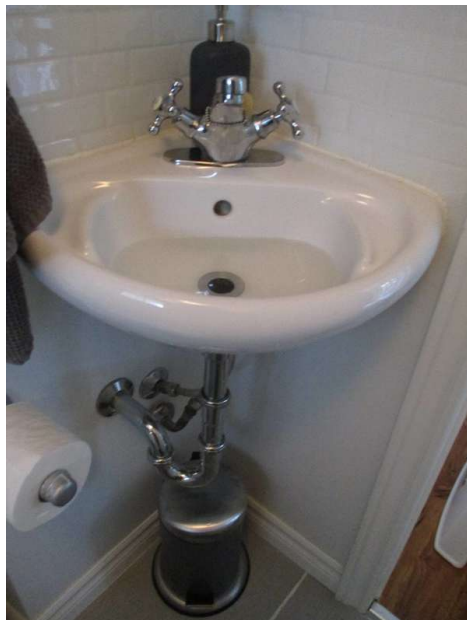
7.2.3 Drain, Waste, & Vent Systems

SINK - POOR DRAINAGE

Sink had slow/poor drainage. Recommend a qualified plumber repair.

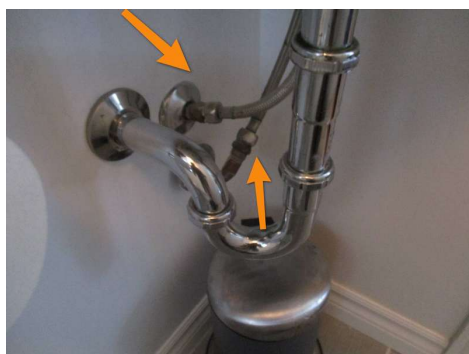
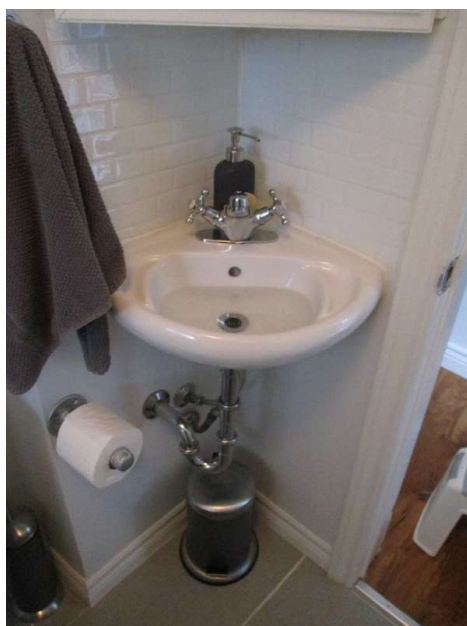
7.3.1 Water Supply, Distribution Systems & Fixtures

IMPROPER INSTALLATION

Distribution pipes were installed in a sub-standard way (Missing Shut-off Valves). Recommend a qualified plumber evaluate and properly fit and install pipes.

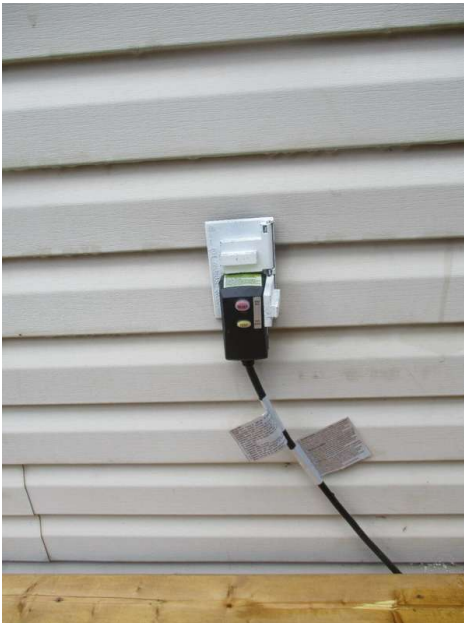
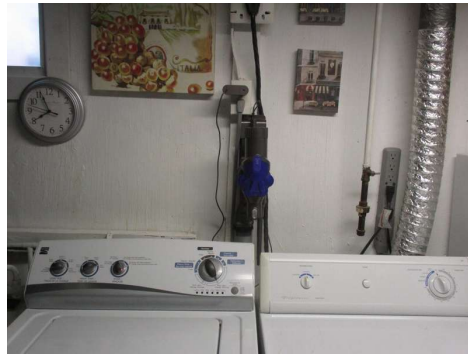
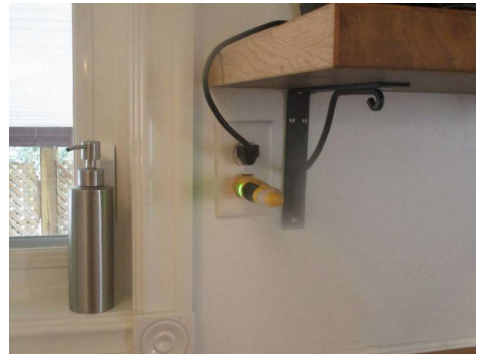
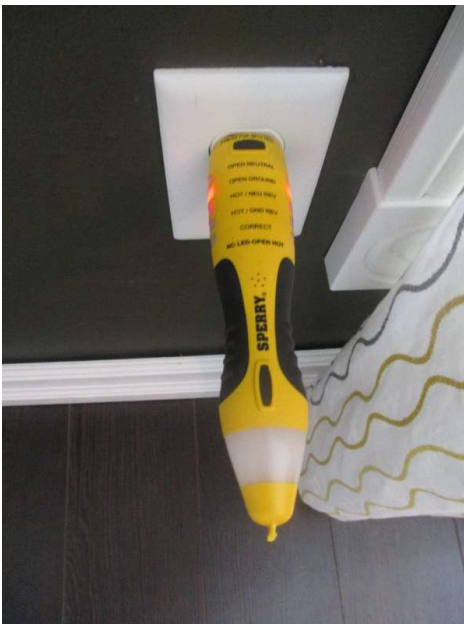
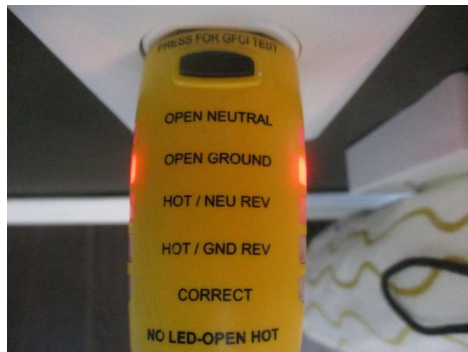
No GFCI protection present in all locations. One or more receptacles are ungrounded. To eliminate safety hazards, all receptacles in kitchen, bathrooms, garage & exterior should be grounded. Recommend licensed electrician upgrade by installing ground fault receptacles in all locations.

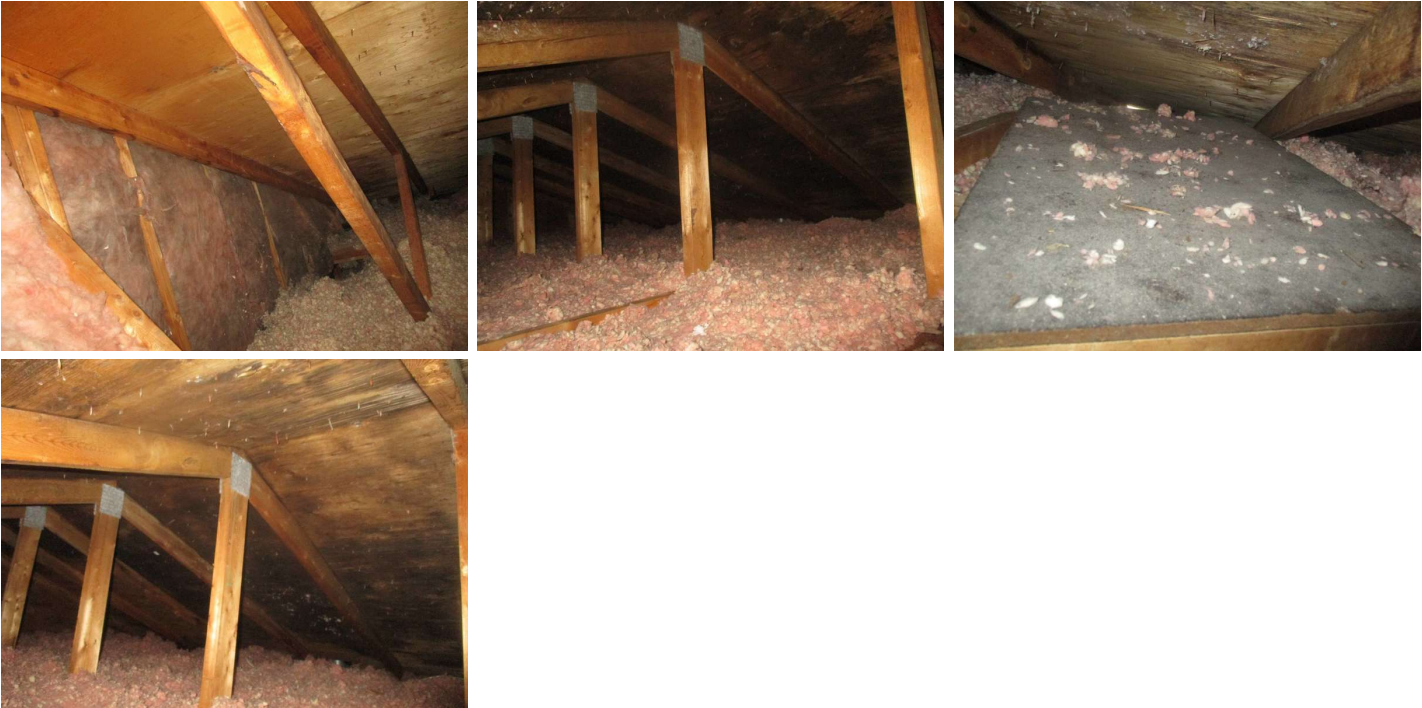
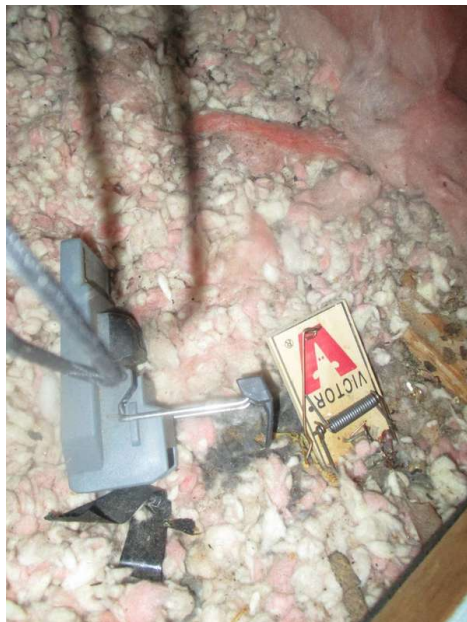
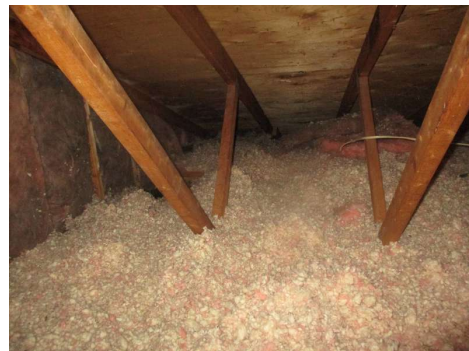
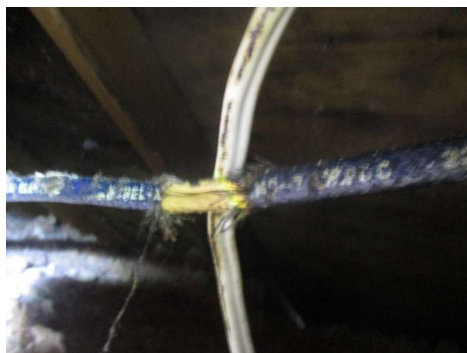
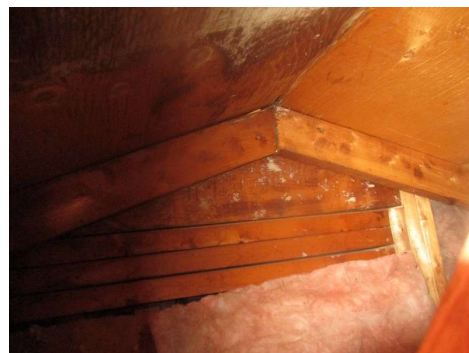
DAMAGED/INSUFFICIENT INSULATION

Insulation appears to have been pulled out and/or damaged by pests. Insulation depth was inadequate. Recommend a qualified attic insulation contractor install additional insulation and evaluate and repair.

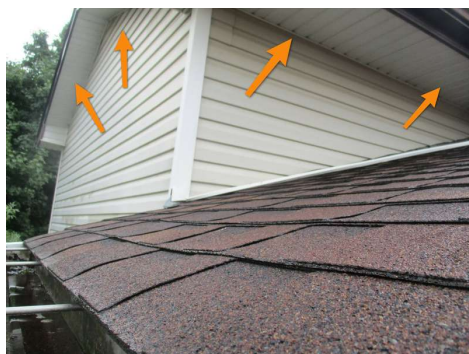
9.3.1 Ventilation

ATTIC VENTILATION INSUFFICIENT

Attic venting was insufficient at time of inspection. Modern standards recommend 1.5 square feet of venting area for every 300 square feet of attic floor space. Recommend an attic contractor evaluate and remedy.

Recommend Soffit Venting

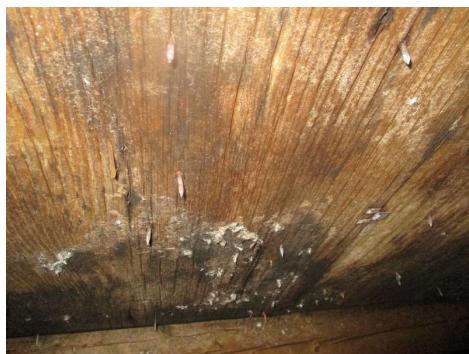
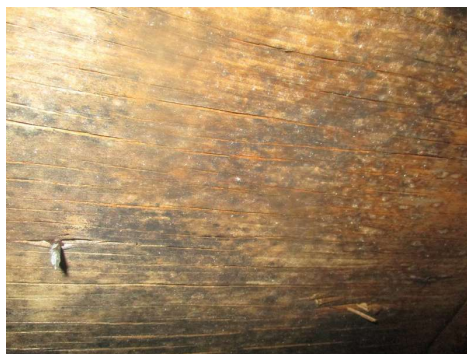
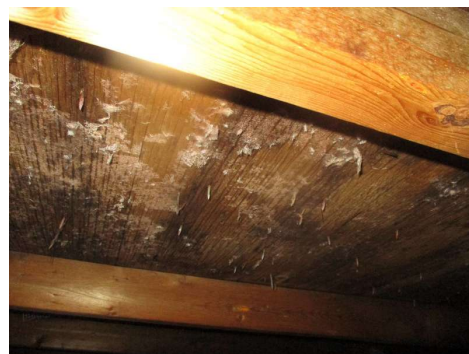
9.3.2 Ventilation

DISCOLORATION - POSSIBLE MOLD

Attic showed areas of discoloration and possible mold growth. Recommend a mold lab analysis to prevent spread of potential mold and damage to home or health risk. I also recommend finding source of moisture or lack of ventilation in attic space.
