THE SALLADE'S INSPECTION SERVICES

YOU'RE HOME INSPECTION

4087 Farm to Market Rd 730 N
Decatur, TX 76234

PROPERTY INSPECTION REPORT FORM

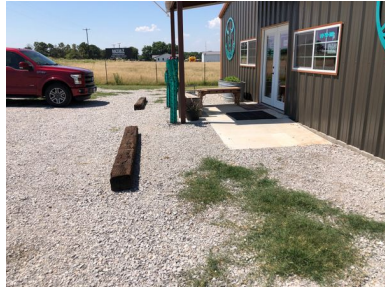
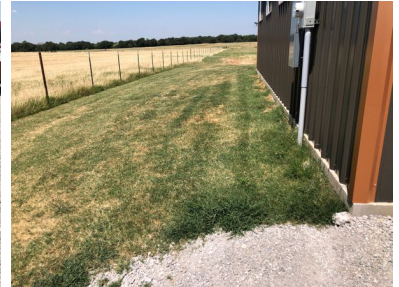
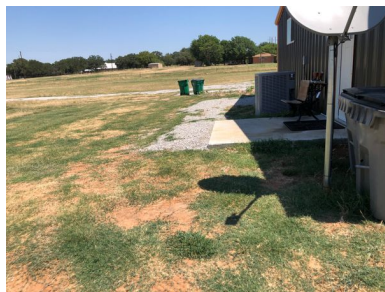
- This property appears to have adequate drainage. No corrective action is recommended at the time of this inspection.

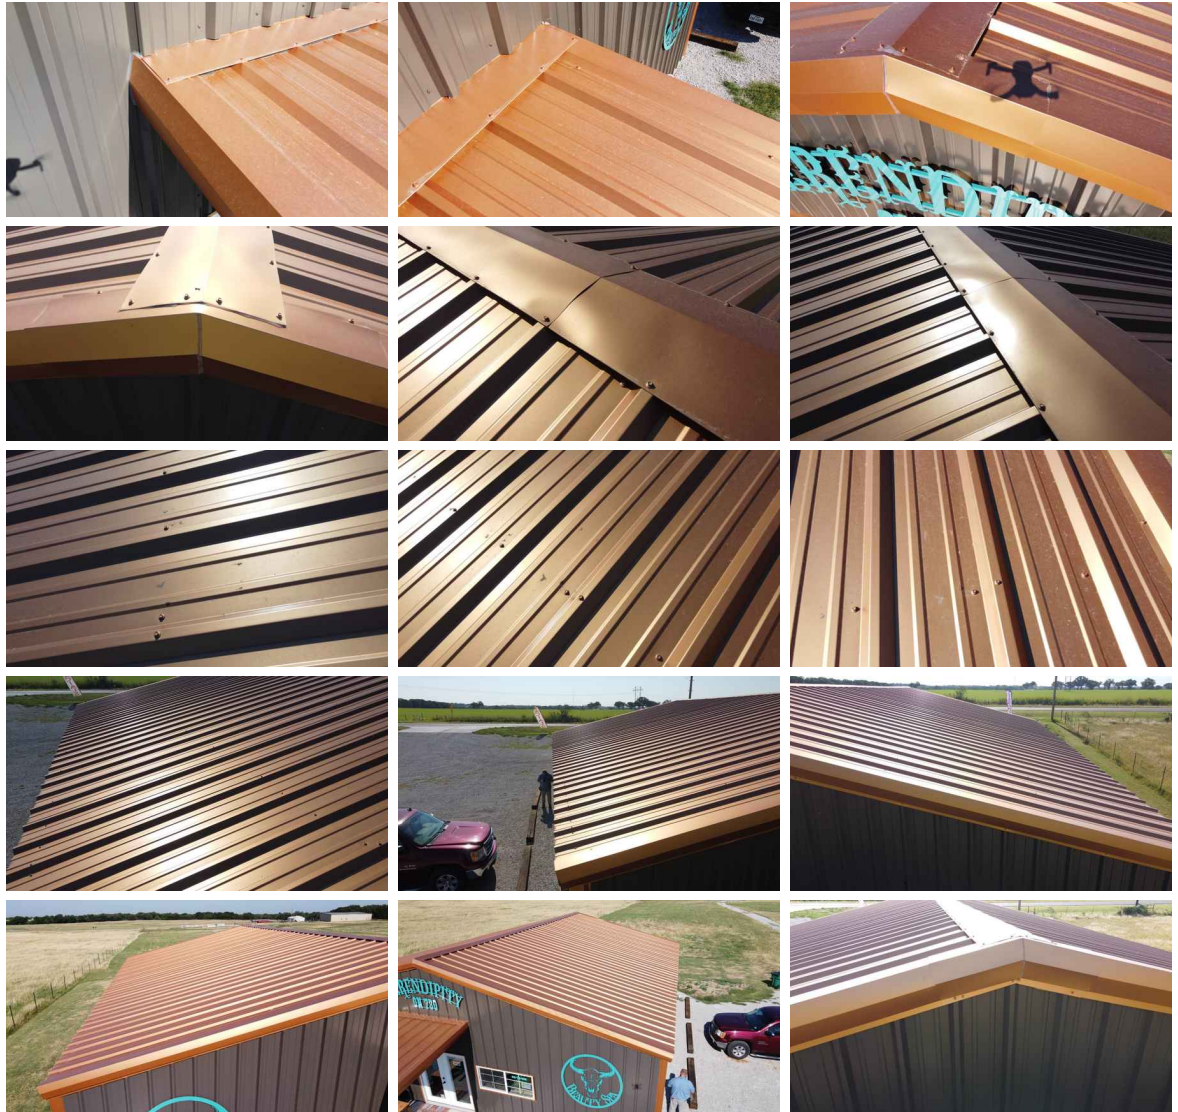
- The roof was inspected and appeared to be in satisfactory condition at the time of this inspection.

- Pictures of the roof covering for reference.

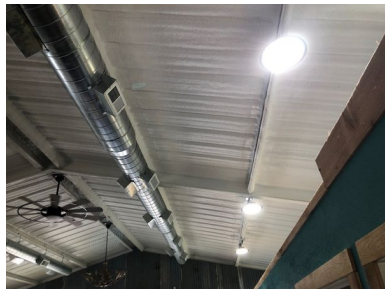
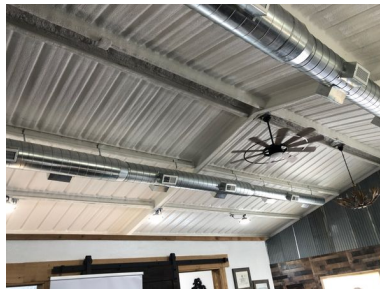
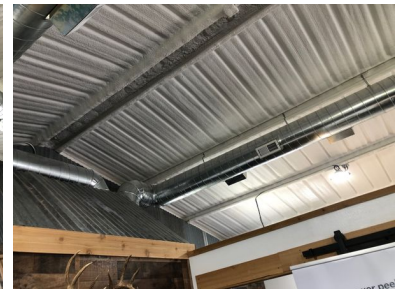
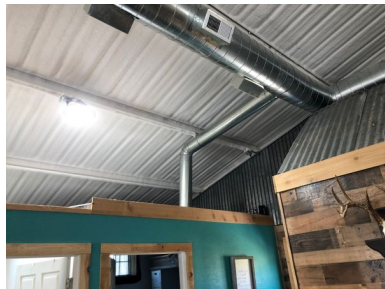
- The roof structural components appeared to be in satisfactory condition at the time of this inspection. No corrective actions are recommended at this time.

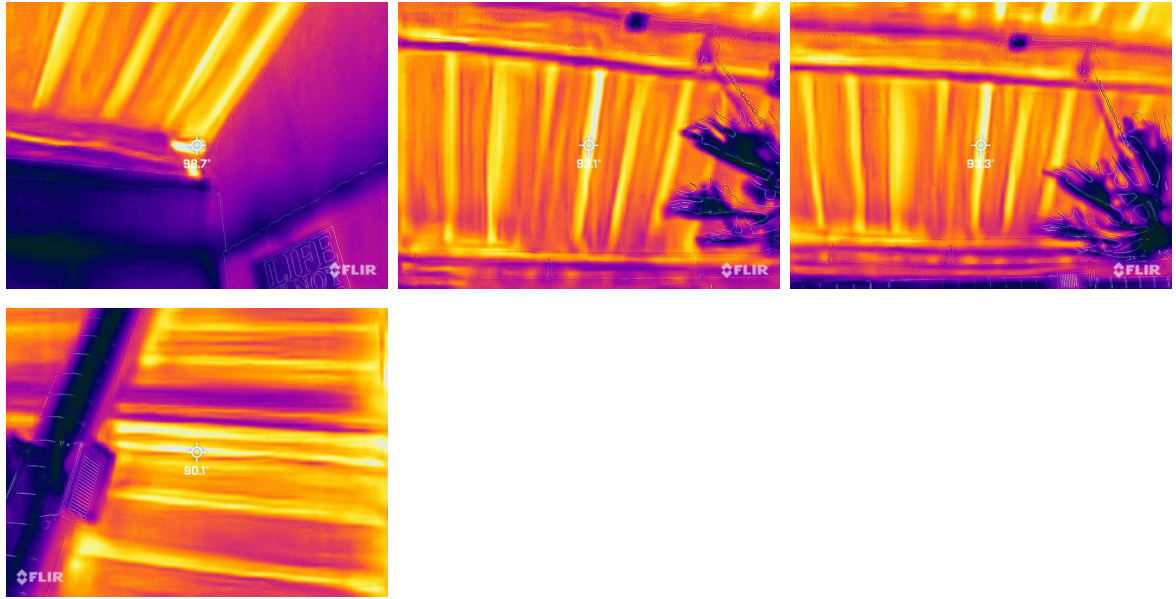
The underside of the roof and rafter insulation was checked with an infrared camera at the time of inspection. The temperature readings indicate that the thickeners level installed may not be adequate. Also the temperature the thermostat was set to was never met by the HVAC system. An insulation contractor should be consulted to see what options are available to correct this condition.

Recommendation: Contact a qualified insulation contractor.

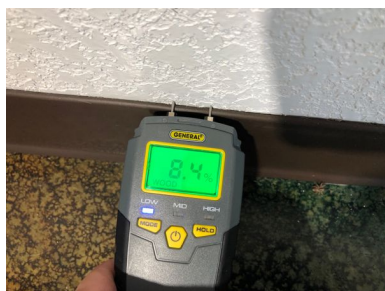
The windows exterior doors and other penetrations were tested by the garden hose. (Not a pressure washer) Moisture readings were taken before and after the water test of the windows. Elevated moisture readings were observed after the water test of the windows. Water was observed on the floor near the front door, the right side waiting room wall, the back door and the corner of the left rear room. The moisture readings before the water test were within normal ranges. The window flashings and sealants should be redone as necessary to prevent leaks into the building. After repairs are made it is recommended that the windows and doors be water tested again to make sure the repairs have been done adequately.

Moisture readings before water test

Recommendation: Contact a qualified professional.

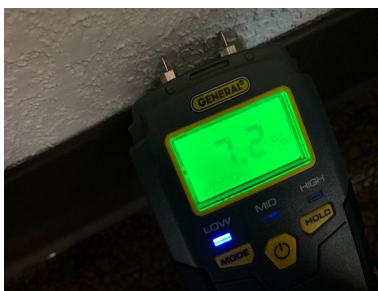
Moisture reading before water test

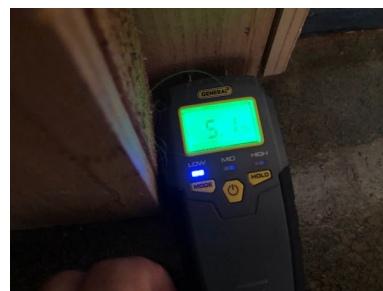
Moisture reading before water test

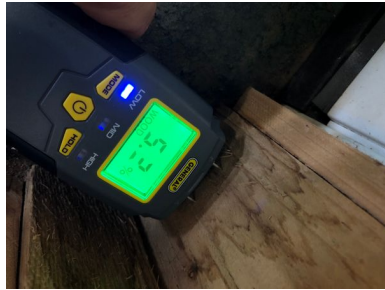
Moisture reading before water test

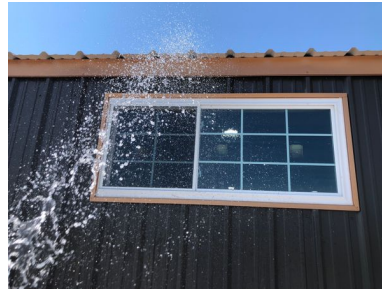
Water test

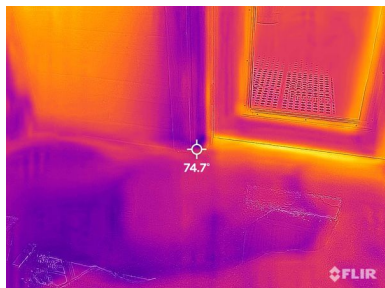
Infrared image of water on the floor

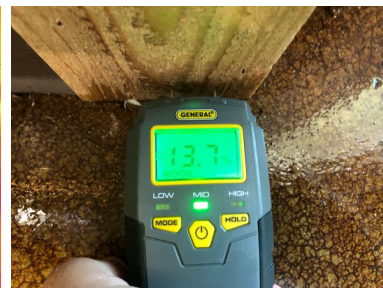
Moisture reading after water test

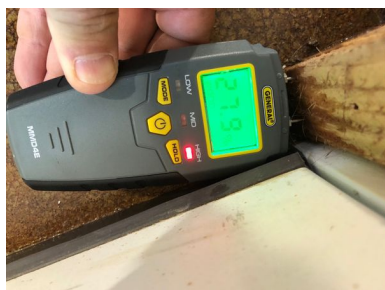
Moisture reading after water test

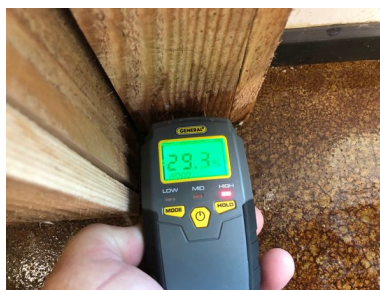
Moisture reading after water test

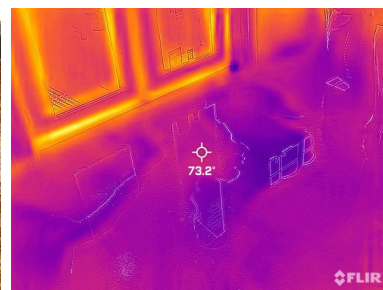
Infrared image of water on floor

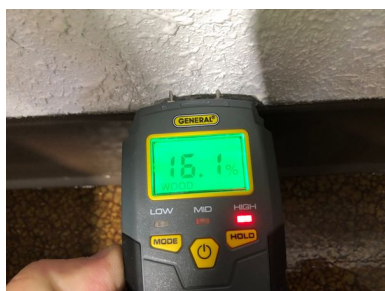
Moisture reading after water test

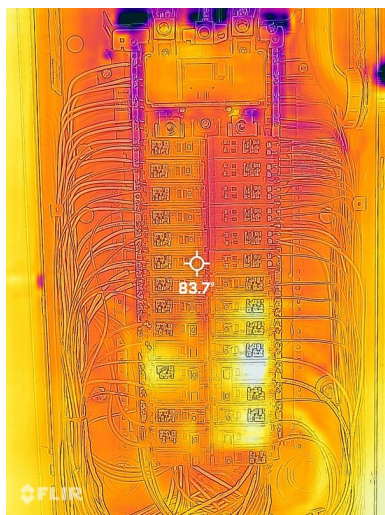
No overheating was found in the panel at the time of this inspection.

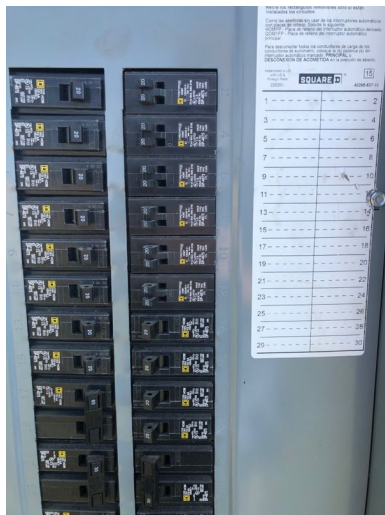
The breakers (over current devices) in the panel box are not all properly labeled. It is recommended that this condition be corrected.

Recommendation: Contact a qualified electrical contractor.

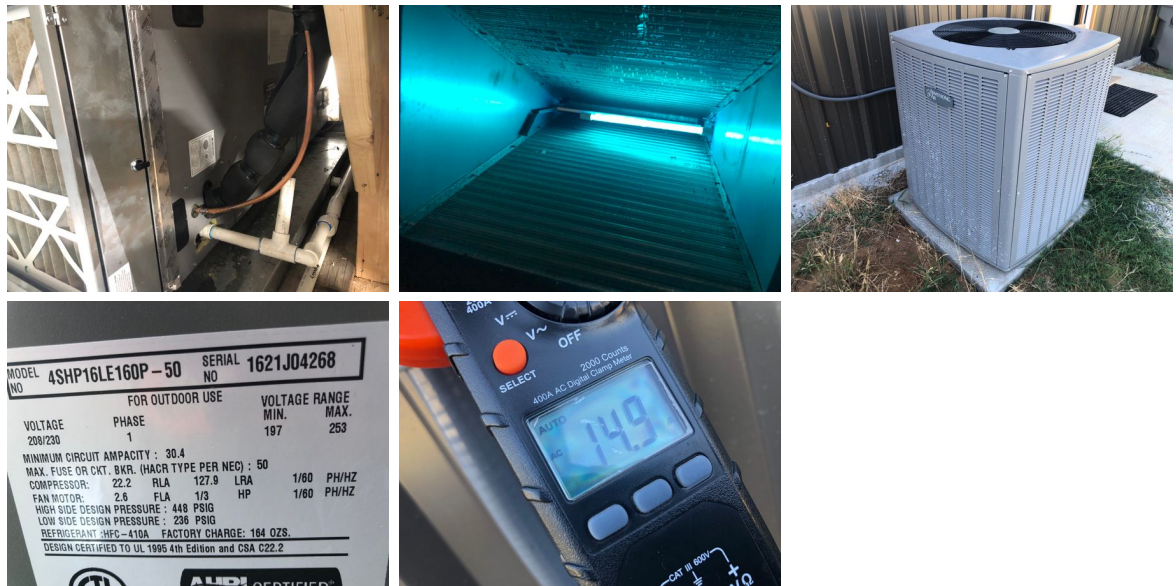
Inside & Outside units : Manufacturers Year, Refrigerant Type, System Size, Temperature Differentials, Recommended Breaker Size, Central Cooling, Armstrong, 2021, 5 TON, R410, 50 AMP -

- Picture of the cooling equipment in the attic/HVAC closet for your reference.
- Picture of the outside condensing unit and manufacturers label for reference.

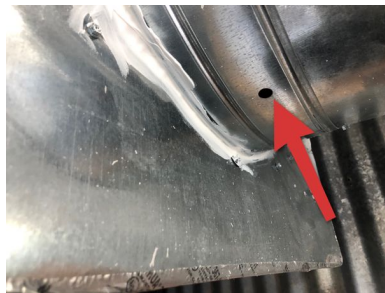
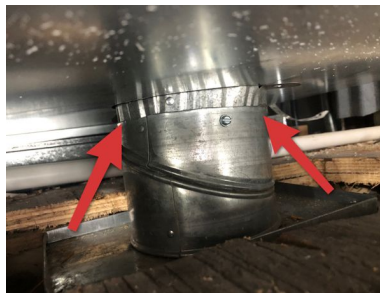
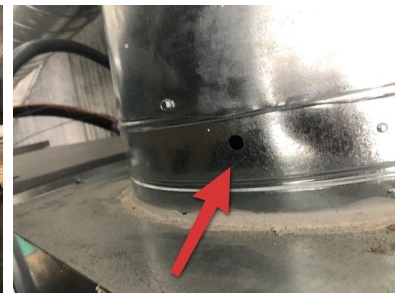
- Air leaks were detected at and around the ductwork connections and or the duct connections to the plenum(s).

Recommendation: Contact a qualified HVAC professional.

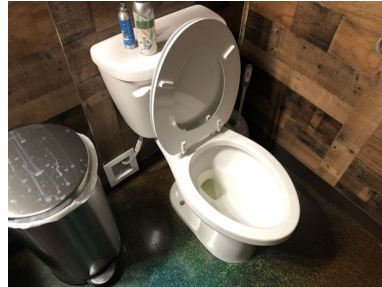
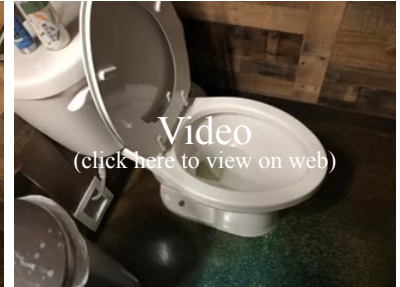
- The commode appears to be excessively loose at the floor mount. This inspector could not confirm if the toilet was loose in the toilet mount flange, or if the toilet mount flange was loose at the floor. Either way, it is recommended replace the wax seal under the toilet connection and properly tighten the toilet to the floor.

Recommendation: Contact a qualified plumbing contractor.

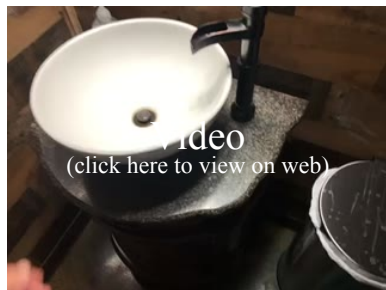
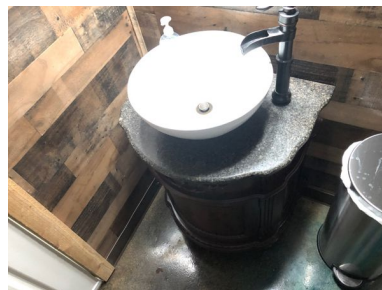
The sink cabinet was loose from its wall Mount and should be resecured.

Recommendation: Contact a qualified professional.

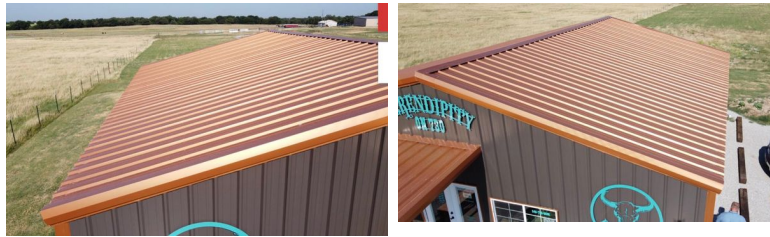
There was observed to be no visible drain waste vent penetrations. There is a bathroom at the back of the building so there should be at least one drain waste vent stack through the roof. Without a vent to the exterior it is possible for sewer gasses to build up inside the living spaces of the building. This condition should be corrected by a licensed plumber and a qualified roofer.

Recommendation: Contact a qualified professional.

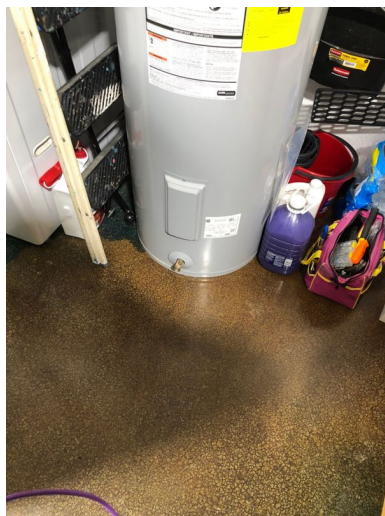
There is no pan installed under the water heater. It is recommended that a licensed plumber install and plumb an emergency drain pan. The pan should be plumbed to drain to the exterior.

Recommendation: Contact a qualified plumbing contractor.

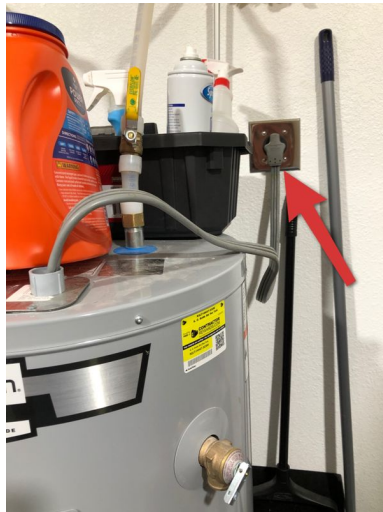
Water heaters are required to be permanently wired with a disconnect within six feet. A pig tail type power cord is no longer acceptable.

Recommendation: Contact a qualified electrical contractor.

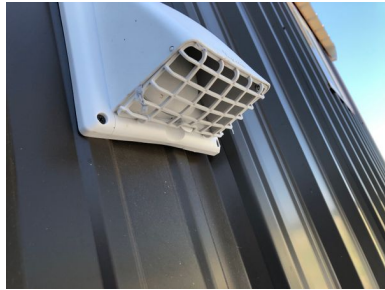
- The dryer duct termination was observed to be screened. Screening the termination is not permitted under current installation standards. Screens can trap lint and create a fire hazard.

Recommendation: Contact a qualified professional.
