## HOME INSPECTION REPORT

123 Dream Home Lane  
Monument CO 80132

JULY 12, 2019

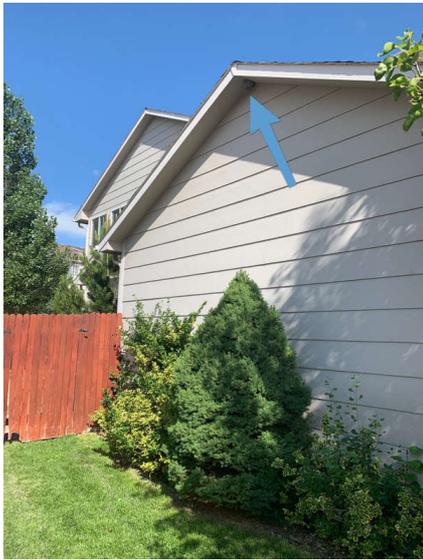
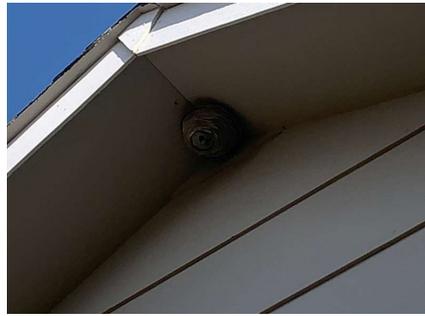
3.6.1 Eaves, Soffits & Fascia

**PEST CONTROL RECOMMENDED**

EXTERIOR NORTH

There is what appears to be an active wasp nest/bee hive on the north gable above the garage. No apparent damage to soffit or eaves. Recommend a qualified pest control company evaluate and remove the nest/hive.

Appears to be a wasp nest.

Recommendation

Contact a qualified professional.

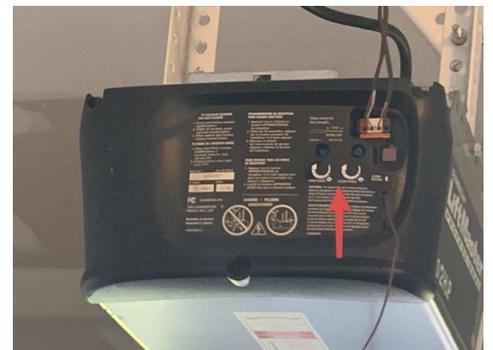
### 7.4.1 Garage Door Opener

**Significant Defect or Safety Hazard**

### PRESSURE TEST FAILED

GARAGE, 2-CAR DOOR OPENER

**\*Saftey\*** Modern automatic garage door openers are installed with a pressure sensitive function which will reverse garage door if an object obstructs the path. Too much pressure is needed to reverse the door which can result in harm to pets or persons. This is a safety hazard to children and pets. Recommend pressure sensitivity be adjusted.

Recommendation

Recommended DIY Project

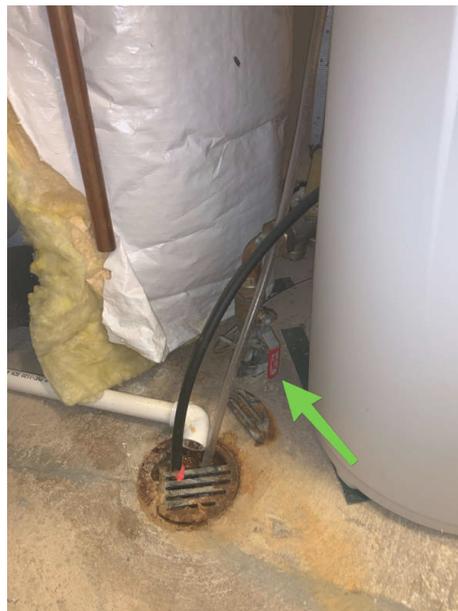
### Main Water Shut-Off Device (Location)

In basement utility room, next to water heater  
Basement

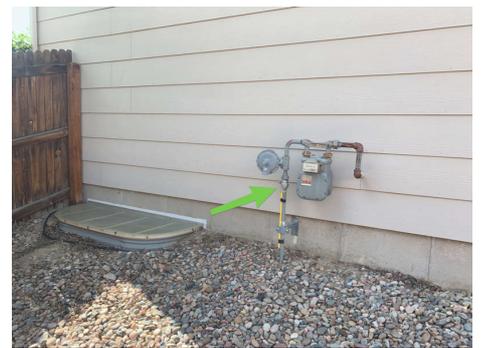
### Main Fuel Shut-Off (Location)

South  
Exterior

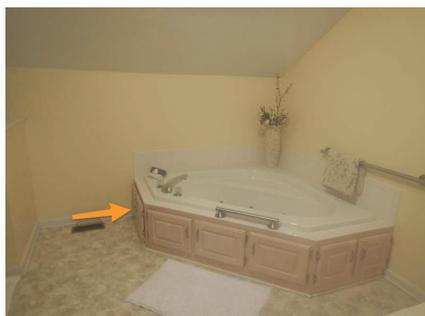
8.1.1 Fixtures / Faucets

Marginal Defect

### WHIRLPOOL TUB LEAKING

MASTER BATHROOM

Whirlpool tub is leaking at one of the pipes in the pipework on the back of the tub, inside cabinet. Moisture stains also visible below on ceiling in garage. Recommend qualified contractor repair leak.

Back side of tub, behind access door

Recommendation

Contact a qualified professional.

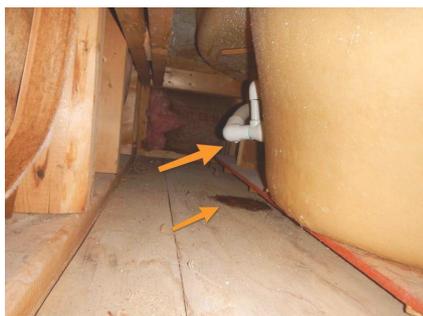
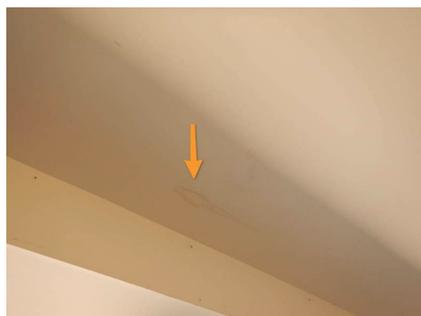
Garage ceiling below master bathroom

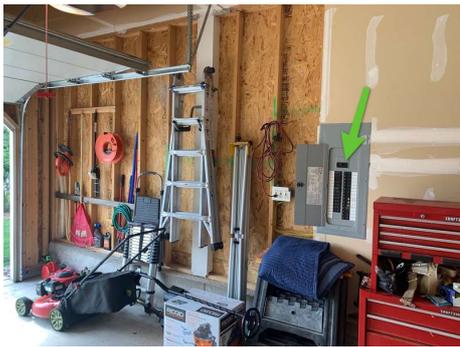
### Main Electrical Shut Off

Garage  
Garage

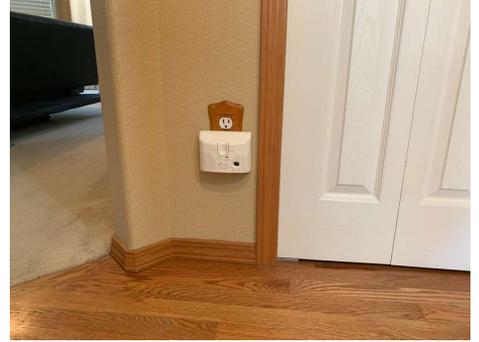
### Carbon Monoxide Detectors: Plug-In CO Detector

Ensure CO Detector remains with home or new one is installed after move in.

1 of 3 plug-in CO Detectors in the home, 1 on each level

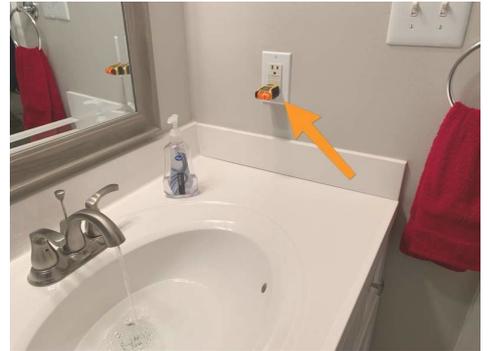
### 9.6.1 GFCI & AFCI

#### GFCI OUTLET(S) WON'T TRIP

##### 2ND FLOOR HALL BATHROOM

One or more Ground Fault Circuit Interrupter (GFCI) outlets won't "trip" when tested. Recommend a licensed electrician evaluate and repair.

— Marginal Defect

Recommendation

Contact a qualified electrical contractor.

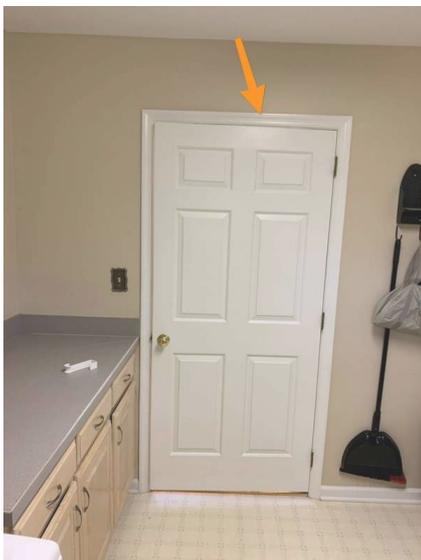
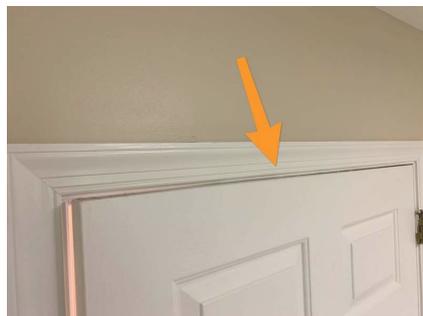
11.6.1 Doors

### DOOR BINDS/STICKS

LAUNDRY ROOM

Marginal Defect

Door binds at the top, unable to fully close the door. Recommend trimming or sanding down top of the door.

[Here is a helpful DIY article](#) on how to fix a sticking door.

Recommendation

Contact a handyman or DIY project
