## HOME INSPECTION REPORT

1837 E Sherman St  
Tacoma WA 98404

Jake & Deanna Velasquez  
OCTOBER 17, 2019

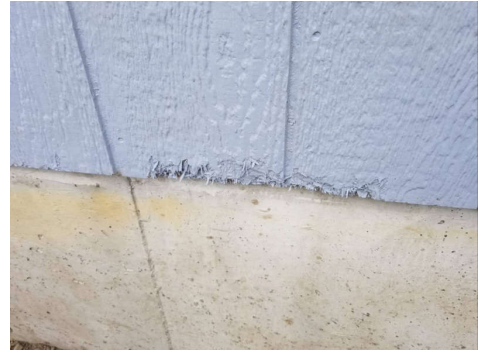
### 3.6.1 Foundation as Viewed from the Exterior

## VERTICAL CRACKS

One or more smaller cracks, within normal tolerances were visible. This type of cracking is often a result of shrinkage of materials and/or minor settlement and usually does not affect the performance of the foundation.

Recommend monitoring.

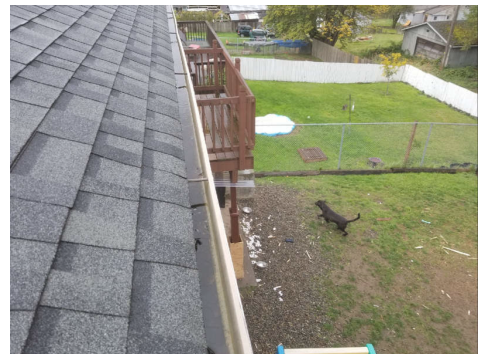
### 4.5.2 Gutters & Drainage

The gutters did not have a proper slope to drain the water towards the downspouts. Recommend repairs to ensure proper drainage.

Contact a qualified professional.

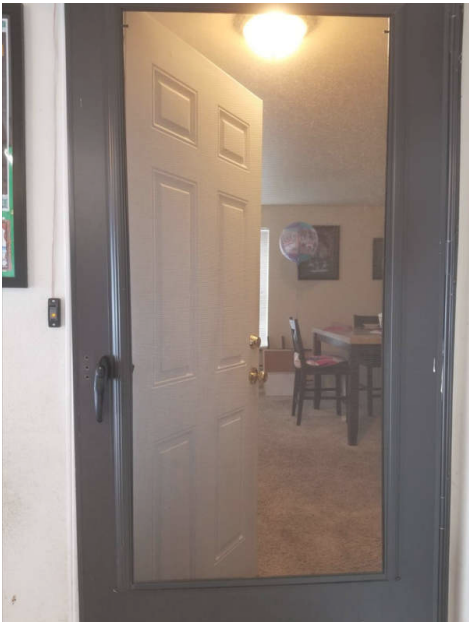
The house garage entry door is functional but does not self-close. This may not have been required when the house was built and you may elect to have self closing hinges installed for modern fire safety.

Recommendation  
Contact a qualified handyman.

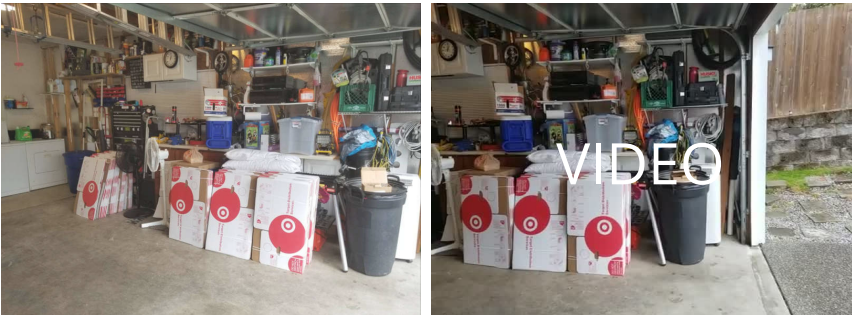
5.5.1 Slab Floor

**FULL OF STORAGE SLAB BLOCKED**

The garage is too full of storage to permit a clear view of the entire slab. I recommend evaluating the floor yourself once the storage is removed.

Recommendation  
Recommended DIY Project

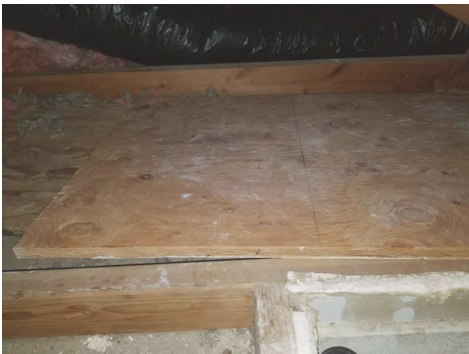
5.7.1 Firewall Separation

**ATTIC ACCESS HATCH NOT FIRE RATED**

The attic access hatch in the garage was not fire rated. We recommend changing for a fire rated approved material.

Recommendation  
Contact a qualified professional.

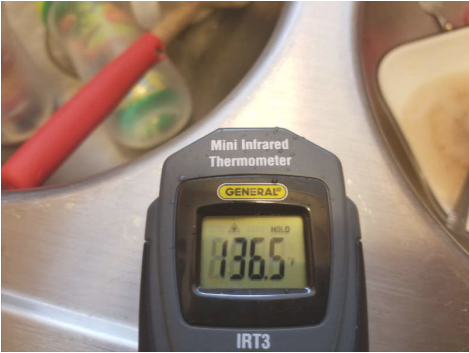
The water temperature is too high and is a potential hazard.  
Recommend water temperature be lowed not to exceed 120 degrees.

Recommendation  
Recommended DIY Project

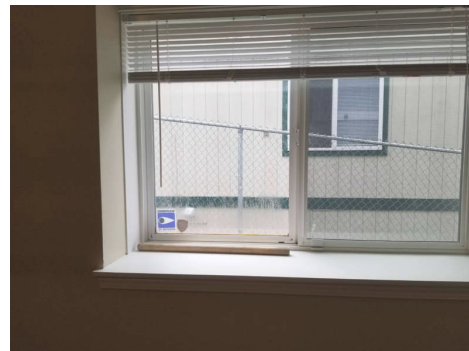
## 13.5.1 Windows

Medium Priority**BROKEN SEALS**

A window(s) has broken hermetic seals, and should be replaced. This is evident from fogging, or condensation forming between the panes of glass, that confirm that the seal has failed. If you are concerned we recommend that you have a professional check out all the windows within the residence.

Contact a qualified window repair/installation contractor.
