## RESIDENTIAL INSPECTION REPORT COPY

Second Sample  
96097

Lori Colombo  
MAY 11, 2019

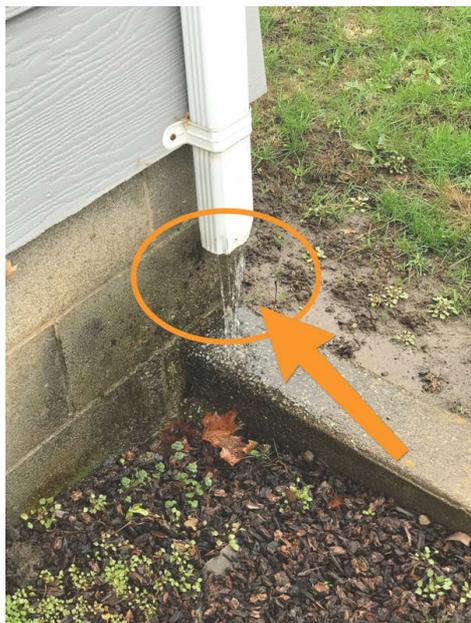
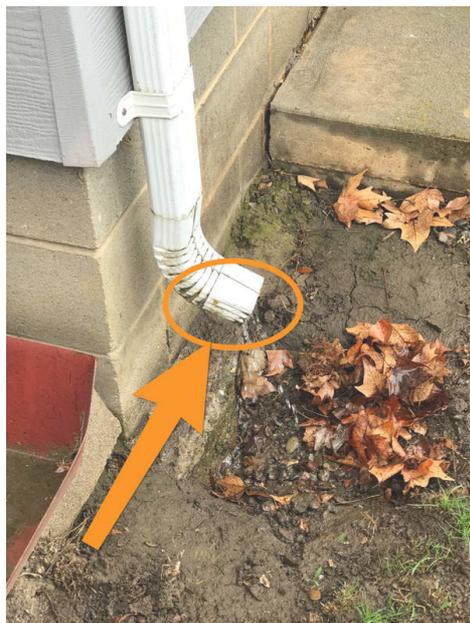
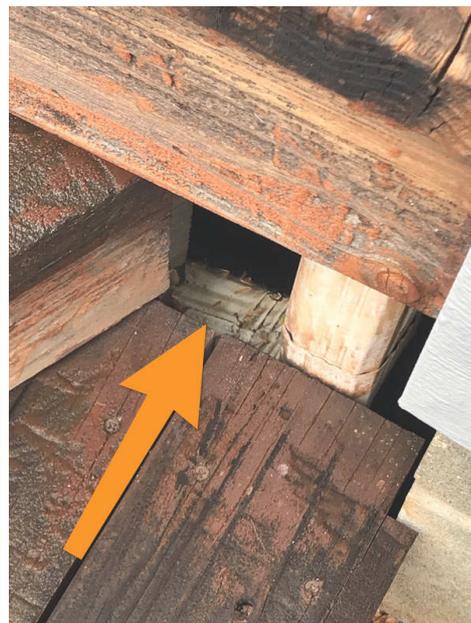
One or more downspouts were observed to terminate (discharge or drain) too close to the foundation. This can result in excessive saturation of the soil around the foundation, which can lead to foundation deterioration, damage and structural movement. Recommend installing downspout extensions to direct water at least four feet from the foundation.

Contact a handyman or DIY project

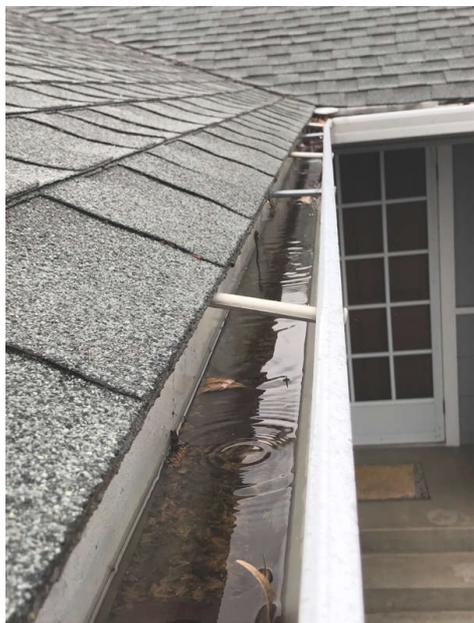
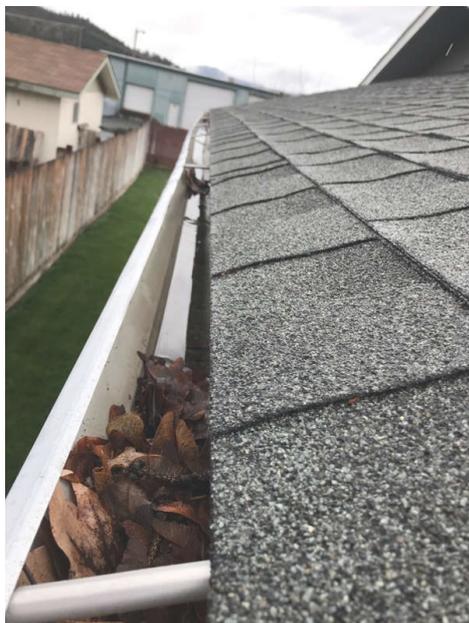
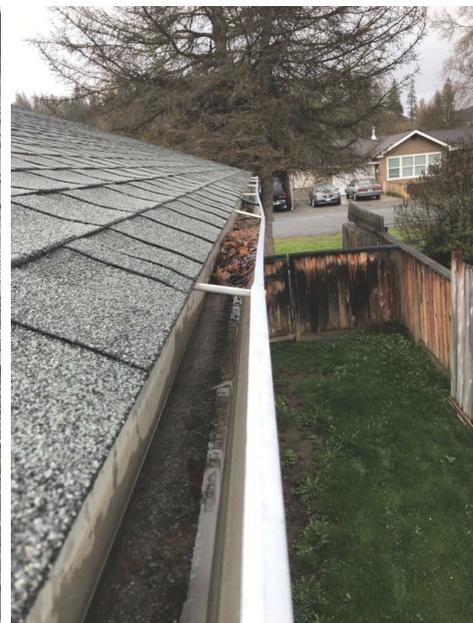
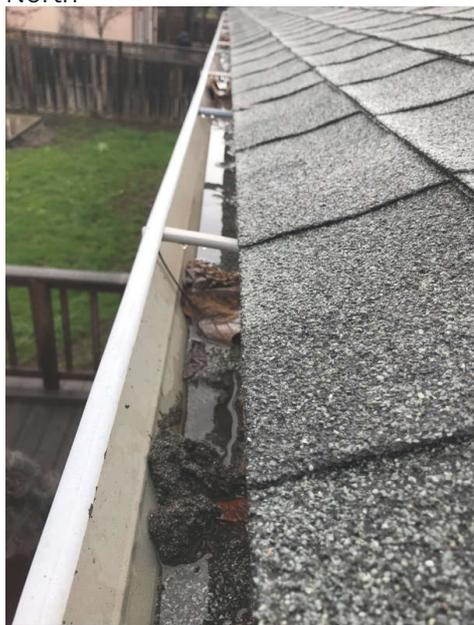
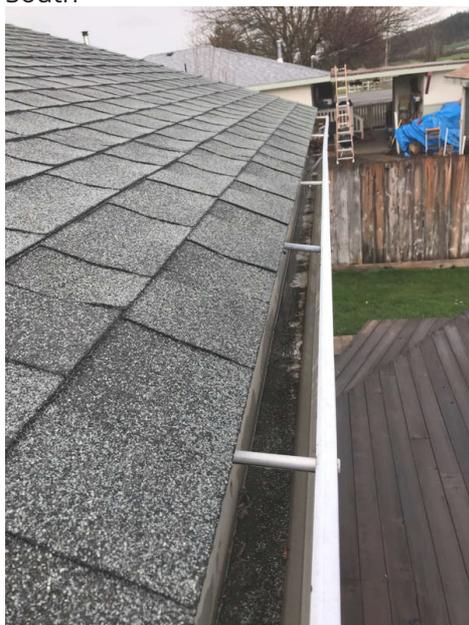
### 2.6.2 Roof Drainage System

Debris was observed to have accumulated in the gutters that has caused to gutters to become plugged. Recommend cleaning all gutters for proper function of rain gutter system.

Contact a handyman or DIY project

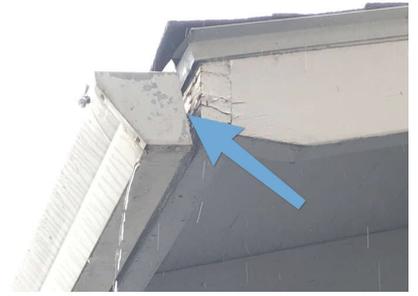
### 2.6.3 Roof Drainage System

#### **GUTTER LOOSE**

One or more areas of the rain gutter and/or downspouts were observed to have loose or missing fasteners, allowing the gutter or downspout to pull away from the house, and therefore not catching rain water runoff. Recommend repair.

Contact a handyman or DIY project

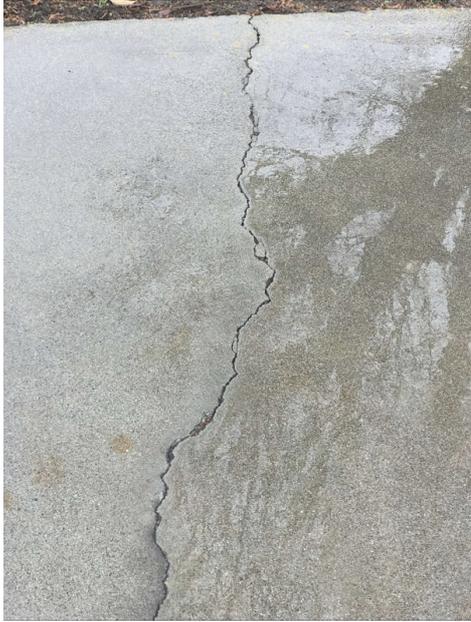
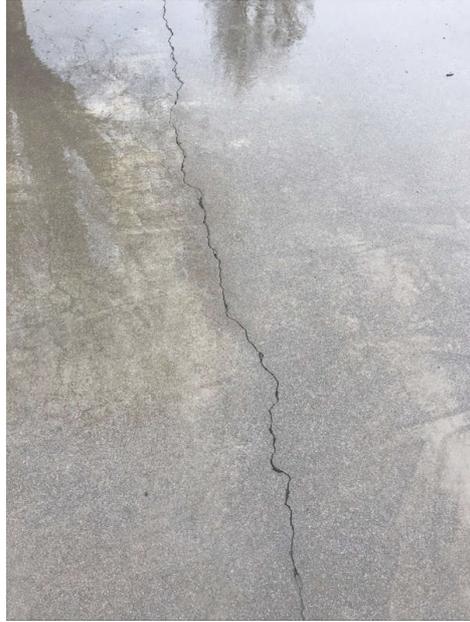
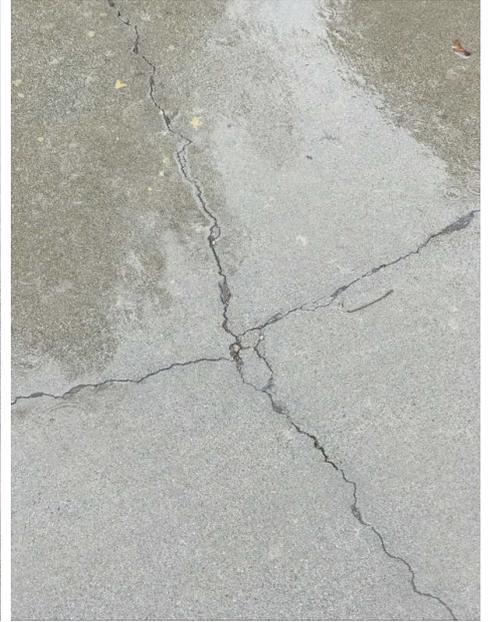
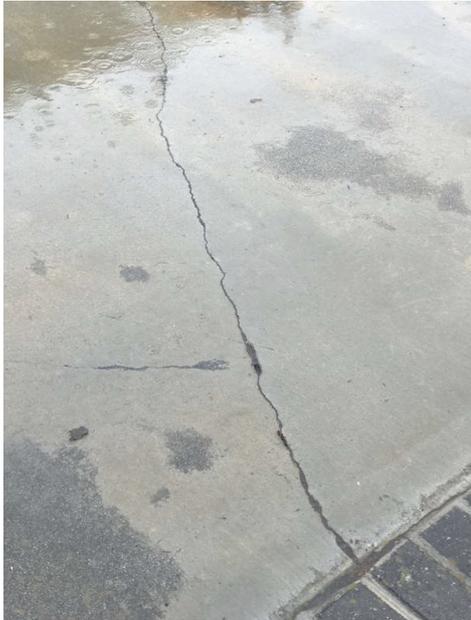
**SETTLING CRACKS**

Damage to cement was observed, that appeared to be caused by settling. This does not impact the house foundation and the slab appeared to be serviceable; however, the concrete was observed to have full width cracks with or without displacement. This could be caused by the method of preparation of the ground under the concrete, construction methods of the slab, the presence of moisture in the soil and the freeze/thaw cycle, tree roots, age, and other reasons. These cracks can be repaired and repair is recommended to extend service life and help arrest current damage.

Contact a handyman or DIY project

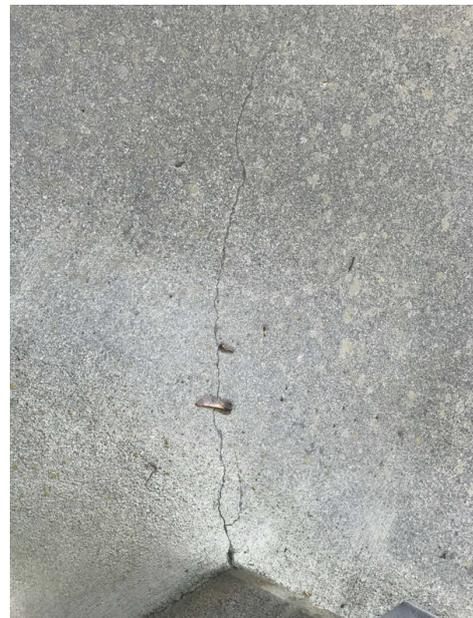
3.4.1 Walkways

**CEMENT CRACKS**

Cement cracks were observed that are likely from normal concrete shrinkage, or some settling. These do not impact the foundation, nor do they represent failure of the concrete. Shrinkage and minor settling cracks causes the cement to become vulnerable to further deterioration when water penetrates and the freeze/thaw cycle starts to damage the concrete. Sealing cracks with the proper sealant can help prevent weathering deterioration at these cracks and prolong service life. Also, using a cement stain, or paint will help prevent spalling. Otherwise, monitor for further, or widening of the cracks and repair as necessary.

Contact a handyman or DIY project

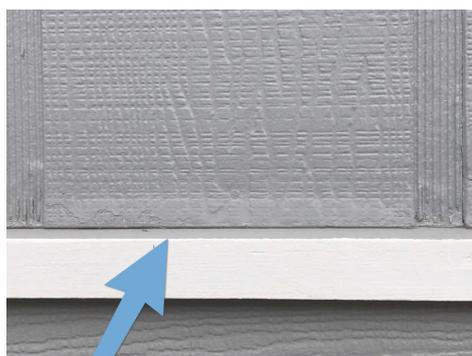
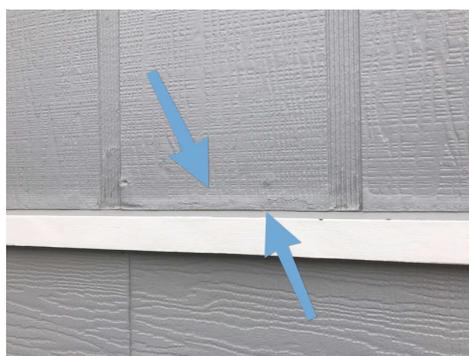
### 3.6.1 Siding

Evidence of water penetration was observed in one or more areas. This is typically evidenced as swelling, deterioration, or delaminating of the siding material, and if applicable, with moisture readings. When siding is saturated, the house sheathing behind the siding, and sometimes the wall framing can be adversely affected. This can happen for a number of reasons such as missing flashing, missing paint or seal, mechanical damage, etc. Recommend repair.

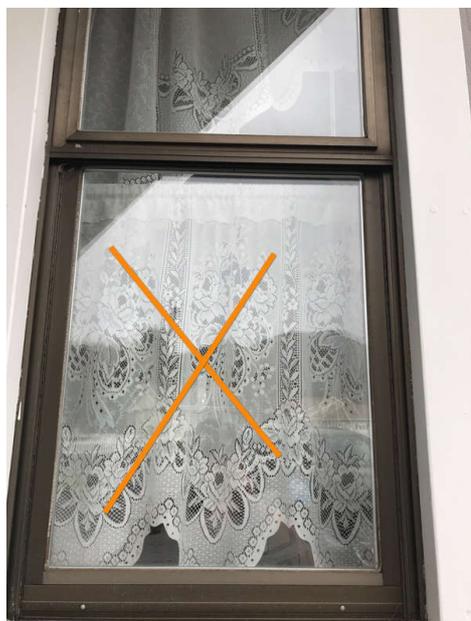
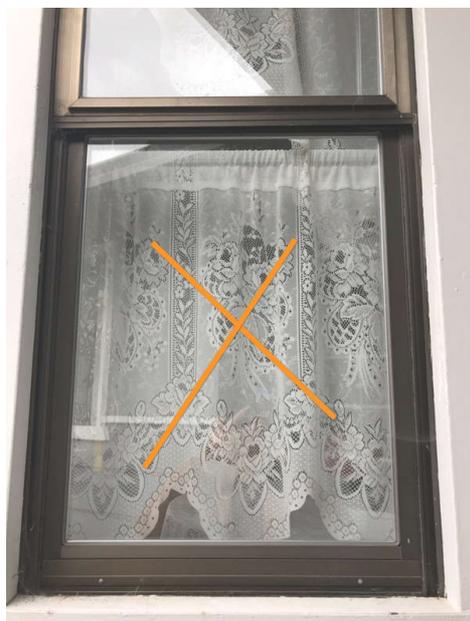
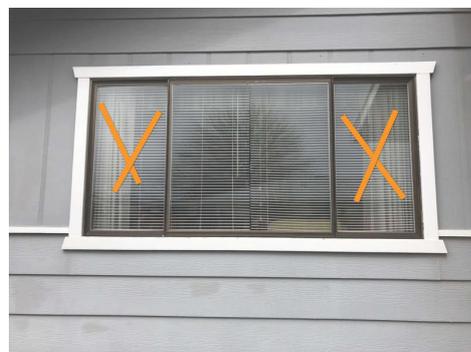
### 3.9.1 Windows

One or more screens were observed to be missing or damaged. Recommend repair or replacement.

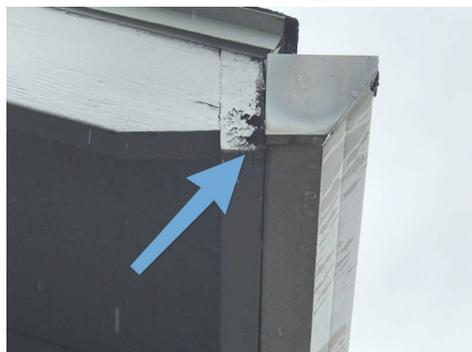
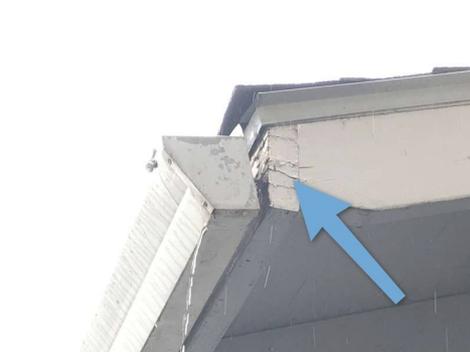
3.11.1 Fascia

**MOISTURE DAMAGE**

One or more sections of the fascia were observed to have moisture damage with areas of wood rot (dry rot) conditions. Fascia board functions as more than just an aesthetic accoutrement to the house. Fascia serves to keep water away from the rafter tails and prevents or discourages water damage. Recommend repair.

Dry Rot: Wood rot/dry rot is caused by biological fungal organisms that require a certain amount of moisture to thrive. The fungus digests the parts of the wood that give the wood strength and stiffness. Scraping/painting only will not stop dry rot from continuing to infiltrate the wood and compromise its integrity.

Treating and preventing dry rot is a three-step process. Step 1 is to locate and stop the source of the moisture. Step 2 is to remove and replace any damaged wood that has become structurally weakened. Step 3 is to treat new and existing wood with borate wood preservative to prevent growth of the dry rot fungus and kill any fungus already in the wood.

Contact a qualified carpenter.

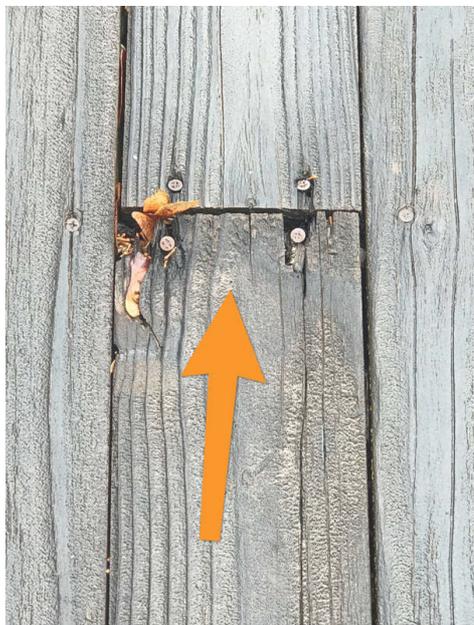
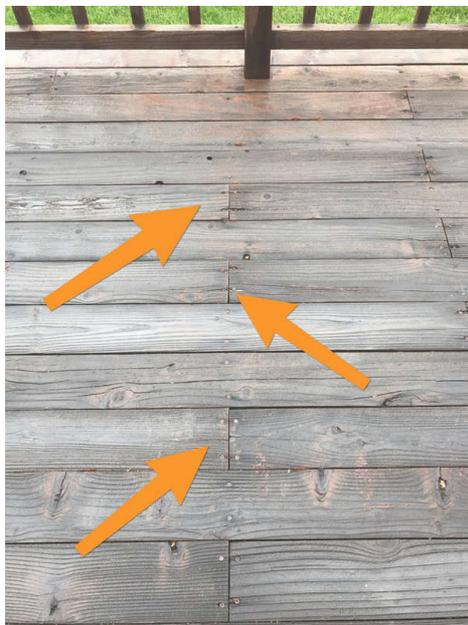
3.12.1 Deck

**MOISTURE DAMAGE - DECK BOARDS**

One or more deck boards and/or structural members were observed to be moisture damaged with dry rot conditions. Recommend repair or replacement, as necessary.

Contact a qualified deck contractor.

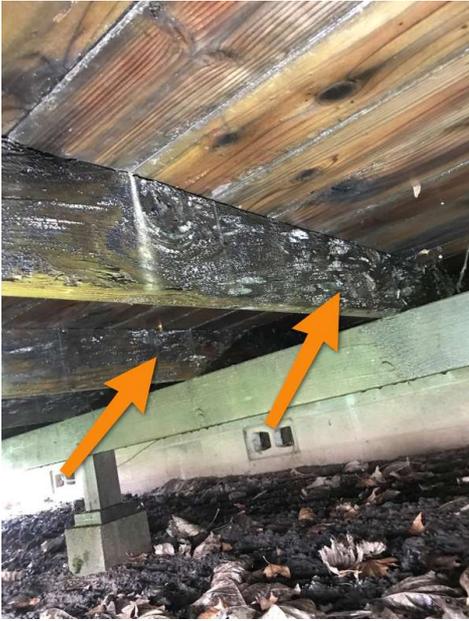
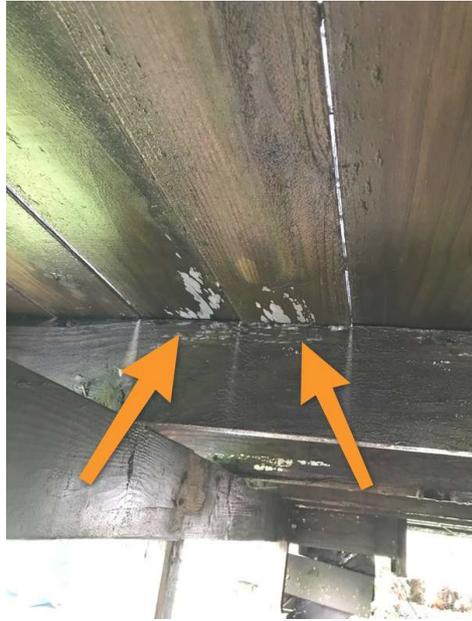
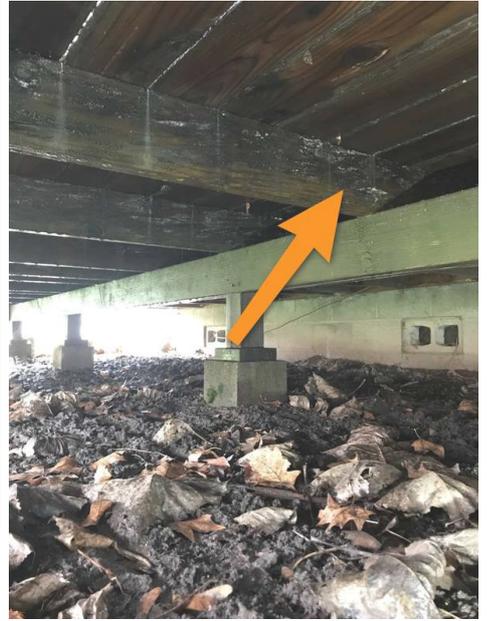
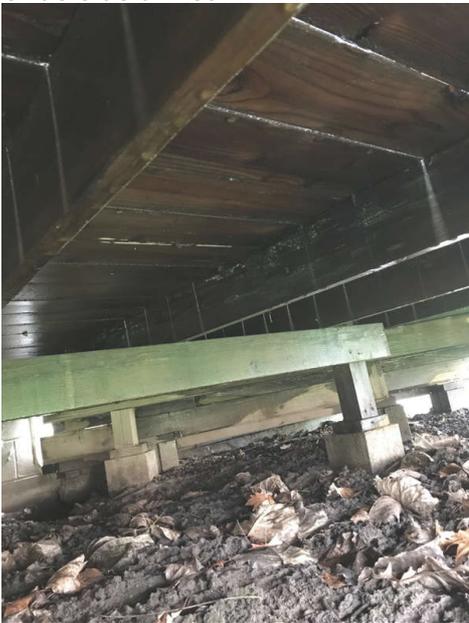
3.12.2 Deck

**MOISTURE DAMAGE - STRUCTURAL**

One or more deck structural members were observed to be moisture damaged with dry rot, or other wood destroying organisms noted. Recommend repair, or replacement as appropriate.

Contact a qualified deck contractor.

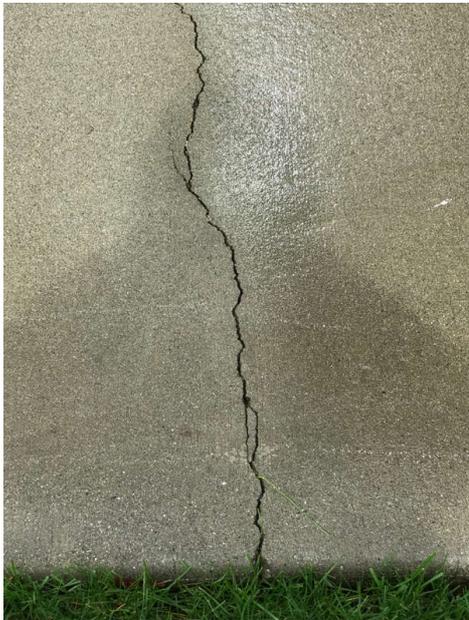
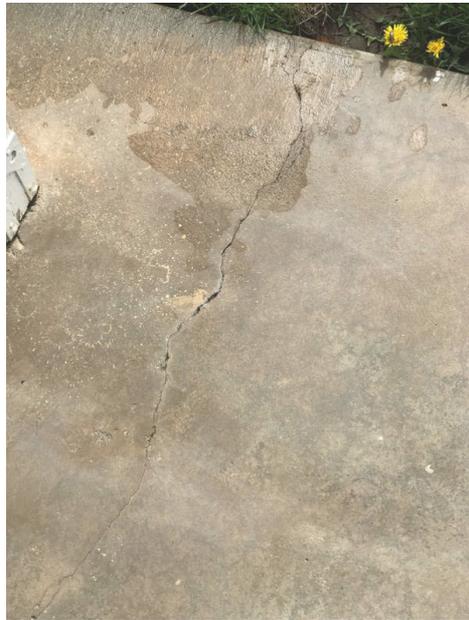
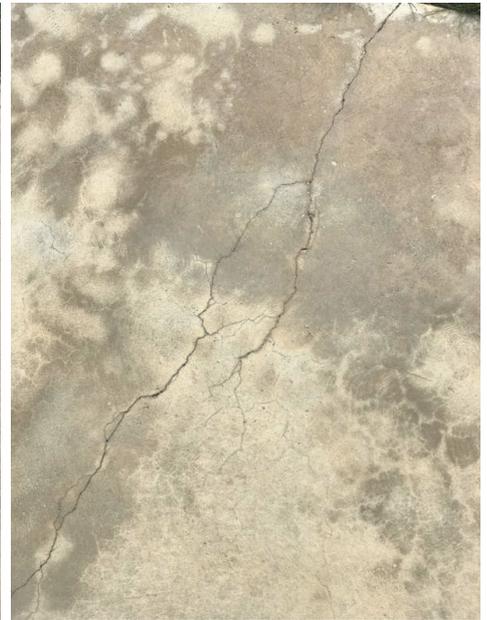
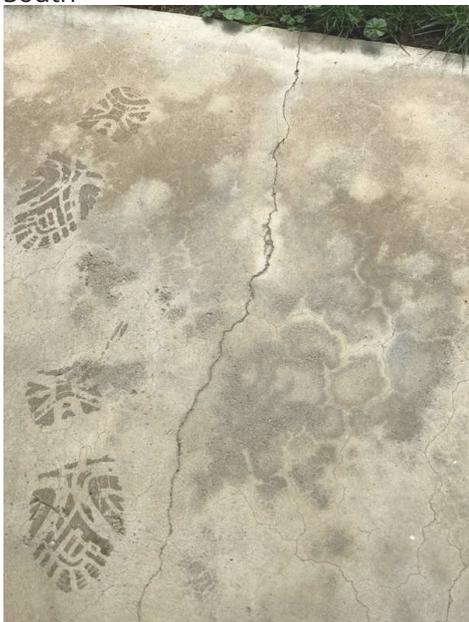
3.14.1 Patio

**SETTLING CRACKS**

Damage to cement was observed, that appeared to be caused by settling. This does not impact the house foundation and the slab appeared to be serviceable; however, the concrete was observed to have full width cracks with or without displacement. This could be caused by the method of preparation of the ground under the concrete, construction methods of the slab, the presence of moisture in the soil and the freeze/thaw cycle, tree roots, age, and other reasons. These cracks can be repaired and repair is recommended to extend service life and help arrest current damage.

Contact a handyman or DIY project

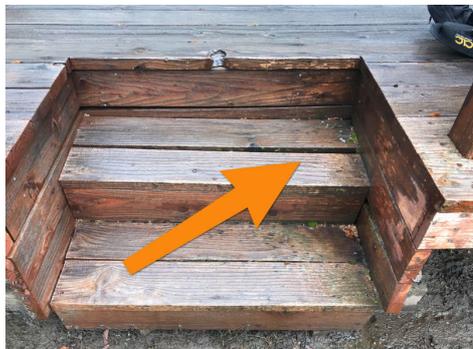
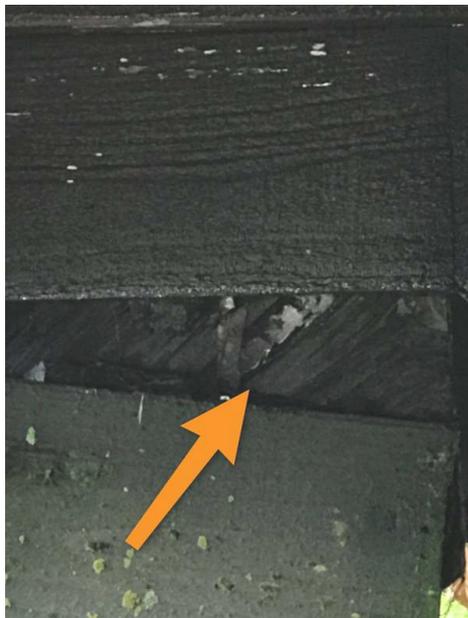
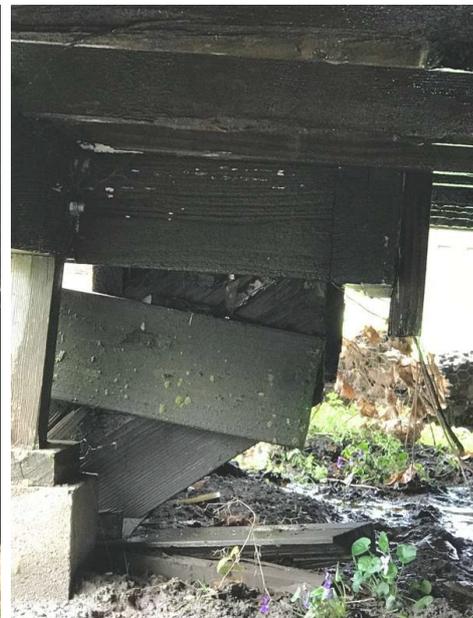
3.15.1 Stairways, Steps, Stoops, & Ramps

**MOISTURE DAMAGED OR DETERIORATED**

One or more sections of the exterior stairs was observed to be moisture damaged or deteriorated, with evidence of dry rot. Recommend repair.

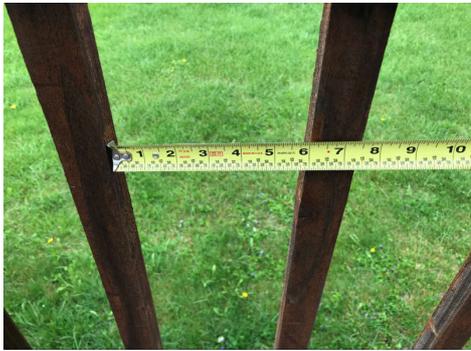
3.16.1 Railing & Handrails

The balusters of the railing and/or handrails were observed to be over-spaced for safety. Requirements vary among states and municipalities; however, the Uniform Building Code states that the balusters cannot be spaced more than 4 inches apart. This spacing is to prevent young children from squeezing between them and falling from the stairway, or getting their heads stuck between balusters. This can also be a pet safety concern for some. Consider modification to ensure safety.

Contact a qualified carpenter.

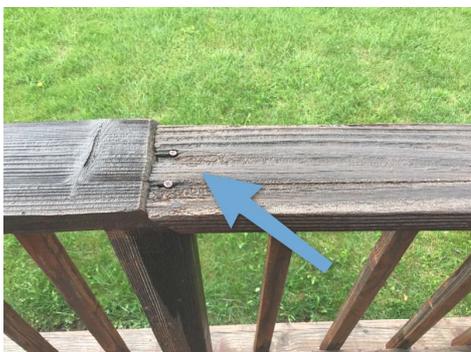
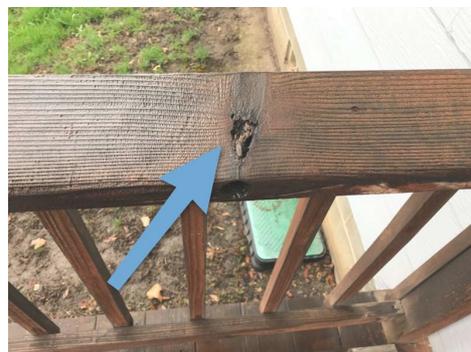
3.16.2 Railing & Handrails

**MOISTURE DAMAGE**

Evidence of some moisture damaged areas were observed in the railings and/or guardrails. These areas may be categorized as either a maintenance item or a deficiency, depending upon location and extent of damage. Recommend repair to maintain structural integrity, safety, and arrest damage.

Contact a qualified carpenter.

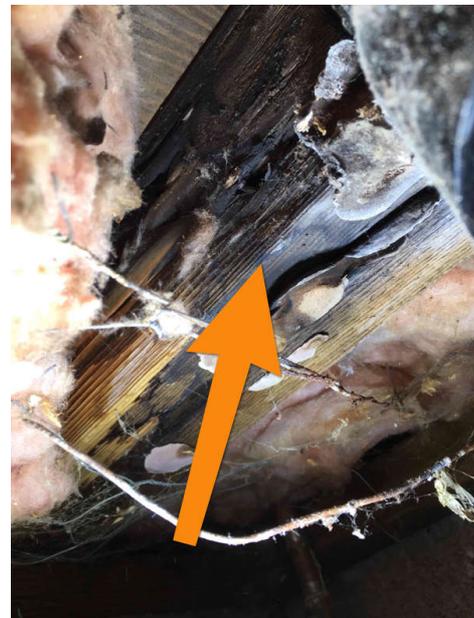
Crawlspace - Half Bath

- 3. There was small amount of moisture damage (dry rot) present in the floor structure under the half bath. This appeared to be from a past toilet fixture leak. Conditions were dry at the time of inspection.**

### MOISTURE DAMAGE

Contact a qualified professional.

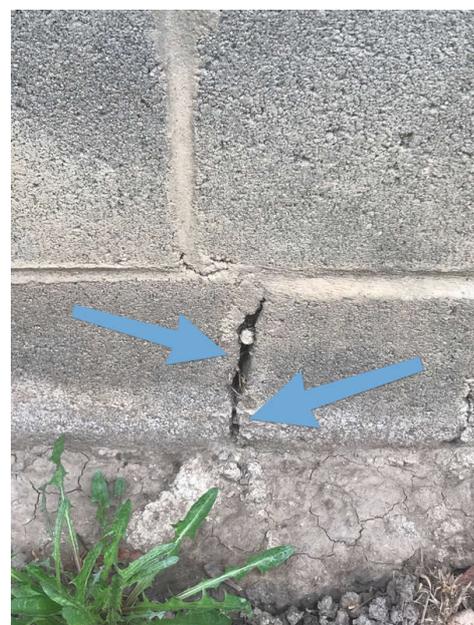
4.5.1 Foundation - Crawlspace & Exterior

**MASONRY BLOCK STRESS CRACKS**

MASONRY BLOCK FOUNDATION CRACK TYPES:

- Horizontal Cracks: Horizontal cracks in your block foundation mean that there is pressure being put on the walls from the outside of the foundation. Pressure can come from water around your foundation. This hydrostatic pressure is a serious sign that your block foundation walls are under strain.
- Vertical Cracks: Vertical block foundation cracks are a sure sign of foundation settlement or heaving. These cracks form slowly but will widen over time due to pressure. If left untreated, they could allow water to enter the building.
- Stair Step Cracks: Sometimes, when settlement or sinking occurs with your foundation, it doesn't occur evenly. This causes stair step cracks in your block foundation.

Contact a foundation contractor.

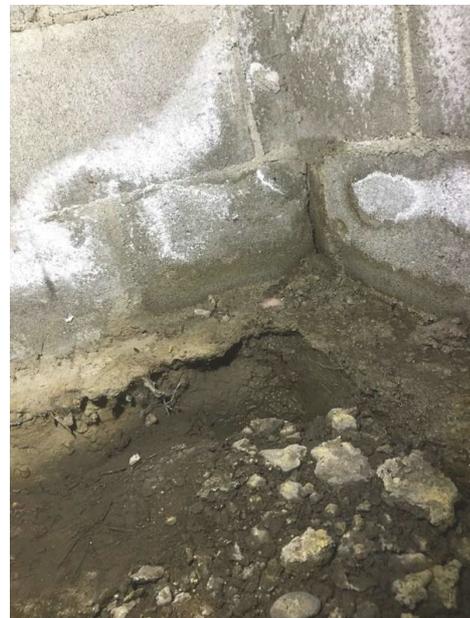
4.5.2 Foundation - Crawlspace & Exterior

- 4. The crawlspace was observed to have wet conditions at the Northeast corner where a downspout is discharging at the foundation. This condition may cause damage to the foundation over time. Recommend extending all downspouts away from the foundation and ensure all water drains away.**

Crawlspace - Northeast

Contact a qualified professional.
