SAMPLE HOME INSPECTION REPORT

Row Home Rd.
Hanover MD 21076

Sally Sample
AUGUST 12, 2018

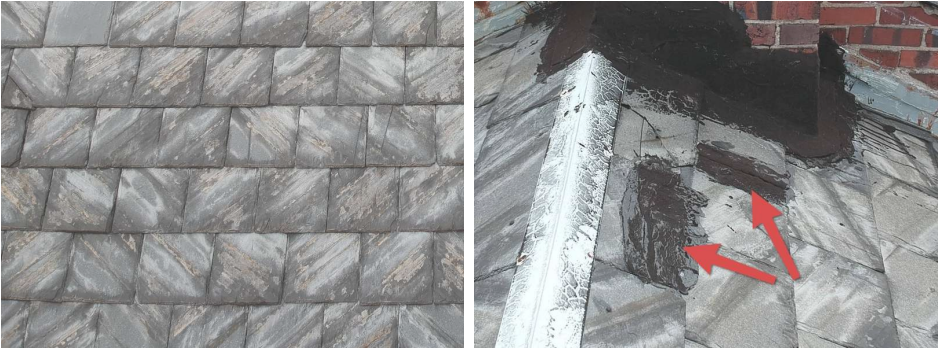
Roof covering material included slate. Slate is a natural stone and slate roofs can last 100 years or longer with correct installation and maintenance. Overall the slate is in fair condition and showing it's age. There are cracks, breaks and a number of repairs.

Past repairs

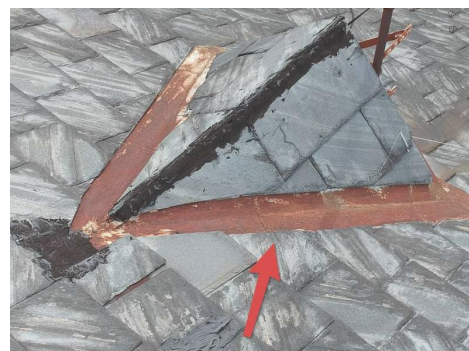
CORRODED FLASHING

Flashing is corroded in one or more areas. This condition may allow leakage and water damage if not corrected.

Contact a qualified roofing professional.

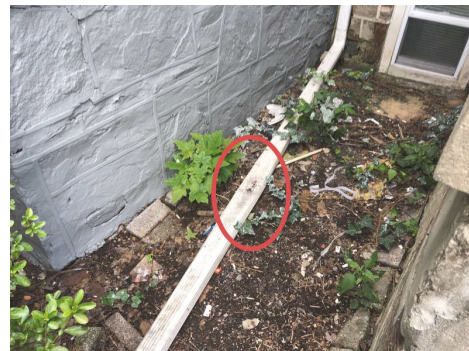
DAMAGED DOWNSPOUT

There is a damaged section of downspout that may collect leaves and clog.

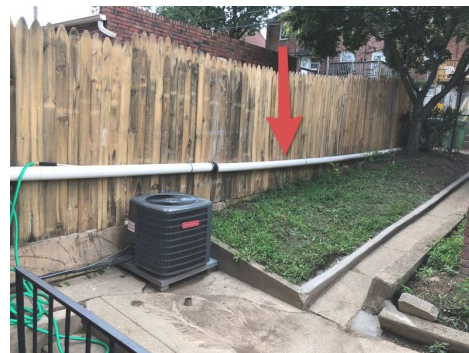
SAGGING PIPE HOLD WATER

The roof discharges to a very long PVC pipe that extends to the rear of the property due to the back yard sloping towards the home. This also carries the water discharged by the sump pump. The pipe is sagging and holds water in the middle. The water in the pipe adds resistance to any added water from the roof or sump pump. This added resistance may cause water to backup near the home. This condition may contribute to a flooded basement in a heavy downpour.

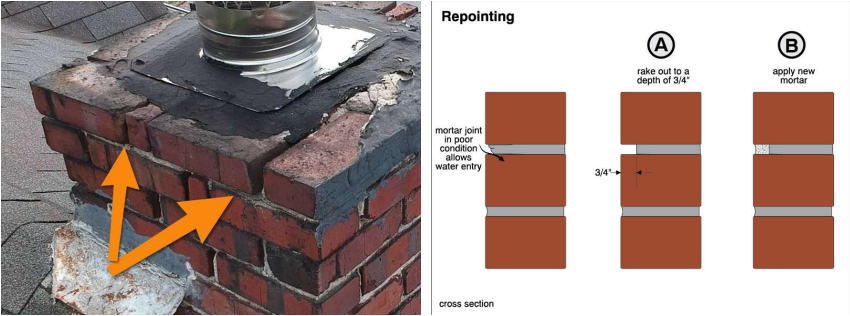
SEVERELY DETERIORATED BRICK/MORTAR

Severe deterioration of portions of the brick mortar was observed. If not corrected this condition will continue to deteriorate.

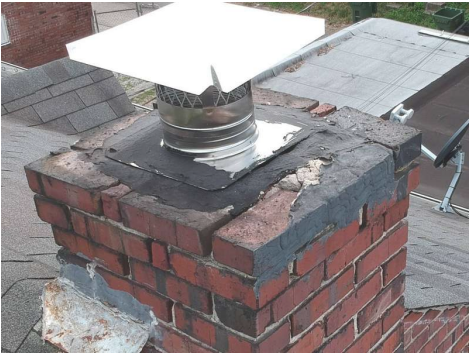
SEVERELY DETERIORATED CROWN

The chimney crown should be replaced to prevent water damage to the chimney chase.

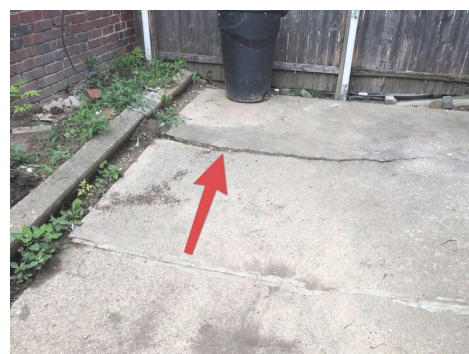
CONCRETE HEAVED TRIP HAZARD

Concrete has heaved and created trip hazards. This should be corrected by a qualified contractor to prevent personal injury.

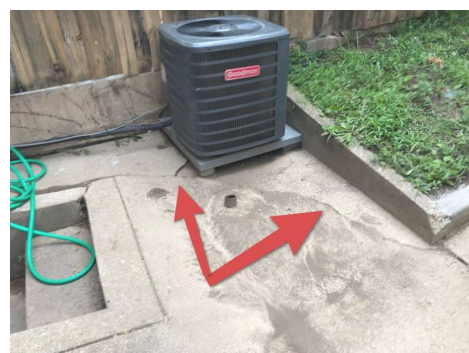
REPAIR CONCRETE CRACKS

There are normal cracks in the concrete which should be filled with an appropriate material to slow the rate of deterioration caused by the freeze/thaw cycle.

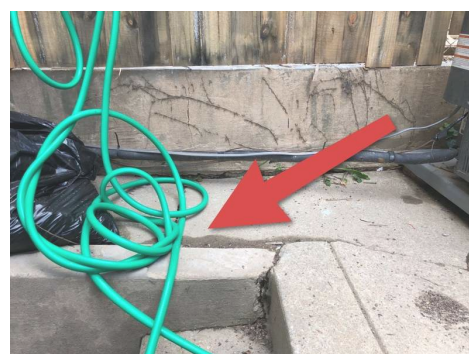
CONCRETE SETTLED AND CRACKED

Concrete is settled and cracked. Use caution as the irregularities make for poor footing. A qualified contractor should correct this to prevent further deterioration and personal injury.

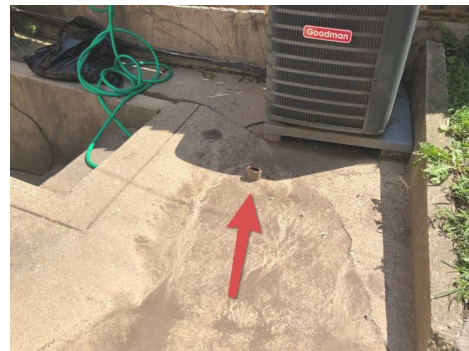
TRIP HAZARD

There is one or more trip hazards that should be corrected to prevent a fall and injury.

Contact a qualified concrete contractor.

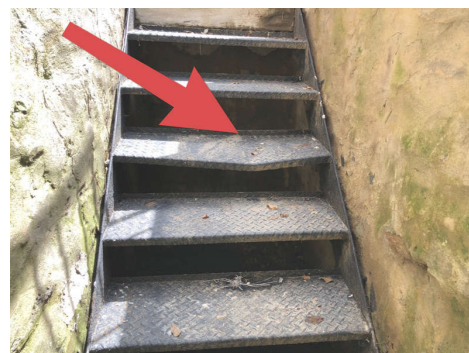
DAMAGED STAIR TREADS

Damaged stair treads should be repaired or replaced to prevent failure and personal injury.

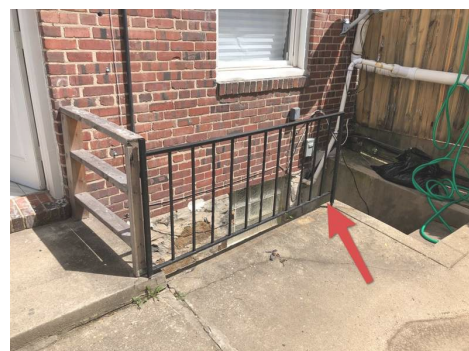
DETERIORATED GUARDRAIL

This guardrail is rusted through and needs to be repaired or replaced for safe use.

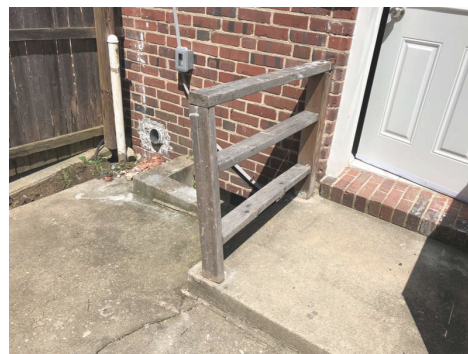
LOOSE GUARDRAIL

This guardrail is loose and should be secured to prevent failure and personal injury.

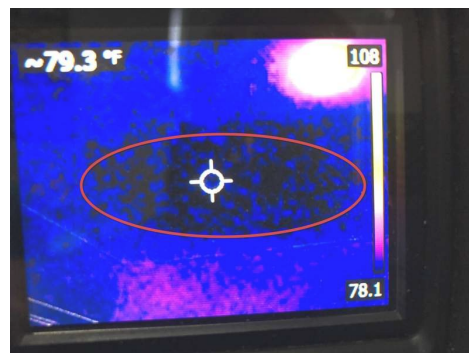
This is thermal image of the ceiling above the front door, beneath the upper hallway bathroom. The dark spot was confirmed to be wet with a moisture meter.

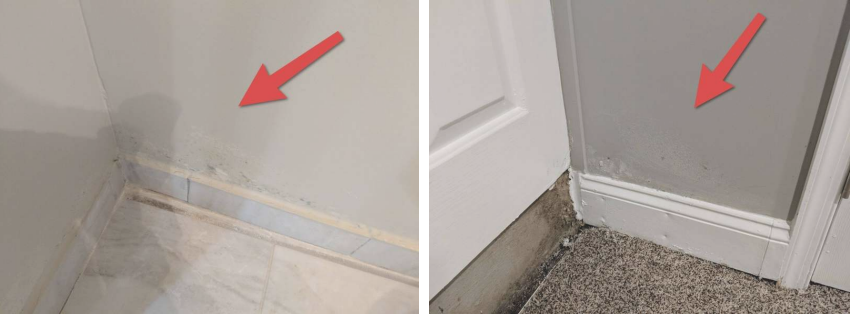
What may have been mold was observed in the basement on the wall near the back door and on the walls of the bathroom. This area should be tested for mold to confirm this and any mold growth should be removed by a qualified mold remediation contractor. When the mold remediation is complete, clearance testing should be performed to ensure that it was effective.
