KNOX HOME INSPECTIONS

13 Haunted House Road
Transylvania NH 03103

Dr. Acula
OCTOBER 31, 2018

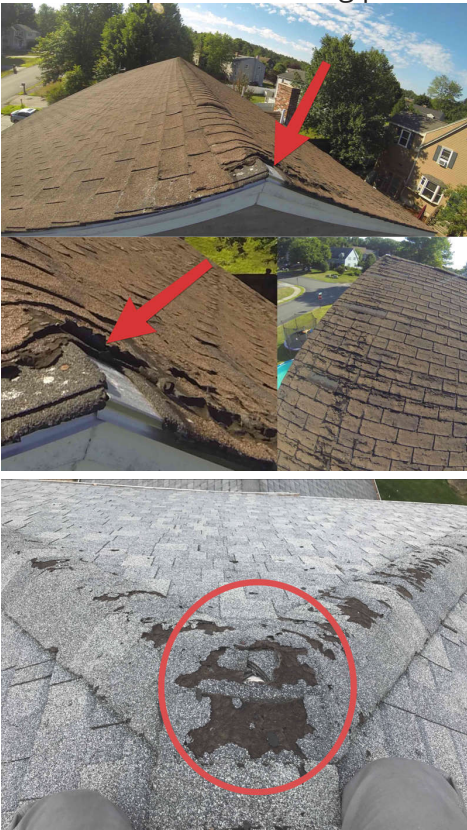
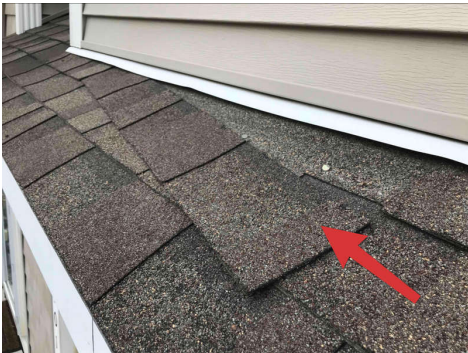
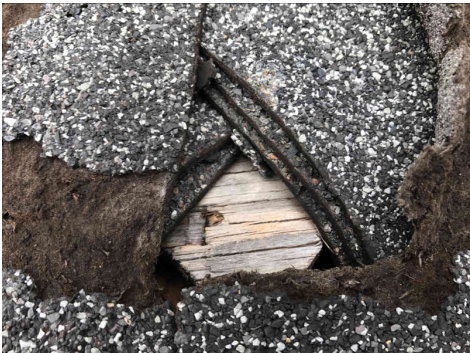
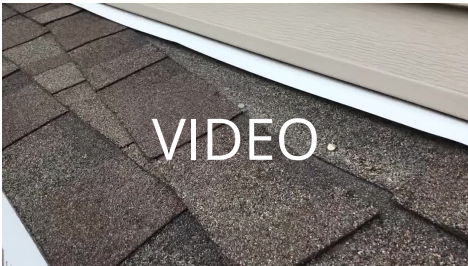
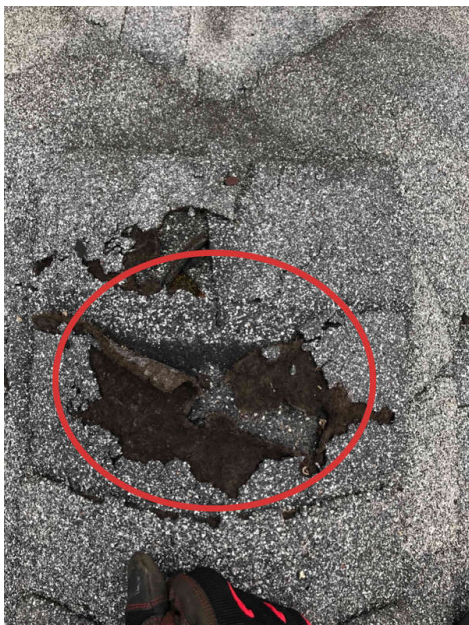
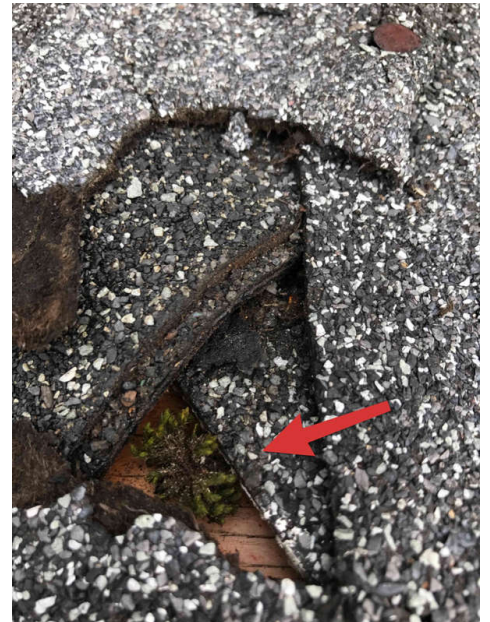
2.2.1 Coverings

DAMAGED (GENERAL)

There are several damaged areas of the roof that need repairs. Recommend further evaluation and repairs as necessary by a roofing contractor.

Hole in the roof

Recommendation
Contact a qualified roofing professional.

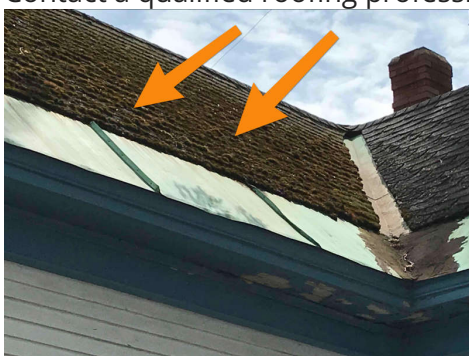
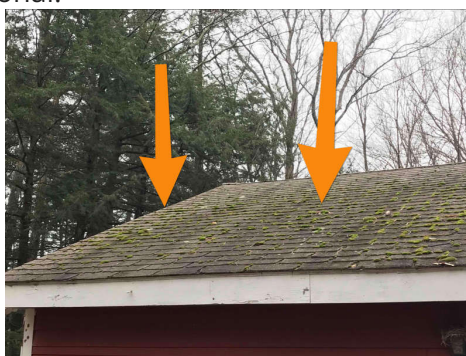
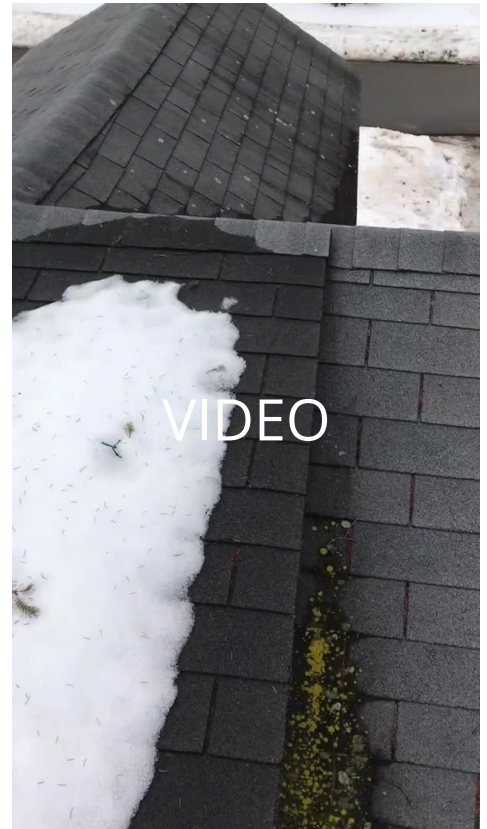
2.2.2 Coverings

MOSS BUILDUP

Recommend removal of moss from roofing materials. Moss can damage the roof and cause premature aging. Recommend removal of moss by roofing professional. Soft wash only, no pressure washing.

Contact a qualified roofing professional.

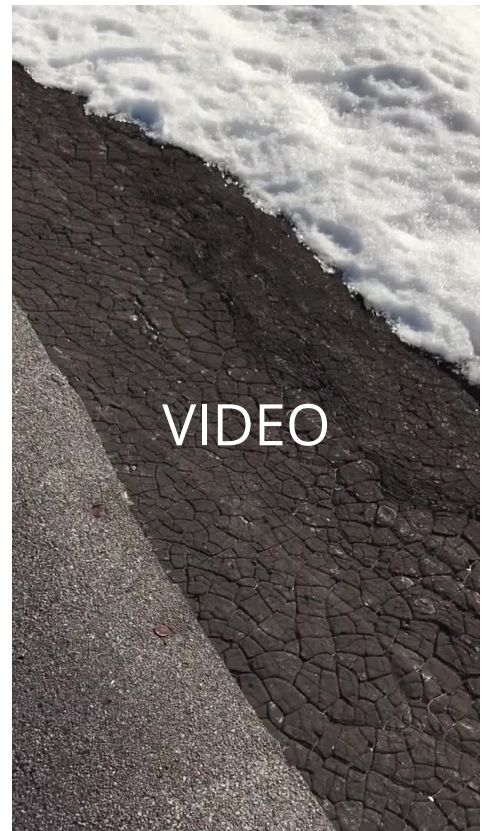
2.2.3 Coverings

RUBBER ALIGATORING / BLISTERING

Rubber roofing can blister and crack over time from water and sun exposure, this is sometimes referred to as "alligatoring". Recommend repairs or replacement of the damaged areas of roofing by a roofing contractor.

Contact a qualified roofing professional.

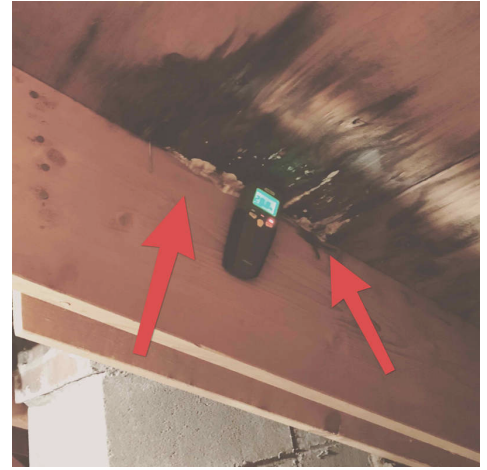
2.2.4 Coverings

ACTIVE ROOF LEAK

There is an active roof leak visible from the attic. They're also mushrooms growing in the attic which indicates moisture. Recommend repairs by a roofing contractor into any damage to roof decking and structural support.

Mushrooms in attic on roof decking

Contact a qualified professional.

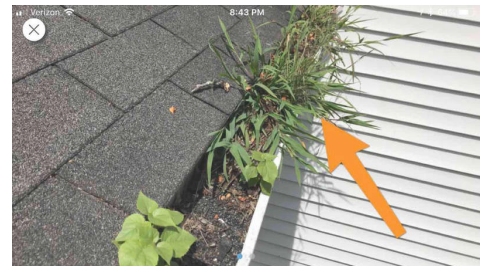
2.3.1 Roof Drainage Systems

DEBRIS

Debris has accumulated in the gutters. Recommend cleaning to facilitate water flow.

Contact a handyman or DIY project

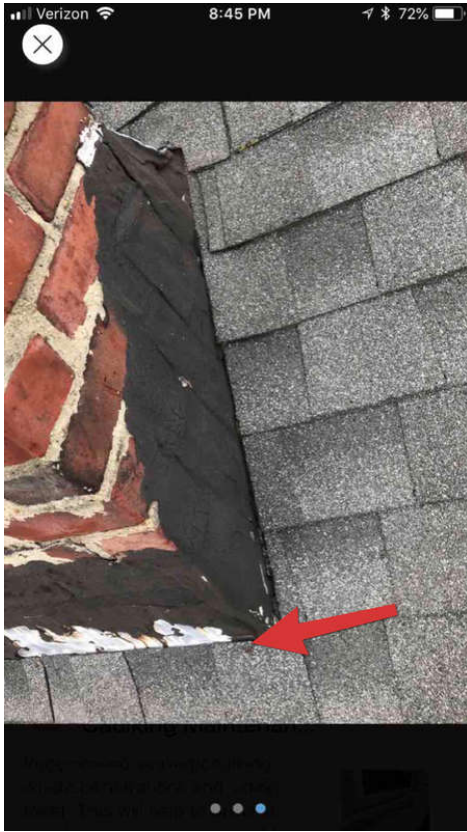
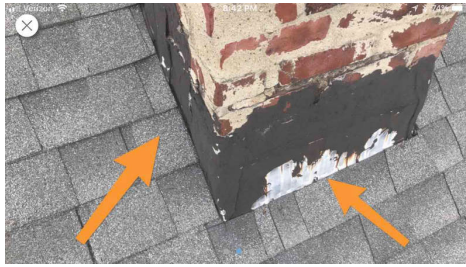
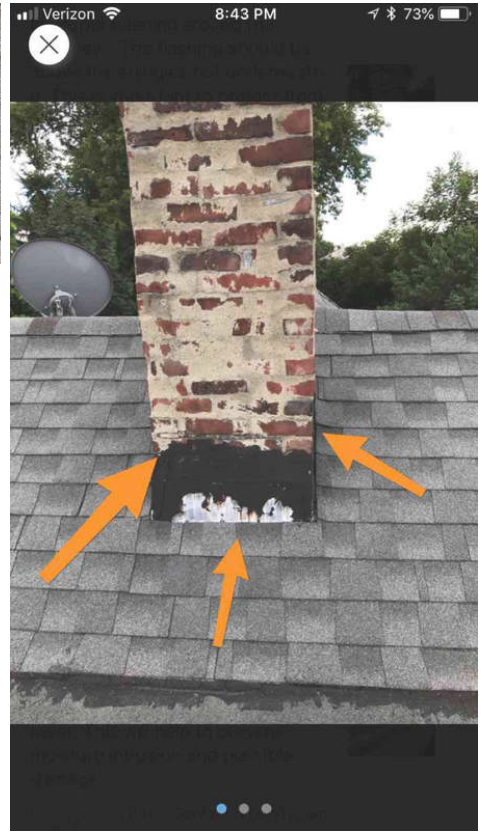
2.4.1 Flashings

IMPROPERLY INSTALLED

Flashings improperly installed, which can lead to water intrusion and/or mold. Recommend a qualified roofing contractor repair.

No apron flashing

Contact a qualified professional.

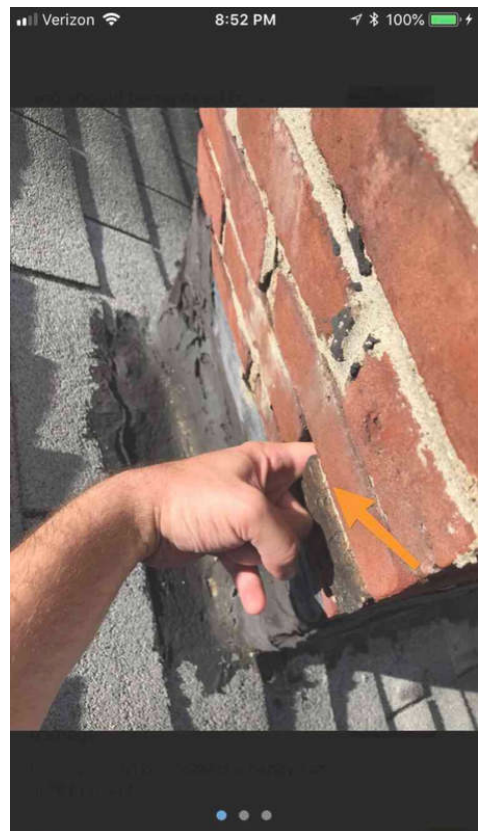
2.5.1 Skylights, Chimneys & Other Roof Penetrations

CHIMNEY - BRICK SPALLING/DETERIORATION

Deterioration of bricks at chimney. Recommend repair and replacement of bricks as needed by a mason.

Contact a qualified professional.

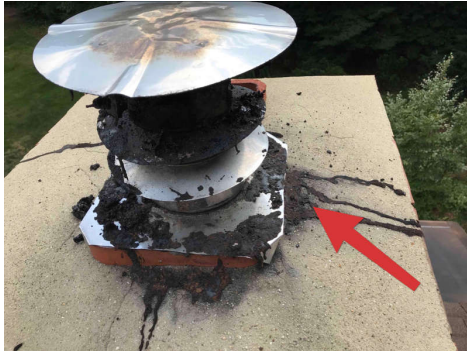
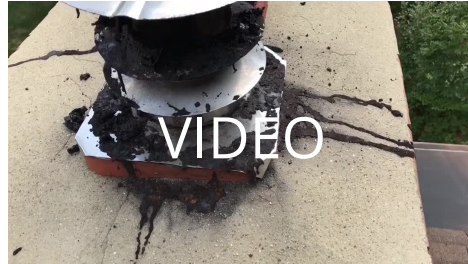
2.5.2 Skylights, Chimneys & Other Roof Penetrations

CHIMNEY FLUE DIRTY

Chimney flue was excessively dirty, which can pose a serious fire hazard. Recommend a qualified chimney contractor clean the build up in the flue.

A lot of creosote built up in flue

Contact a qualified roofing professional.

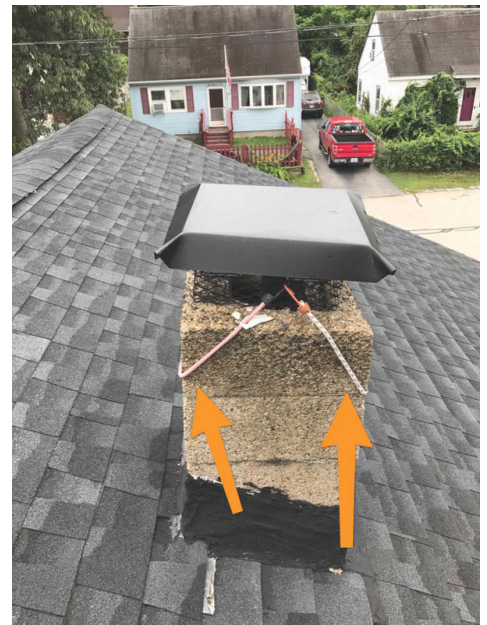
2.5.3 Skylights, Chimneys & Other Roof Penetrations

CHIMNEY CAP BUNGEE CORDS

The Chimney cap is being held on with bungee cords. This is not a proper installation and should be corrected by a chimney repair contractor.

Bungee cords

Contact a qualified professional.

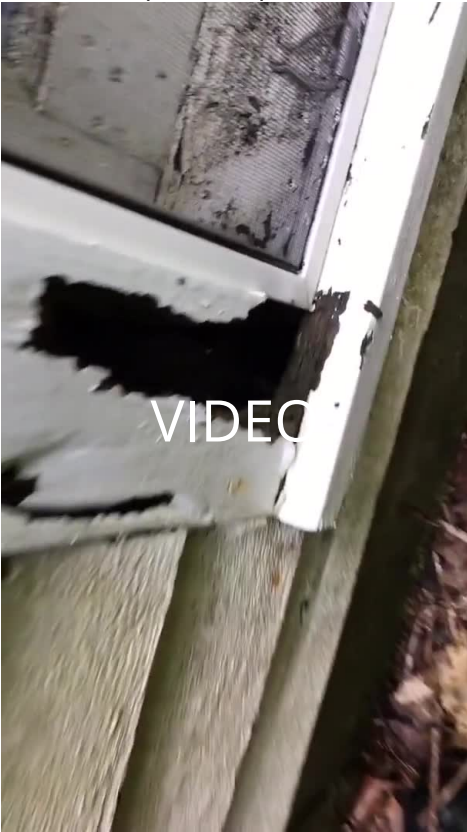
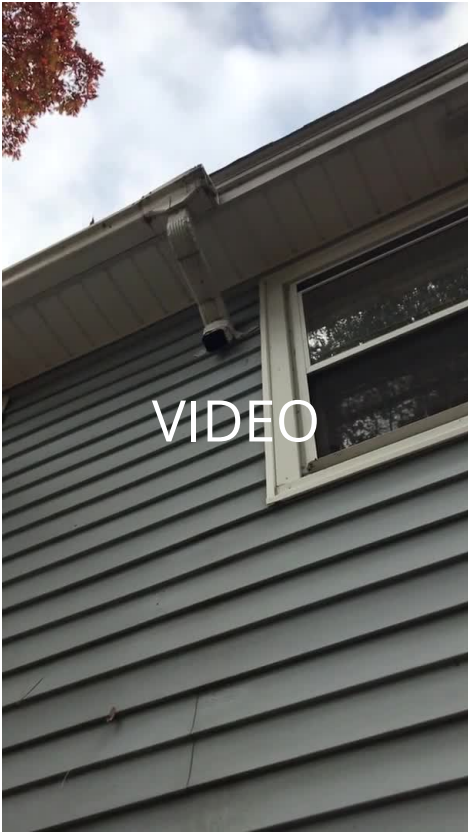
3.1.1 Siding, Flashing & Trim

DAMAGED SIDING

Some areas of the siding were damaged. Recommend repair.

Contact a qualified professional.

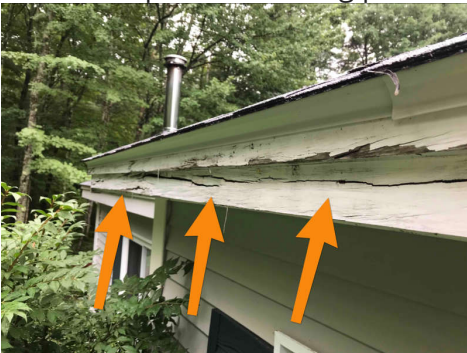
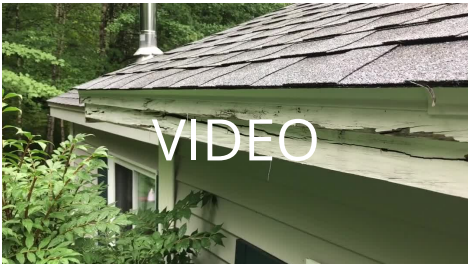
3.6.1 Eaves, Soffits & Fascia

FASCIA - ROTTED

One or more sections of the fascia are rotted. Recommend qualified roofer evaluate & repair.

Contact a qualified roofing professional.

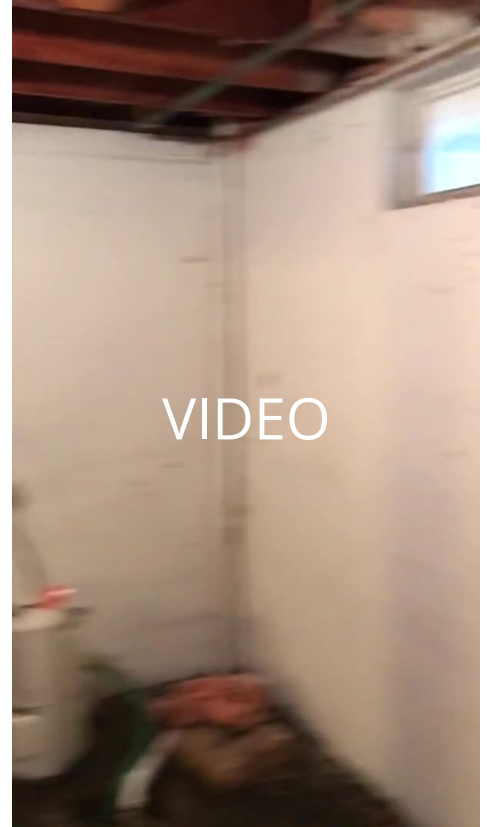
4.2.1 Foundation

FOUNDATION CRACKS - MAJOR

Severe cracking noted at the foundation. This is typically consistent with soil movement and could lead to serious damage to structural components, foundation and/or slabs. Recommend a structural engineer evaluate and provide a report on course of action and remedy.

Contact a qualified structural engineer.

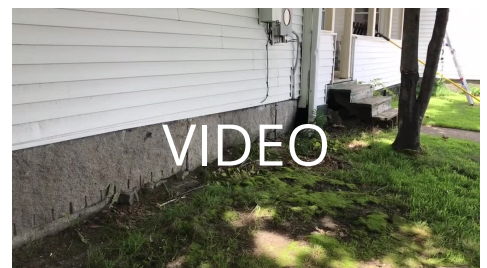
4.2.2 Foundation

WALL(S) BOWING/LEANING

Foundation wall is bowing and/or leaning. Recommend qualified professional review and provide evaluation of findings.

Contact a qualified structural engineer.

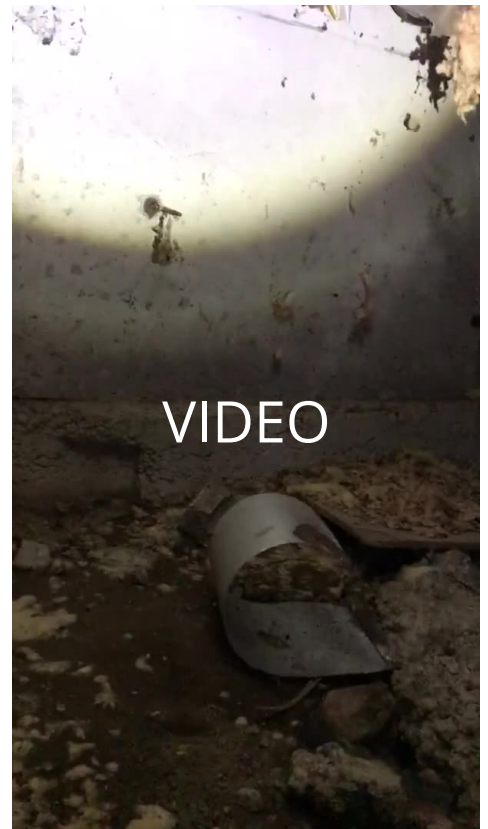
4.3.1 Basements & Crawlspaces

INSULATION DAMAGED IN CRAWLSPACE

Insulation in the crawlspace is falling down it should be repaired. Pests or moisture can get in and cause damage if it is not repaired.

Contact a qualified professional.

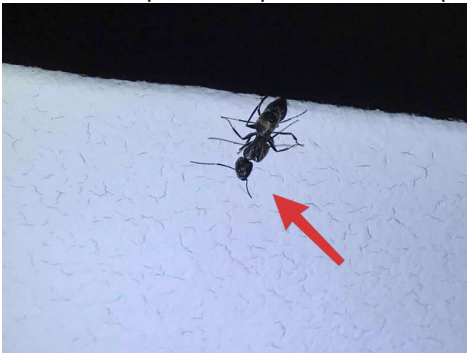
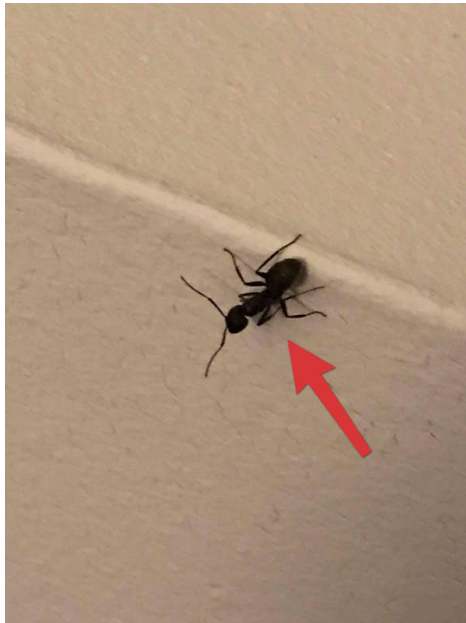
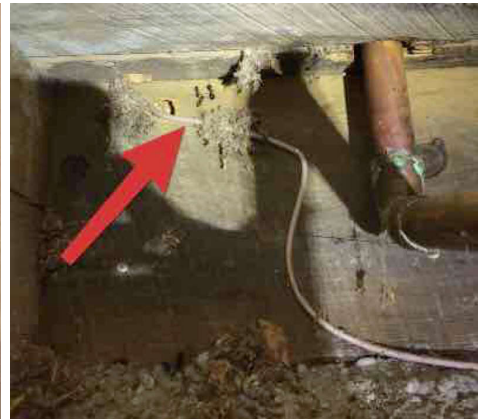
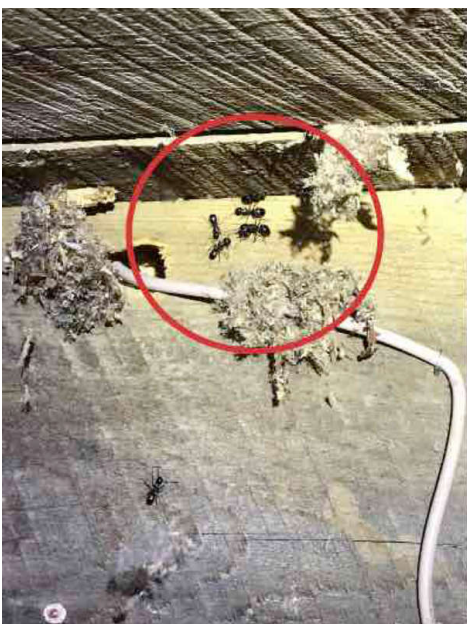
5.1.1 Pest Evidence

CARPENTER ANTS

Carpenter ant activity was visible in the areas above.

Recommend a pest removal company treat and remove all active Carpenter ants any damage from Carpenter ants will need to be repaired. There may be damage that is not visible until repairs are started.

Contact a qualified pest control specialist.

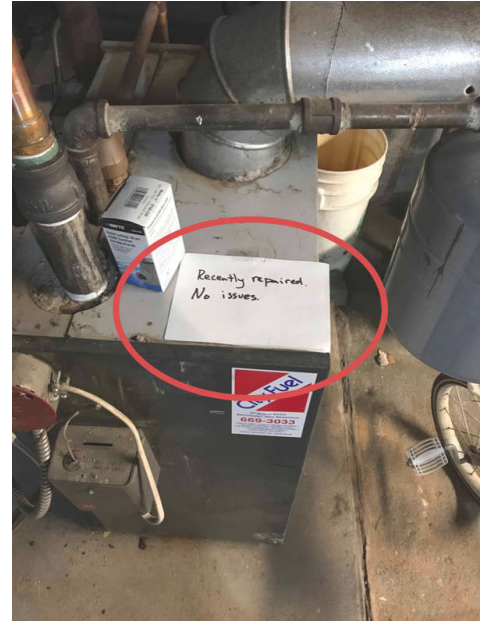
6.1.1 Equipment

ANNUAL SERVICING/CLEANING

Heating equipment should be cleaned and serviced annually. No recent cleaning or service tags were visible on the unit. Just a tag that says "recently repaired no issues." Recommend a qualified HVAC contractor clean, service and certify heating equipment.

Contact a qualified HVAC professional.

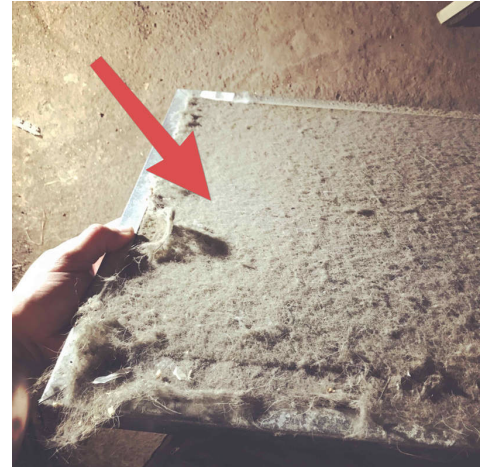
6.1.2 Equipment

FILTER DIRTY

The furnace filter is dirty and needs to be replaced per the manufacturer recommendations. Filter should be replaced periodically. A clogged filter can decrease efficiency and cause problems with your heating system.

Contact a handyman or DIY project

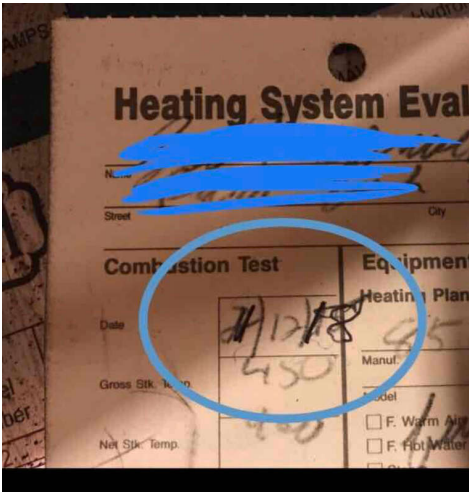
6.1.3 Equipment

CLEAN AND SERVICE NEEDED

There is an old cleaning and service tag from a HVAC company but the date has been changed to a year later. This is not proper and this unit is overdue for a cleaning and service.

Contact a qualified professional.

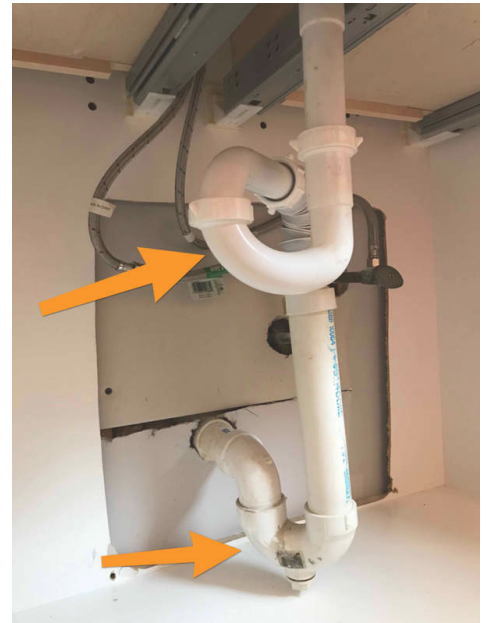
8.3.1 Drain, Waste, & Vent Systems

DOUBLE TRAP

There are 2 traps installed under the sink. This is not a proper setup and should be corrected by a plumber.

Contact a qualified plumbing contractor.

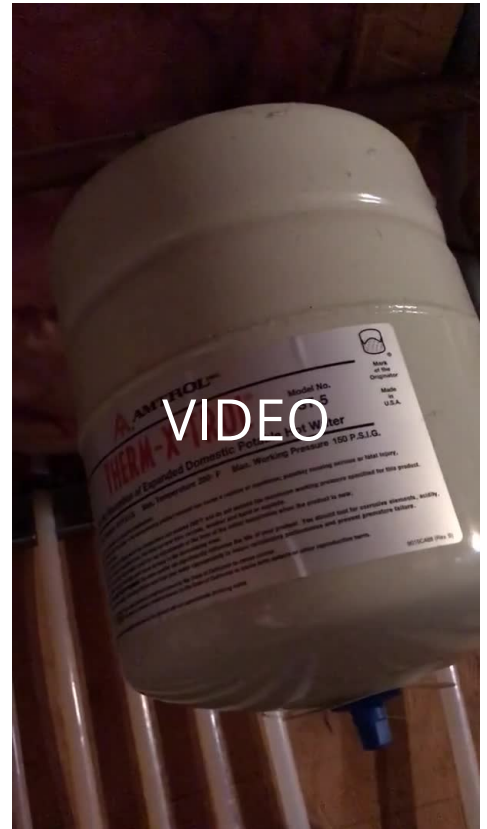
8.4.1 Water Supply, Distribution Systems & Fixtures

EXPANSION TANK LOGGED

Expansion tank is damaged the diaphragm in the middle is broken.
Recommend replacement by a plumber.

Contact a qualified professional.

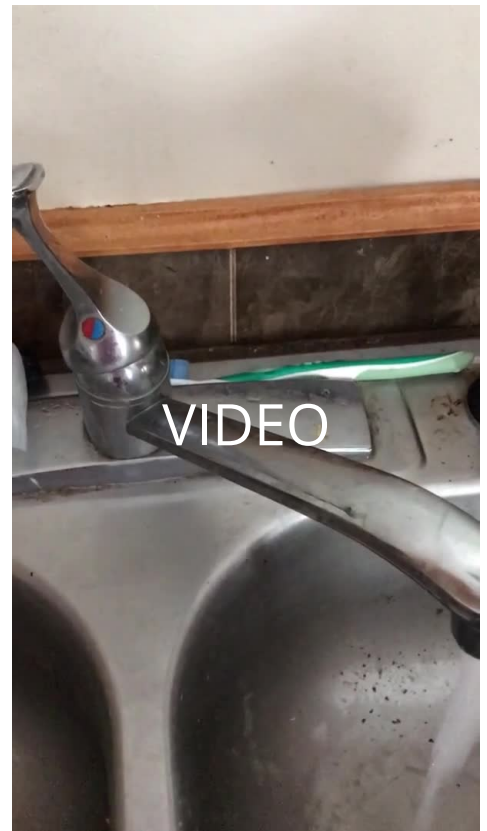
8.4.2 Water Supply, Distribution Systems & Fixtures

WATER HAMMER

There is a very loud water hammer when the hot water is running.
Recommend corrections by a plumber.

Contact a qualified professional.

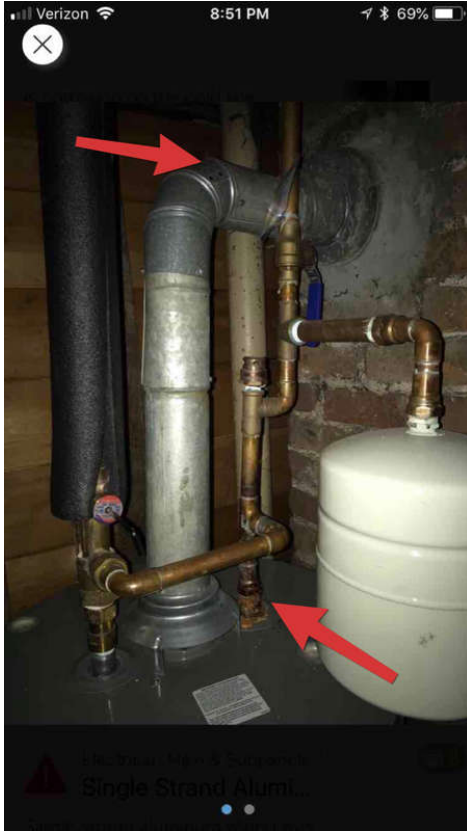
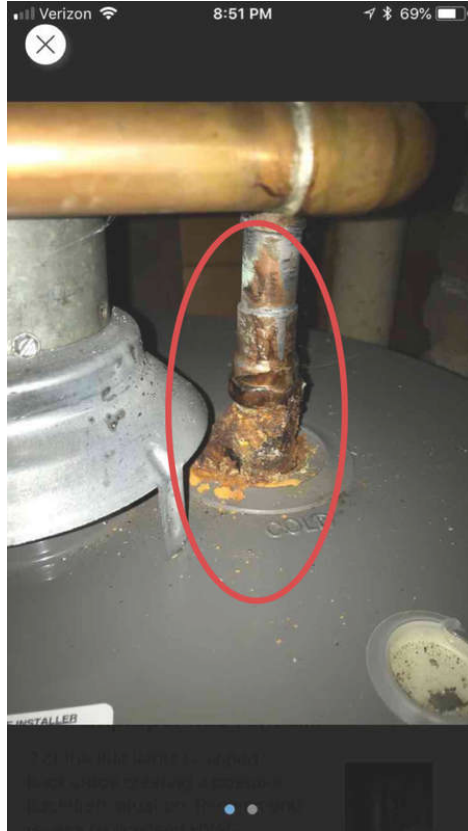
8.5.1 Hot Water Systems, Controls, Flues & Vents

POSSIBLE BACKDRAFT

Possible Backdraft problem on the exhaust of the water heater there is corrosion on the cold line and some melting on the hotline. Recommend full of valuation of the water heater and the exhaust by a licensed HVAC technician and repairs to the corroded areas.

Exhaust sloped incorrectly

Contact a qualified professional.

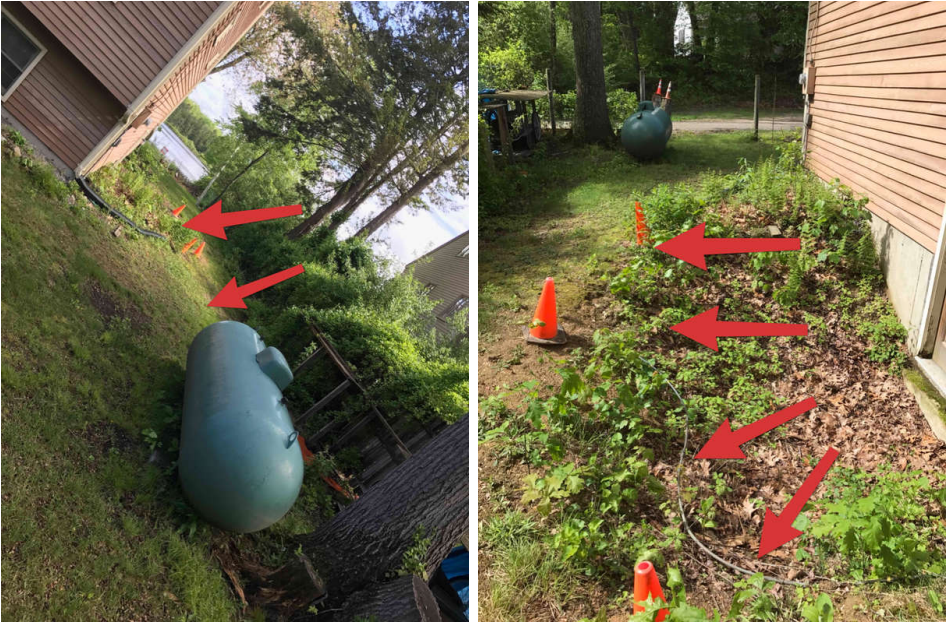
8.6.1 Fuel Storage & Distribution Systems

EXPOSED GAS LINE IN YARD

The yard line for the propane is exposed on the lawn. This is a safety hazard and should be properly buried by a professional HVAC technician.

Contact a qualified professional.

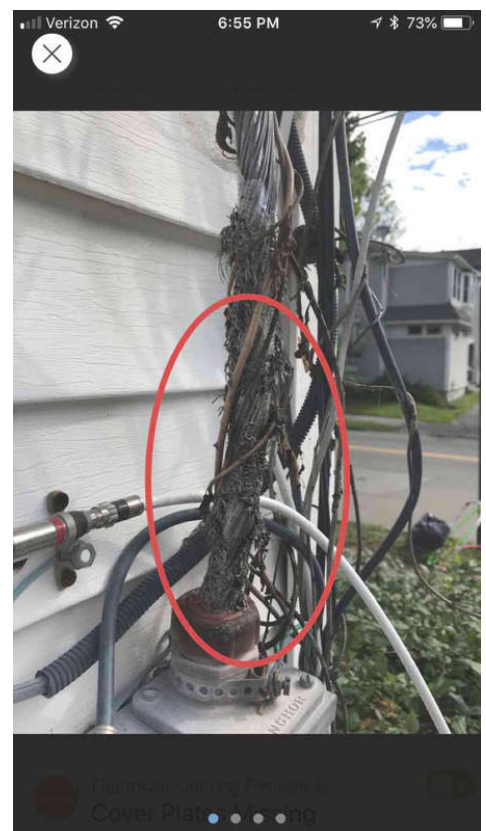
9.1.1 Service Entrance Conductors

FRAYED SHEATHING

Wires on service entrance are damaged or frayed. Recommend contacting your electric utility company or a qualified electrician to evaluate and repair.

Contact a qualified electrical contractor.

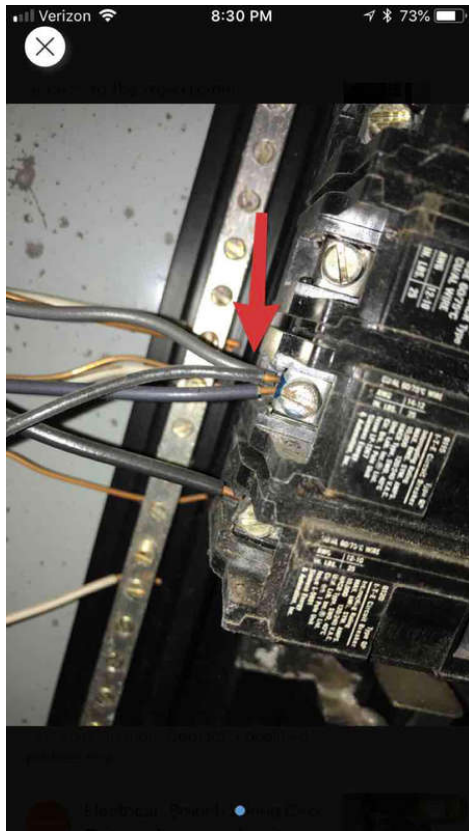
9.2.1 Main & Subpanels, Service & Grounding, Main Overcurrent Device

DOUBLE TAPPED CIRCUIT BREAKERS

There are "double tapped" circuits in the main panel. This is when two circuits are connected to the same breaker. Some breakers are designed to carry 2 and some are not. This should be corrected by an electrician. [Click here for more info about Double Taps](#)

Contact a qualified electrical contractor.

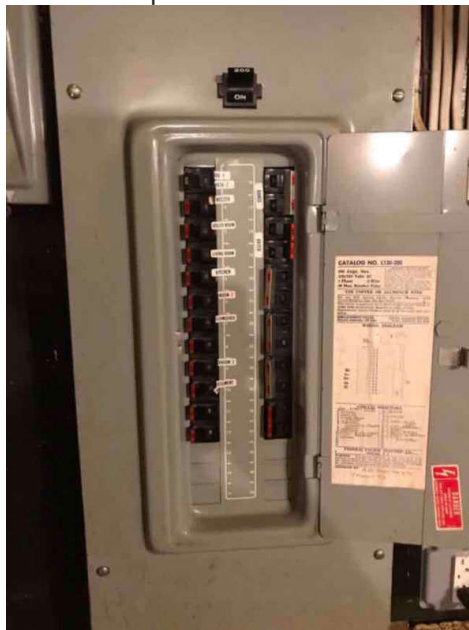
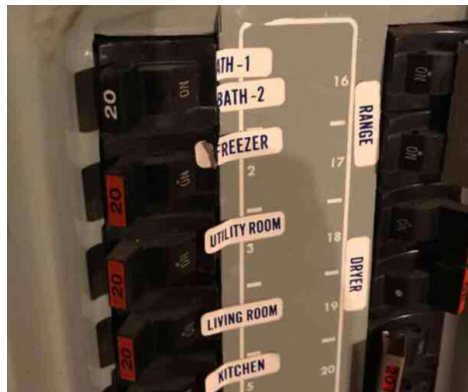
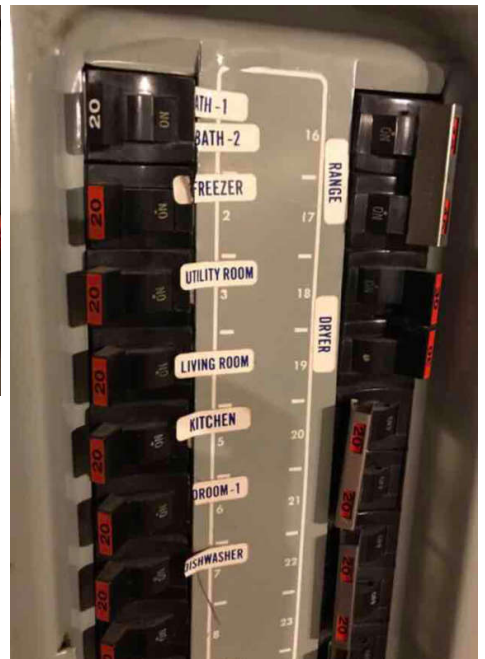
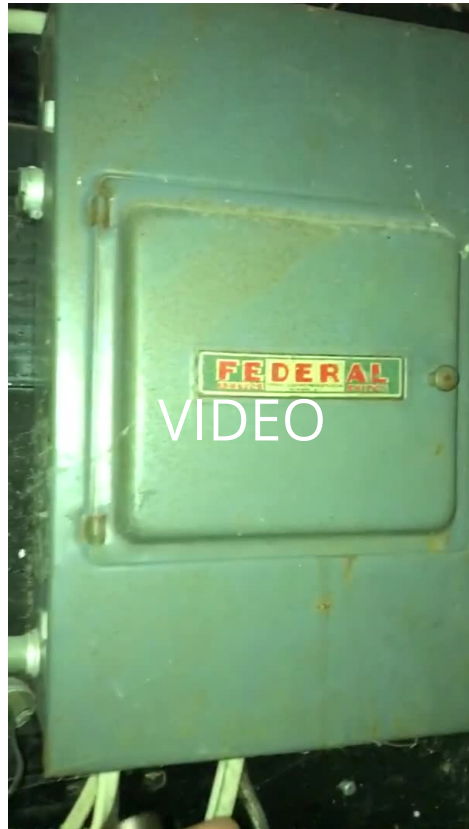
9.2.2 Main & Subpanels, Service & Grounding, Main Overcurrent Device

FEDERAL PACIFIC PANEL NEEDS REPLACEMENT

The main panel is a Federal Pacific panel and should be replaced. Federal Pacific panels have a history of causing fires and having loose connections. This is a safety issue and should be replaced by an electrician.

Contact a qualified electrical contractor.

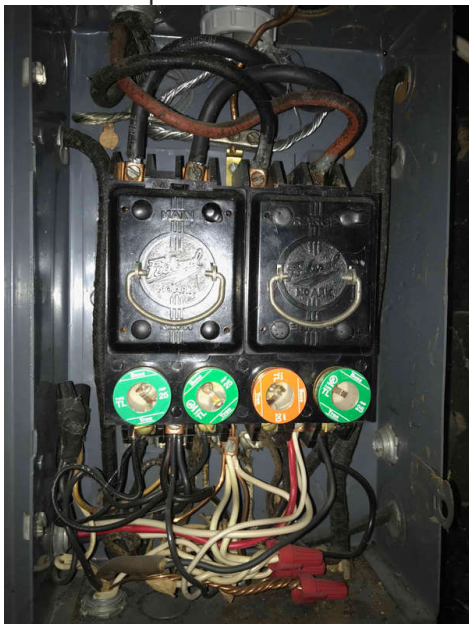
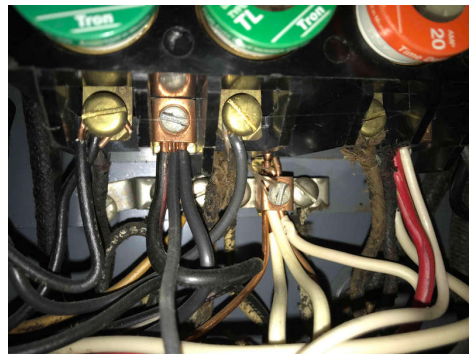
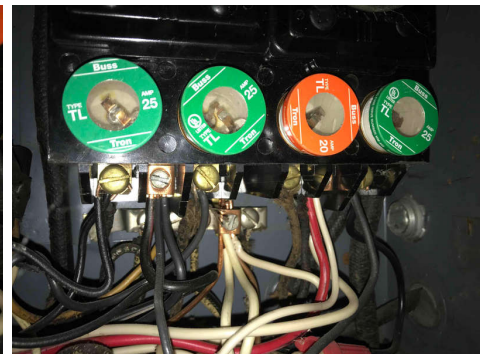
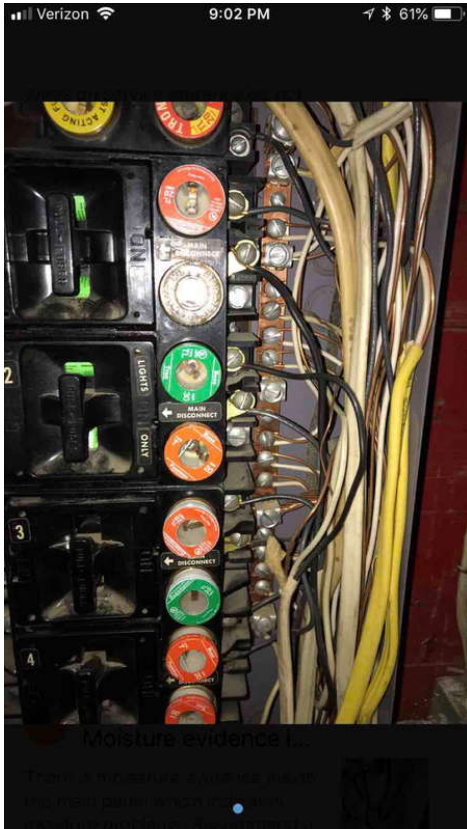
9.2.3 Main & Subpanels, Service & Grounding, Main Overcurrent Device

FUSES PRESENT

Fuses are no longer the electrical standard and should be removed. This can also cause problems with homeowners insurance. Recommend removal by a licensed electrician.

Contact a qualified electrical contractor.

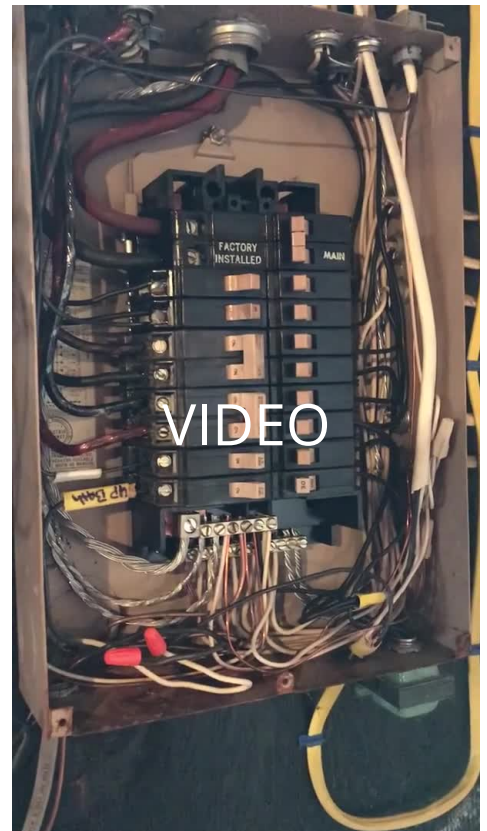
9.2.4 Main & Subpanels, Service & Grounding, Main Overcurrent Device

SINGLE STRAND ALUMINUM WIRING

Single strand aluminum wiring was present inside the breaker panel. Single strand aluminum wiring is no longer used for interior circuits and is a potential fire hazard. Recommend removal by a licensed electrician.

Contact a qualified electrical contractor.

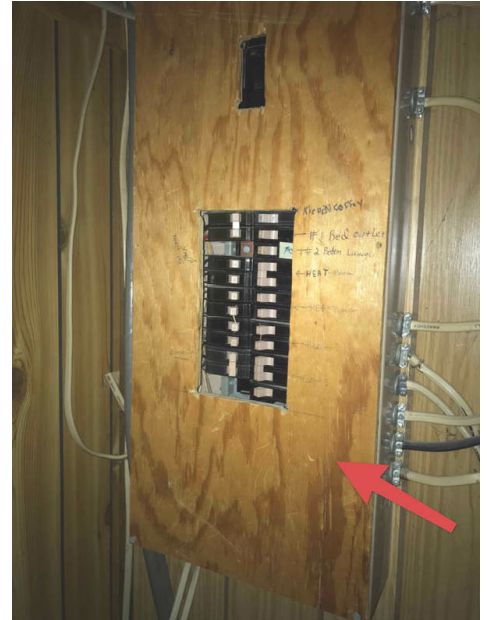
9.2.5 Main & Subpanels, Service & Grounding, Main Overcurrent Device

IMPROPER ELECTRIC PANEL COVER

The main electrical panel cover is made out of wood. This is not a proper material. Recommend repairs by electrician.

Contact a qualified professional.

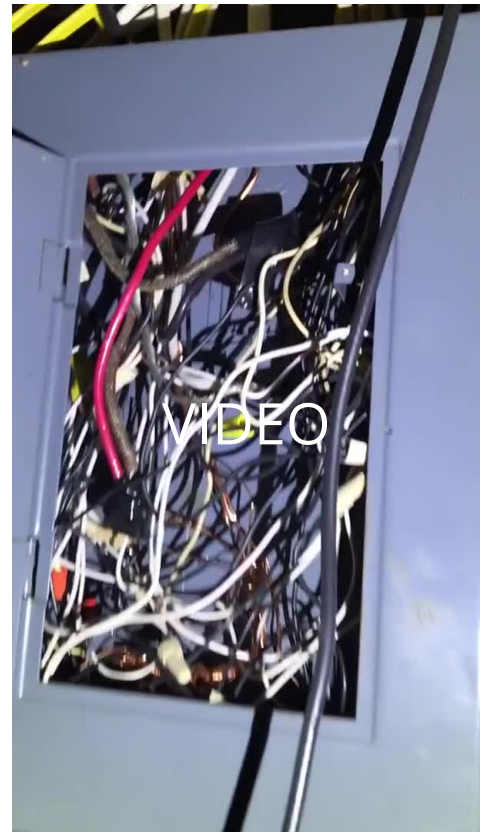
9.2.6 Main & Subpanels, Service & Grounding, Main Overcurrent Device

ELECTRICAL MESS

There is an electrical mess inside the junction box in the basement. Recommend evaluation and corrections by and electrician.

Contact a qualified professional.

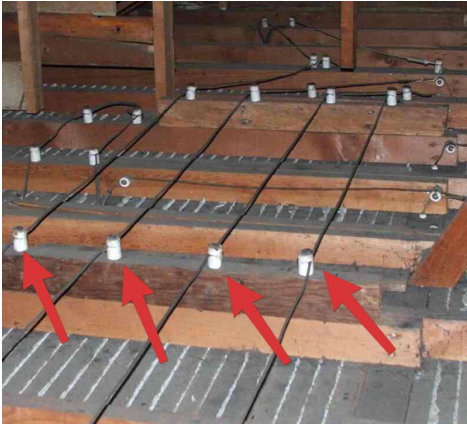
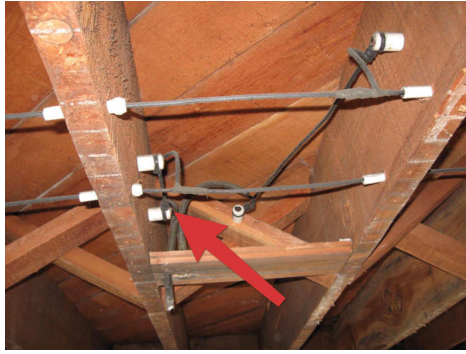
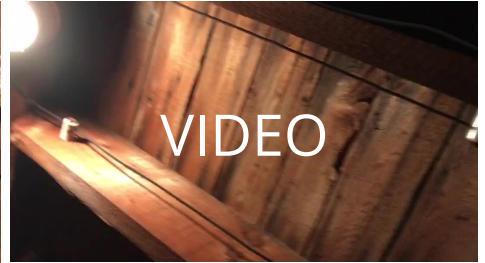
9.3.1 Branch Wiring Circuits, Breakers & Fuses

LIVE KNOB AND TUBE WIRING

There is live knob and tube wiring in the area as pictured above. All live knob and tube wiring should be removed by an electrician. This is a safety concern.

Contact a qualified professional.

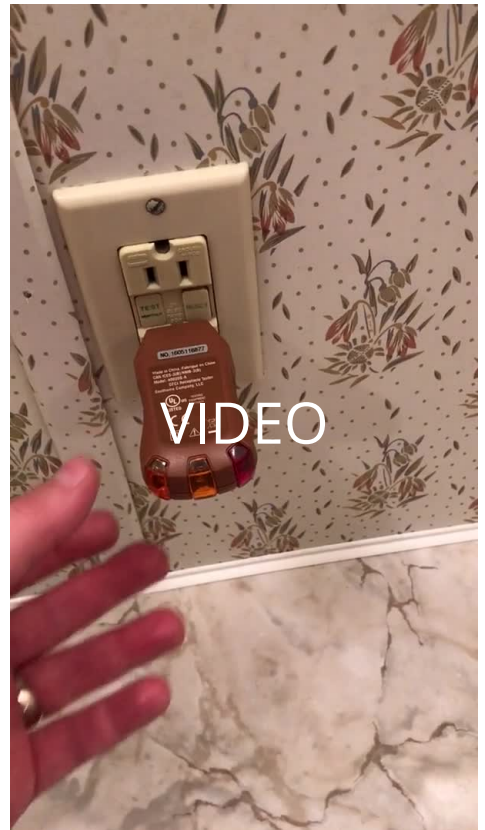
9.4.1 Lighting Fixtures, Switches & Receptacles

LOOSE OUTLET

There are one or more loose electrical outlets that should be secured in place by electrician.

Contact a qualified electrical contractor.

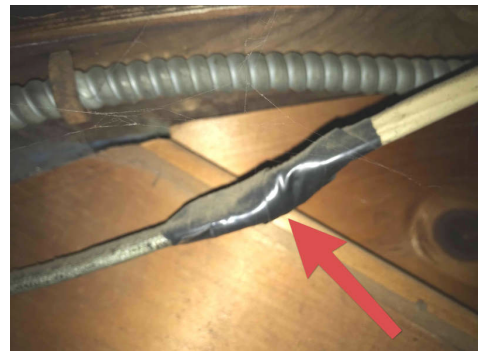
9.4.2 Lighting Fixtures, Switches & Receptacles

OPEN SPLICE

There are electrical connections that are not inside of a proper junction box or receptacle, this is called an open splice. Open splices should be put inside of a fixture or junction box by an electrician.

Contact a qualified electrical contractor.

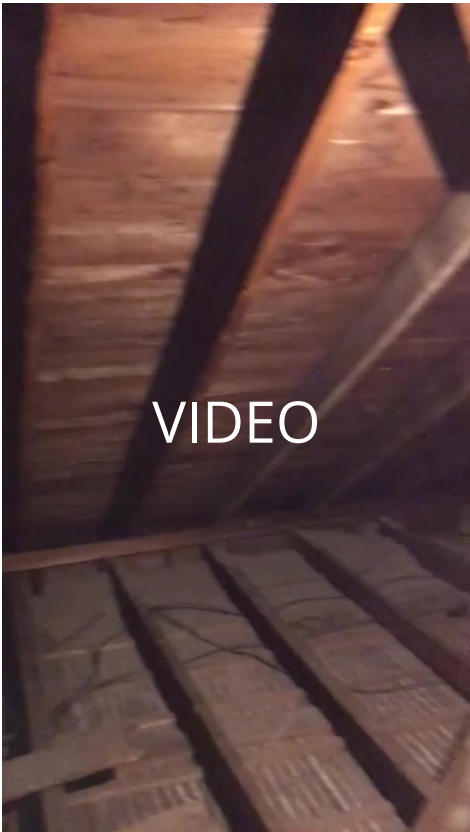
10.2.1 Attic Insulation

INSUFFICIENT INSULATION

Insulation depth was inadequate in comparison to current industry standards and building energy efficiency guidelines. Recommend a qualified attic insulation contractor install additional insulation.

Contact a qualified insulation contractor.

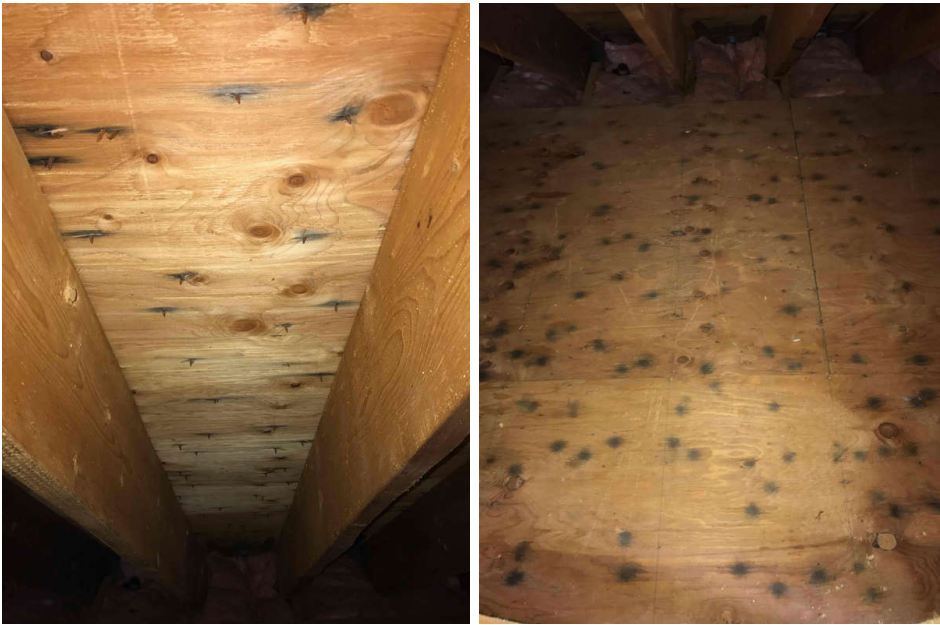
10.3.1 Ventilation

ATTIC VENTILATION INSUFFICIENT

Attic venting was insufficient at time of inspection. Modern standards recommend 1.5 square feet of venting area for every 300 square feet of attic floor space. Recommend an attic contractor evaluate and remedy.

Contact a qualified professional.

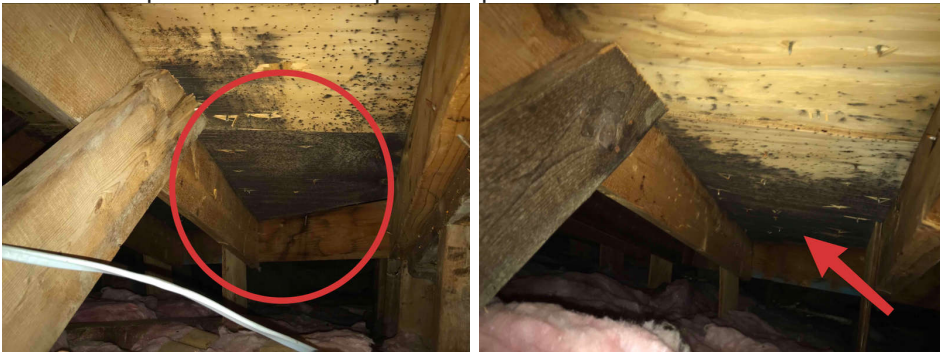
10.3.2 Ventilation

DISCOLORATION - POSSIBLE MOLD

Attic showed areas of discoloration. This is most likely caused from moisture and a lack of ventilation. recommend finding source of moisture or lack of ventilation in attic space And correcting it to prevent mold from occurring.

Contact a qualified mold inspection professional.

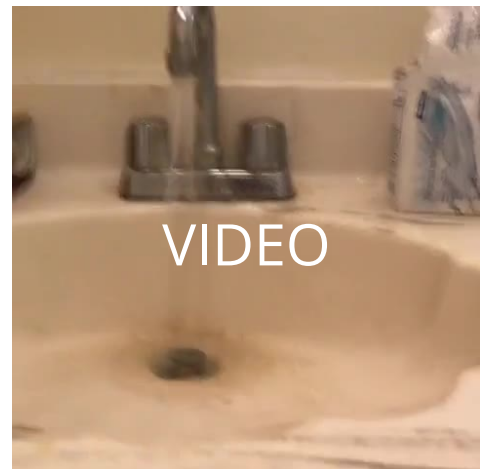
12.2.1 Plumbing & Fixtures

LEAKING DRAIN PIPE

A drain, waste and/or vent pipe showed signs of a leak. Recommend a qualified plumber evaluate and repair.

Contact a qualified plumbing contractor.

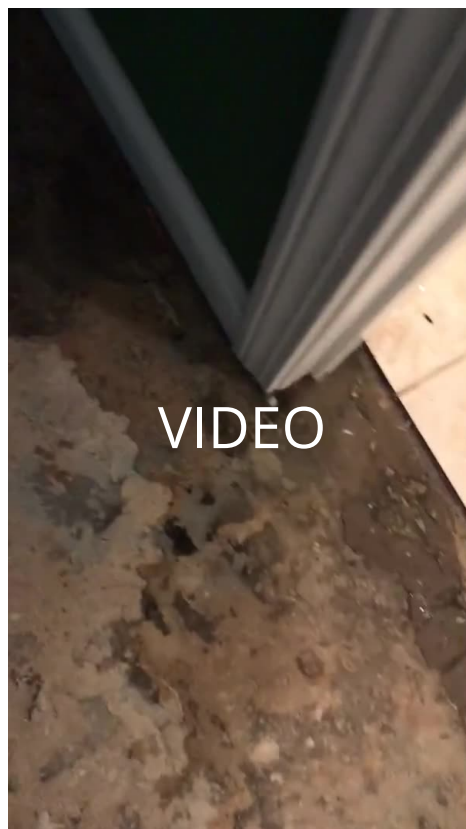
12.2.2 Plumbing & Fixtures

TOILET LEAKS

The toilet is leaking and needs repairs or replacement by a plumber.

Contact a qualified professional.
