SEVEN PEAKS INSPECTIONS, LLC

## STANDARD - SEVEN PEAKS INSPECTIONS

2855 Central Park Blvd  
Denver CO 80238

MARCH 12, 2020

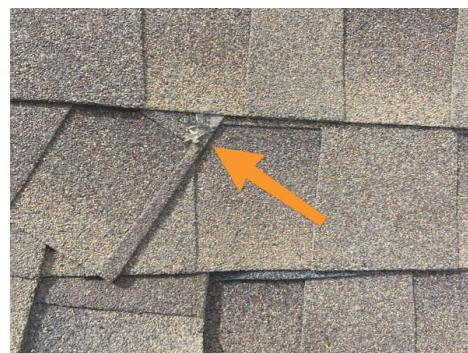
I observed indications of exposed fasteners at the roof-covering materials. Fasteners should not be exposed. Potential water entry points. Roof could leak. Further evaluation and correction is recommended.

Major Defect

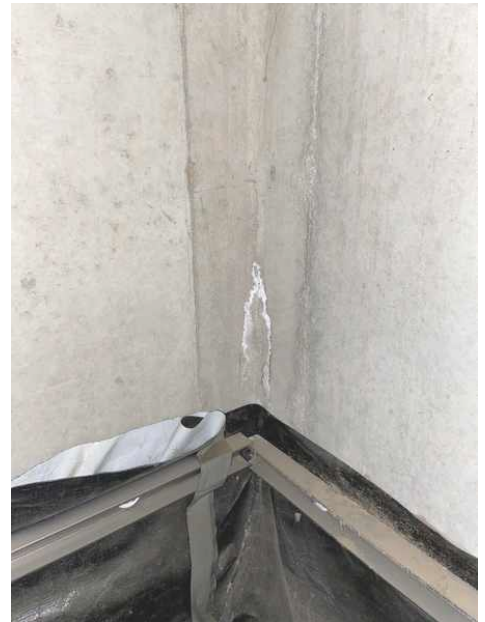
**EFFLORESCENCE OBSERVED**

I observed efflorescence from the crawlspace.

Efflorescence is the white chalky powder that you might find on the surface of a concrete or brick wall. It can be a cosmetic issue, or it can be an indication of moisture intrusion that could lead to major structural and indoor air quality issues.

I noted the presence of efflorescence in the inspection report because it generally occurs where there is excess moisture, a condition that also encourages the growth of mold.

Contact a qualified professional.

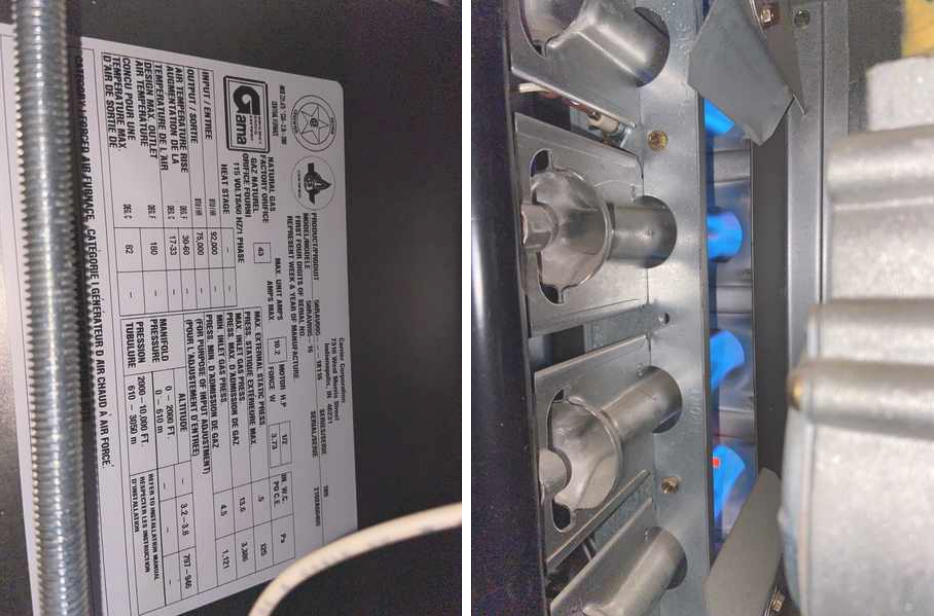
Most HVAC (heating, ventilating and air-conditioning) systems in houses are relatively simple in design and operation. They consist of four components: controls, fuel supply, heating or cooling unit, and distribution system. The adequacy of heating and cooling is often quite subjective and depends upon occupant perceptions that are affected by the distribution of air, the location of return-air vents, air velocity, the sound of the system in operation, and similar characteristics.

**It's your job** to get the HVAC system inspected and serviced every year. And if you're system has an air filter, be sure to clean or replace per the manufacturer's standards.

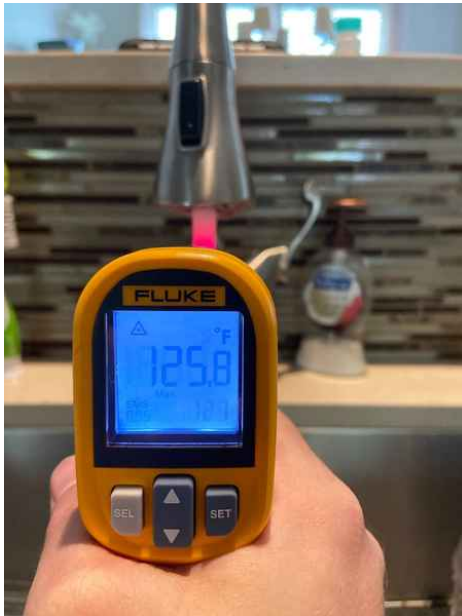
I measured the temperature at one of the faucets in the home with an infrared thermometer at time of inspection, see image below. The Department of Energy recommends having your tank-based hot water heater set to 120 degrees Fahrenheit. Water temperatures over 125°F can cause severe burns instantly or death from scalds.

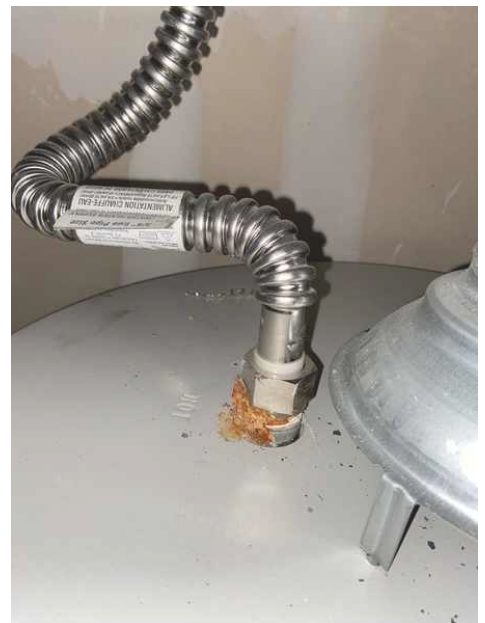
**CORROSION**

I observed corrosion at the hot water source.

**Major Defect**

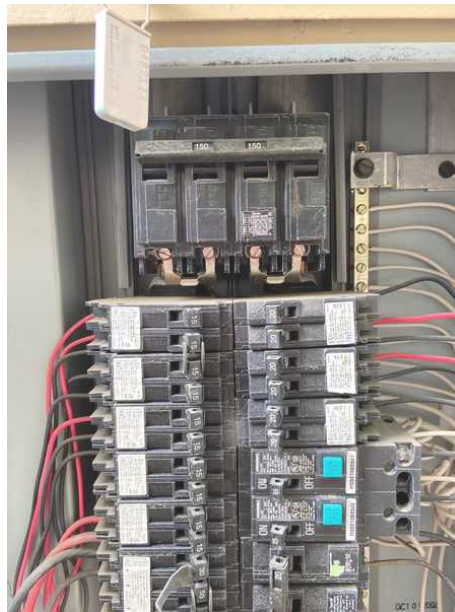
#### Electrical Wiring: Type of Wiring, If Visible

NM-B (Romex)

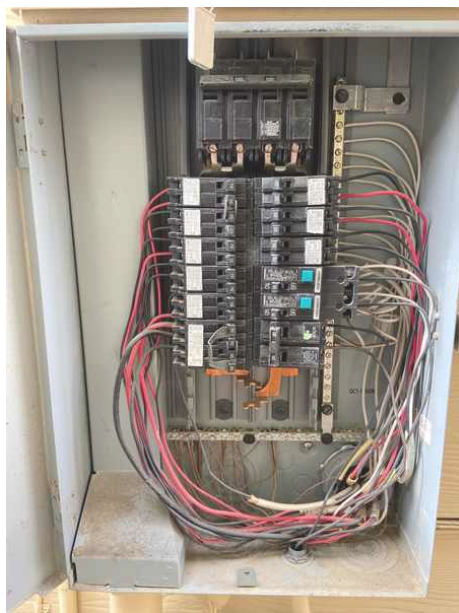
#### Panelboards & Breakers: Inspected Main Panelboard & Breakers

- Yes

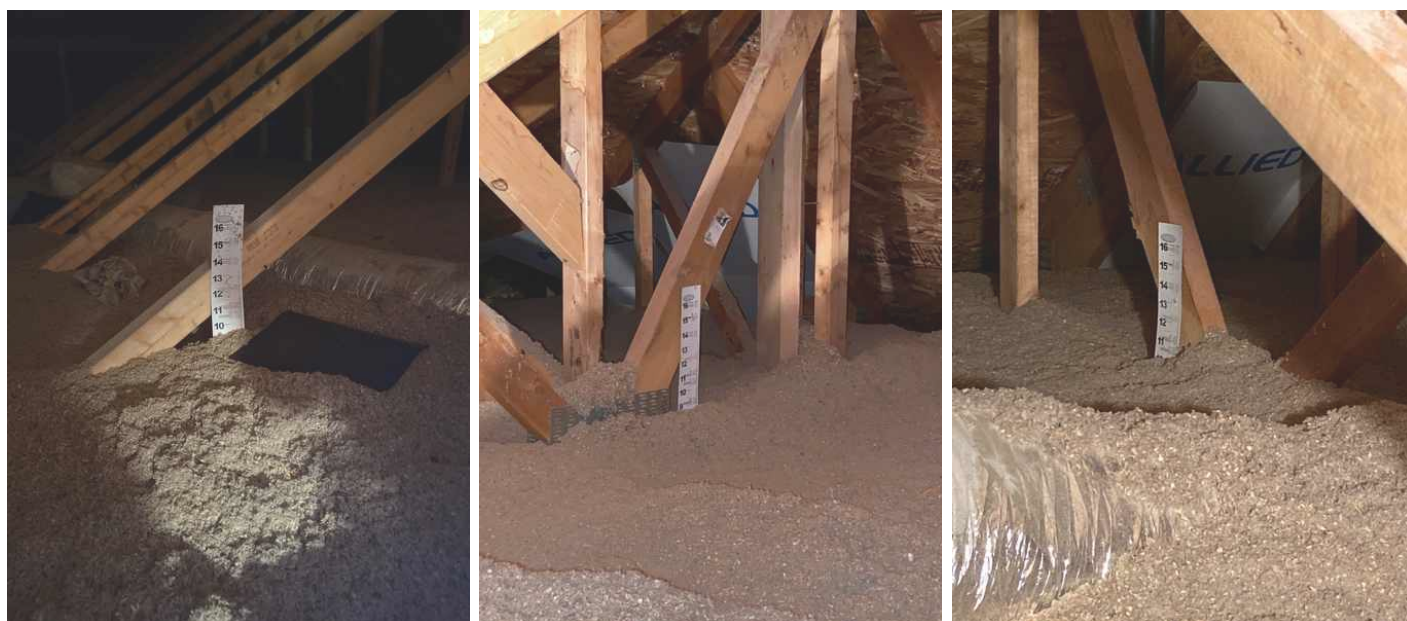
9-12 inches

Determining how much insulation should be installed in a house depends upon where a home is located. The amount of insulation that should be installed at a particular area of a house is dependent upon which climate zone the house is located and the local building codes.

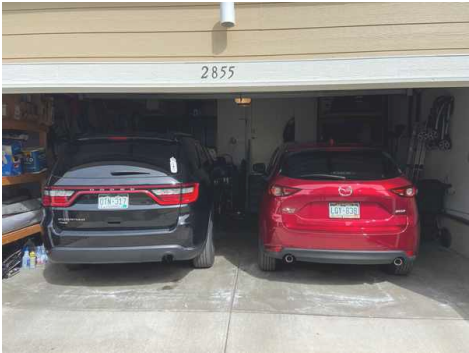
Electric in Garage

## COULD NOT GET TO GFCI OUTLET DUE TO OBSTRUCTIONS

Vehicles and/or materials in garage limited movement to and access to some or all locations.

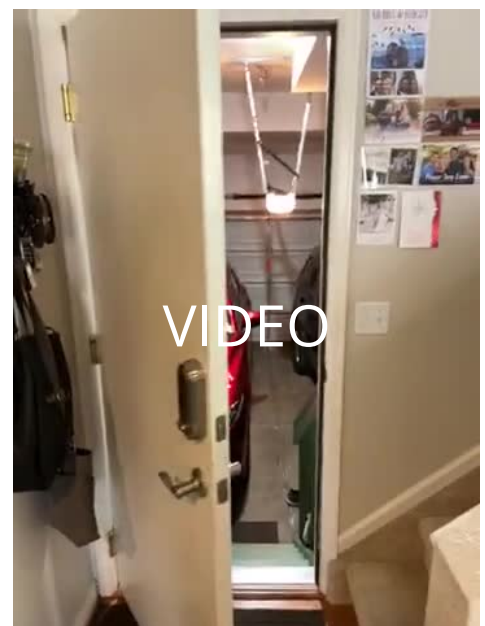
14.5.1 Ceiling, Walls & Firewalls in Garage

### DEFECT AT DOOR BETWEEN GARAGE AND HOUSE

I observed a defect at the door between the garage and the house. Door did not self close.

Contact a qualified general contractor.
