HOME INSPECTION REPORT COPY COPY

1329 196th St E
Spanaway WA 98387

Jeff Scott
MARCH 13, 2019

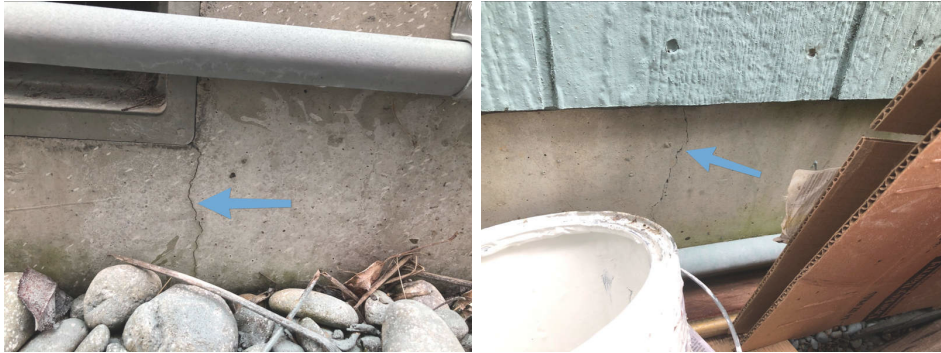
3.6.1 Foundation as Viewed from the Exterior

**SMALL CRACKS**

Hairline and/or small cracks, within normal tolerances were visible. This type of cracking is often a result of shrinkage of materials and/or minor settlement and usually does not affect the performance of the foundation.

Recommend monitoring.

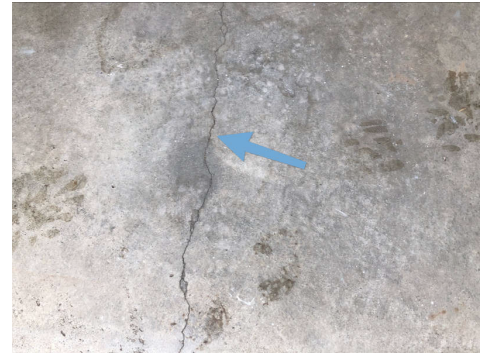
5.5.1 Slab Floor

SMALL CRACKS

The garage slab floor is structurally integral, and has some typical and moderately small cracks that are probably as a consequence of curing, but could indicate the presence of expansive soils. We do not regard these as being structurally threatening, but the slab is integral and you may wish to have an engineer confirm this.

Contact a qualified concrete contractor.

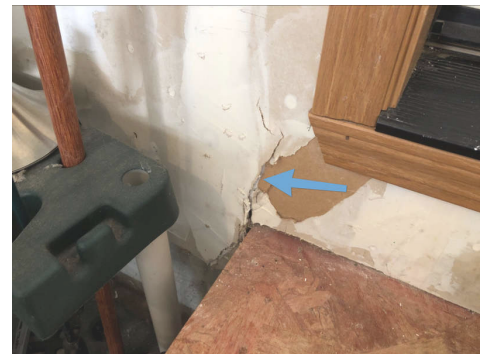
5.8.1 Walls and Ceiling

WALLS/CEILING HAVE DAMAGE

The walls/ceiling have some damage and repair is recommended.

Contact a qualified drywall contractor.

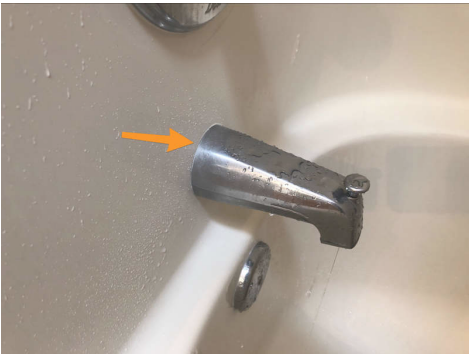
I recommend caulking or sealing around shower valves and faucets etc to help prevent moisture intrusion behind or into the walls. Monitoring these areas is also recommended to help ensure an adequate seal is in place.

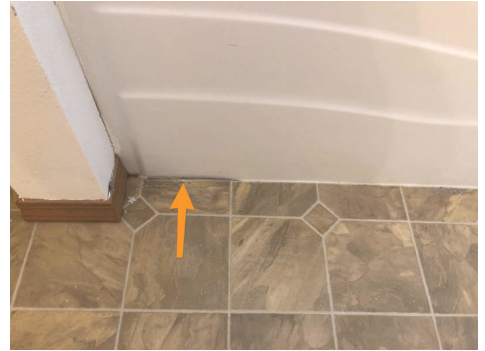
11.4.2 Tub-Shower

MISSING OR DETERIORATED CAULK/GROUT

The tub surround is has missing or deteriorated caulk/grout. Recommend caulking or sealing to prevent moisture intrusion.

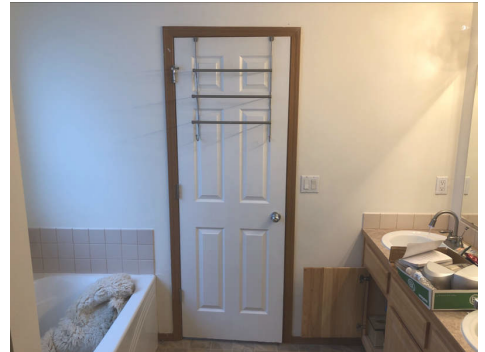
11.9.1 Doors

DOOR RUBS

The door rubs and service is recommended.

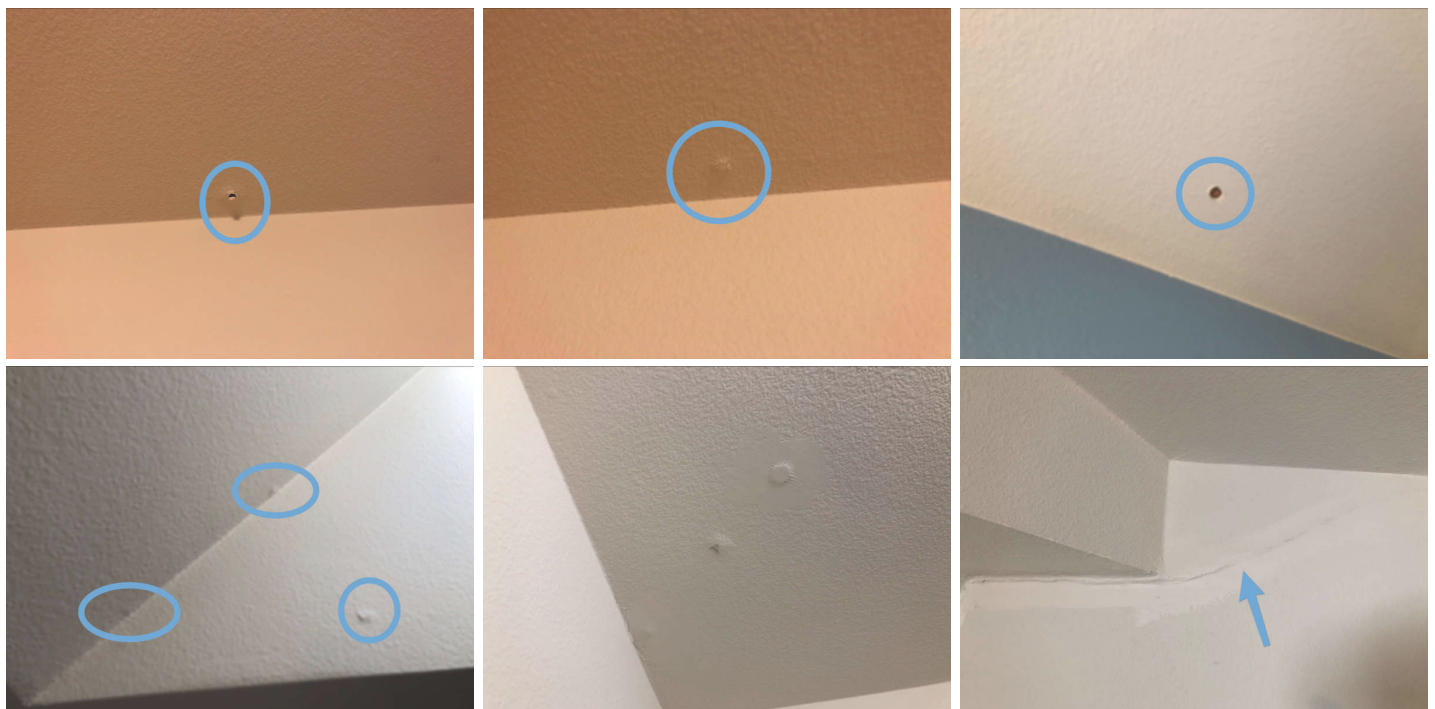
TYPICAL SETTLEMENT CRACKING/NAIL POPS

Observed typical settlement type cracking and nail pops on walls and ceilings. Recommend repairs as needed. Home owner to identify all areas for repair.

Recommend monitoring.

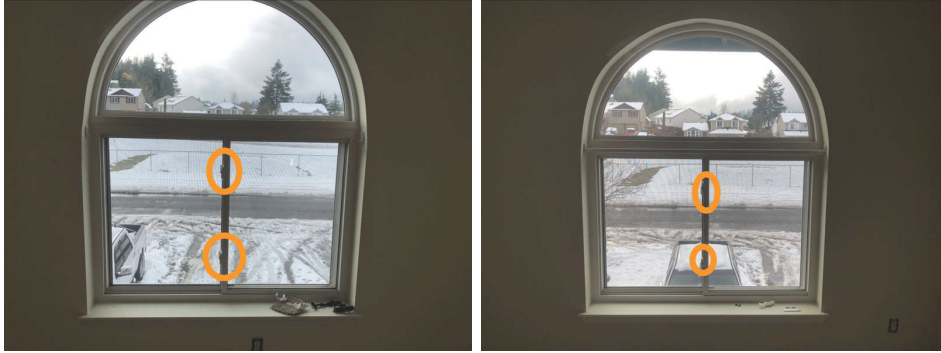
13.5.1 Windows

A WINDOW LOCK IS MISSING OR DOES NOT ENGAGE

A window lock is missing or does not engage, and should be serviced.

Contact a qualified window repair/installation contractor.

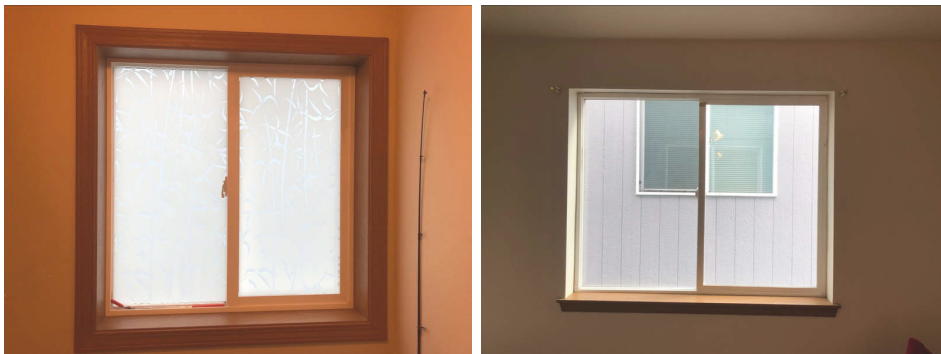
13.5.2 Windows

SCREENS DAMAGED/MISSING

Window screens were missing or damaged in one or more areas. We recommend repair or replacement as needed.

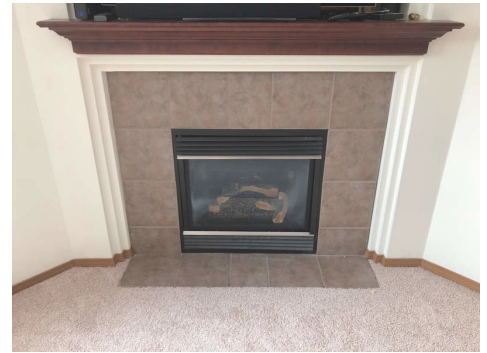
The pilot lite was off on the fireplace and demonstration is recommended.

Contact a qualified handyman.

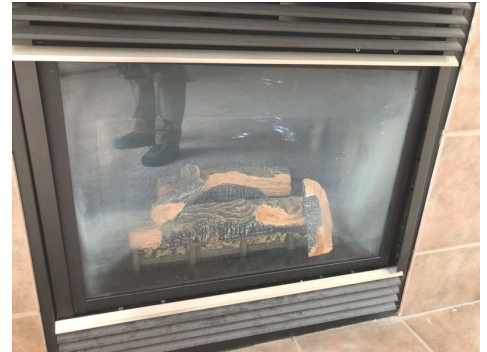
13.9.2 Fireplace Notes

CLEAN GAS FIREPLACE GLASS

The fireplace glass was dirty on the inside of the fireplace. This is a cosmetic issue and typically can be clean. Recommend a service contractor provide this service as desired.

Contact a qualified professional.
