HOME INSPECTION REPORT

233 Norpoint Way NE
Tacoma WA 98422

Jeff Scott
MAY 8, 2019

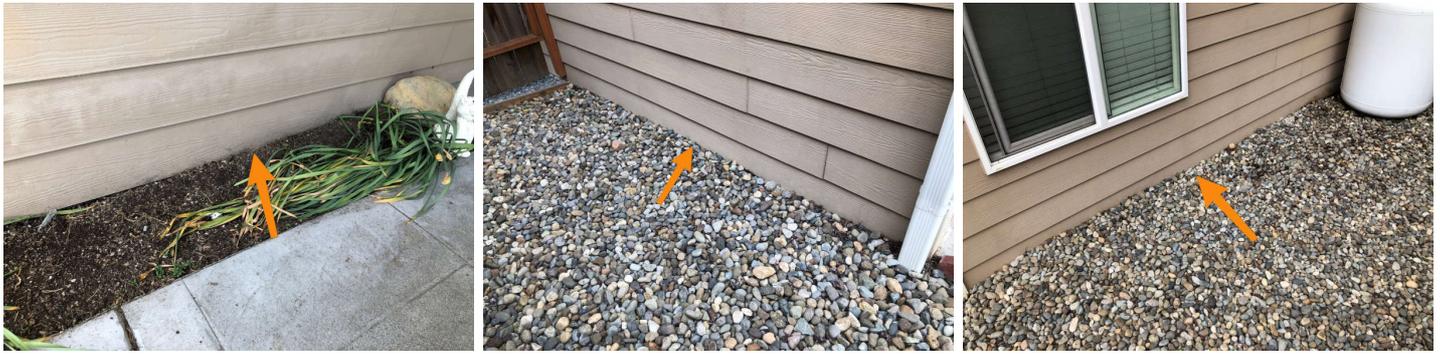
3.5.1 Exterior Siding Notes

The siding was in contact with or nearly contacting soil or mulch or concrete. This is a condition conducive to deterioration and wood destroying organism infestation. We recommend removing soil a six-inch space between any siding material and soil where possible and repairs to any damaged or deteriorated siding.

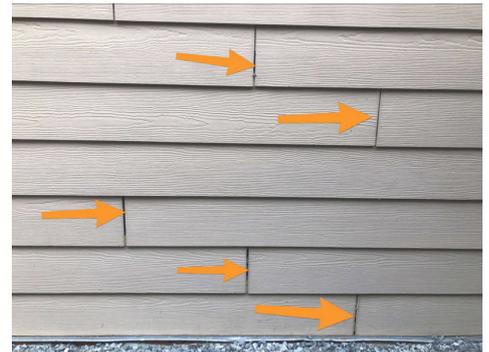
3.5.2 Exterior Siding Notes

SEPARATIONS ON THE SIDING
RIGHT SIDE

Contact a qualified siding specialist.

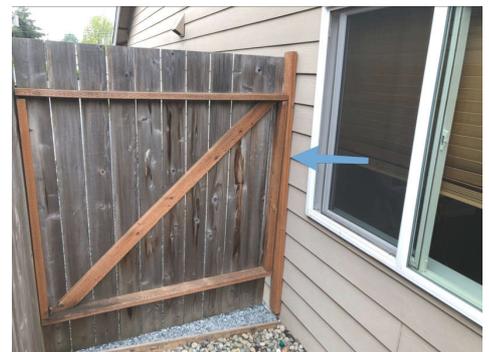
3.5.3 Exterior Siding Notes

FENCE ATTACHED TO HOUSE

Fence(s) were attached to or in contact with the building exterior. Such attachments can serve as a pathway for wood-destroying insects and can retain moisture against the exterior after it rains. We recommend repairs as necessary so there is at least a 2-inch gap between rails and building exteriors.

Contact a qualified professional.

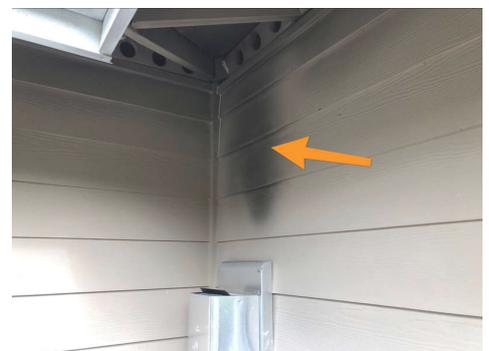
3.5.4 Exterior Siding Notes

GAS FIREPLACE VENT
REAR

The gas fireplace vent is creating black soot marks on the siding. This could be from incomplete combustion of the gas being burned in the fireplace. Recommend repairs.

Contact a qualified professional.

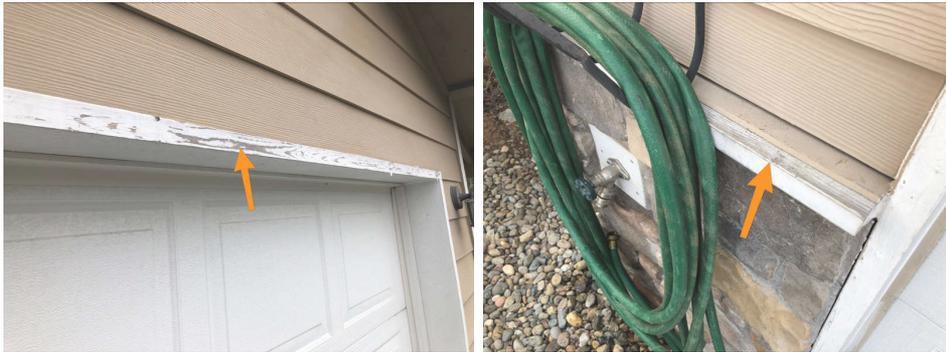
3.7.1 Fascia, Trim & Eaves

SECTIONS OF FASCIA OR WOOD TRIM ARE WEATHERED
FRONT

Sections of the fascia board or wood trim around the residence are slightly weathered, and should be serviced as necessary to prevent further deterioration. Service such as scraping, repainting and sealing.

Contact a qualified handyman.

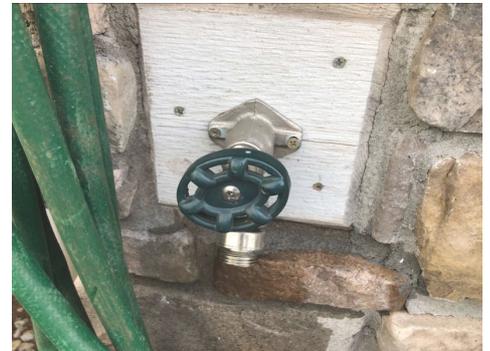
3.8.1 Exterior Plumbing

NOT SECURED TO WALL

The hose bib is not secured to the wall. This could potentially damage the Plumbing. Recommend securing.

Contact a qualified professional.

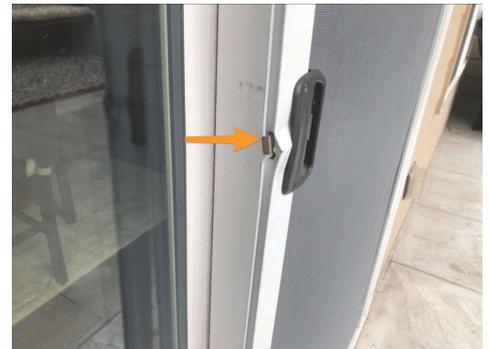
3.10.1 Exterior Doors

SLIDING DOOR SCREEN MISSING/DAMAGED

The rear sliding screen is missing or needs work. Have it repaired by a qualified contractor.

Contact a qualified handyman.

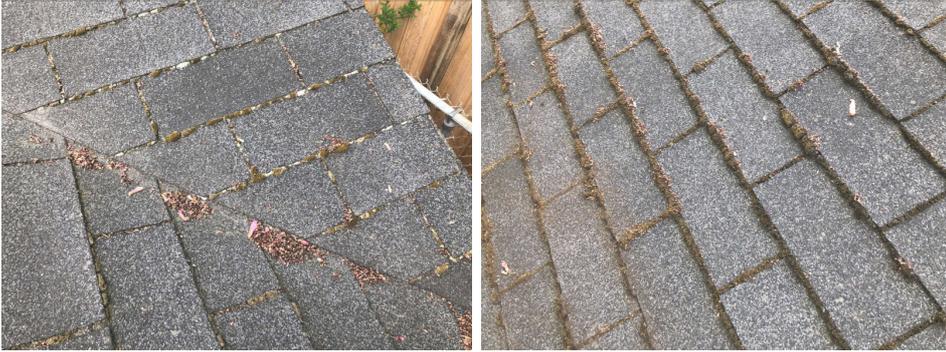
Parts of the roof needs to be cleaned of moss and/or debris. This can restrict drainage and lead to moisture intrusion and moisture damage if not corrected.

Contact a qualified professional.

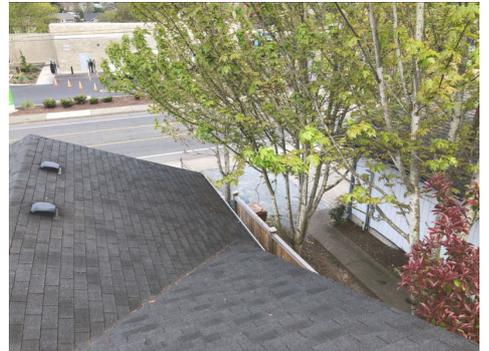
4.3.2 General Observations

Trees near the dwelling have overhanging branches and/or branches in contact with the roof surface, which may cause damage to the roof surface. This condition may also cause the obstruction of roof water runoff and is a access for rodents, animals and carpenter ants. All overhanging or touching branches in contact of the roof surface should be trimmed to eliminate this condition.

Contact a qualified professional.

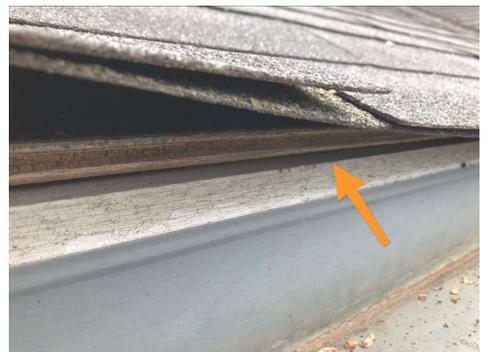
4.4.1 Vents & Flashings

There is no drip-edge at the eaves, or edge of the roof, which is recommended to protect the wood sheathing.

Contact a qualified roofing professional.

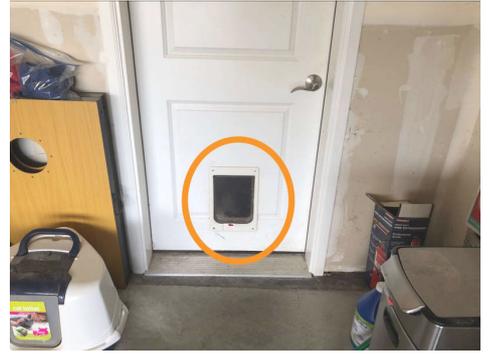
The pet door installed in the main entry door eliminates the door's function as a fire rated door. We advise repair or replacement of the door to return its use as a fire rated door.

Contact a qualified professional.

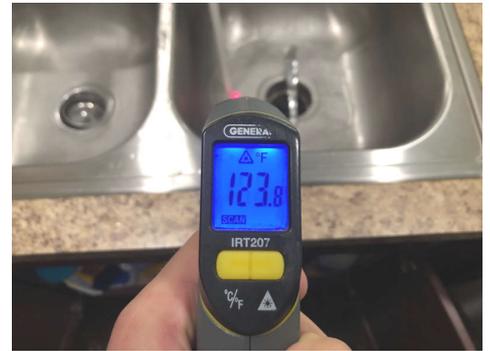
The water temperature is too high and is a potential hazard.
Recommend water temperature be lowed not to exceed 120 degrees.

Recommended DIY Project

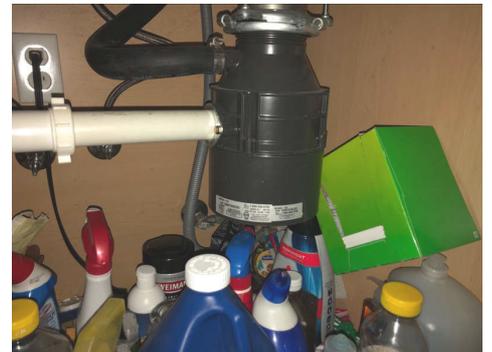
Garbage disposal was excessively noisy. Recommend evaluation and or repair by a qualified licensed professional.

Contact a qualified professional.

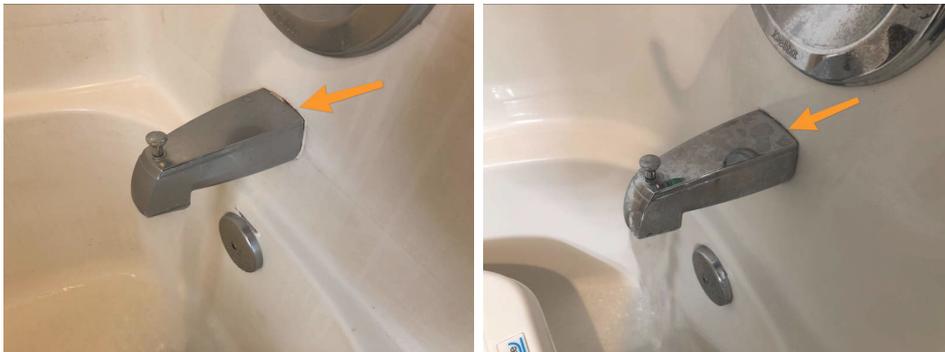
I recommend caulking or sealing around shower valves and faucets etc to help prevent moisture intrusion behind or into the walls. Monitoring these areas is also recommended to help ensure an adequate seal is in place.

Contact a qualified handyman.

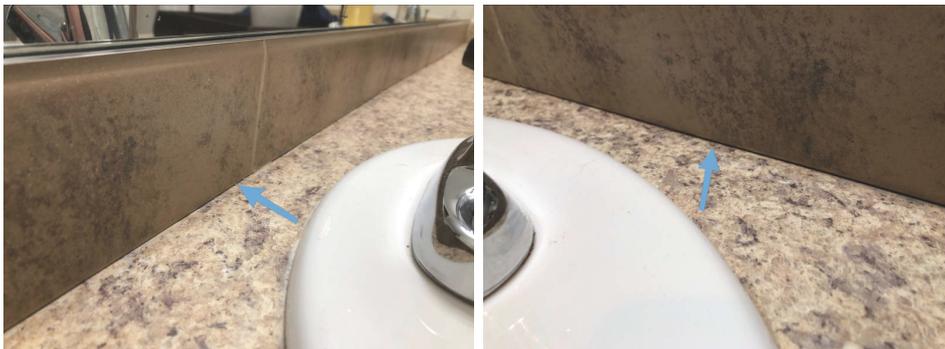
10.6.1 Countertop

Low Priority**MISSING OR DETERIORATED CAULK/GROUT**

The caulking or grout for the backsplash is missing, has gaps and/or not installed properly. We advise caulking/grout be installed and/or gaps filled to prevent possible water intrusion.

Recommended DIY Project

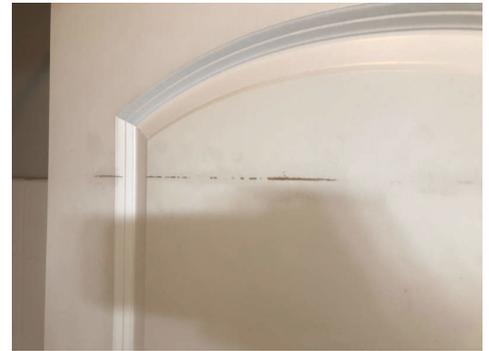
DOOR DAMAGE

The door has damage that you may want repaired

Contact a qualified handyman.

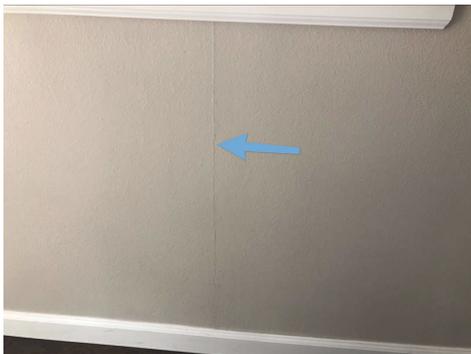
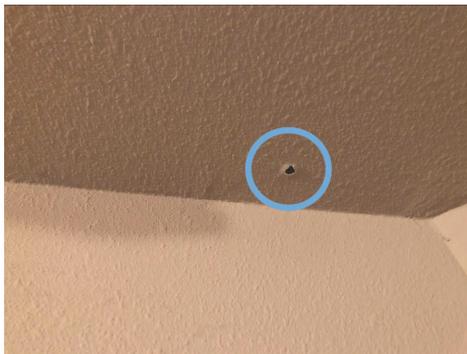
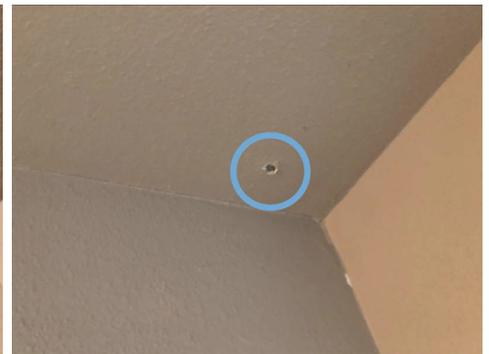
12.4.1 Walls and Ceiling

TYPICAL SETTLEMENT CRACKING/NAIL POPS

Observed typical settlement type cracking and nail pops on walls and ceilings. Recommend repairs as needed. Home owner to identify all areas for repair.

Recommend monitoring.

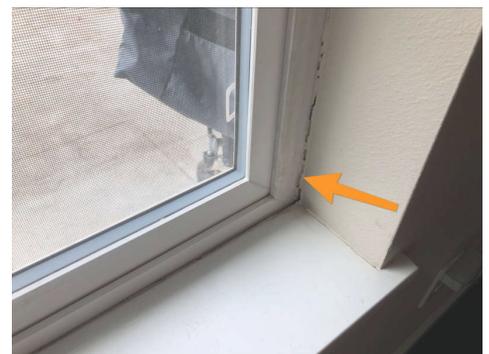
12.5.1 Windows

WINDOW CAULK

The caulk around a window is separated/deteriorated. Recommend repairs.

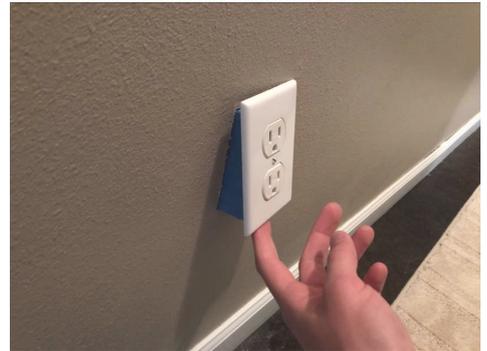
12.10.2 Outlets, Electrical

LOOSE OUTLET

A outlet was loose and should be serviced
