GENERAL HOME INSPECTION

123 Example Ave.
Firestone, Colorado 80504

JULY 10, 2022

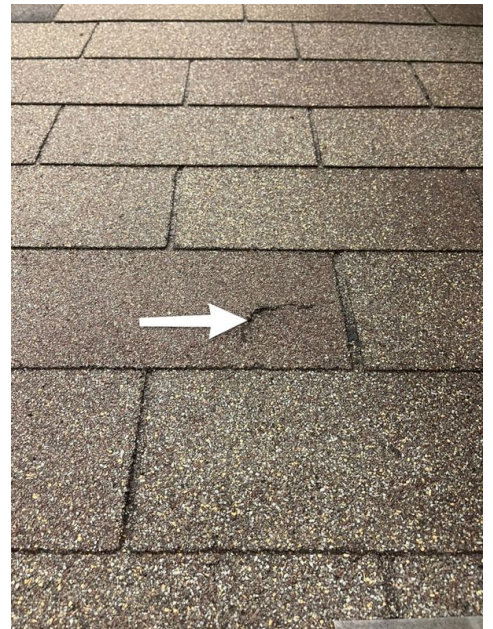
CRACKED ROOF-COVERING MATERIAL
SOUTH SIDE FRONT

Observed: Cracked and damaged shingles.

Concern: Prone to water intrusion and roof leaks.

Recommendation: Further evaluation and correction by a qualified roofing contractor or other qualified professional.

Contact a qualified roofing professional.

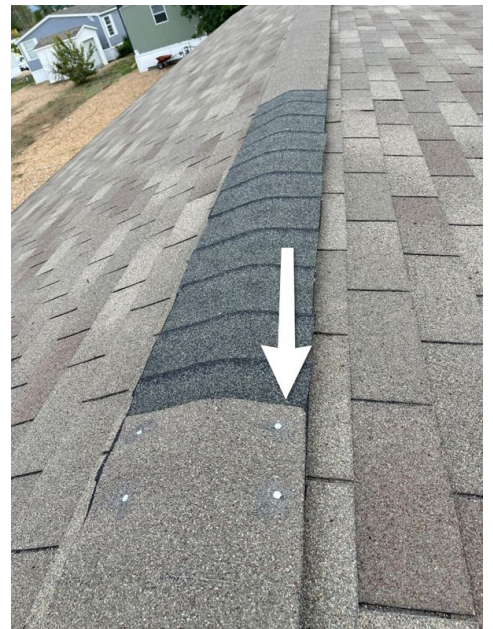
2.2.2 Roof Covering

EXPOSED FASTENERS

Observed: Indications of exposed fasteners at the roof-covering materials. Fasteners should not be exposed.

Concern: Prone to water intrusion and roof leaks.

Recommendation: Further evaluation and correction by a qualified roofing contractor or other qualified professional.

Contact a qualified roofing professional.

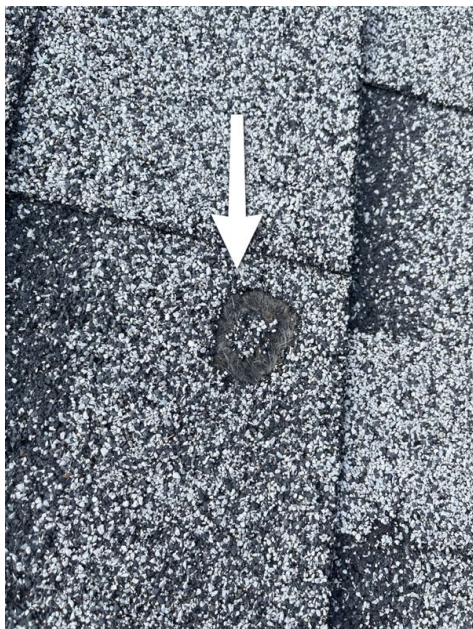
2.2.3 Roof Covering

HAIL DAMAGE

Observed: Indications of hail damage to roof covering.

Concern: Potential performance issues to the rifting system, prone to leaking and water intrusion.

Recommendation: Further evaluation and correction by a roofing contractor or other qualified professional.

Contact a qualified professional.

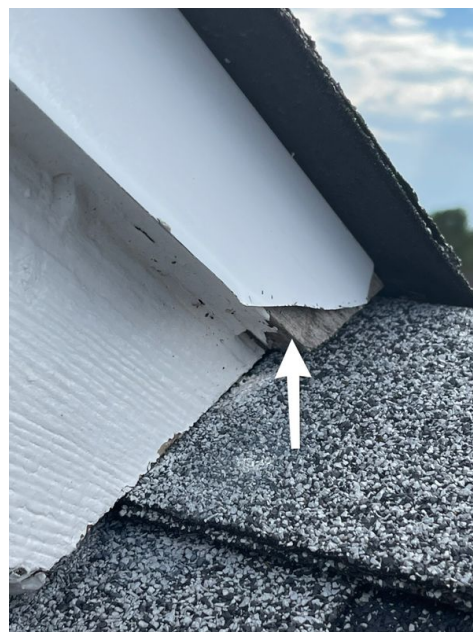
2.3.1 Flashing

MISSING FLASHING

Observed: Areas where flashing was missing or Improper installation of flashing.

Concern: These areas of missing flashing are prone to water penetration. Flashing is installed to provide protection against roof leaks and to divert water away from certain areas.

Recommendation: Further evaluation and correction by a qualified roofing contractor or other qualified professional.

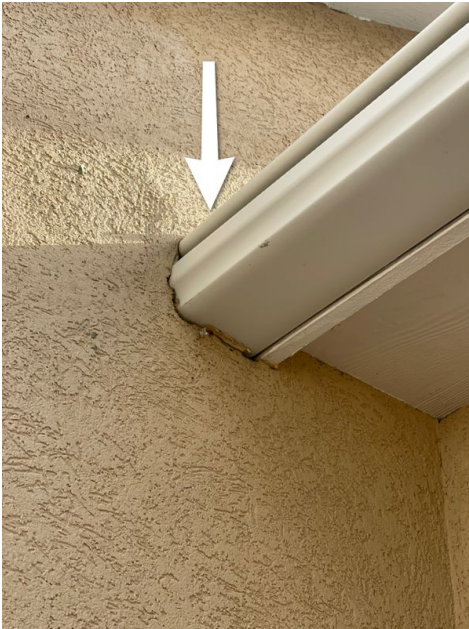
2.3.2 Flashing

MISSING KICKOUT FLASHING

Observed: kickout flashing is missing. Not installed. A kickout flashing "kicks" the roof water away from the house structure and diverts it into a gutter.

Concern: This missing flashing could lead to hidden moisture intrusion and water damage issues that would not be observable during a visual-only home inspection.

Recommendation: Further evaluation and correction by a qualified roofing contractor or other qualified professional.

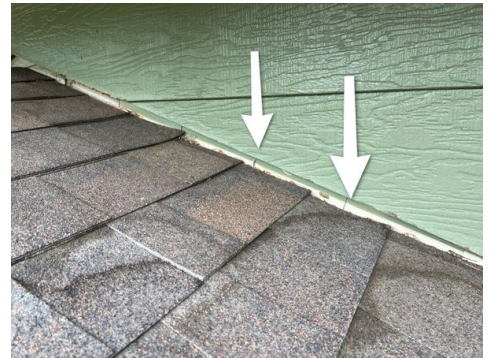
2.3.3 Flashing

STEP FLASHING IMPROPERLY INSTALLED

Observed: Indications that the step flashing on may have been improperly installed.

Concern: Prone to water intrusion and leaking.

Recommendation: Further evaluation and correction by a roofing contractor or other qualified professional.

Contact a qualified professional.

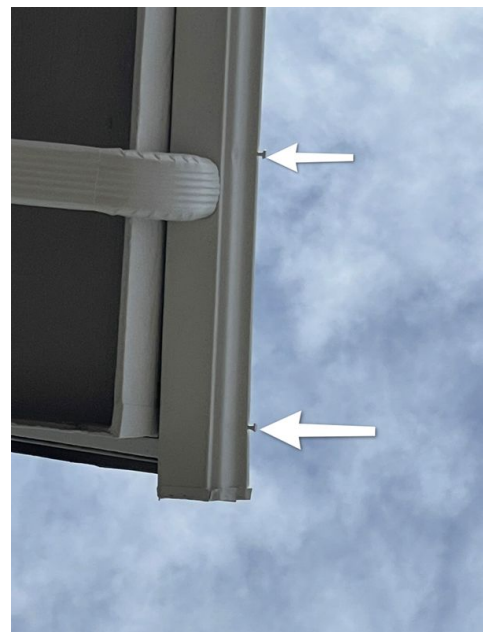
2.6.1 Gutters & Downspouts

GUTTER FASTENING DEFECT

Observed: Indications of a defect at the gutter fastening.

Concern: Damaged gutters can cause excess water to leak or overflow and collect around the foundations of your home. If left unchecked, this excess water can cause cracks in the foundation. When your home's foundation is damaged it can lead to a structural damage to your home.

Recommendation: Further evaluation and correction by a qualified Gutter Contractor or other qualified professional.

Contact a qualified gutter contractor

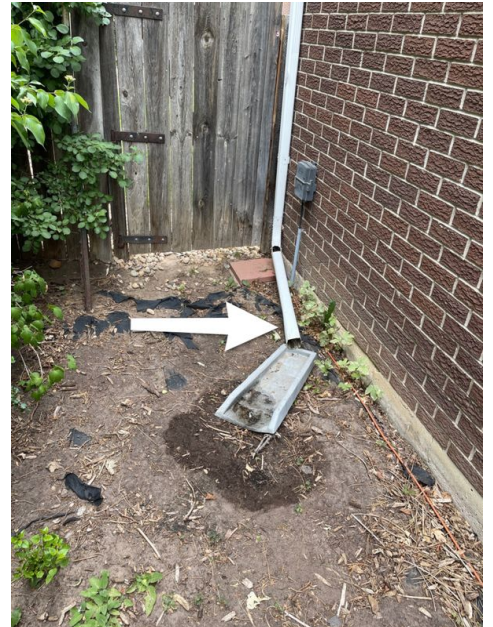
2.6.2 Gutters & Downspouts

Observed: One or more downspouts drain too close to the home's foundation.

Concern: This can result in excessive moisture in the soil at the foundation, which can lead to foundation/structural movement. Downspout extensions to drain at least 6 feet from the foundation.

Recommendation: This adjustment is typically easy to do yourself. If additional assistance is needed, Further evaluation and correction by a qualified Gutter Contractor or other qualified professional.

Recommended DIY Project

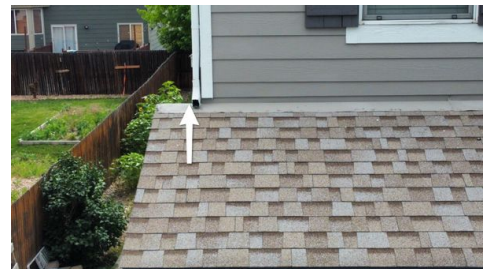
2.6.3 Gutters & Downspouts

Observed: Downspout Terminating onto the roof covering.

Concern: may cause accelerated deterioration of the roof covering material at the point of discharge and lead to water intrusion under the roof covering or into the structure.

Recommendation: Further evaluation and correction by a qualified Gutter Contractor or other qualified professional.

Contact a qualified professional.

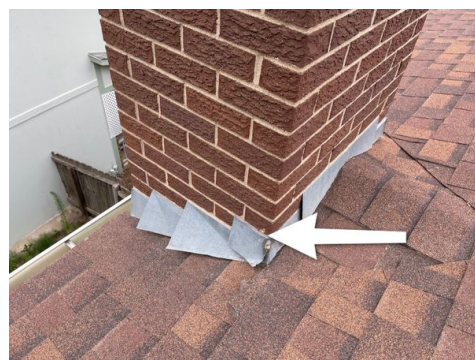
CHIMNEY FLASHING DEFECT

Observed: Defect at the chimney flashing.

Concern: This condition may cause water intrusion or leaks. May cause deterioration of the chimney system.

Recommendation: Further evaluation and correction by a qualified Chimney Repair contractor or other qualified professional.

Contact a qualified chimney contractor.

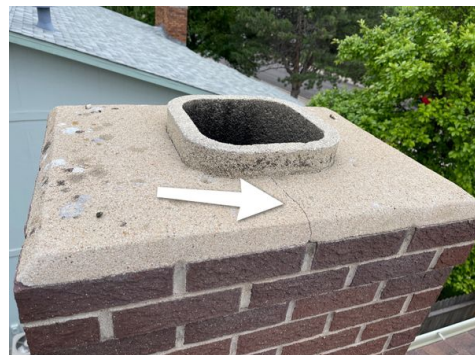
CROWNED CAP DEFECT

Observed: Indications of a defect at the chimney crowned cap. This is the top of the chimney that is shaped or "crowned" to divert water away from the top of the chimney stack. (Cracking)

Concern: This condition may cause water intrusion or leaks. May cause deterioration of the chimney system.

Recommendation: Further evaluation and correction by a qualified Chimney Repair contractor or other qualified professional.

Contact a qualified chimney contractor.

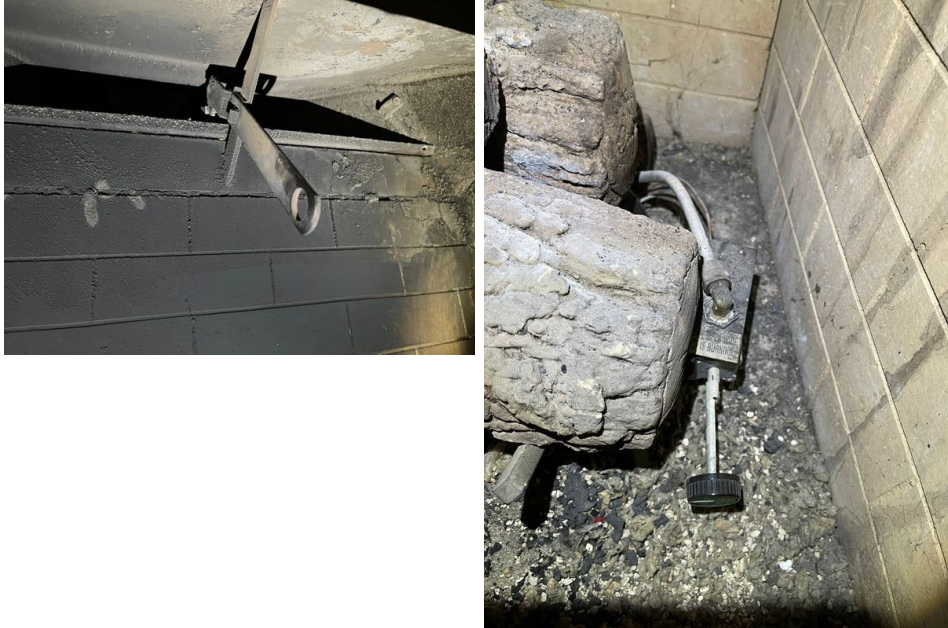
**DEFECT AT DAMPER DOOR**

Observed: Defect at the fireplace damper door. The damper door should be removed or permanently secured open when a gas insert is installed into the fire place.

Concern: This is a fire hazard and potential safety risk of carbon monoxide build up in the home.

Recommendation: Further evaluation and correction by a qualified Chimney Repair contractor or other qualified professional.

Contact a qualified fireplace contractor.

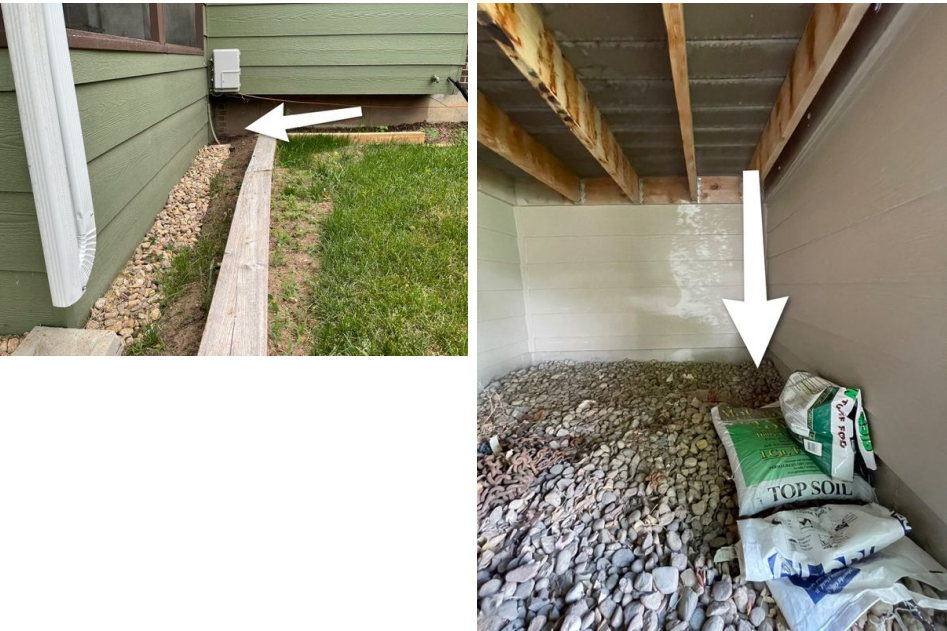
Observed: Grading is sloping towards the home in some areas. The ground around a house should slope away from all sides, ideally 6 inches for the first 10 feet from the house foundation perimeter. Downspouts, surface gutters and drains should also be directing water away from the foundation.

Concern: This could lead to water intrusion and foundation issues.

Recommendation: Further evaluation and correction by a qualified Landscape contractor or other qualified professional.

Contact a qualified landscaping contractor

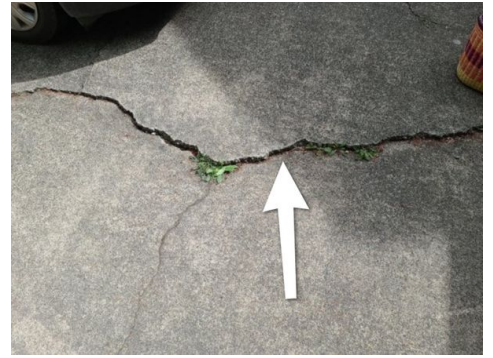
4.3.1 Walkways & Driveways

MAJOR CRACKING AT WALKWAY

Observed: Major cracking at the walkway.

Concern: Cracking in pavement can lead to water intrusion which may result in further deterioration of the system and heaving due to freeze thaw cycles. This also may be or become a trip hazard.

Recommendation: Further evaluation and correction by a qualified Concrete contractor or other qualified professional.

Contact a handyman or DIY project

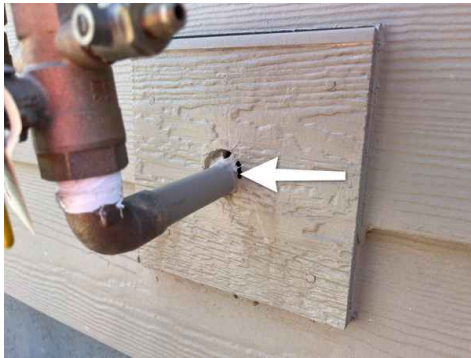
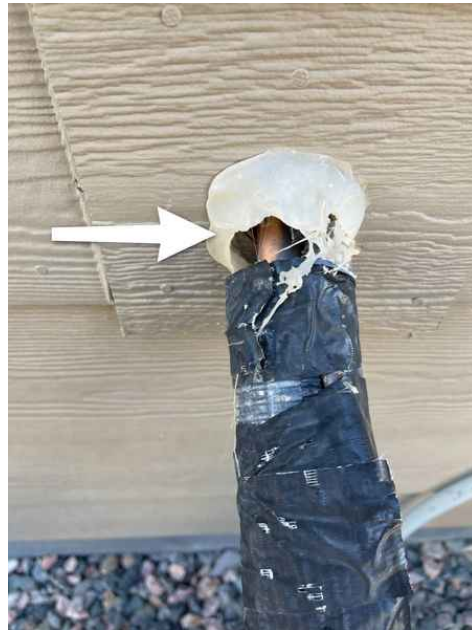
4.4.1 Wall-Covering, Flashing & Trim

CAULKING NEEDED

Observed: At the time of inspection multiple locations were observed as in need of sealing and caulking.

Concern: Missing or deteriorated caulking could allow for water penetration or leaking.

Recommendation: Further evaluation and correction by a qualified General contractor or other qualified professional.

Contact a qualified professional.

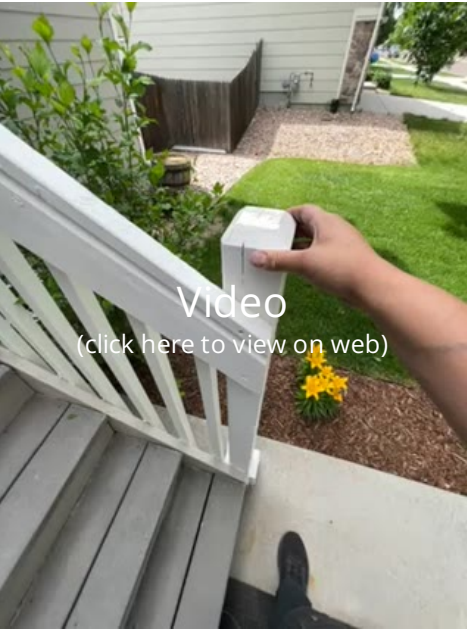
4.9.1 Stairs, Steps, Stoops, Stairways & Ramps

LOOSE HANDRAIL

Observed: Loose handrail.

Concern: This condition is a safety hazard.

Recommendation: Further evaluation and correction by a qualified contractor or other qualified professional.

Contact a qualified professional.

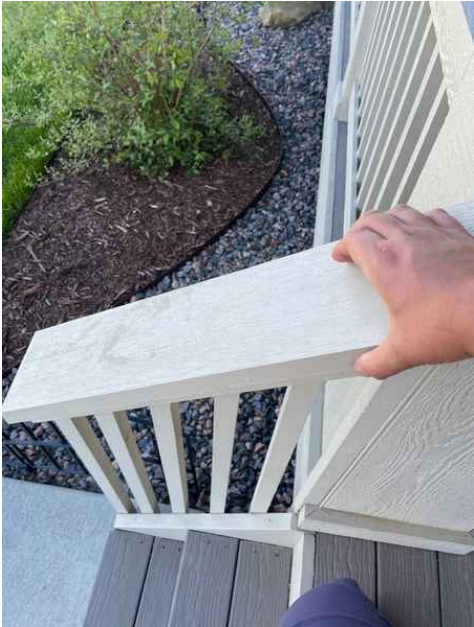
4.10.1 Railings, Guards & Handrails
HANDRAIL NOT GRASPABLE

Observed: Handrail that is not graspable.
Concern: Potential safety risks.
Recommendation: Further evaluation and correction by a qualified contractor or other qualified professional.
Recommendation
Contact a qualified general contractor.

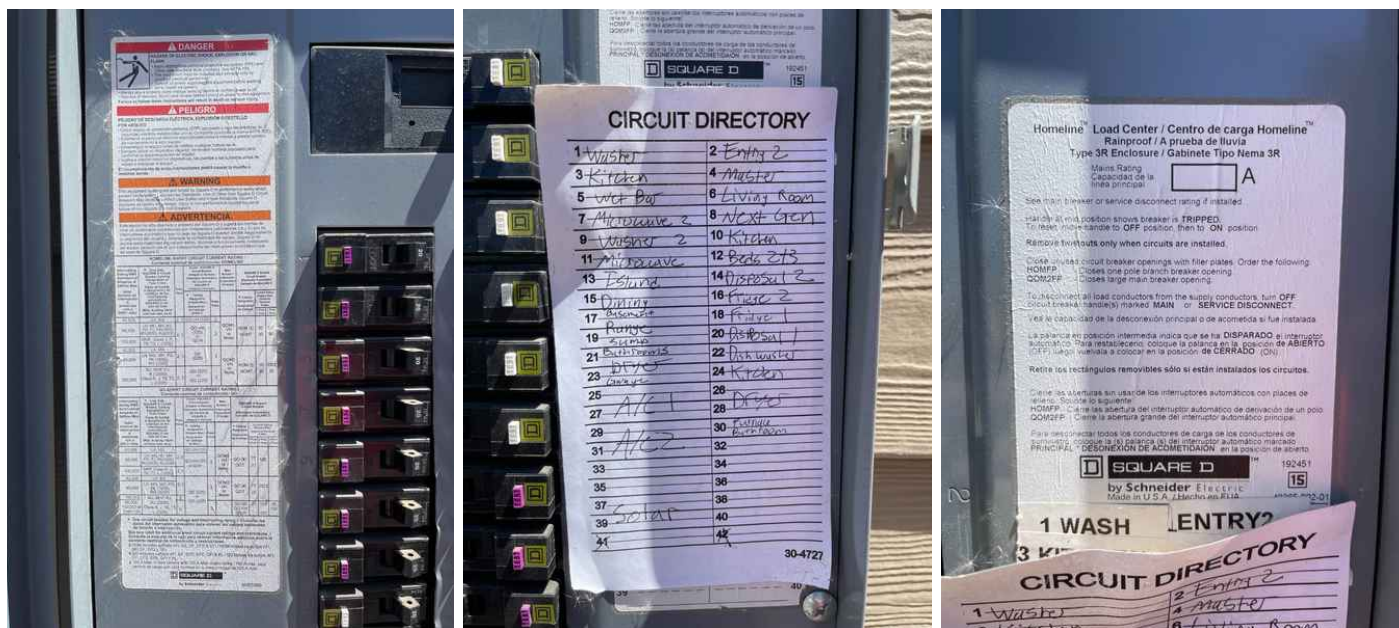
General: Data Photos

Main Service disconnect

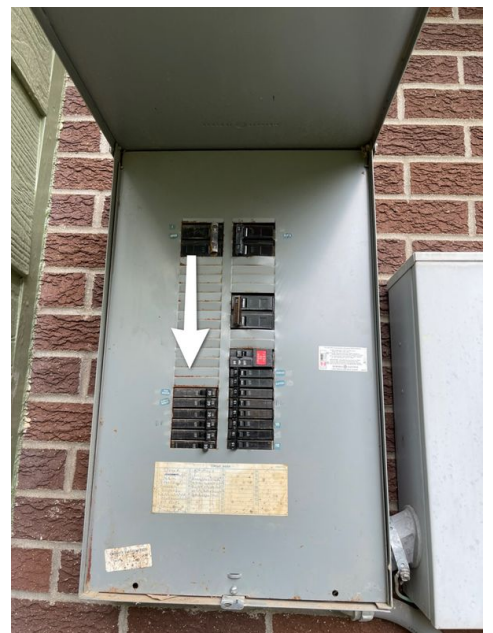
RUST, CORROSION, WATER INSIDE CABINET

Observed: Indications of water intrusion, rust and corrosion inside the electrical panel cabinet.

Concern: Electrical hazard!

Recommendation: Further evaluation and correction by an electrical contractor or other qualified professional.

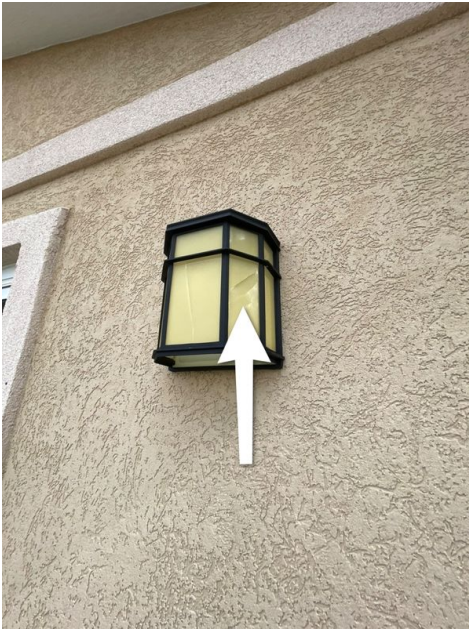
5.12.1 Electrical Defects

BROKEN LIGHT FIXTURE EXTERIOR

observed a broken light fixture on the exterior back of the home.

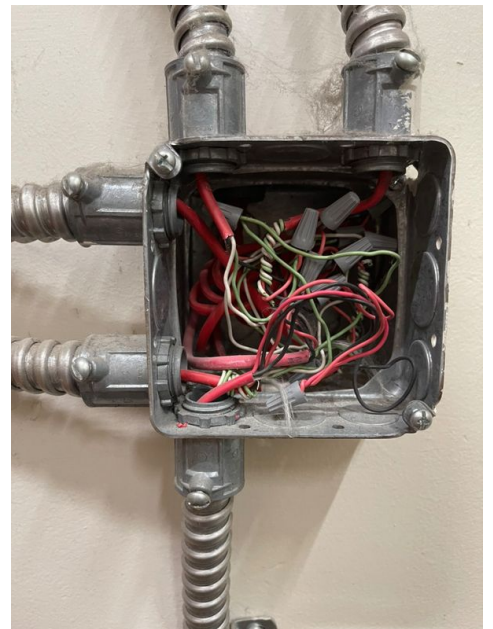
5.12.2 Electrical Defects

MISSING JUNCTION BOX COVER

Observed: missing cover on junction box.

Concern: potential electrical and safety hazard.

Recommendation: Potential DIY project if unsure how to correct safely and properly then further evaluation and correction by an electrical contractor or other qualified professional.

Contact a qualified professional.

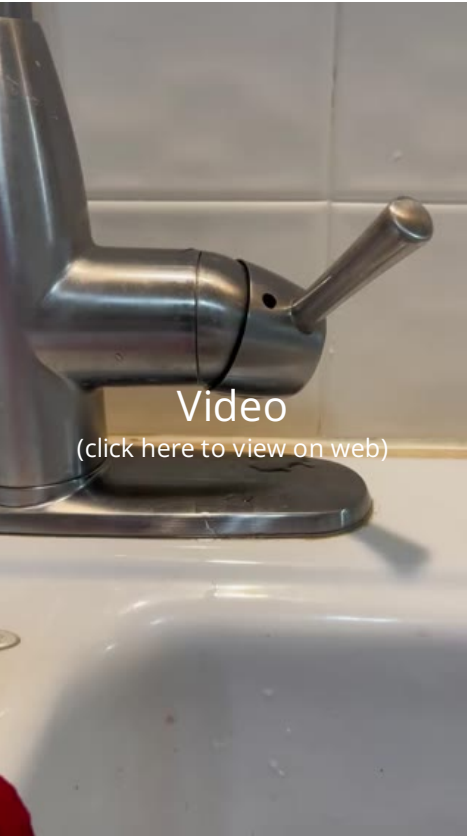
10.2.1 Kitchen Sink

DEFECT AT THE KITCHEN SINK

Observed: Indications of a defect at the kitchen sink.

Recommendation: Further evaluation and correction by an Plumbing contractor or other qualified professional.

Recommendation
Contact a qualified plumbing contractor.

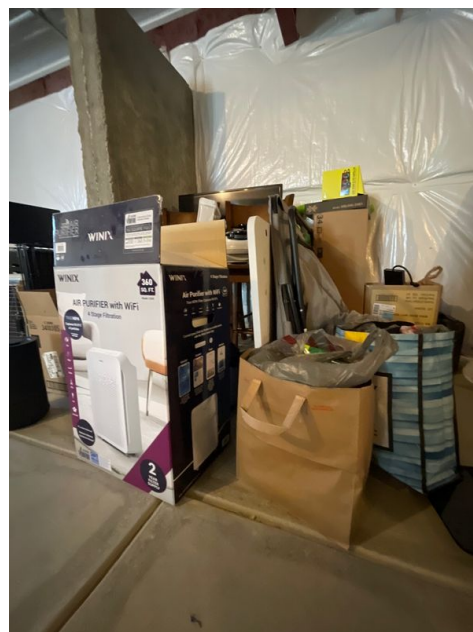
PERSONAL STORAGE RESTRICTION

Personal items limited my visual inspection. Moving personal items and storage is not required by the Standards of Practice. I could not see everything. Many things were blocking my inspection.

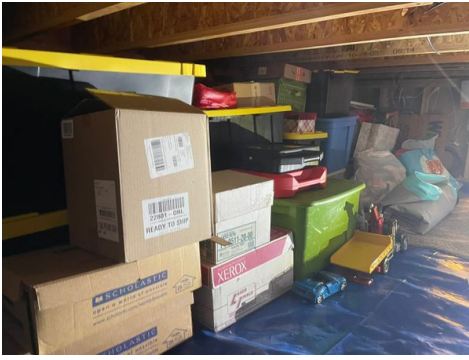
Crawlspace

PERSONAL STORAGE RESTRICTION

Personal items limited my visual inspection. Moving personal items and storage is not required by the Standards of Practice. I could not see everything. Many things were blocking my inspection.

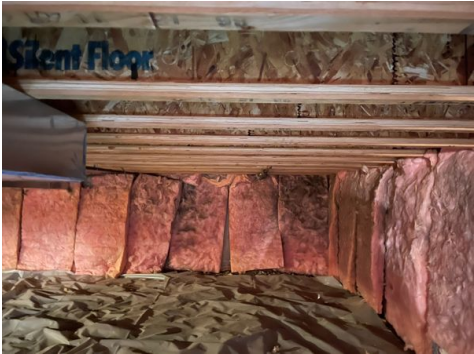
11.5.2 Crawlspace

VAPOR BARRIER DEFECT

Contact a qualified professional.

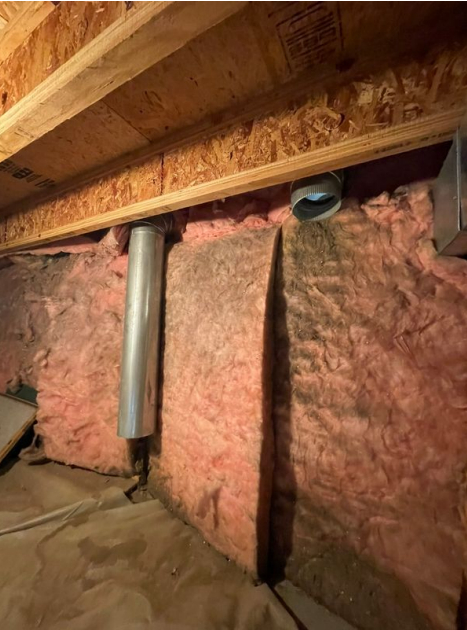
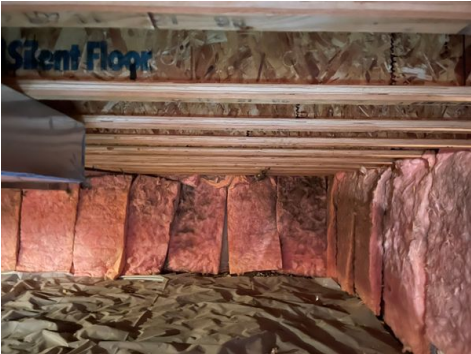
11.6.1 Insulation in Crawlspace

INSULATION HANGING LOOSELY

Contact a qualified insulation contractor.
