RED FLAG HOME INSPECTION RESIDENTIAL REPORT

10308 Greenhedges Dr
Tampa, FL 33626

David Smith
MARCH 23, 2022

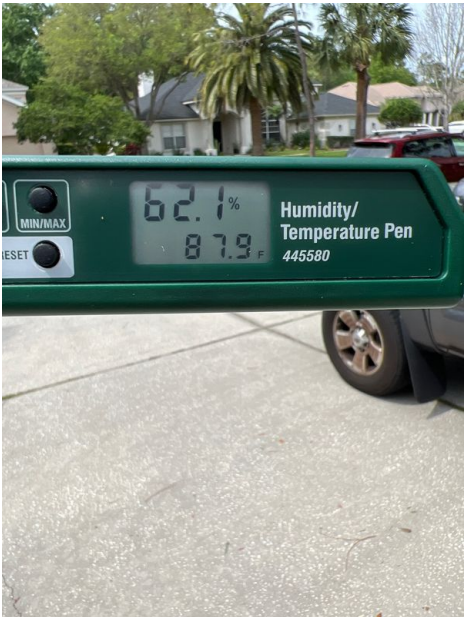
In Attendance Client, Home Owner, Listing Agent	Occupancy Furnished, Occupied	Style Modern
Type of Building Single Family	Weather Conditions Hot, Clear, Humid	Temperature/Humidity at Exterior (for Baseline Reference) Driveway 87.9 F, 62.1 % Humidity

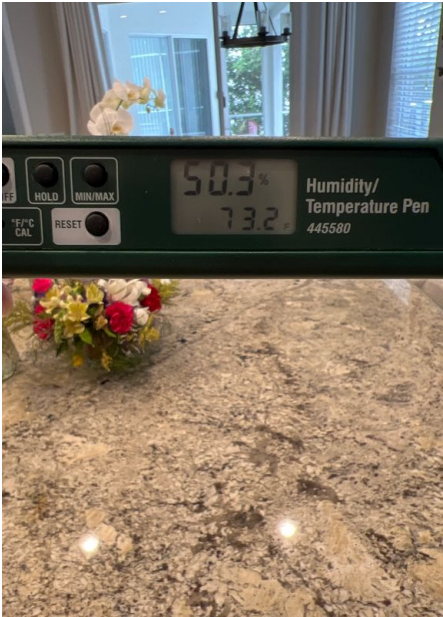
Kitchen

Indoor temperature and humidity

73.2 F, 50.3% Humidity

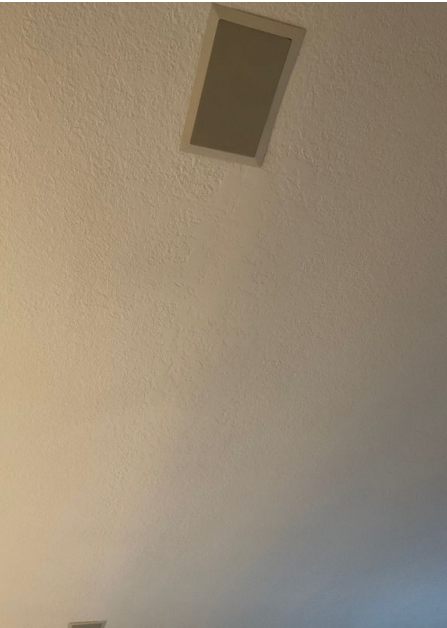
Floors, Walls & Ceilings: Thermal Image Anomaly

Playroom

Thermal imaging revealed an area in the ceiling that is warmer than the rest of the ceiling possibly due to missing insulation. Recommend that this be investigated by a qualified contractor.

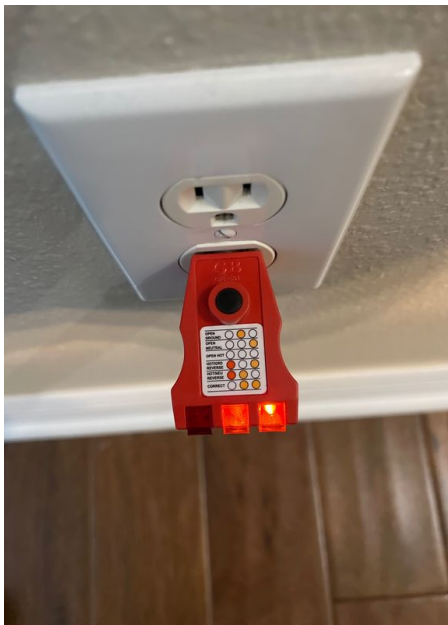
Floors, Walls & Ceilings: Electrical Receptacles

Tested a representative number of electrical receptacles and all functioned as expected.

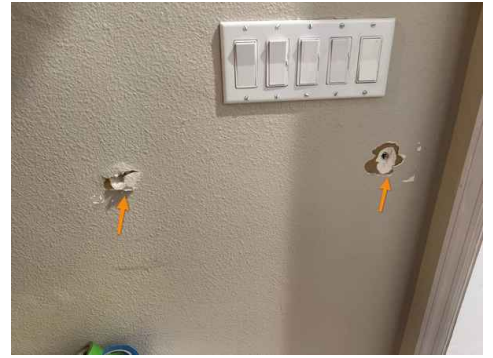
DAMAGED DRYWALL

Drywall damage visible in the entryway likely due to wall anchors failing.

Contact a qualified drywall contractor.

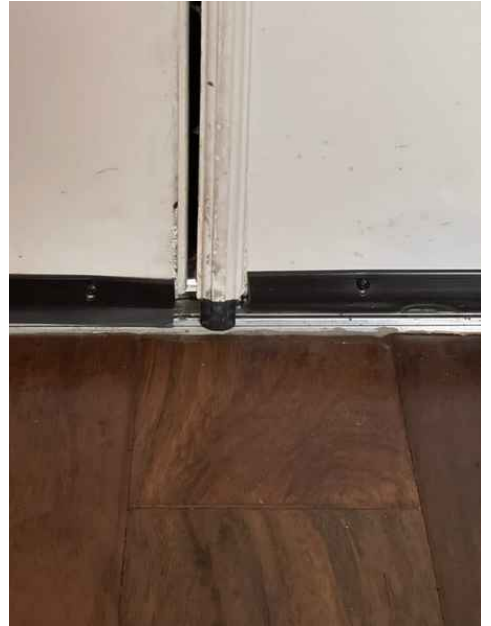
Air gap exists at the base of the French door which could lead to energy loss and pest infestation. Recommend handyman or door contractor evaluate.

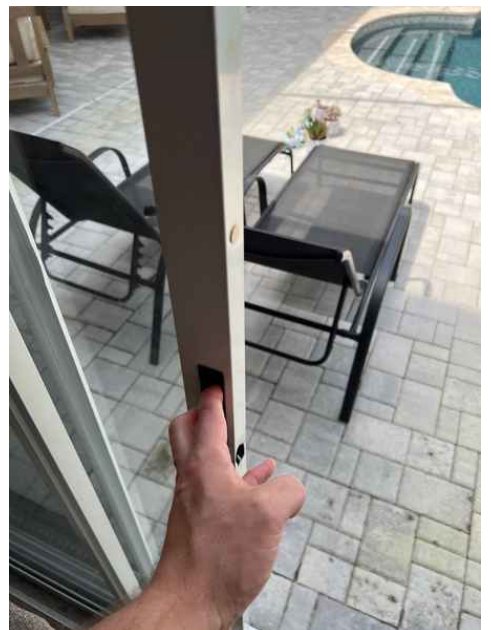
3.1.2 Doors

PATIO DOOR DOESN'T SLIDE SMOOTHLY

Contact a qualified door repair/installation contractor.

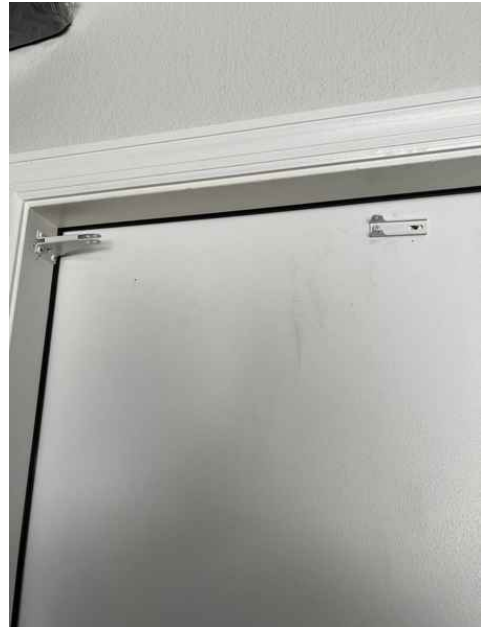
3.1.3 Doors

FIRE DOOR SELF-CLOSE MECHANISM MISSING

Contact a qualified door repair/installation contractor.

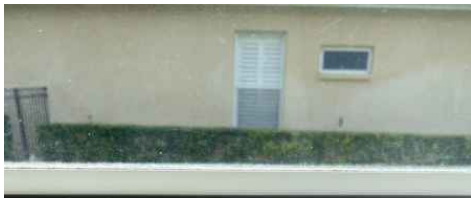
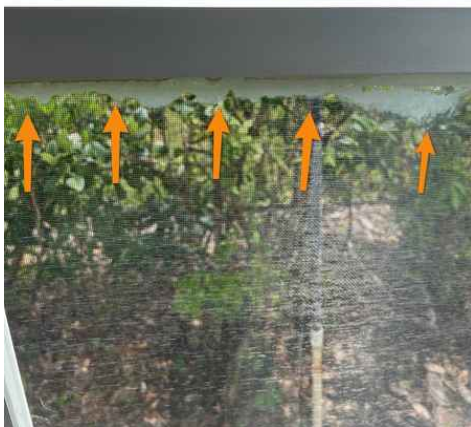
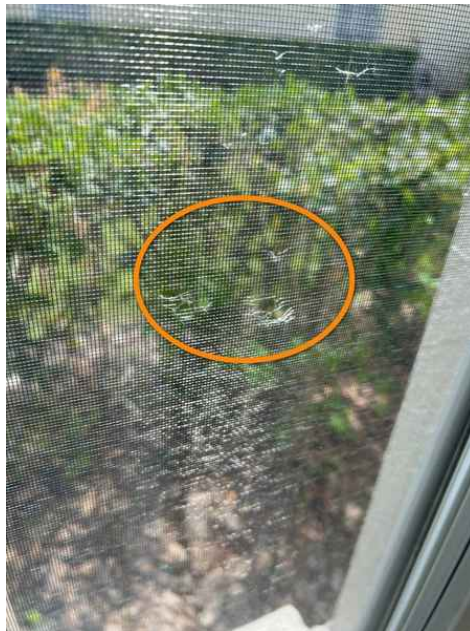
3.2.1 Windows

DAMAGED WINDOW

One or more windows appears to have general damage, but are operational in the East middle bedroom. There is staining on the glazing and the screen is damaged. Recommend a window professional clean, lubricate & adjust as necessary.

Contact a qualified window repair/installation contractor.

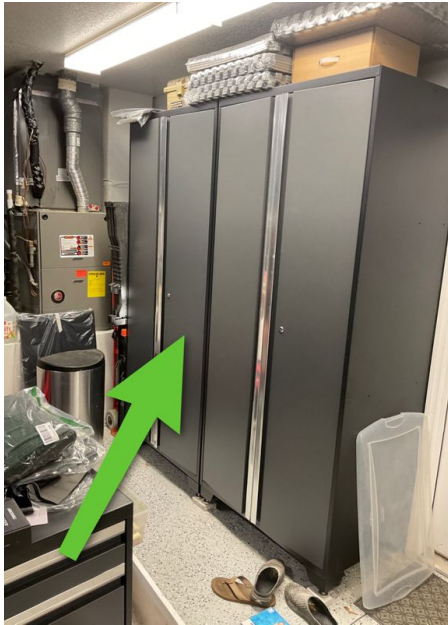
GFCI & AFCI, Grounding & Bonding: GFCI Outlets were tested and reset without Issue (No Defect)

GFCI Outlets were tested and reset without Issue (No Defect)

Bathroom gfci protection triggers the gfci outlet in the garage cabinet.

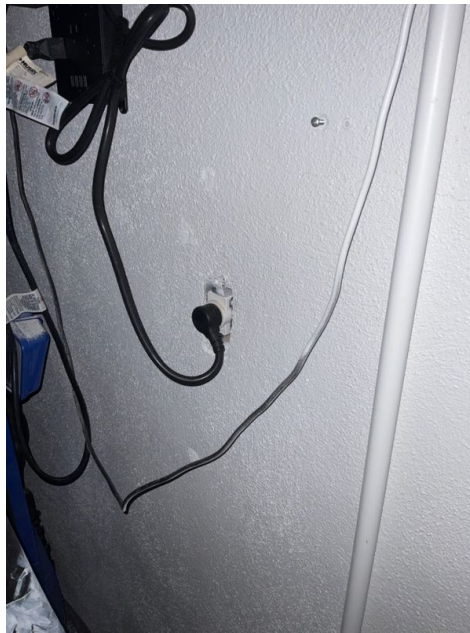
5.5.1 Lighting Fixtures, Switches & Receptacles

COVER PLATES MISSING

One or more receptacles are missing a cover plate. This causes short and shock risk. Recommend installation of plates.

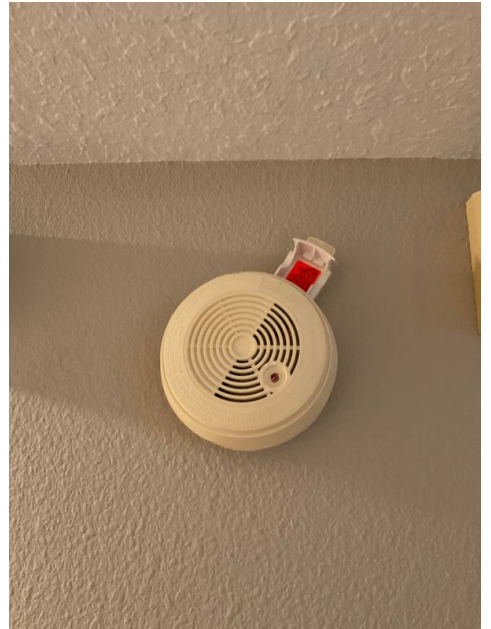
5.7.1 Smoke Detectors

SMOKE DETECTORS ARE TOO OLD

The Smoke Detectors were over 10 years old and should be replaced.

Recommended DIY Project

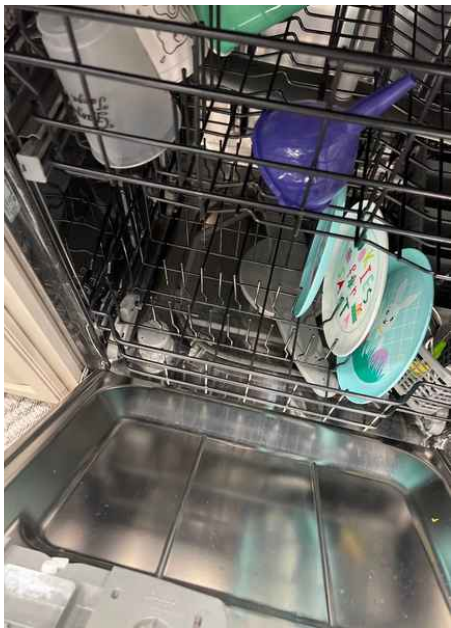
Dishwasher: Inspected Dishwasher

I inspected the dishwasher by turning it on and letting it run a short cycle.

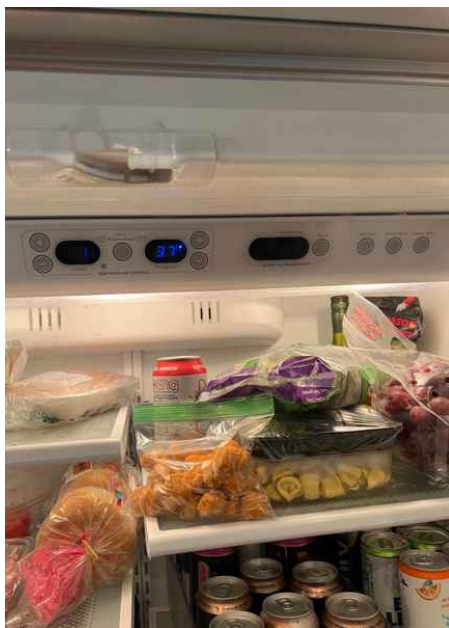
Refrigerator: Refrigerator Was On

I checked to see if the refrigerator was on. It was. That's all I inspected in relation to a refrigerator. Refrigerators are beyond the scope of a home inspection.

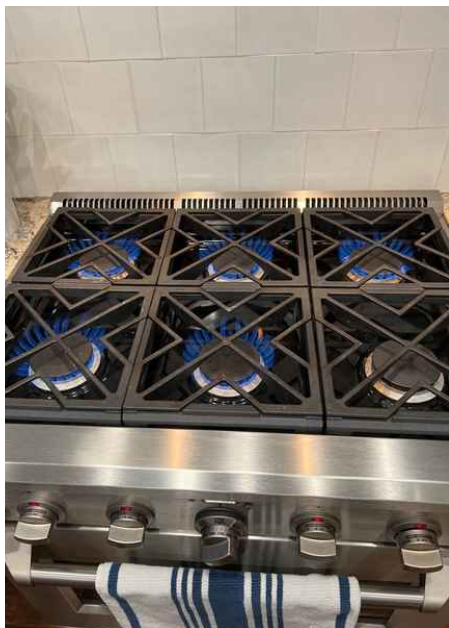
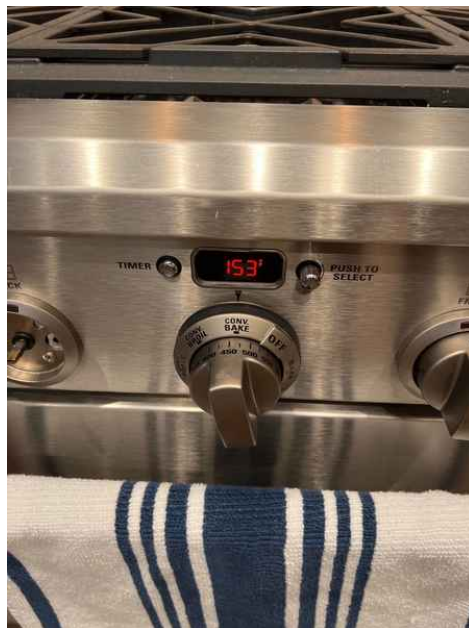
Range/Oven/Cooktop: Turned On Stove & Oven

I turned on the kitchen's stove and oven.

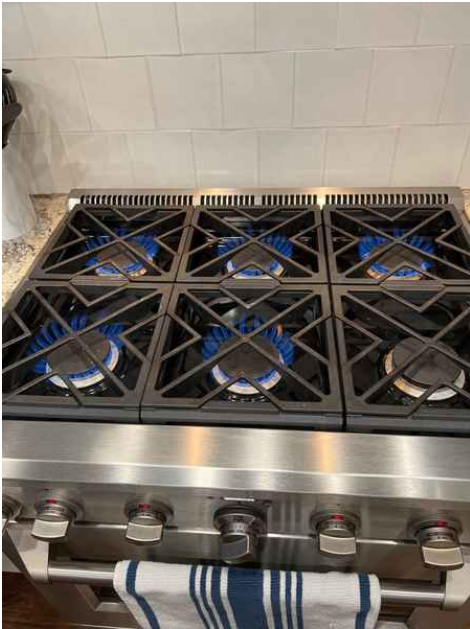
6.3.1 Range/Oven/Cooktop

BURNER NOT LIGHTING

One or more heating elements did not heat up when turned on. Recommend qualified professional evaluate & repair.

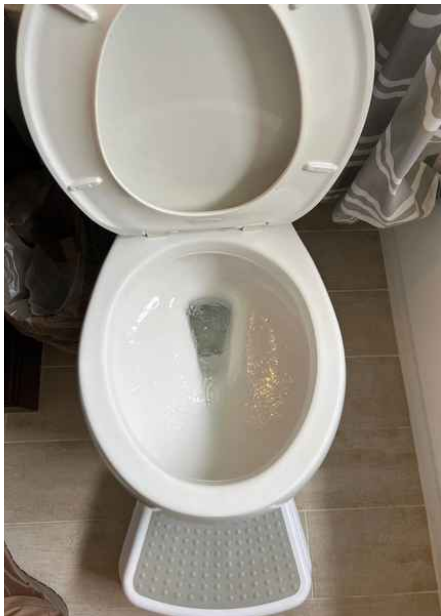
Toilets: Toilets inspected and flushed

I flushed all of the toilets.

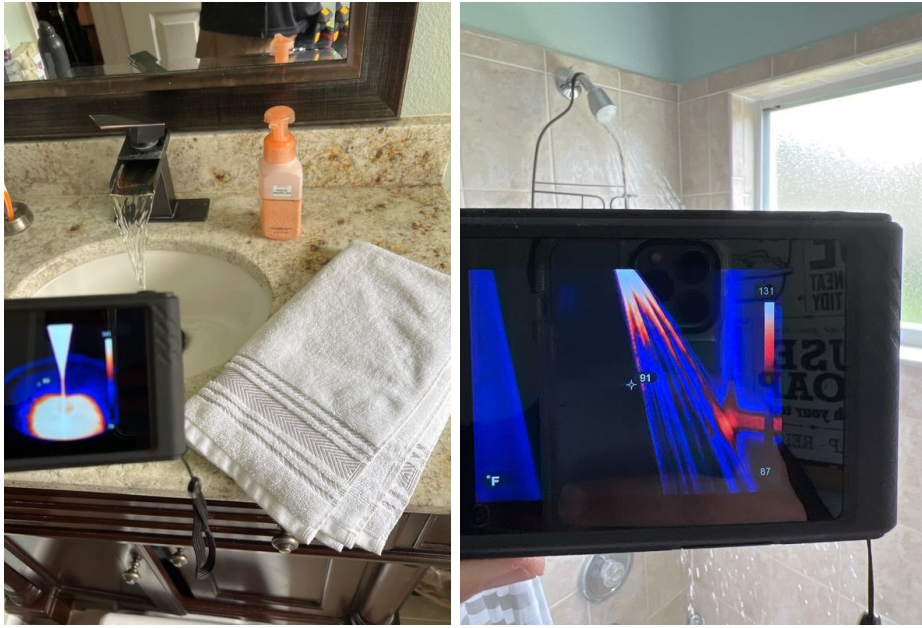
Sinks, Tubs & Showers: Ran Water at Sinks, Tubs & Showers

I ran water at all bathroom sinks, bathtubs, and showers. I inspected for deficiencies in the water supply by viewing the functional flow in two fixtures operated simultaneously.

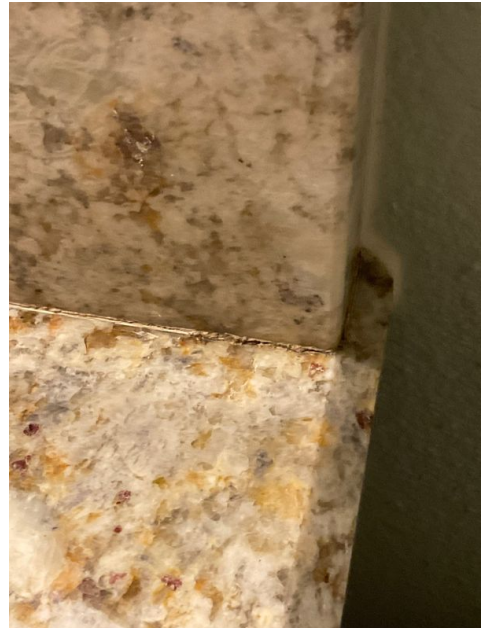
7.5.1 Countertops & Surfaces

POOR/MISSING CAULK

Bathroom countertop was missing sufficient caulk/sealant at the wall. This can lead to water damage. Recommend adding sealant at sides and corners where counters touch walls.

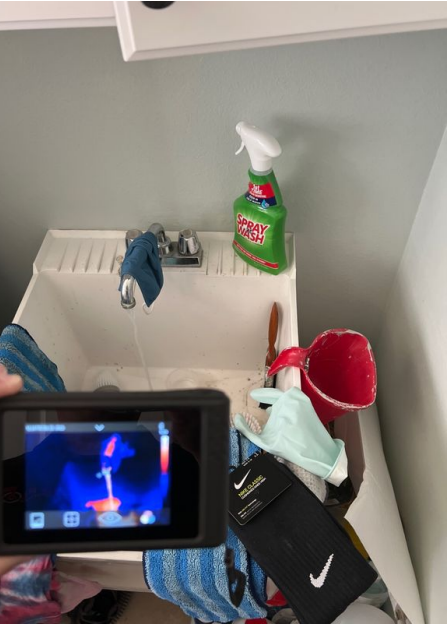
Laundry Room: Laundry Room Sink Basin Inspected

We ran the Laundry Room Sink Basin and did not observe any leaks or notable defects. Basin hot and cold water functional. Thermal image showed no leaking at the trap.

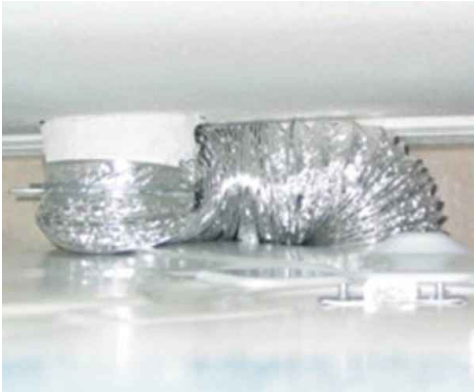
8.1.1 Laundry Room

DAMAGED DRYER EXHAUST PIPE

I observed indications of a damaged exhaust pipe of the clothes dryer.

Recommendation
Recommended DIY Project

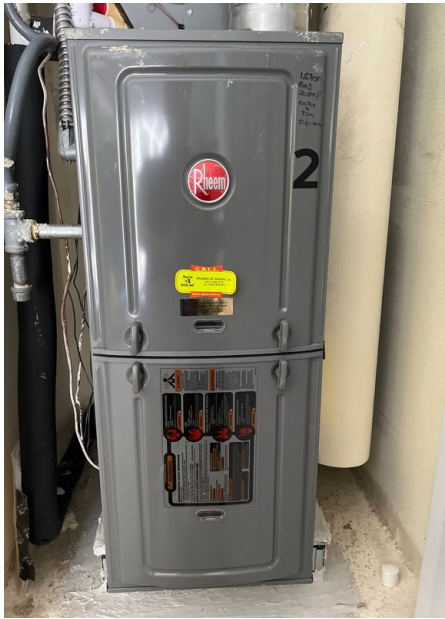
Equipment: Energy Source
Natural Gas

Equipment: Heat Type
Gas-Fired Heat

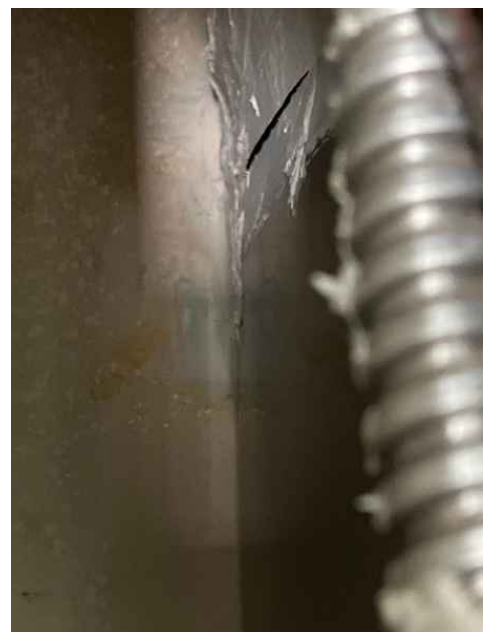
The seal from the duct to the air handler is separating. Recommend evaluation by a qualified HVAC technician.

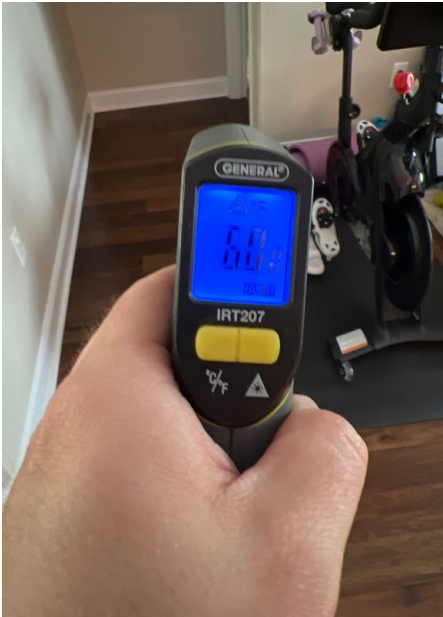
Service Disconnect Inspected I observed a service disconnect within sight of the cooling system.	Cooling Equipment: Energy Source/Type Electric	Cooling Equipment: Location Garage
Normal Operating Controls: Thermostat Location Dining room, Multiple Locations	Presence of Installed Cooling Source in Each Room: Supply Air was Located in All Rooms A supply air device/register was observed in all rooms of the residence.	Temperature test return and supply: Return Dining Room 75 degrees F
Temperature test return and supply: Supply 60.0 degrees F

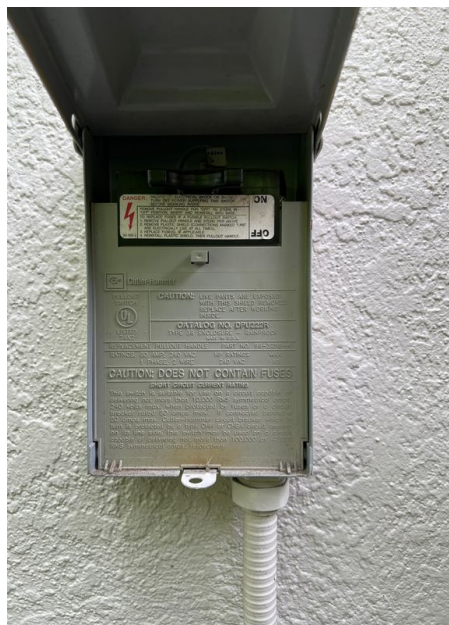
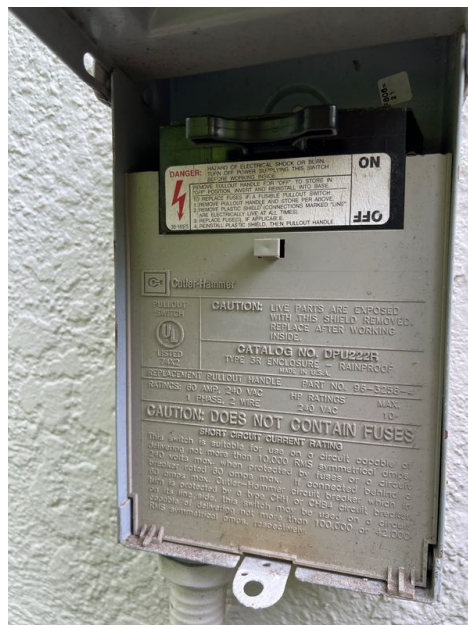
Cooling Equipment: Brand Rheem

Cooling Equipment: SEER Rating 14 SEER

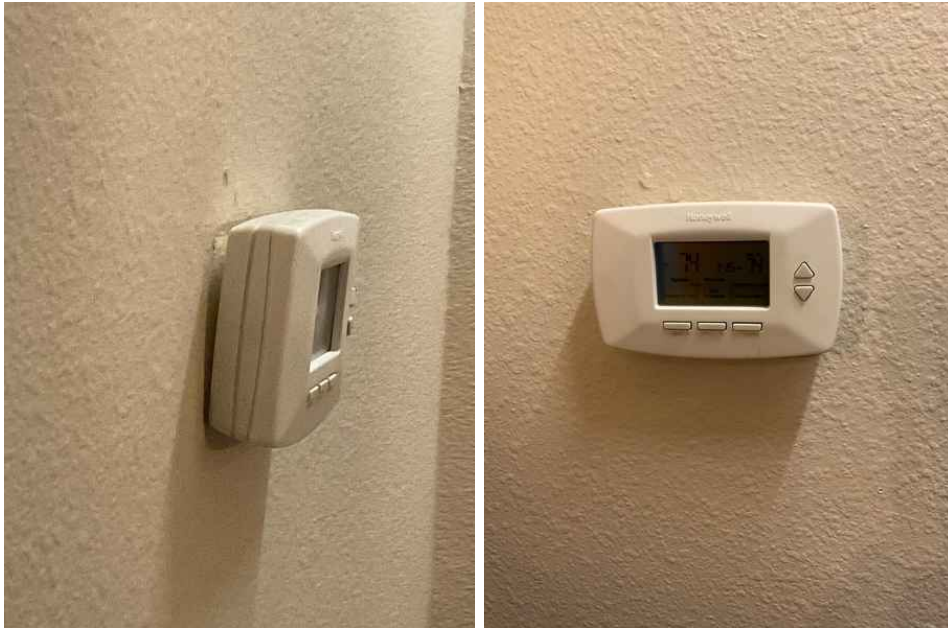
LOOSE THERMOSTAT

Thermostat was loose. Recommend repair or replacement.

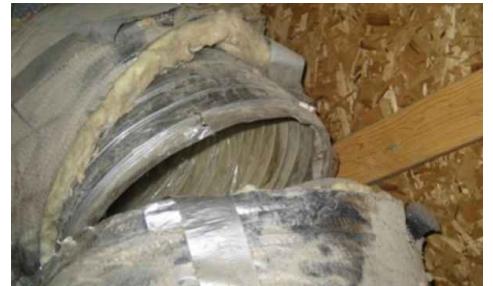
There are disconnected joints in the ductwork, resulting in significant energy loss and localized condensation/mold. Recommend licensed HVAC contractor repair or replace.

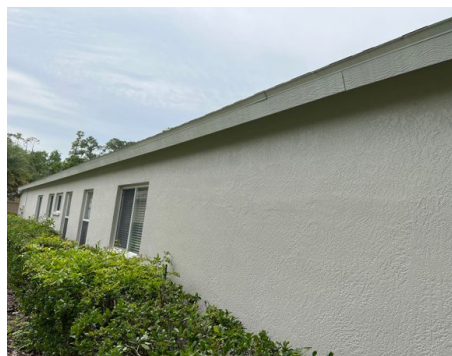
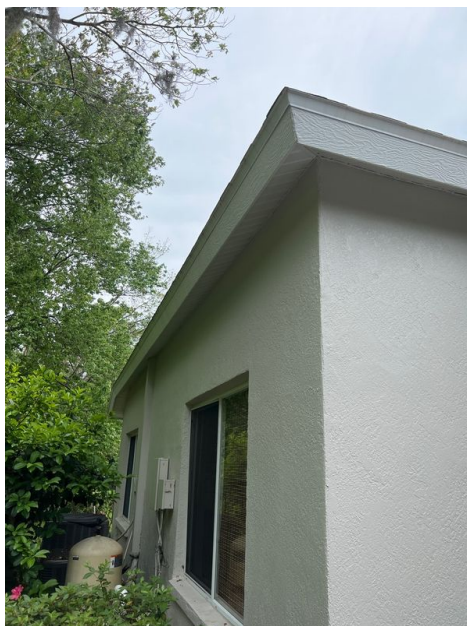
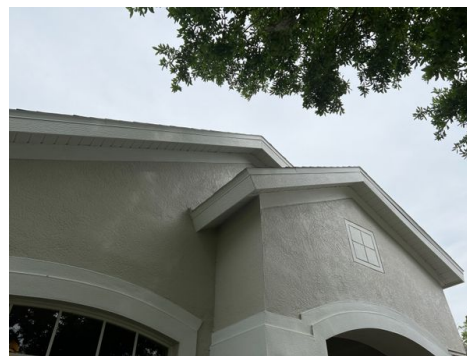
Eaves, Soffits & Fascia: Eaves, Soffits and Fascia Were Inspected

I inspected the eaves, soffits and fascia. I was not able to inspect every detail, since a home inspection is limited in its scope.

the eaves, soffit and fascia were inspected and found to be in GOOD and SERVICEABLE condition.
