# MOUNTAINS TO SOUND HOME INSPECTION LLC

## HOME INSPECTION REPORT

32138 37th Pl S  
Federal Way WA 98001

AUGUST 15, 2019

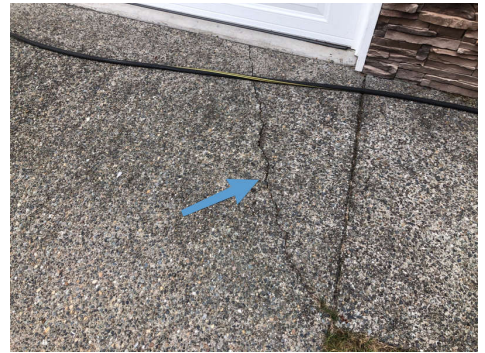
3.2.1 Driveway, Walkways & Patio

**SMALL CRACKS IN DRIVEWAY**

There are common cracks in the driveway that would not necessarily need to be serviced.

Recommend monitoring.

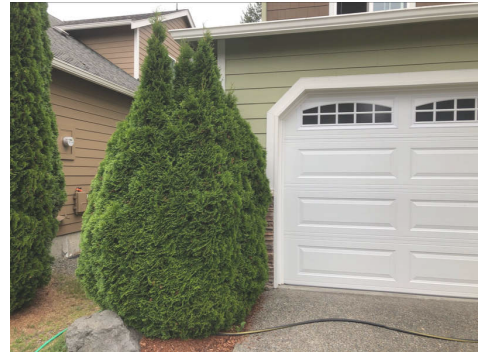
## 3.5.1 Exterior Siding Notes

Vegetation is encroaching on the structure, and should be kept a minimum of twelve inches away for the general welfare of the walls and foundation.

Contact a qualified landscaping contractor

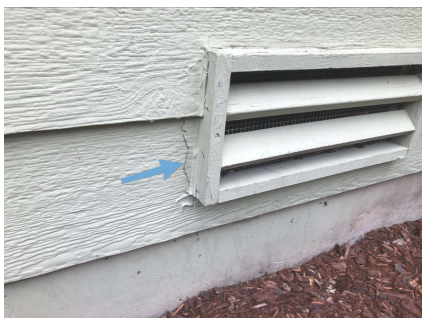
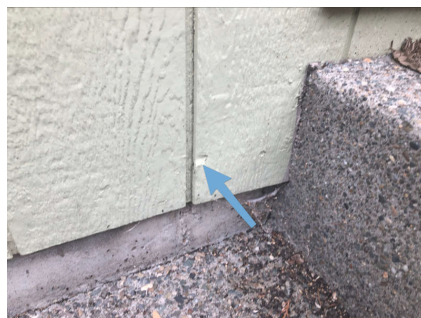
## 3.5.2 Exterior Siding Notes

**MINOR DAMAGE**

Contact a qualified professional.

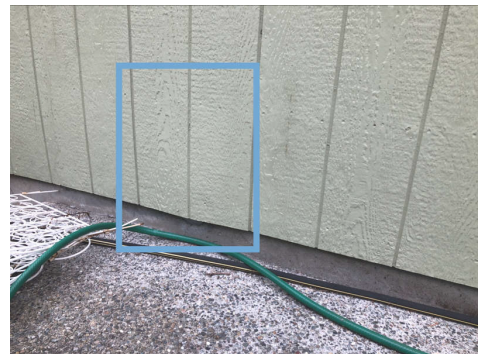
## 3.5.4 Exterior Siding Notes

There are areas of swelling and/or a bulge of the siding which should be monitored and repaired as necessary.

Contact a qualified handyman.

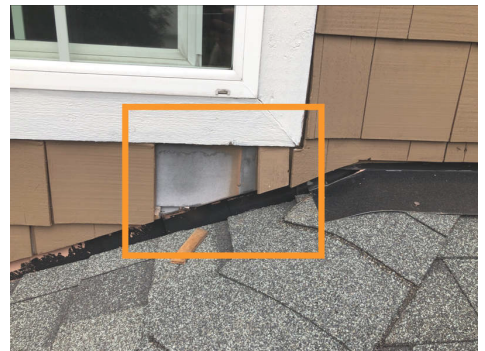
## 3.5.5 Exterior Siding Notes

**DAMAGED SIDING**

Observed areas of damaged siding around the residence that should be repaired to help prevent moisture intrusion issues. These damaged areas can allow moisture to penetrate the walls if not properly repaired.

Contact a qualified handyman.

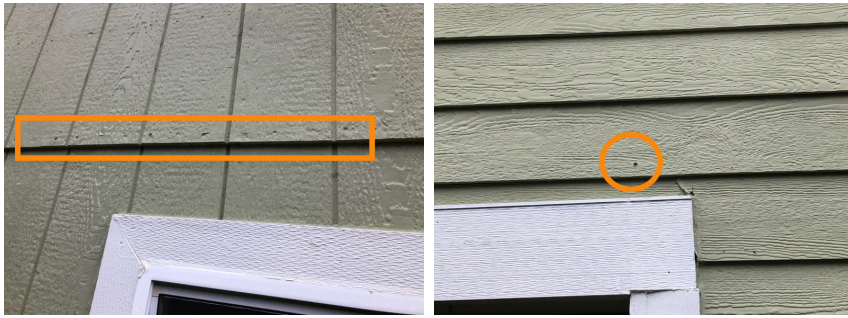
## 3.5.6 Exterior Siding Notes

A number of holes or deflections through the surface of the siding material were not properly caulked and sealed. These were caused by driving nails deep into the siding material. This can cause accelerated deterioration of the siding from moisture. Caulking and painting of all nail heads, surface breaks and depressions that have broken through the siding surfaces is recommended.

Contact a qualified professional.

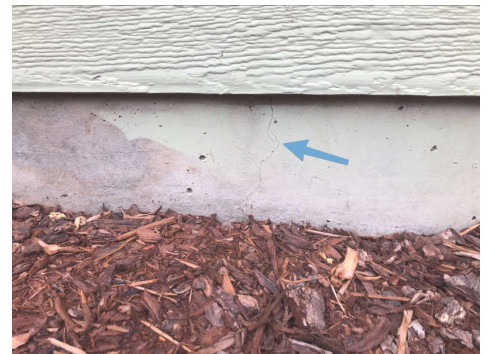
### 3.6.1 Foundation as Viewed from the Exterior

#### **SMALL CRACKS**

Hairline and/or small cracks, within normal tolerances were visible. This type of cracking is often a result of shrinkage of materials and/or minor settlement and usually does not affect the performance of the foundation.

Recommend monitoring.

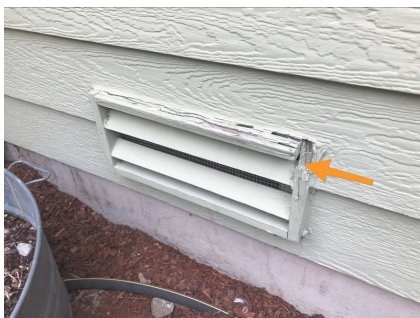
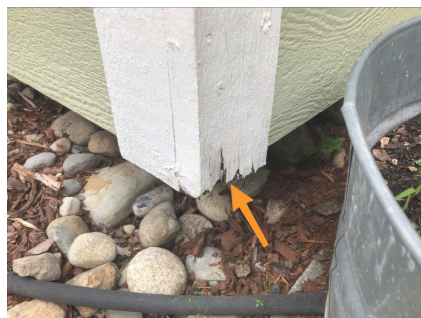
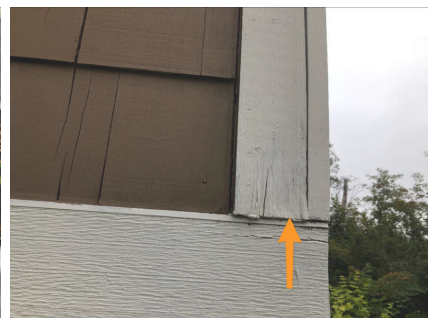
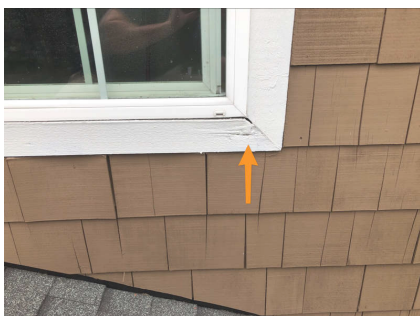
### 3.7.1 Fascia, Trim & Eaves

#### **SECTIONS OF FASCIA & TRIM MOISTURE DAMAGED**

Sections of the fascia board or wood trim are weathered, moisture damaged and should be serviced or replaced as necessary by a qualified professional contractor to help prevent further wear or deterioration.

Contact a qualified handyman.

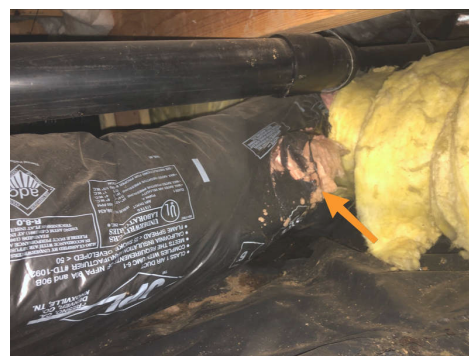
Medium Priority**OUTER SLEEVE DAMAGED**

The ducts are a modern flexible type that are comprised of an outer plastic sleeve and a clear inner liner that contains fiberglass insulation. However, portions of the outer sleeve are damaged and the ducting should be replaced.

Contact a qualified HVAC professional.

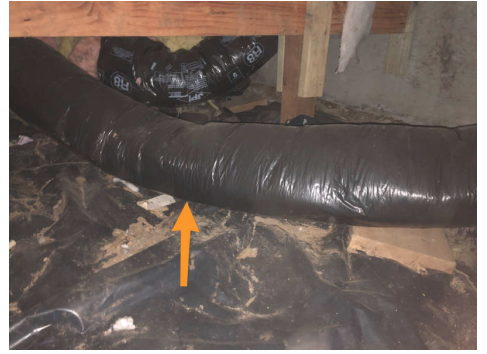
### 7.9.2 Ducting

One or more of the heating ducts were in contact with the ground. We recommend A minimum of 4" of clearance be maintained.

Contact a qualified professional.

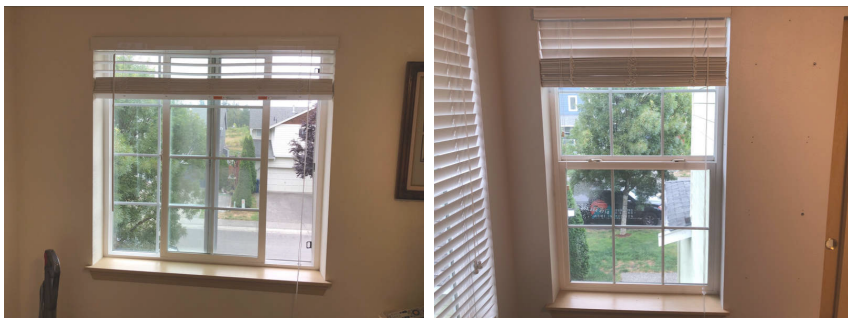
## 13.5.1 Windows

**BROKEN SEALS**

Contact a qualified window repair/installation contractor.

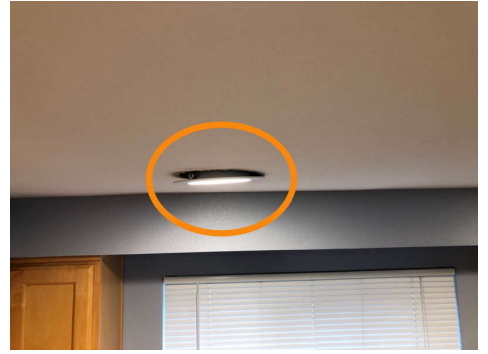
## 13.12.1 Lights, Wall Switches

**A LIGHT IS LOOSE**

Contact a qualified handyman.
