## HOME INSPECTION REPORT

4211 S Mead St  
Seattle WA 98118

Nelson Abaga  
APRIL 22, 2019

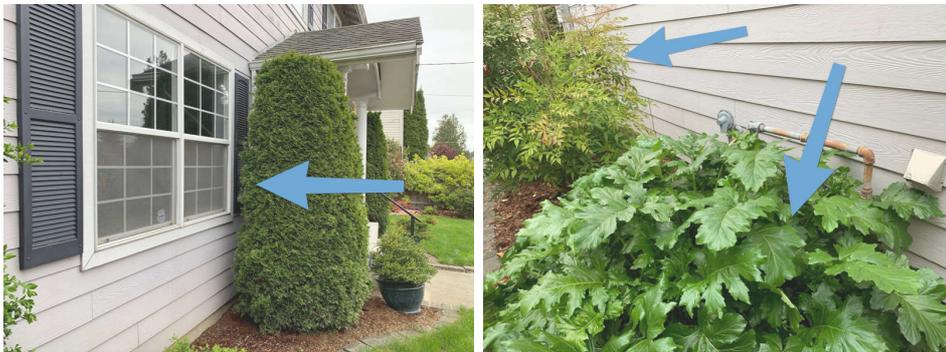
Vegetation is encroaching on the structure, and should be kept a minimum of twelve inches away for the general welfare of the walls and foundation.

Recommendation

Contact a qualified landscaping contractor

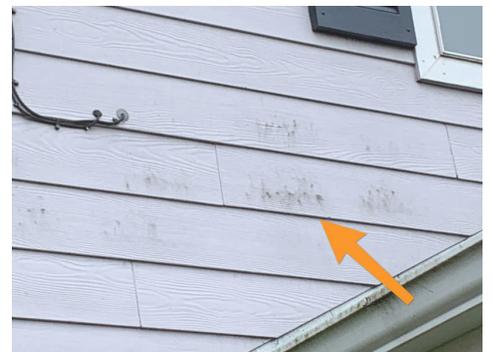
Front Above Entry

## 3.5.2 Exterior Siding Notes

The exterior siding is weathered. Maintenance and minor repairs are recommended.

Recommendation

Contact a qualified professional.

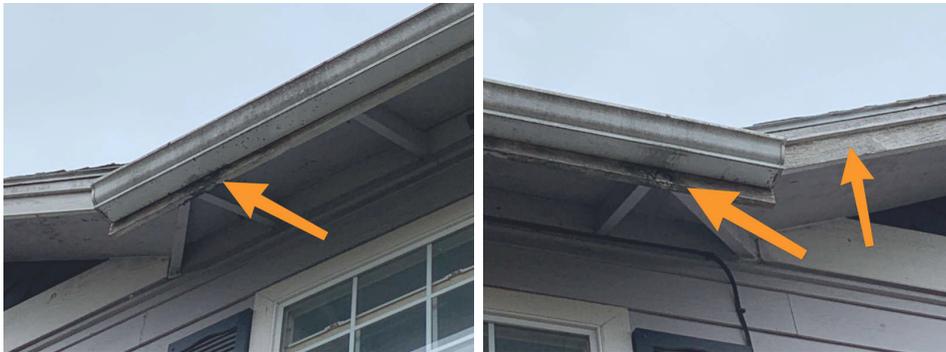
## 3.7.1 Fascia, Trim &amp; Eaves

Sections of the fascia board or wood trim around the residence are slightly weathered, and should be serviced as necessary to prevent further deterioration. Service such as scraping, repainting and sealing.

Recommendation

Contact a qualified handyman.

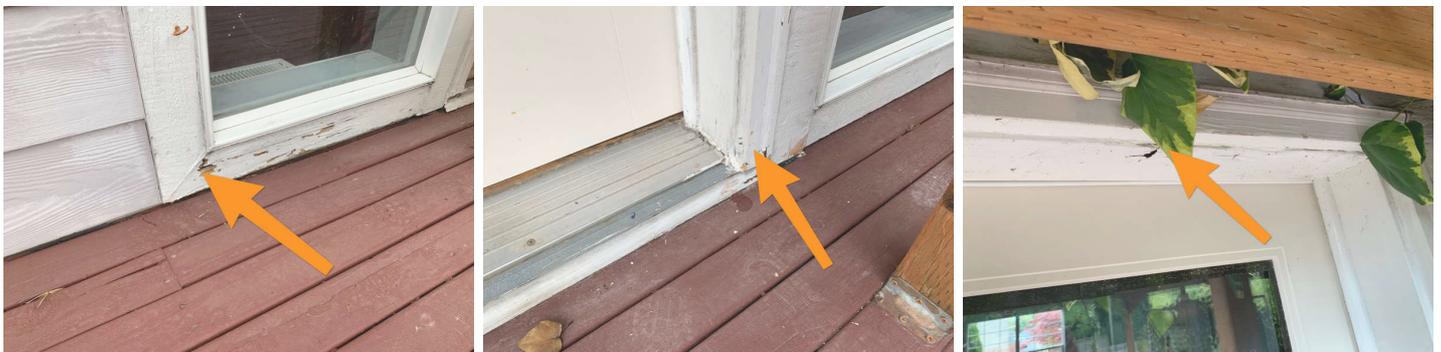
## 3.7.2 Fascia, Trim &amp; Eaves

Medium Priority**SECTIONS OF FASCIA & TRIM MOISTURE DAMAGED**

Sections of the fascia board or wood trim are weathered, moisture damaged and should be serviced or replaced as necessary by a qualified professional contractor to help prevent further wear or deterioration.

Recommendation

Contact a qualified handyman.

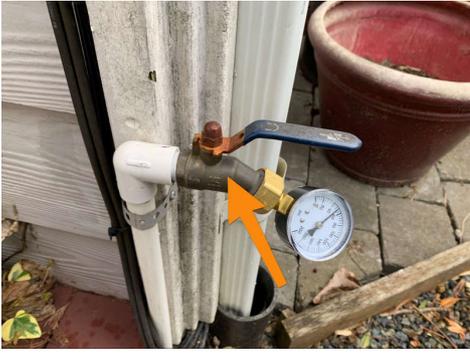
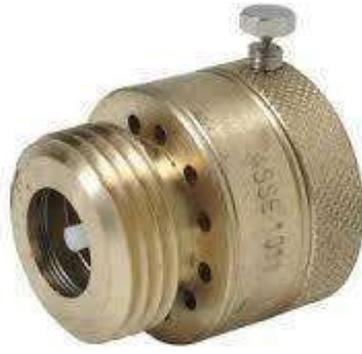
## 3.8.1 Exterior Plumbing

Anti Siphon

Recommendation

Contact a qualified handyman.

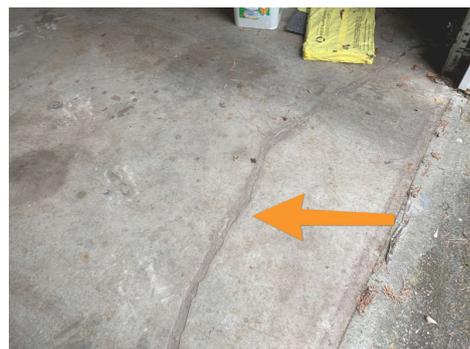
#### CRACKED BUT NOT LOAD-BEARING

The garage slab floor is cracked, but not load-bearing. Such cracks are common and result as a consequence of the curing process, seismic activity, ordinary settling, or the presence of expansive soils, but are not structurally threatening. You may wish to have a structural engineer confirm this.

#### Recommendation

Contact a qualified handyman.

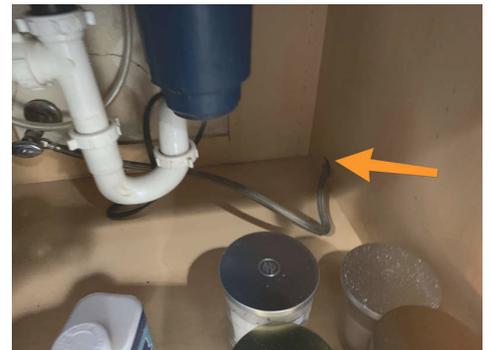
**IMPROPER INSTALLATION**

No drain line

Recommendation

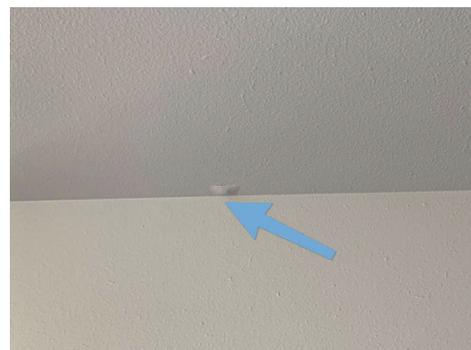
Northeast bedroom

#### TYPICAL SETTLEMENT CRACKING/NAIL POPS

Observed typical settlement type cracking and nail pops on walls and ceilings. Recommend repairs as needed. Home owner to identify all areas for repair.

Recommendation

Recommend monitoring.

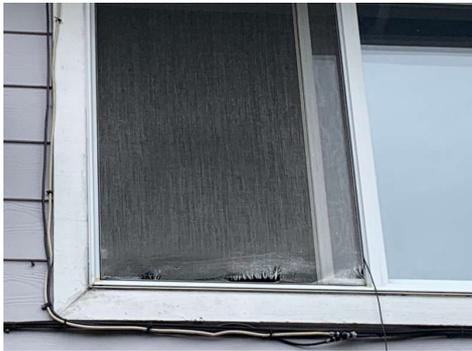
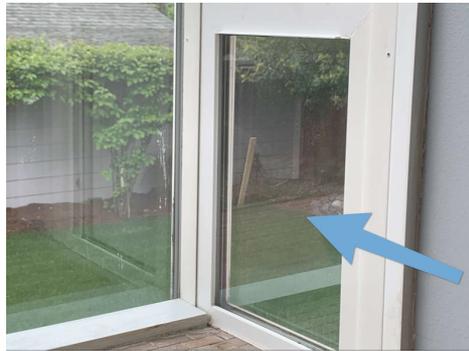
### 13.5.1 Windows

#### SCREENS DAMAGED/MISSING

Window screens were missing or damaged in one or more areas. We recommend repair or replacement as needed.

Upper floor rear

Kitchen window

Recommendation

Contact a qualified professional.

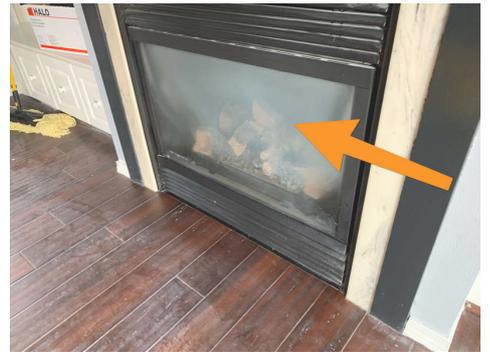
### 13.9.1 Fireplace Notes

The fireplace glass was dirty on the inside of the fireplace. This is a cosmetic issue and typically can be clean. Recommend a service contractor provide this service as desired.

Recommendation

Contact a qualified professional.

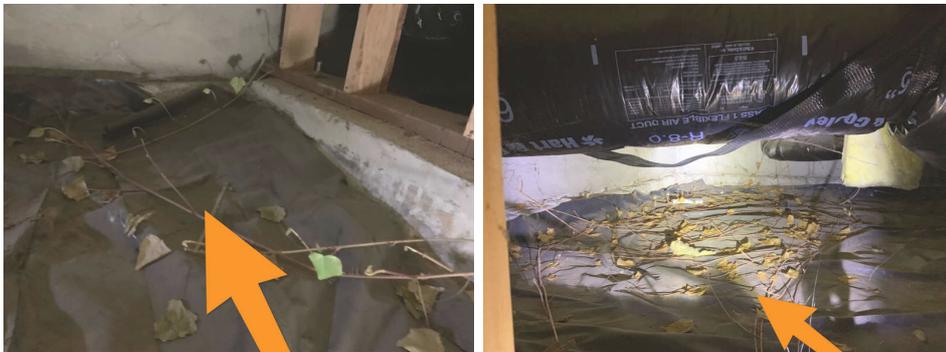
There is a significant amount of vegetation that hasn't close the crawlspace that should be removed to prevent past moisture and other environmental damage

Recommendation

Contact a qualified professional.
