## ZOOM INSPECTION REPORT

2525 Galileo Way  
Sample, WA 98000

APRIL 20, 2019

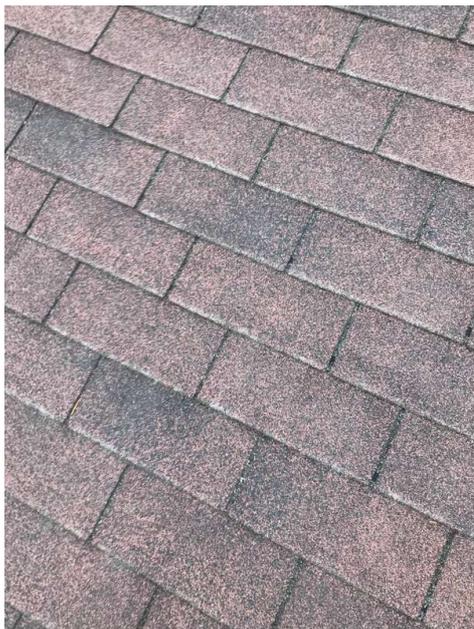
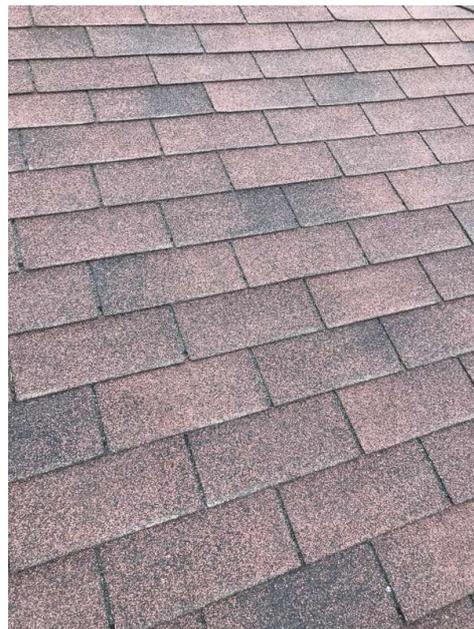
2.1.1 Coverings

**DAMAGED COVERINGS**

Shingles show age with granular loss. Roof coverings exhibited general damage that could affect performance. Recommend a qualified roofer evaluate and repair.

Granular Loss

Contact a qualified roofing professional.

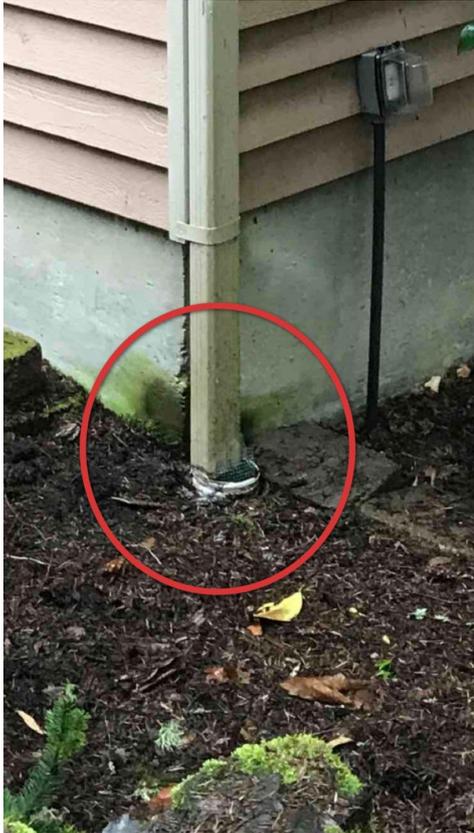
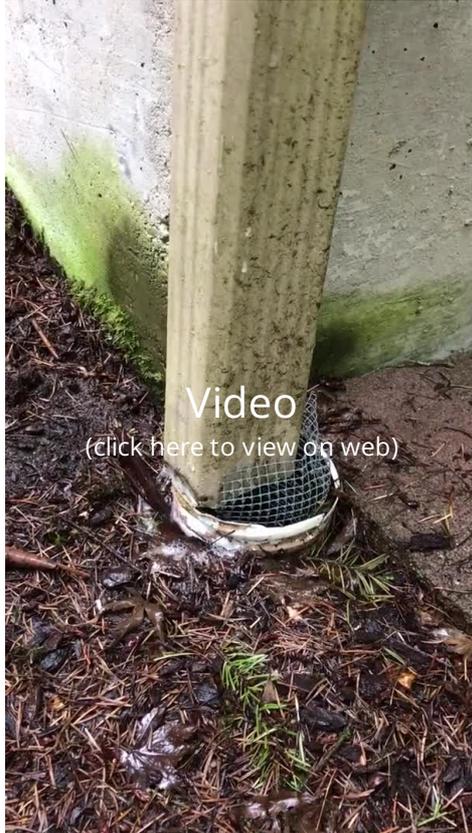
2.2.1 Roof Drainage Systems

**DOWNSPOUTS DRAIN NEAR HOUSE**

One or more downspouts drain too close to the home's foundation. This can result in excessive moisture in the soil at the foundation, which can lead to foundation/structural movement. Recommend a qualified contractor adjust downspout extensions to drain at least 6 feet from the foundation.

Contact a qualified professional.

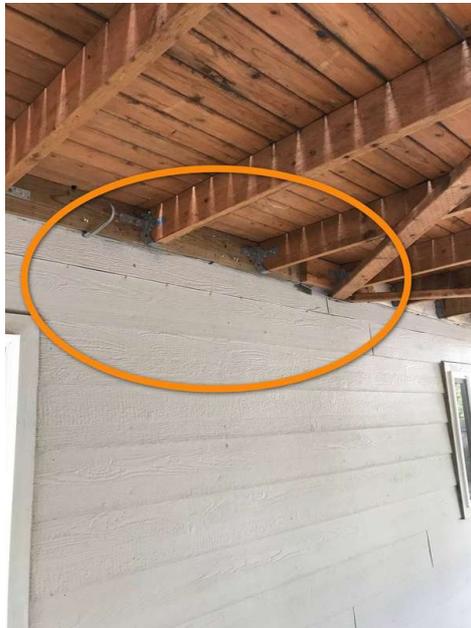
## 3.3.1 Decks, Balconies, Porches &amp; Steps

**MISSING LEDGER FASTENERS**

Missing proper fasteners at the ledger board. These fasteners are responsible for attaching the deck structure to the home structure. Not having these can allow the deck to disconnect from the home. Recommend a qualified decking contractor correct for increased safety.

Contact a qualified deck contractor.

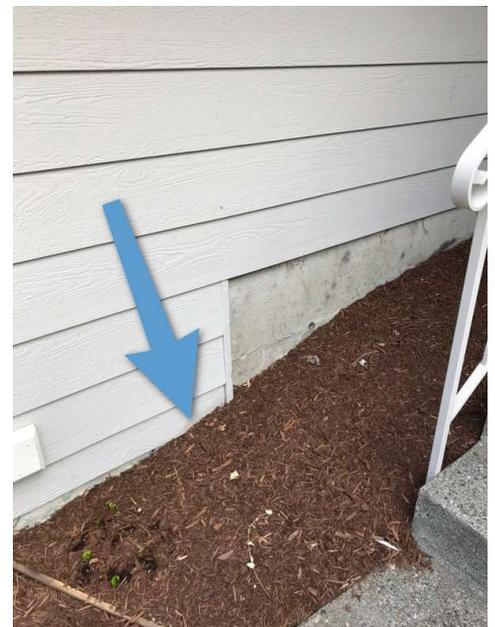
## 3.4.1 Vegetation, Grading, Drainage &amp; Retaining Walls

**EARTH TO WOOD CONTACT**

Earth to wood contact observed. This is a conducive condition for wood destroying organisms. Recommend correction to prevent wood destroying organism activity and damage to wood products.

Contact a qualified professional.

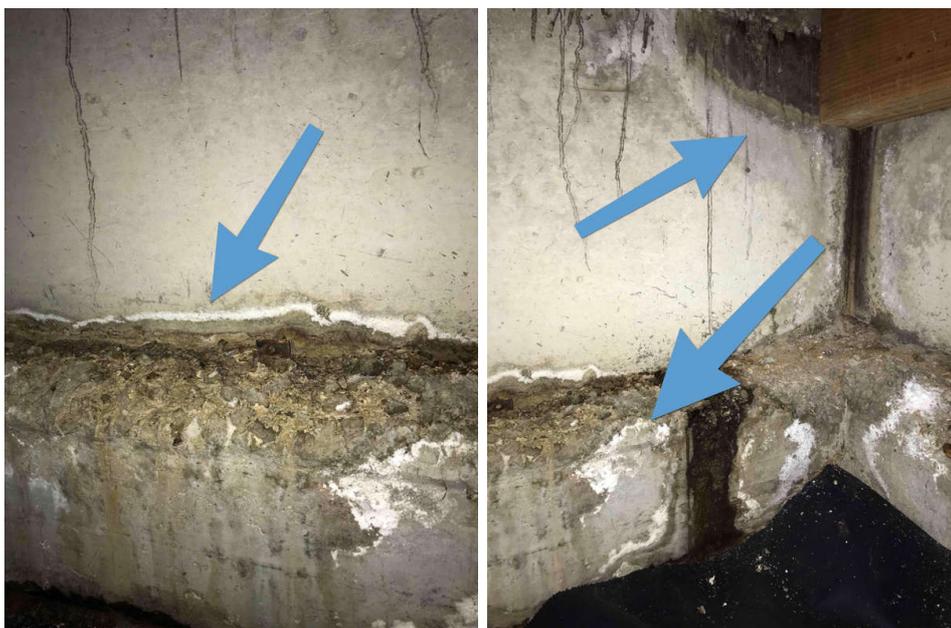
### 4.1.1 Foundation, Basement & Crawlspace

#### EFFLORESCENCE

Efflorescence noted on the crawlspace surface. This is a white, powdery deposit that is consistent with moisture intrusion. This can compromise the soil's ability to support the home structure and/or lead to mold growth. Recommend a qualified contractor identify source or moisture and correct.

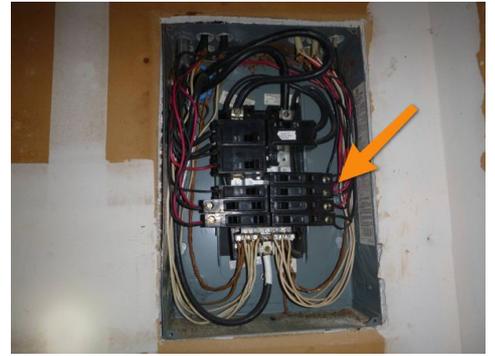
5.2.1 Service and Grounding Equipment, Main  
Overcurrent Device, Main and Distribution Panels

### **INCORRECT WIRING AT BREAKER**

Circuit breaker was incorrectly wired/installed. This can indicate wiring performed by a non professional and poses a safety hazard. Recommend that a licensed electrician check the entire panel and repair/replace as need.

Contact a qualified electrical contractor.

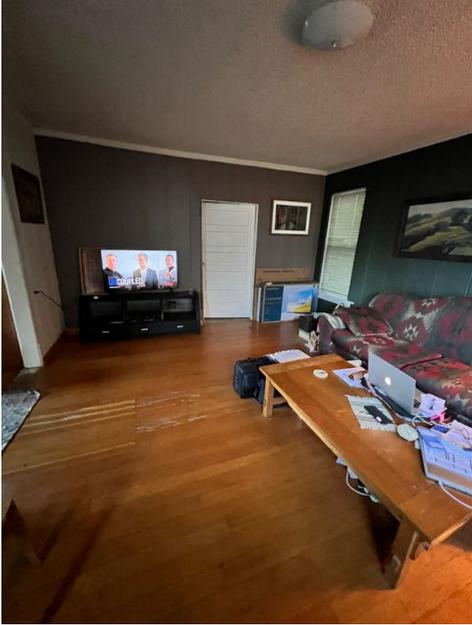
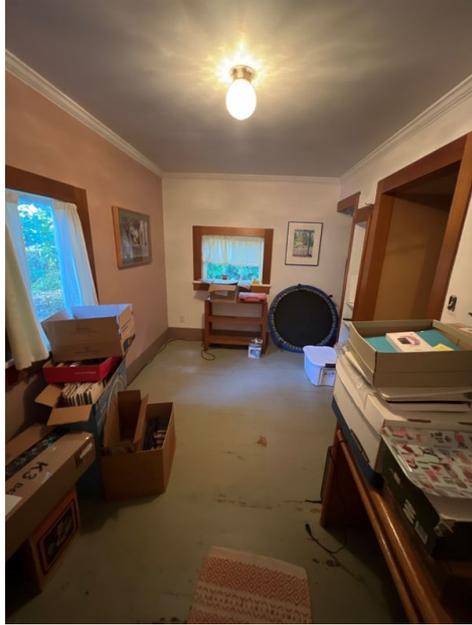
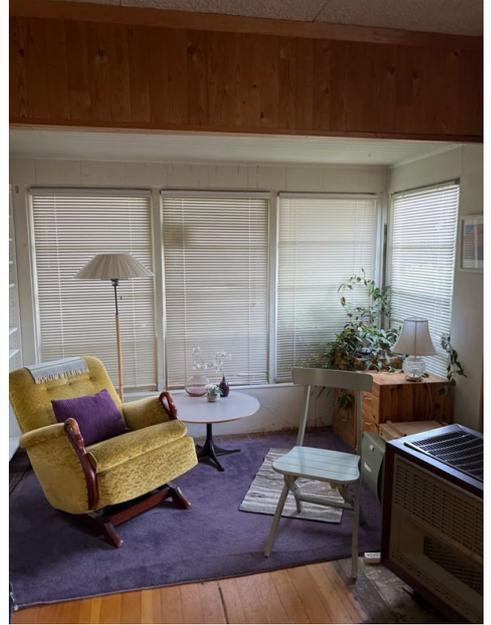
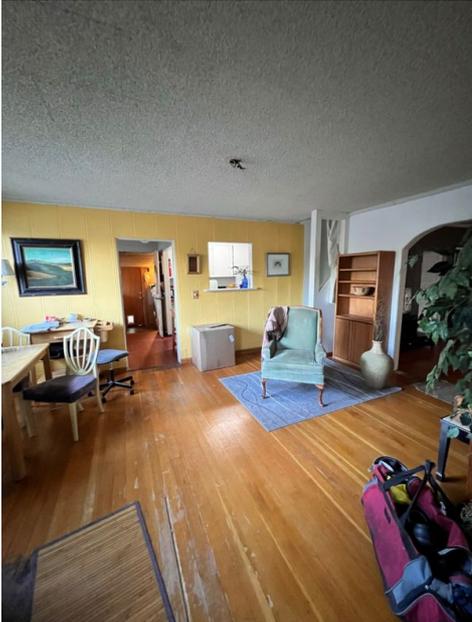
5.4.1 Connected Devices and Fixtures

**INADEQUATE NUMBER OF RECEPTACLES**

There is a minimal number of receptacles in the home. This can cause a short circuit if increased demand is present. Recommend licensed electrician add additional receptacles.

Contact a qualified electrical contractor.

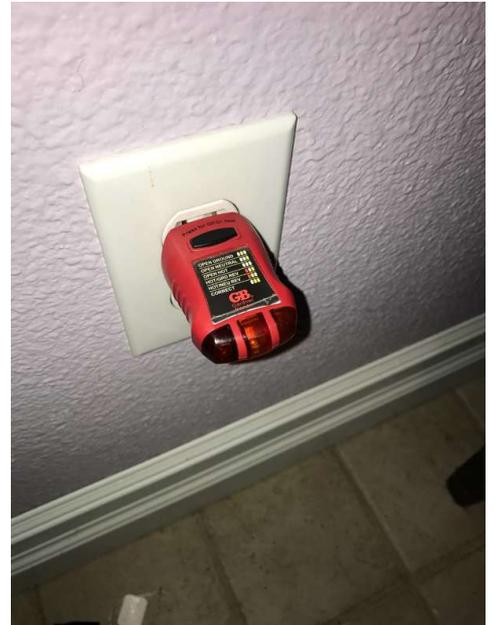
## 5.5.1 Polarity and Grounding of Receptacles

Safety Concern**OUTLET(S) NOT GROUNDED**

One or more 3 prong outlets are not grounded. See photos for details. Recommend a qualified electrician repair/replace to meet current building standards.

Bedroom

Contact a qualified electrical contractor.

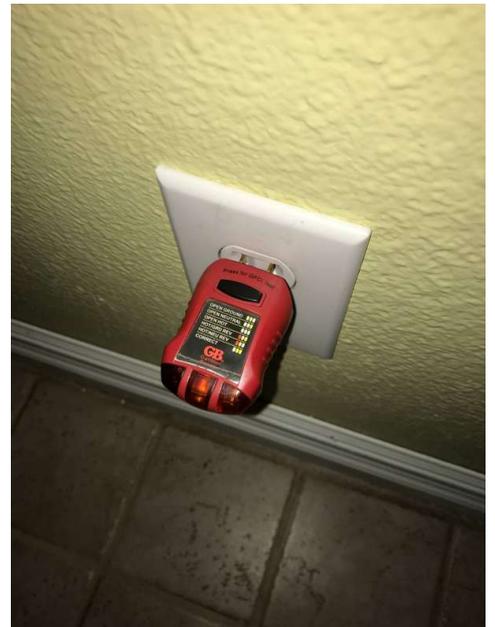
## 5.5.2 Polarity and Grounding of Receptacles

Safety Concern**REVERSE POLARITY**

One or more receptacles have been wired with reverse polarity. See photos for details. This can increase shock hazard and limit the lifespan of electrical equipment. Recommend licensed electrician evaluate & repair.

Primary Bedroom

Contact a qualified electrical contractor.

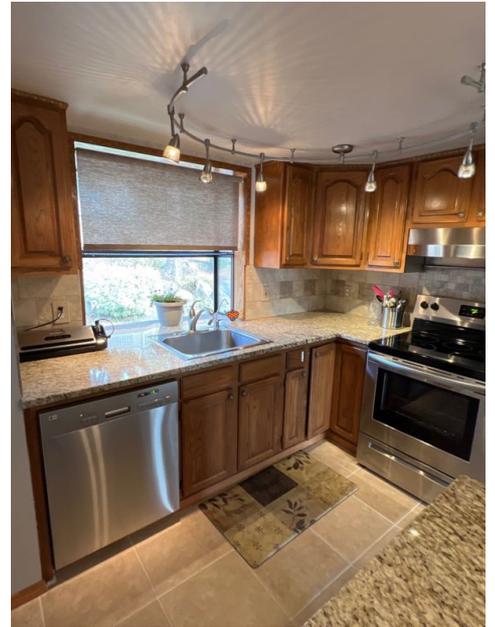
## 5.6.1 GFCI &amp; AFCI

Safety Concern**NO GFCI PROTECTION INSTALLED**

No GFCI protection present in all locations. Recommend licensed electrician upgrade by installing ground fault receptacles in all locations.

Kitchen

Contact a qualified electrical contractor.

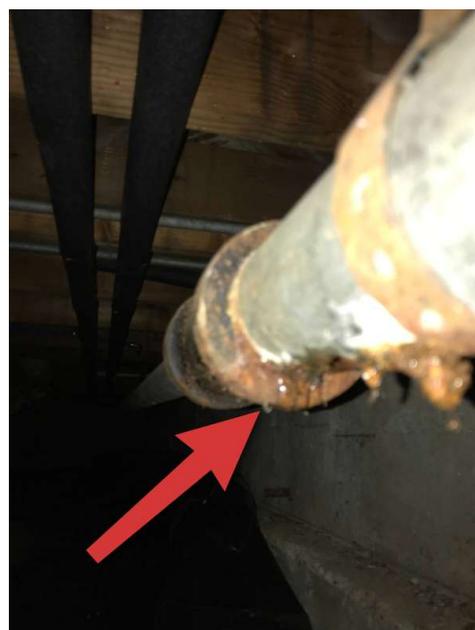
6.2.1 Drain, Waste, & Vent Systems

**LEAK IN GALVANIZED DRAIN LINE**

Galvanized drain lines show excessive rust and leaking. I recommend a qualified plumbing contractor evaluate the drain lines for repair/replacement as needed.

Contact a qualified plumbing contractor.

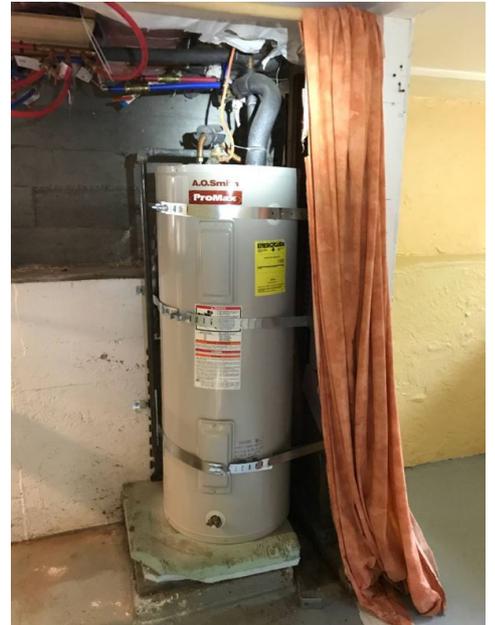
## 6.3.1 Water Heater

Major Defect**PAST EXPECTED LIFE**

Water heater appears to be over 20 years old, standard expected life of water heaters is about 8 to 12 years. I recommend evaluation for replacement by a qualified plumbing contractor.

Manufactured in 2001

Contact a qualified plumbing contractor.

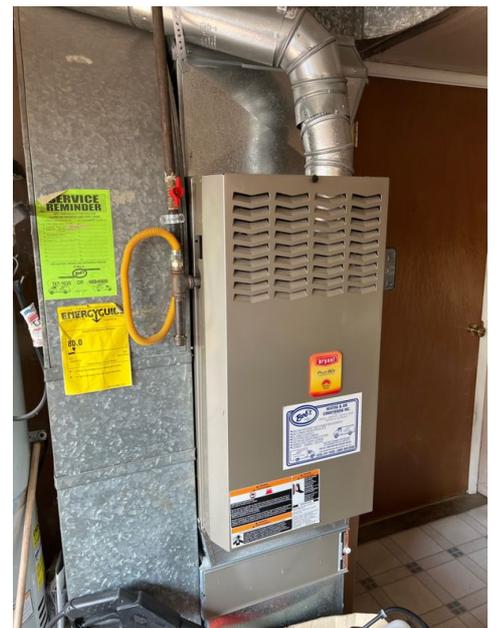
#### 7.1.1 Heating Equipment

#### **NEEDS SERVICING/CLEANING**

Furnace should be cleaned and serviced annually. Recommend a qualified HVAC contractor clean, service and certify furnace. Standard expected life of furnaces is about 15 to 18 years with proper, regular maintenance. This furnace is over 25 years old.

Manufactured in 1996

Contact a qualified HVAC professional.

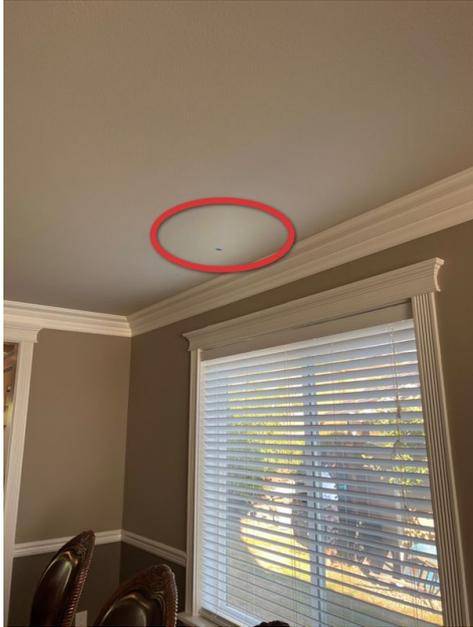
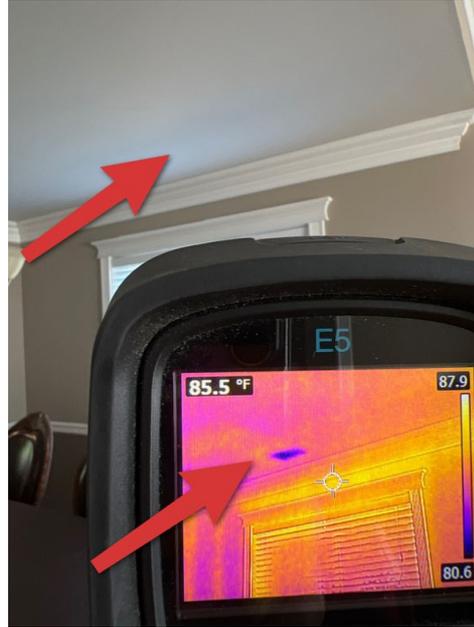
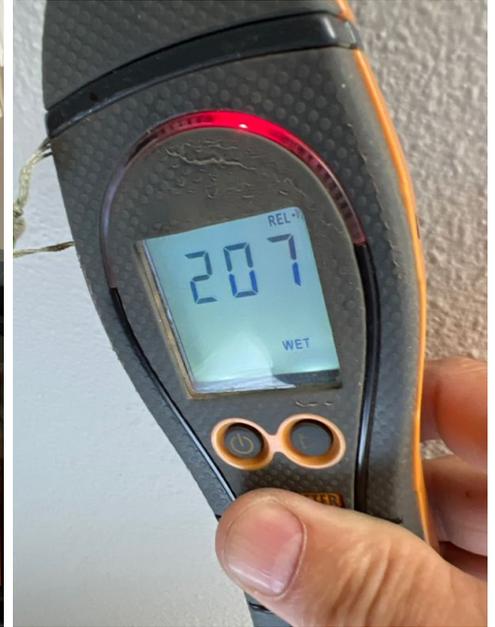
9.2.1 Ceilings

**SIGNS OF MOISTURE INTRUSION**

Infrared camera detects signs of moisture intrusion in dining room ceiling. Elevated moisture detected at above 20%. See photos for details. Recommend a qualified roofing professional evaluate and repair or replace all damaged areas as needed.

Area of concern

Infrared image of cold spot

Above 20% moisture reading detected

Contact a qualified roofing professional.

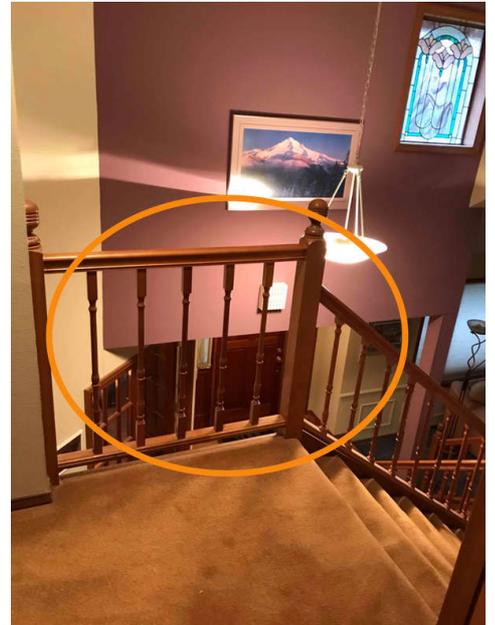
## 9.4.1 Steps, Stairways &amp; Railings

**BALUSTER SPACES TOO WIDE**

The baluster spacing is not up to modern safety standards. The space between balusters should not allow passage of a toddlers head for safety reasons. Recommend a qualified stairway installer repair to meet current building standards.

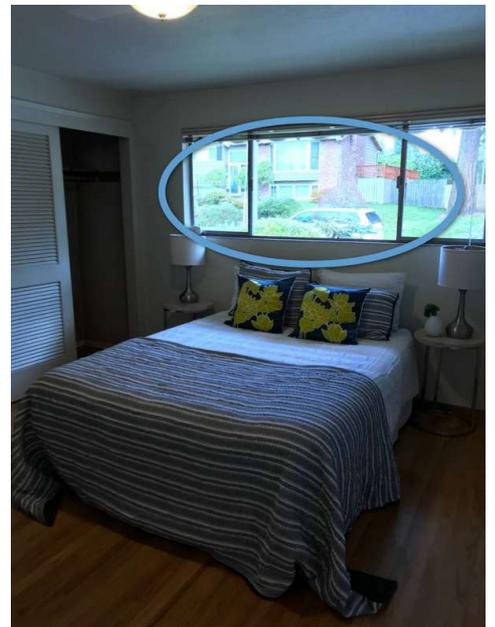
## 9.7.1 Windows

**FAILED SEAL**

Observed condensation between the window panes, which indicates a failed seal. Recommend qualified window contractor evaluate & replace.

Contact a qualified window repair/installation contractor.

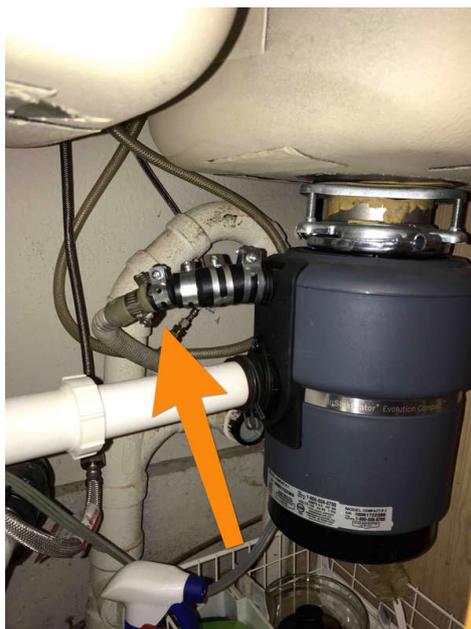
#### 10.1.1 Dishwasher

#### IMPROPER DRAIN CONFIGURATION

In order to prevent a possible cross connection condition, reconfiguring the dishwasher drain is recommended. The correct method is to simply secure the flex drain line high inside the kitchen cabinet prior to discharging into the sink drain. This creates a high loop preventing the water from being sucked back into the dishwasher. A cross connection condition is considered a potential safety hazard as this has the potential to contaminate the municipal water supply.

Example

Contact a qualified professional.

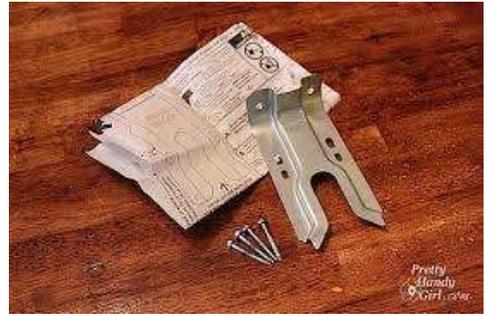
## 10.3.1 Range/Oven/Cooktop/Cook Vent

Safety Concern**RANGE NOT FASTENED**

Range was not properly fastened to the floor with an anti-tip bracket. This poses a safety hazard to children and other occupants. Recommend a qualified contractor properly secure range so it can't tip.

Anti-Tip Bracket

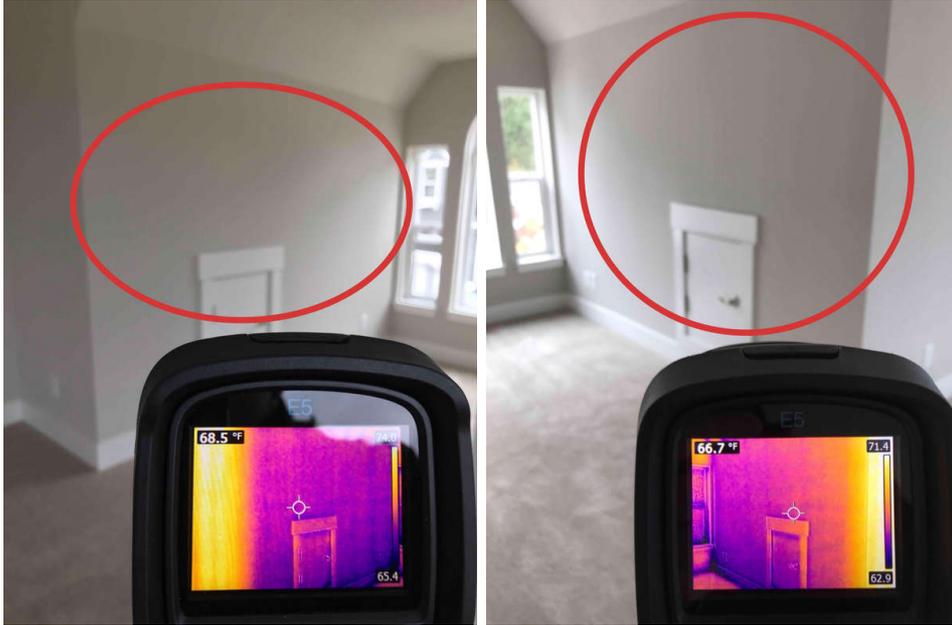
Major Defect**MISSING INSULATION**

There are areas of missing insulation at the exterior walls. Recommend a qualified contractor correct for increased heating and cooling efficiency.

Contact a qualified professional.

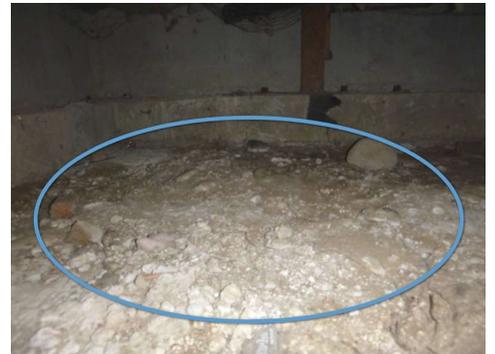
## 11.2.1 Vapor Retarders

Deferred Maint/Inquire with Seller**VAPOR BARRIER DAMAGED**

Vapor barrier is damaged in one or more areas leaving exposed bare ground. Recommend a qualified professional repair or replace. This is a conducive condition for wood destroying organisms.

Contact a qualified professional.
