EAGER INSPECTIONS, PLLC

PROPERTY INSPECTION REPORT

Concerning: 1000 Sample Report, Dallas TX 75214

Tristan Eager - Texas Professional Engineer #128938 TREC

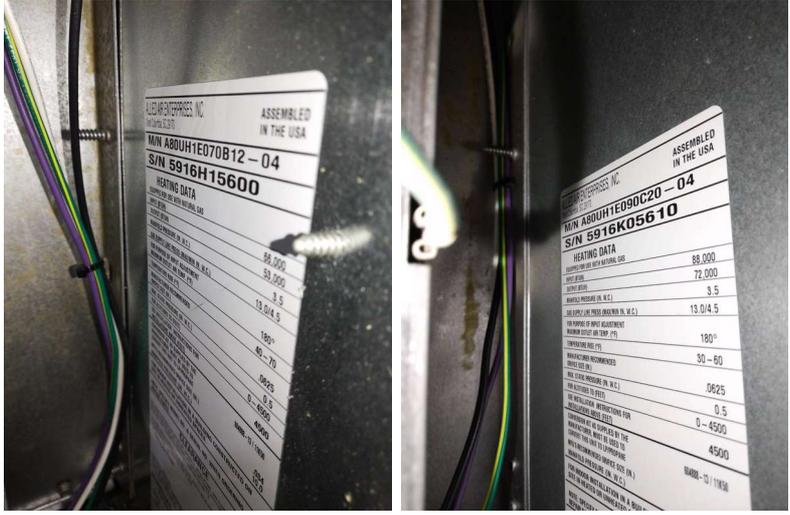
Furnace Energy Source: Natural Gas
Furnace Nameplate:

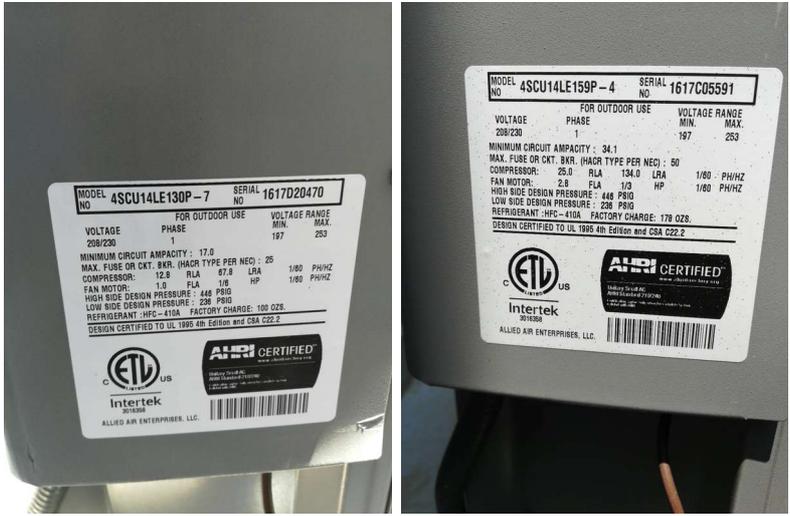
Type of Cooling System: Central Ducted
Condenser Manufacturer: Armstrong Air
Condenser Date of Manufacture: 2017
Condenser Nameplate:

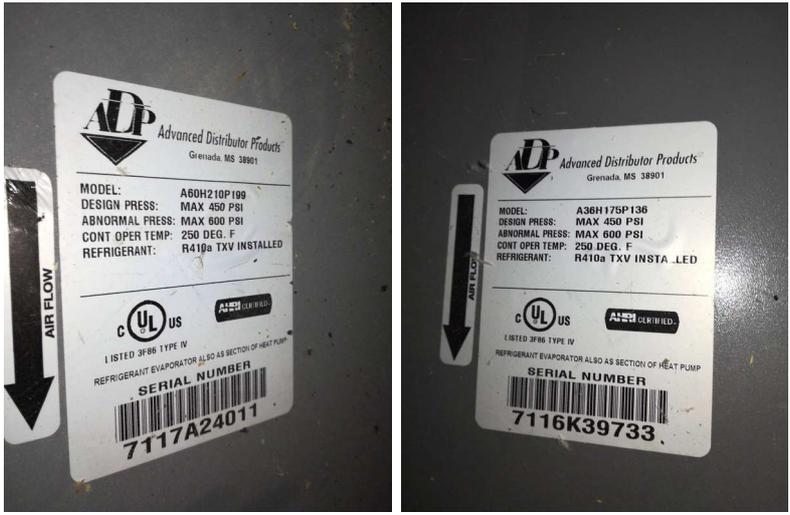
Evaporator Manufacturer: ADP
Evaporator Date of Manufacture: 2017
Evaporator Nameplate:

1: Air Conditioner Performance

- 9 degree cooling difference between supply in east room (1st floor) and return register (72F/63F)
- 12 degree cooling difference between supply in northwest bedroom (2nd floor) and return register (60F/72F)
- 12 degree cooling difference between supply in southeast bedroom (2nd floor) and return register (60F/72F)

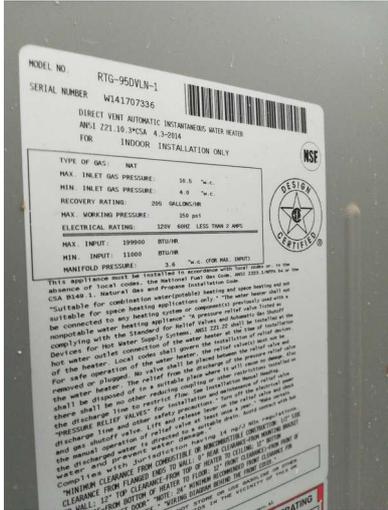
C. Water Heating Equipment
Water Heater Manufacturer: Rheem
Water Heater Power Source: Natural gas
Water Heater Capacity: Tankless Tankless
Water Heater Location: Garage
Water Heater Date of Manufacture: 2017
Water Heater Nameplate: . -
