CHESTER COUNTY HOME INSPECTIONS

RESIDENTIAL INSPECTION

917 Roundelay Dr
West Chester PA 19382

JULY 18, 2018

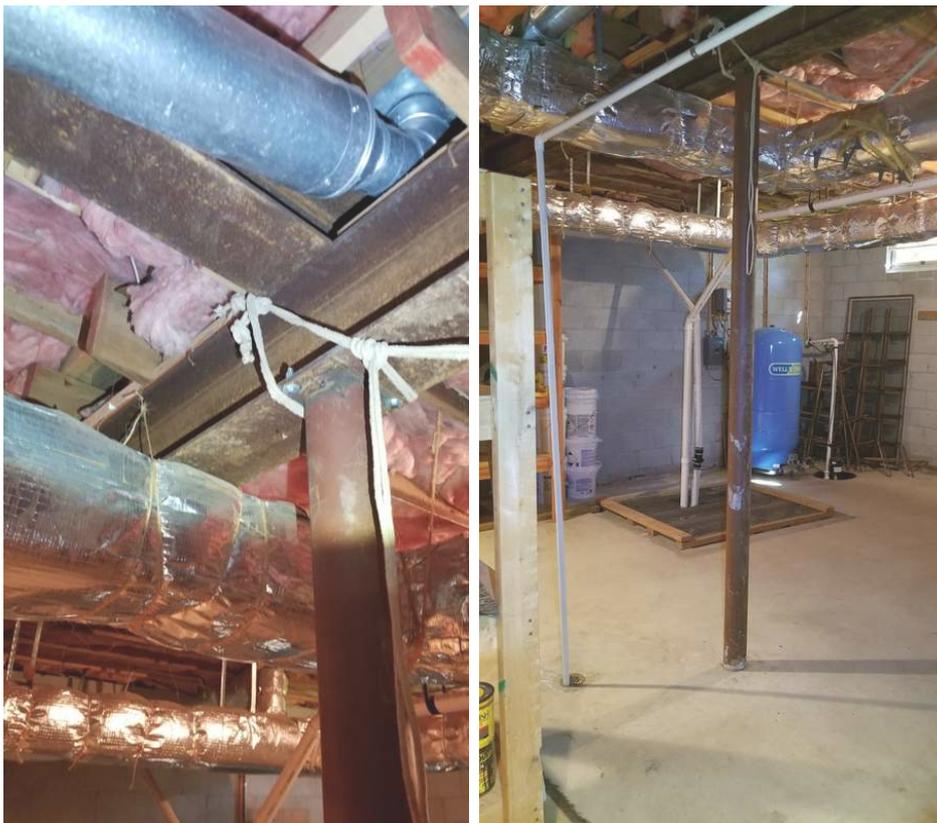
Foundation: Beam & Joist Material

Steel Beam, Wood Floor Joist

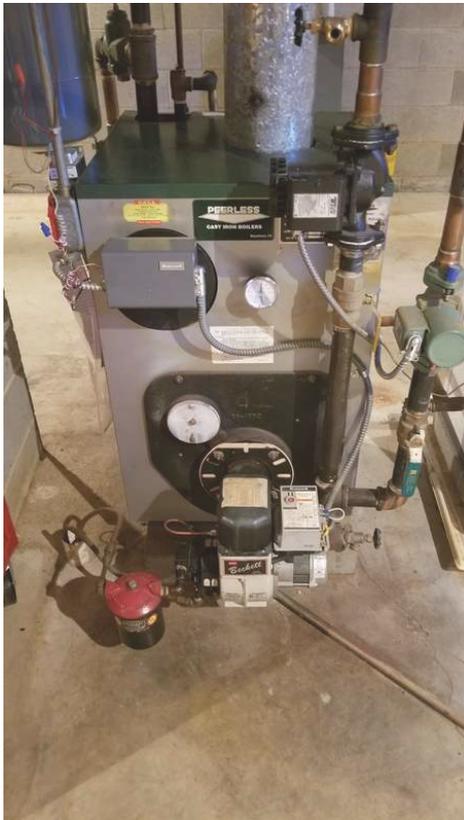
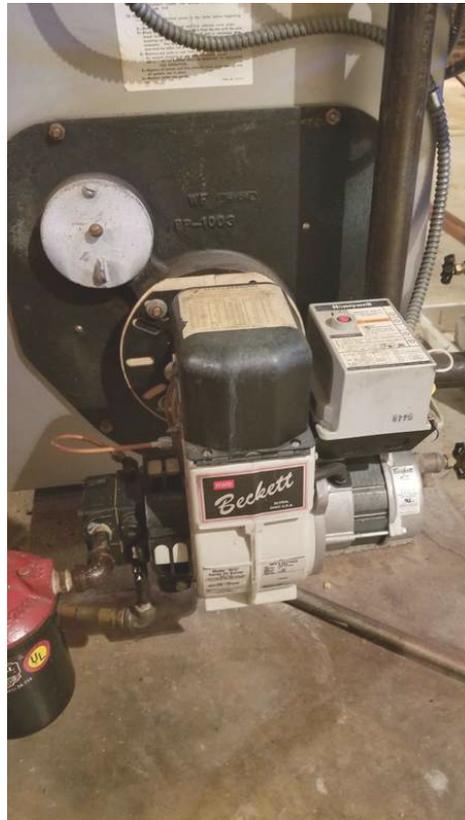
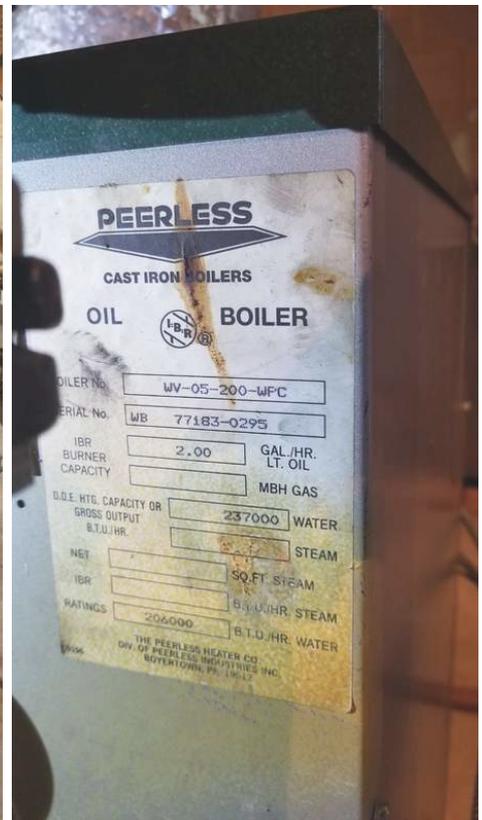
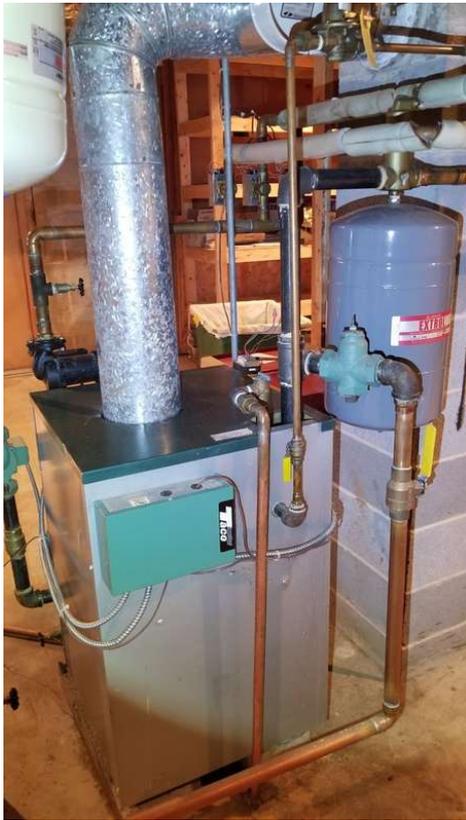
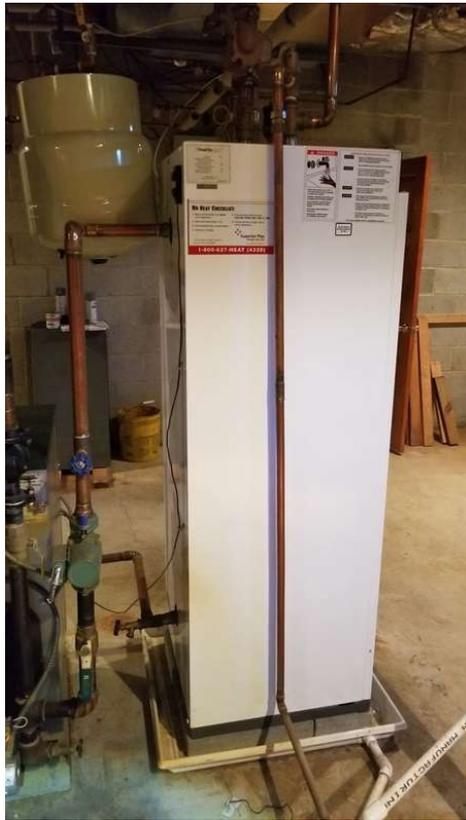
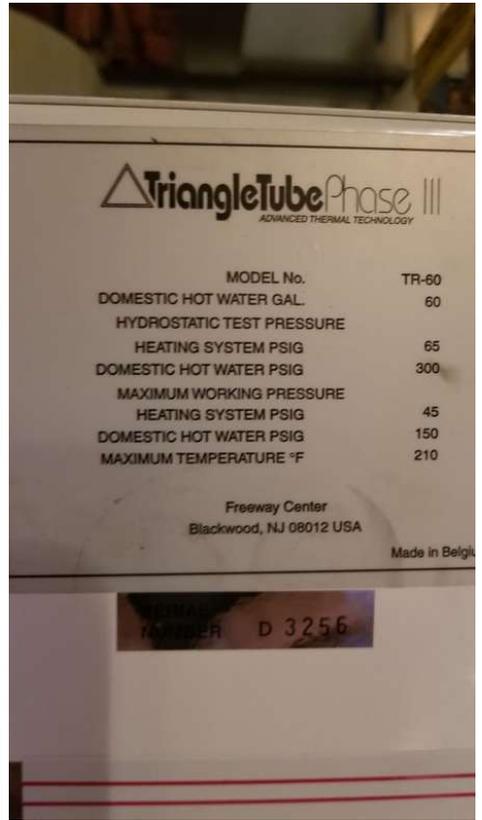
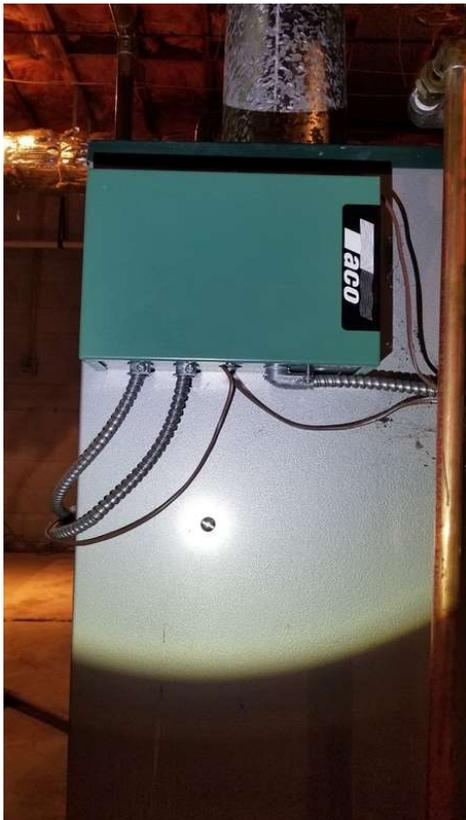
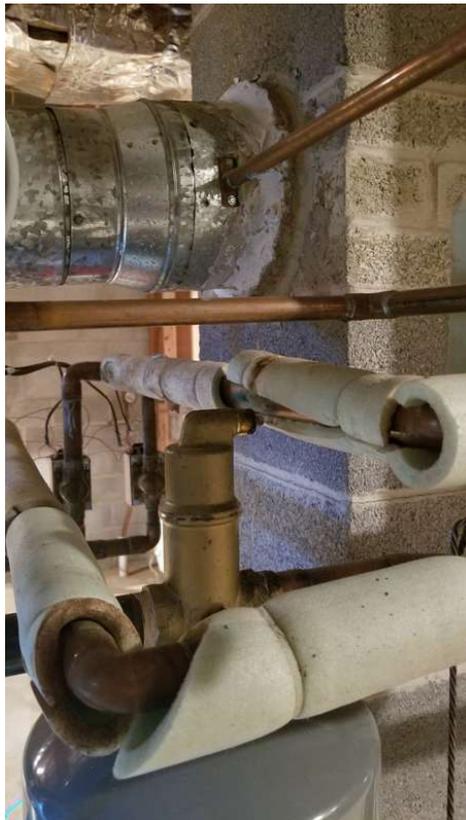
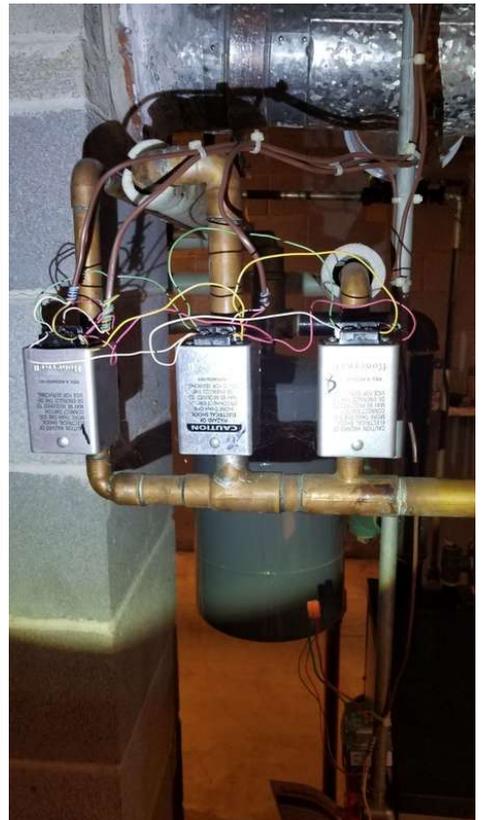
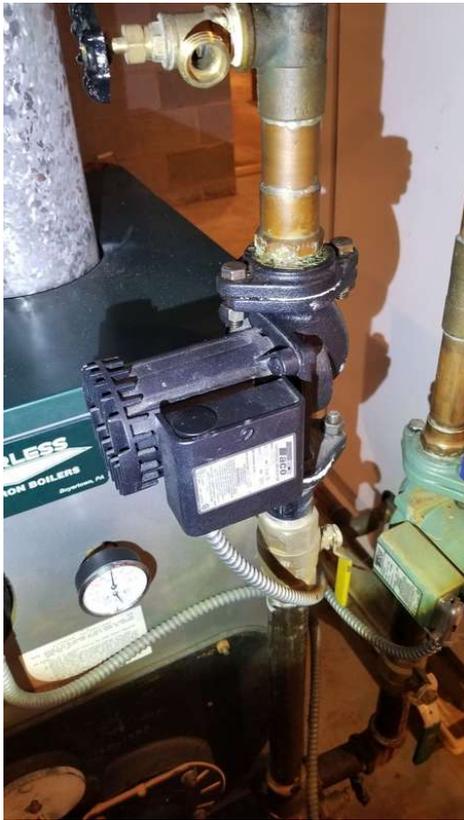
Heating Equipment: Photos

Overall, the system appears in good condition.

This is a low efficiency boiler, approximate 60% AFUE, meaning about 40% of the heating energy is lost. High cost of heating oil makes this an important consideration. When this boiler is in need of major repair, consider upgrading to more efficient equipment. For more information, refer to www.energy.gov/energysaver/home-heating-systems/furnaces-and-boilers.
