MOUNTAINS TO SOUND HOME INSPECTION LLC

HOME INSPECTION REPORT

6134 147th Pl SE
Bellevue WA 98006

Moin Shaikh
JUNE 11, 2019

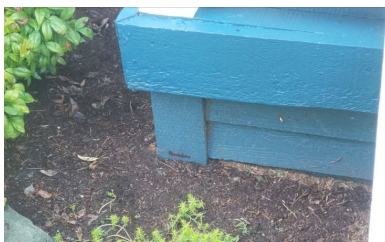
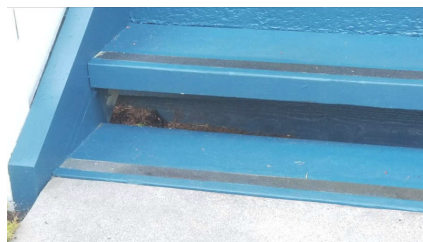
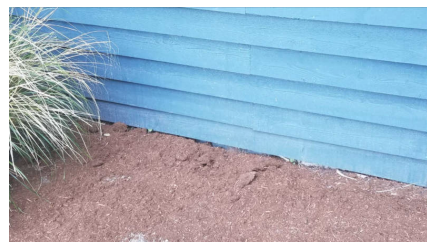
3.5.1 Exterior Siding Notes

VEGETATION IS ENCROACHING

Vegetation is encroaching on the structure, and should be kept a minimum of twelve inches away for the general welfare of the walls and foundation.

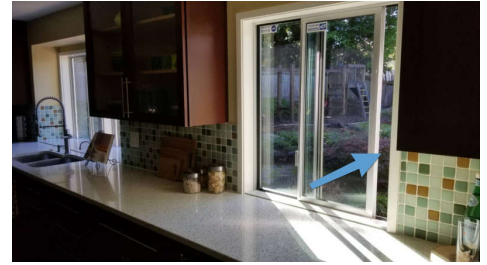
SCREENS DAMAGED/MISSING

Window screens were missing or damaged in one or more areas. We recommend repair or replacement as needed.

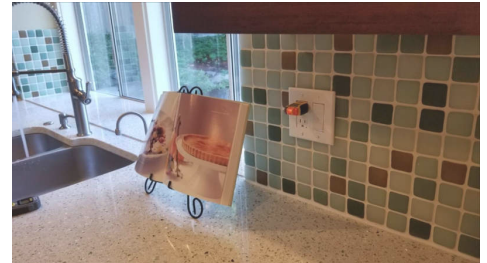
9.11.1 Outlets, Electrical Observations

OPEN GROUNDED OUTLET

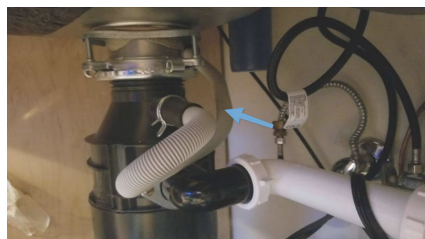
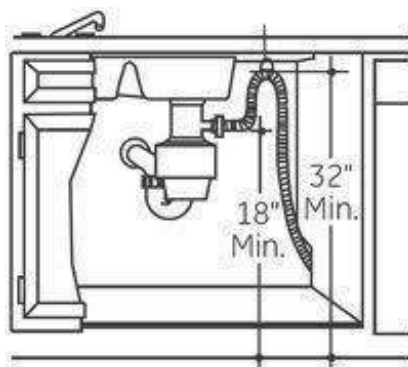
Dishwasher drain pipe was installed without an air gap/high loop to prevent cross contamination. Recommend a qualified licensed professional evaluate and or repair.

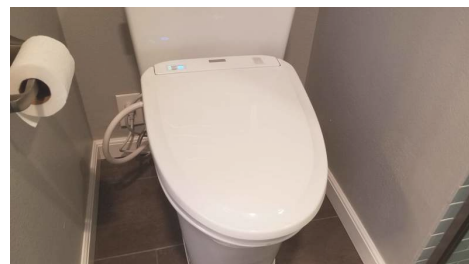
MASTER BATHROOM

The bidet in the washroom was not inspected. Recommend demonstration if the unit is to stay.

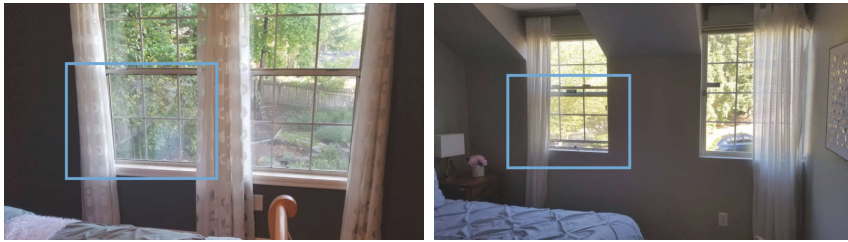
One or more windows were difficult to open or close and may need maintenance or repair.

Recommendation

Contact a qualified window repair/installation contractor.

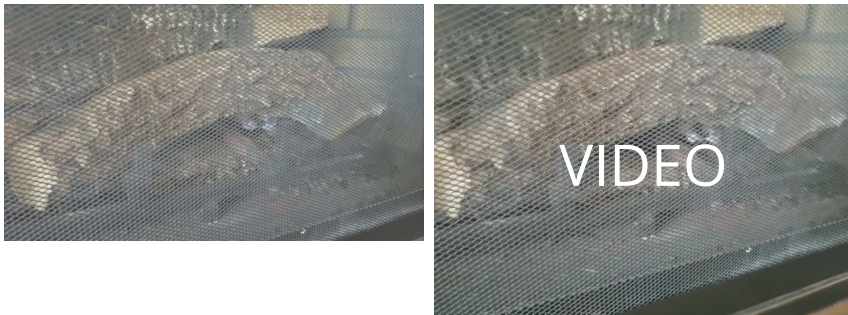
13.8.1 Fireplace Notes

DID NOT INSPECT FIREPLACE OPERATION

We did not locate operator controls for the gas fireplace. Further evaluation or demonstration is recommended.

Recommendation

Contact a qualified fireplace contractor.

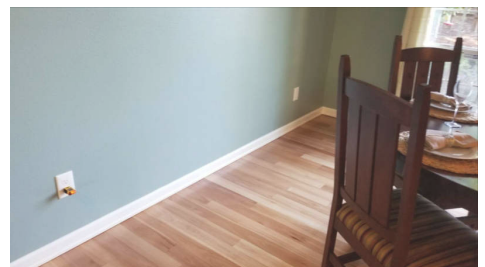
13.12.1 Outlets, Electrical

OPEN GROUNDED OUTLET

Recommendation

Contact a qualified electrical contractor.

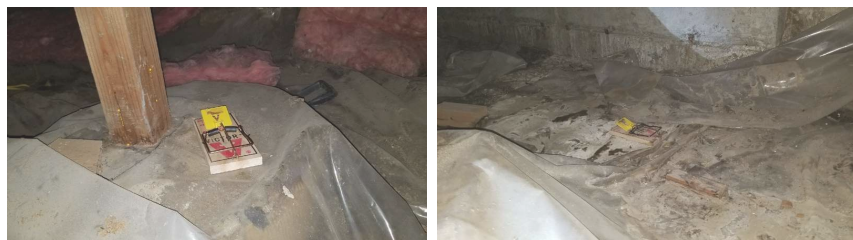
Empty rodent traps were observed in the crawl space. We recommend monitoring for rodent activity.

Recommendation

Contact a qualified professional.

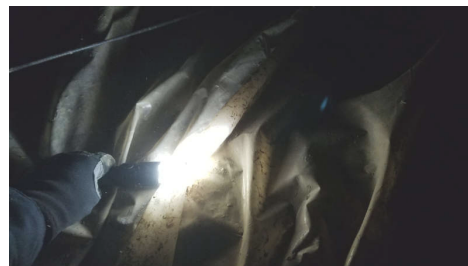
15.1.2 Crawlspace Notes

VAPOR BARRIER CLEAR

The vapor barrier was installed but was clear. We recommend black vapor barrier be installed.

Recommendation

Contact a qualified professional.

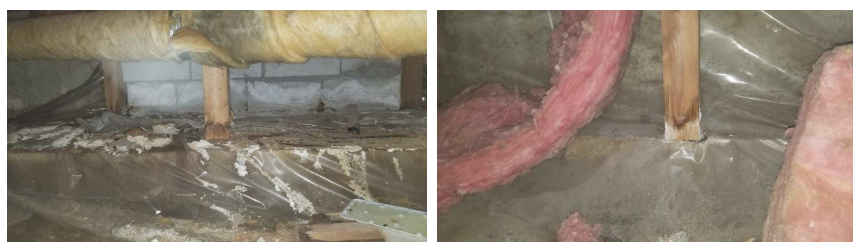
15.1.3 Crawlspace Notes

MOISTURE INFLUENCE

There was moisture present in one or more locations of the crawlspace at the time of the inspection. Recommend evaluation and or repair by a qualified licensed professional.

Recommendation

Contact a qualified professional.

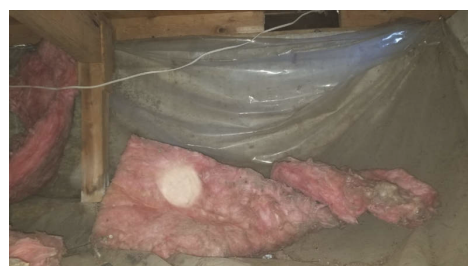
15.1.4 Crawlspace Notes

INSULATION FALLING DOWN

Recommendation

Contact a qualified handyman.

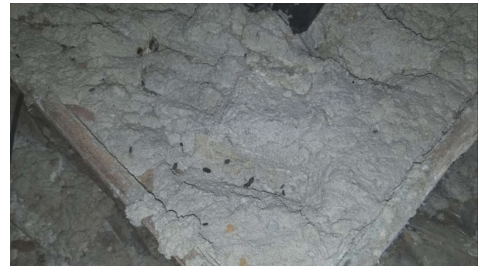
15.1.5 Crawlspace Notes

Evidence of past pest activity was observed in the crawl space. There was no evidence that this was an active infestation. Further evaluation by an exterminator would be appropriate.

Recommendation

Contact a qualified pest control specialist.
