## PRE-DRYWALL INSPECTION REPORT

1010 New Homesite  
Denver CO 80538

Leon Homebuyer  
AUGUST 5, 2019

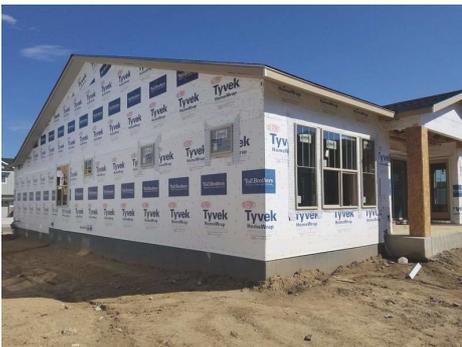
#### General photos

The following photos document the general condition of the exterior of the home. These photos reflect areas that have no existing concerns at this time. Areas with a specific concern or defect are noted separately, referencing the specific issue and area of concern.

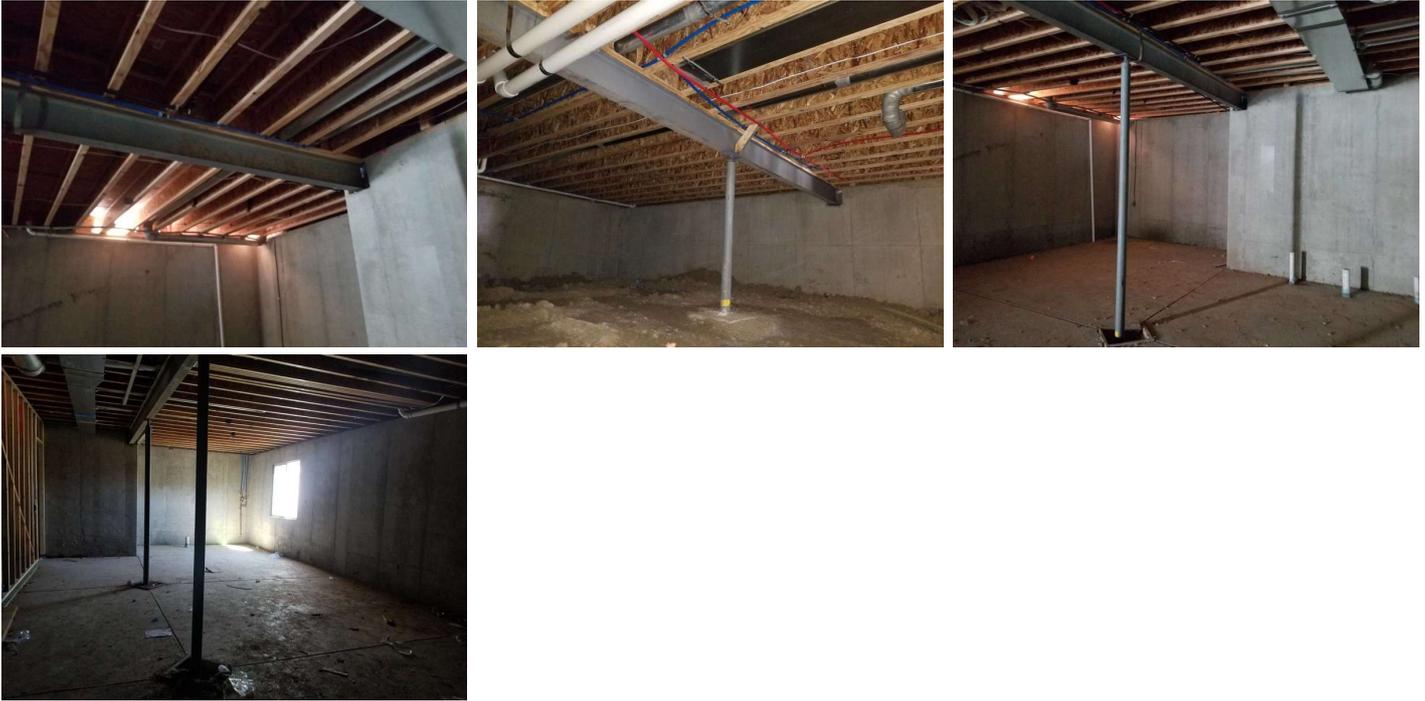
**General photos**

The following photos document the general condition of the foundation/basement/crawlspace of the home. These photos reflect areas that have no existing concerns at this time. Areas with a specific concern or defect are noted separately, referencing the specific issue and area of concern.

The structure and foundation of the home were visually inspected where readily accessible for signs of problems or concerns. No indications of significant structural concerns were observed at the time of the inspection.

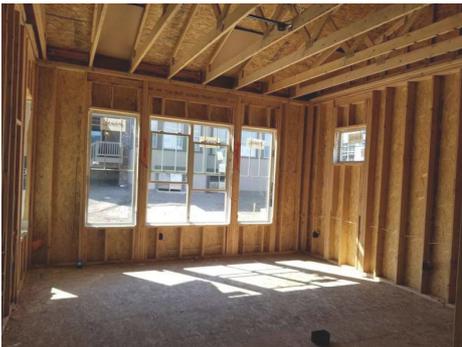
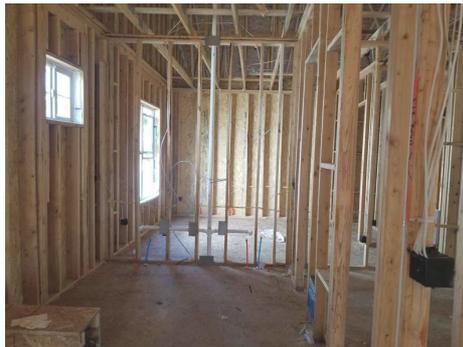
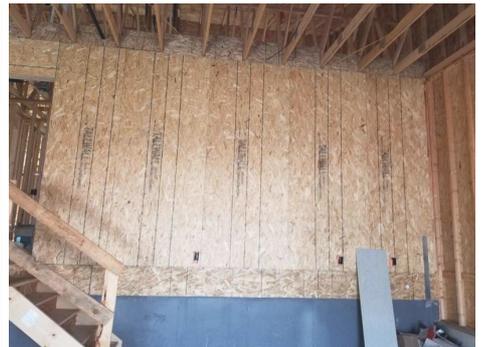
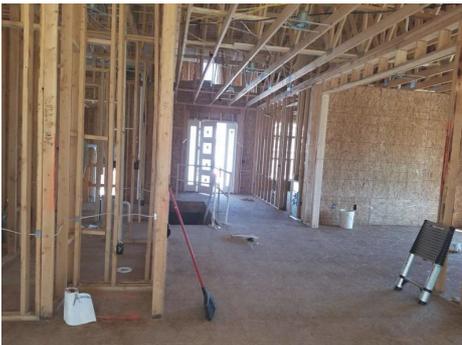
#### General photos

The following photos document the general condition of the wall structure and framing of the home. These photos reflect areas that have no existing concerns at this time. Areas with a specific concern or defect are noted separately, referencing the specific issue and area of concern.

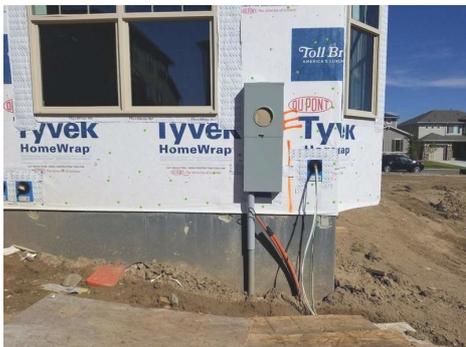
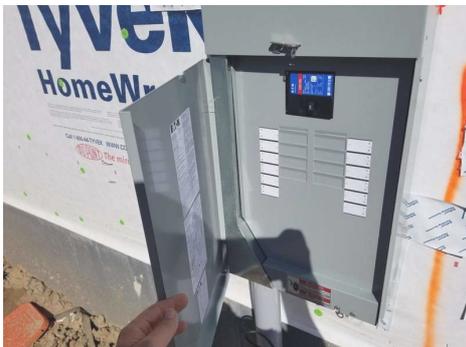
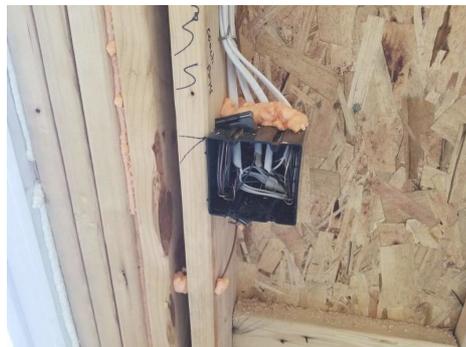
#### General photos

The following photos document the general condition of electrical system and components if applicable. These photos reflect areas that have no existing concerns at this time. Areas with a specific concern or defect are noted separately, referencing the specific issue and area of concern.

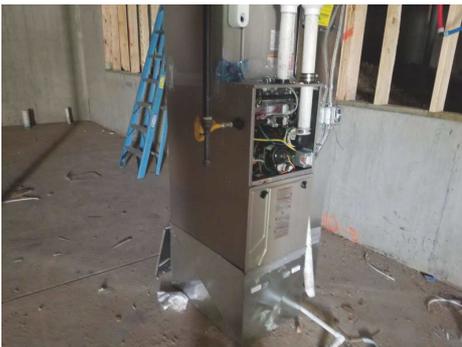
#### General photos

The following photos document the general condition of heating and cooling system and components if applicable. These photos reflect areas that have no existing concerns at this time. Areas with a specific concern or defect are noted separately, referencing the specific issue and area of concern.

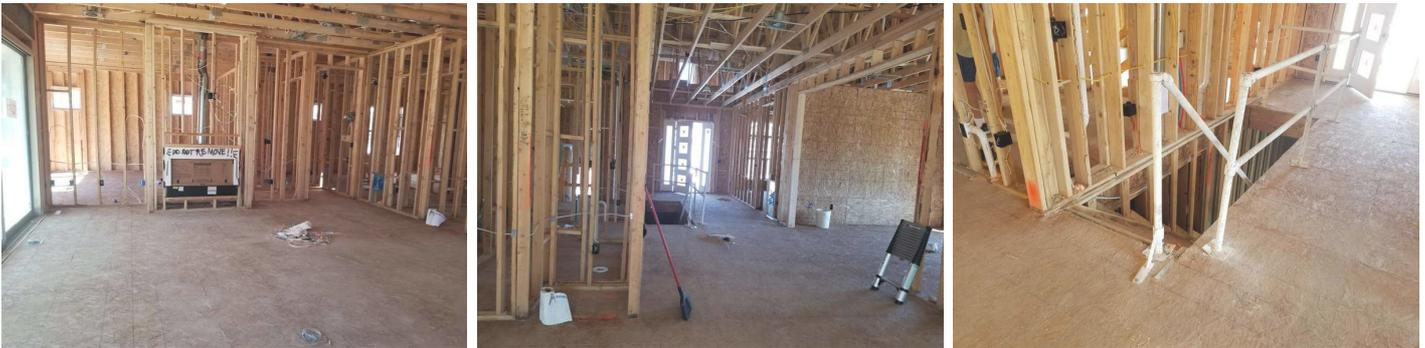
#### General photos

The following photos document the general condition of the interior areas of the home. These photos reflect areas that have no existing concerns at this time. Areas with a specific concern or defect are noted separately, referencing the specific issue and area of concern.
