PROPERTY INSPECTION REPORT

Concerning: 123 Lucky Loop, Round Rock, Texas 78665

11/19/2019 8:30 am

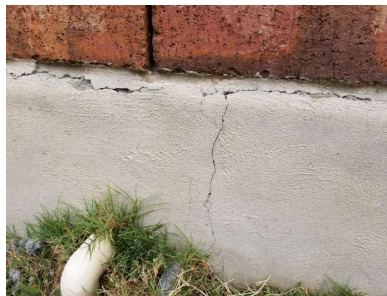
South Side

2: Cracking of skim coat

Cracks were observed in the cosmetic skim coat covering the concrete perimeter beam of the foundation. Cracks in the cosmetic skim coat should be repaired as this allows moisture penetration, can create conducive conditions for wood destroying insects and allow further deterioration of the cosmetic skim coat. This should be closely monitored and repaired as needed.

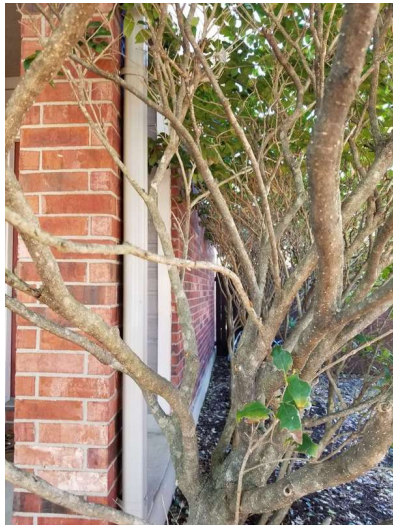
Foliage limits the inspectors visual observation of the exterior surfaces. Heavy foliage at exterior surfaces can damage exterior veneer, create conditions for wood destroying insects and trap moisture. It is recommended at have all foliage trimmed away from the exterior surface a minimum of 18 inches.

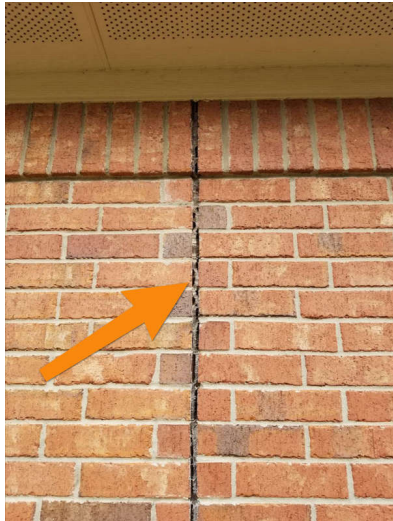
South Side

3: Widening/separating of expansion joint

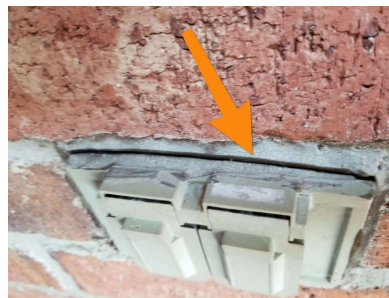
Entryway

4: Deteriorated or missing sealants/caulking

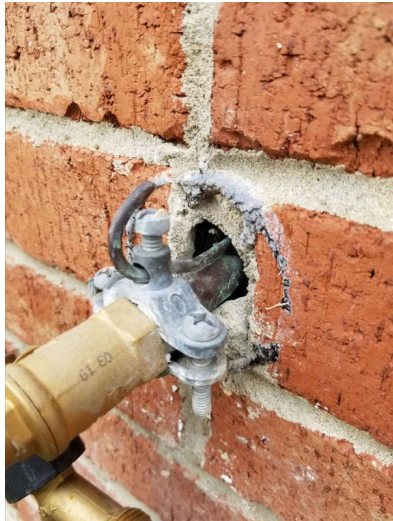
South Side

5: Seal around hose bibb

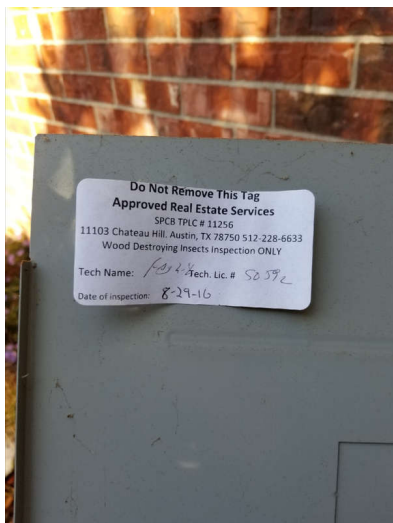
Indications of a previous wood destroying insect (WDI) treatment were observed. It is recommended that the buyer learn more about the treatment prior to closing.

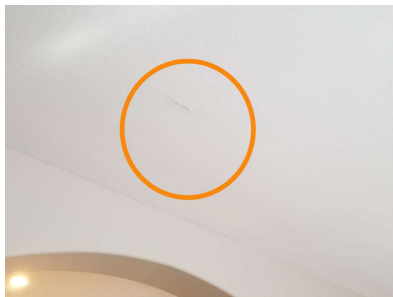
Living Room

Water stains were observed on the ceiling finish material at one or more location. The reason for the water penetration is unknown and it is recommended to monitor these areas for any changes especially during heavy rainfall to determine if the leak is still active.

The leak was checked with a moisture meter at the time of the inspection and the area was found to be dry.

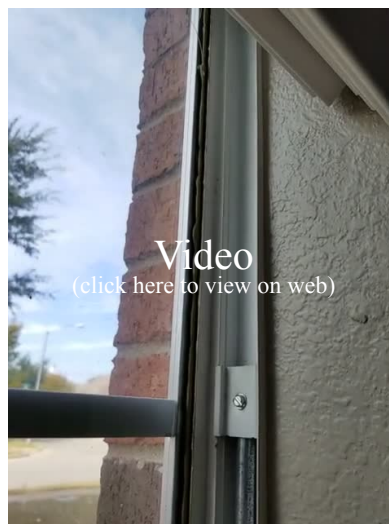
2: Lost thermal seal in window

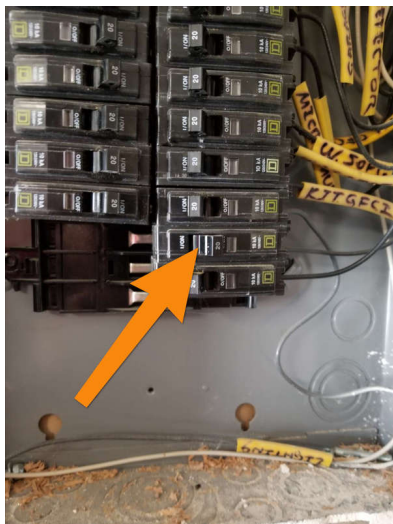
Subpanel

One or more of the breakers were in the off position at the time of the inspection.

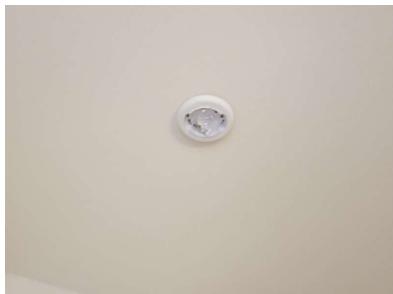
Master Bedroom

One or more smoke alarm was missing. Under current building standards, there should be a smoke alarm located in every bedroom, immediately outside of every bedroom, in the living areas and on each habitable level of the home. This considered to be a SAFETY HAZARD.

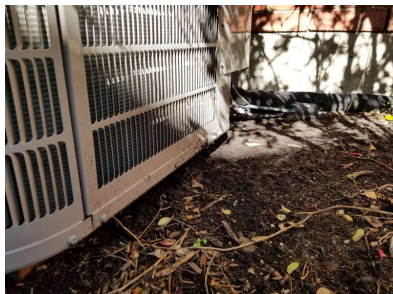
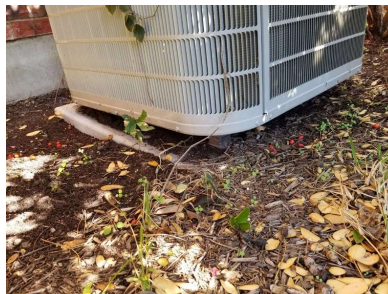
The AC condensing unit was not installed 3 inches above the grade. The improper height of the AC condensing pad may allow moisture to penetrate the equipment, reduce equipments serviceable life and may affect the condensing units performance. It is recommended to improve the grading around the AC condensing unit pad.

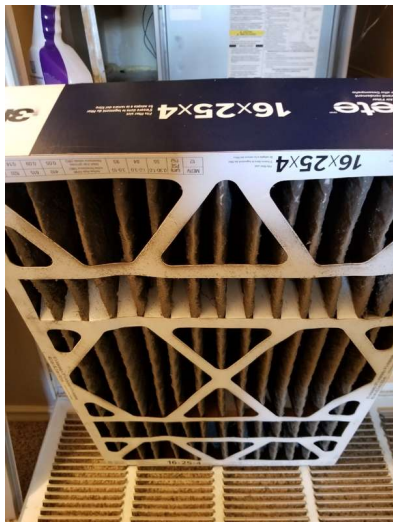
A media (thick) filter has been installed for the HVAC system. When a media filter is installed, smaller air return filters are normally not installed at the return air registers.

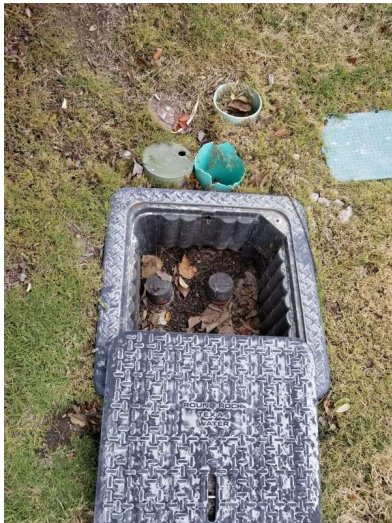
Static water pressure reading: 78 -

The recommended water pressure for the house should be between 40-80 psi.

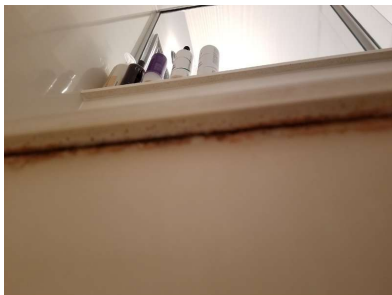
Master Bathroom

Cracked, deteriorated and/or missing caulking and/or grout was observed under the sitting ledge in the master shower. Cracked, deteriorated and/or missing caulk or grout should be repaired or replaced to prevent water penetration.

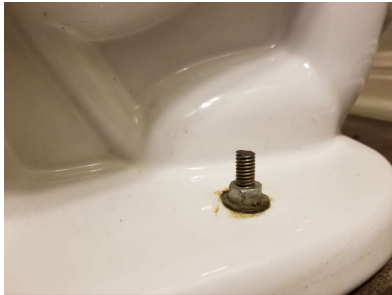
Half Bathroom

The toilet anchor bolts protruding from the base of the toilet were not properly covered. The bolts should be covered to help prevent rust and deterioration from occurring.

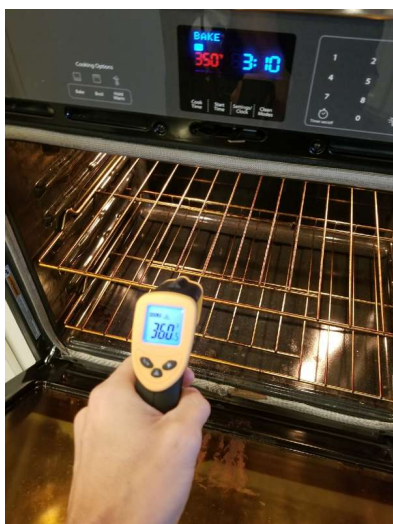
Oven temperature reading: 360 -

The recommended temperature differential is +/- 25 degrees when set to 350 degrees. At the time of the inspection the oven reading was within the recommended range.

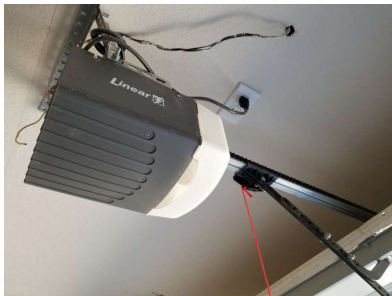
Left Garage Door

The automatic garage door opener's light was found to be inoperative. This condition may need a bulb replacement, fixture repair or a fixture replacement.

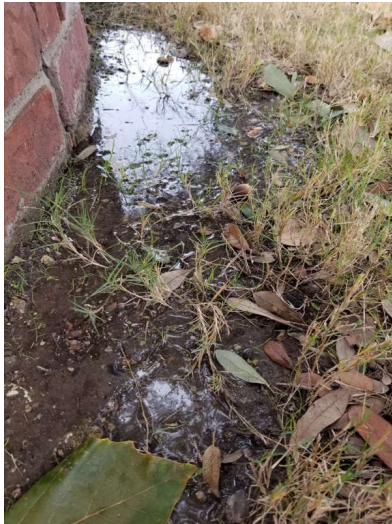
Zone 2 at Flowerbed

A damaged sprinkler head was found in zone 2. It is recommended that an irrigation specialist repair of the affected heads.

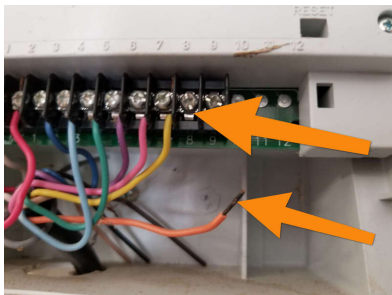
Zone 8 was found to not be connected to the controller and was found to not operate at the time of the inspection.
