MOUNTAINS TO SOUND HOME INSPECTION LLC

HOME INSPECTION REPORT

120 NW 43rd St
Seattle WA 98107

MARCH 12, 2018

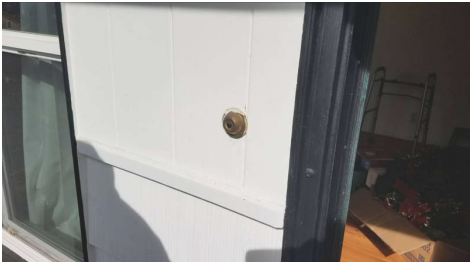
The doorbell does not work on demand and service is recommended .

Recommendation

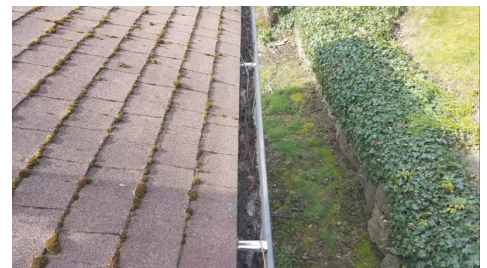
Parts of the roof needs to be cleaned of moss and/or debris. This can restrict drainage and lead to moisture intrusion and moisture damage if not corrected.

Recommendation

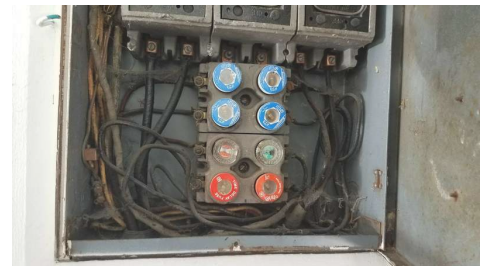
Branch wiring visible inside the service panel contained aluminum wires. Neglected aluminum wiring connections are a potential fire hazard. The Inspector recommends that you have the entire electrical system evaluated and any necessary maintenance which would include paste at all outlets and inside the panel and or corrections, or upgrades performed by a qualified electrician.

Contact a qualified electrical contractor.

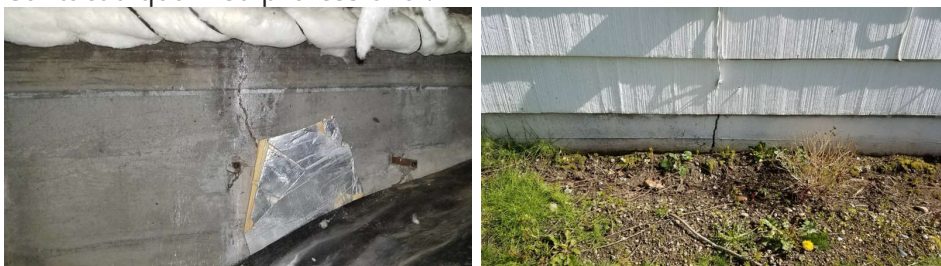
16.2.1 Foundation

CRACKS MODERATE

Contact a qualified professional.
