# MOUNTAINS TO SOUND HOME INSPECTION LLC

## HOME INSPECTION REPORT

6206 75th St W  
Lakewood WA 98499

Trong Dang  
MARCH 2, 2019

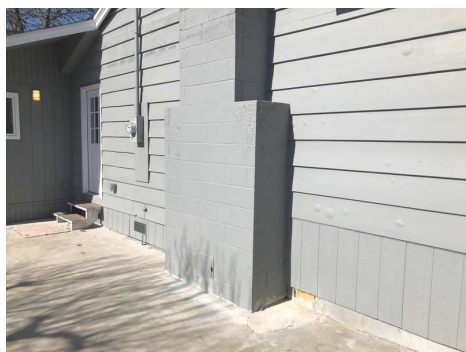
**Exterior Chimney: Serviceable Condition**

The exterior chimney was in serviceable condition. See additional notes in the roofing section of this report.

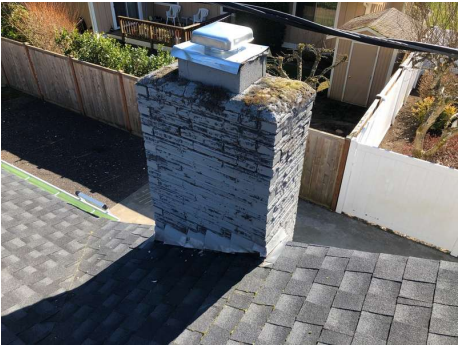
Chimney On Roof & Photo:  
Chimney Photo

The chimney has a functional weather cap/spark arrestor.

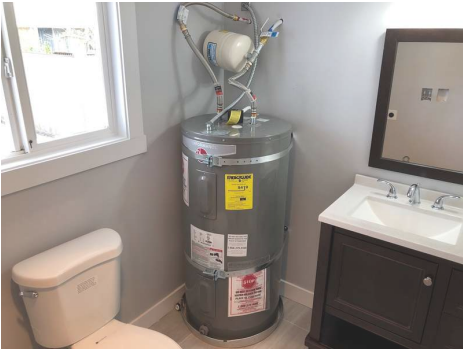
**Water Heating System: Manufacturer and picture**  
Rheem

I recommend flushing & servicing your water heater tank annually for optimal performance. Water temperature should be set to at least 120 degrees F to kill microbes and no higher than 130 degrees F to prevent scalding.  
[Here is a nice maintenance guide from Lowe's to help.](#)

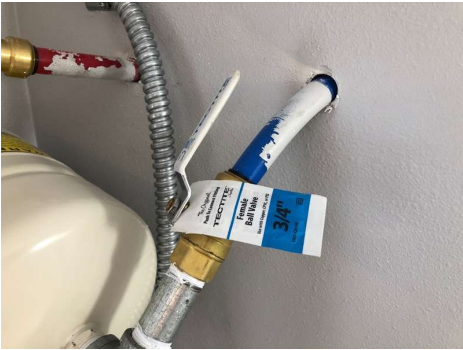
**Water Heating System: Water Shut-Off Valve & Connectors**  
The shut-off valve and water connectors appear functional but was not tested.

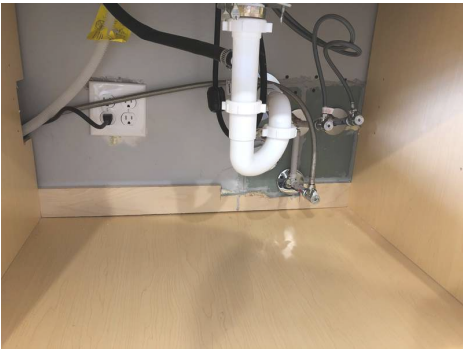
### Under Sink Photos

The presence of seller's items limited our view of the cabinet and plumbing below the sink.

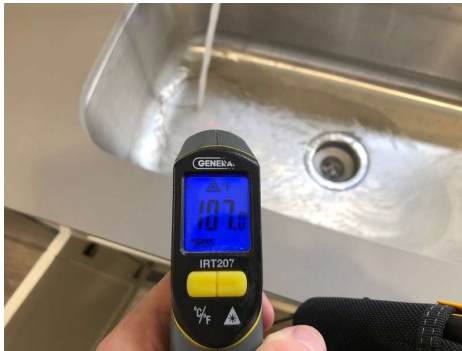
**Sink and Faucet: Water temp**

The Water temp at the Kitchen Faucet is Currently noted in the photo below. The U.S. Consumer Product Safety Commission (CPSC) urges all users to keep their water heater temps at 120 degrees Fahrenheit to prevent scalding and bacteria prevention reasons.

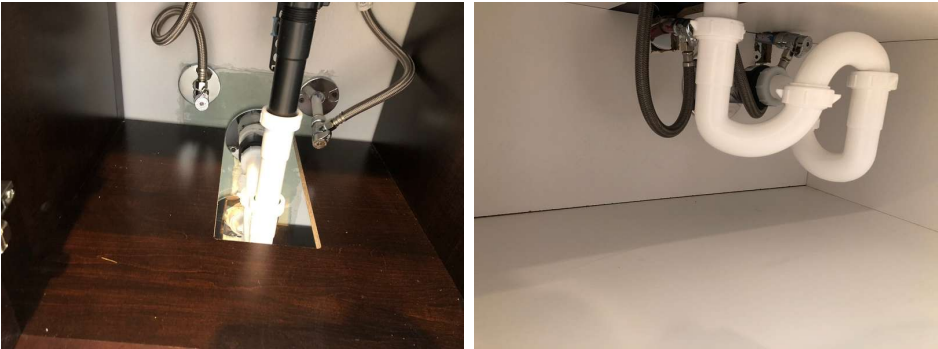
**Below Sink Photos**

The presence of seller's items limited our view of the cabinet and plumbing below the sink(s).
