# MOUNTAINS TO SOUND HOME INSPECTION LLC

## HOME INSPECTION REPORT

2715 103rd Ave Ct E  
Edgewood WA 98372

Daleen & Justin Lyle  
DECEMBER 6, 2019

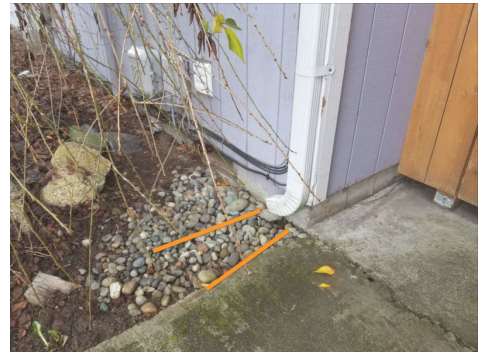
The downspouts are missing parts. Recommend repairs to allow for proper drainage away from the structure.

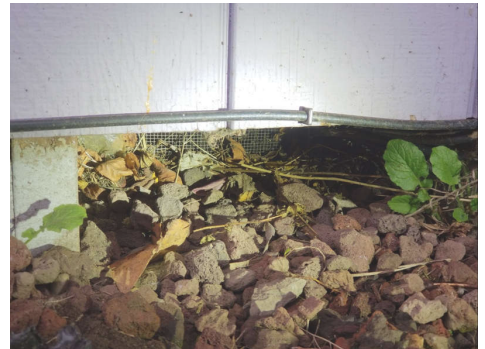
### 3.12.1 Crawlspace Vents

#### **BLOCKED SCREENS**

One or more crawlspace vent screens were blocked by vegetation, debris or otherwise obstructed. Recommend clearing to allow for proper ventilation.

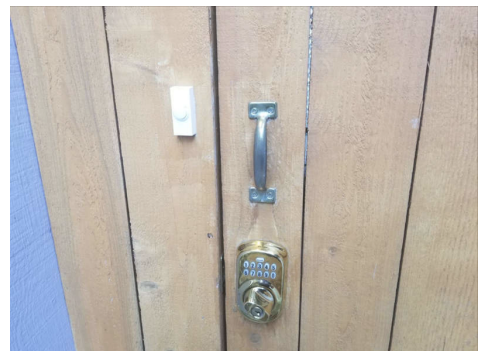
### 3.13.1 Doorbell

#### **DOES NOT WORK**

The doorbell does not work on demand and service is recommended .

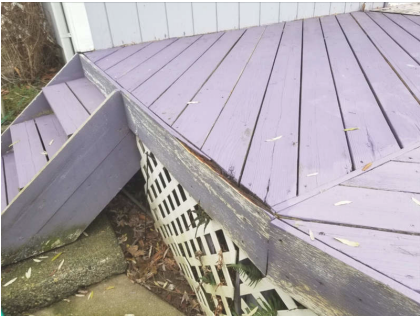
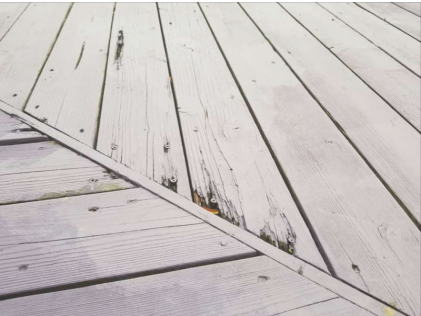
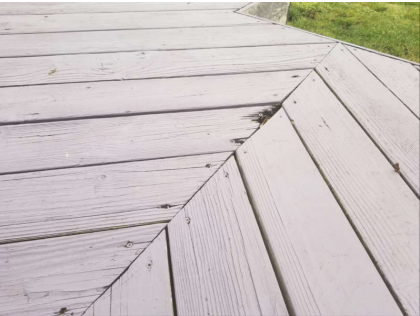
DECK IS DETERIORATED

One or more sections of the deck are damaged or deteriorated. Further evaluation and repair is recommended

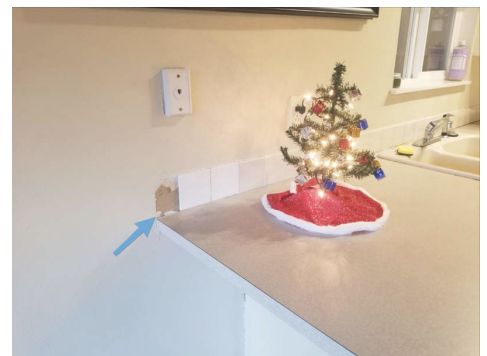
9.4.2 Countertop

### **BACKSPLASH DAMAGED**

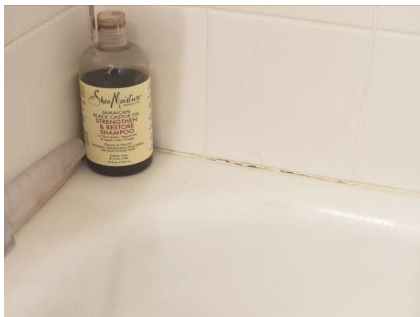
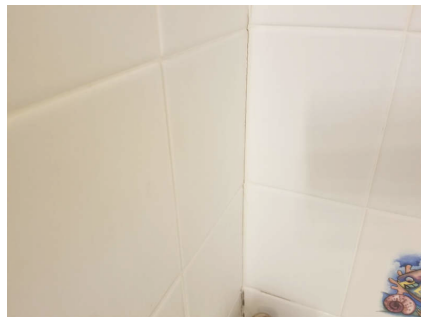
## 11.4.1 Tub-Shower

11.4.1 Bathrooms - Tub-Shower: Missing or deteriorated caulk/grout

Contact a qualified professional.

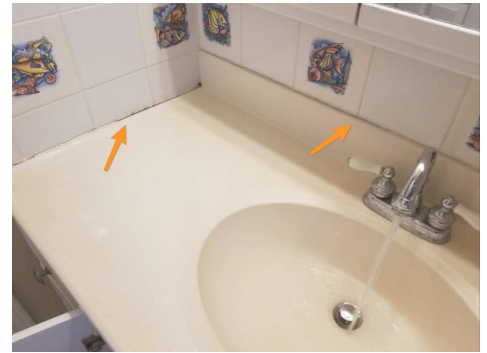
## 11.6.1 Countertop

**MISSING OR DETERIORATED  
CAULK/GROUT**

The caulking or grout for the backsplash is missing, has gaps and/or not installed properly. We advise caulking/grout be installed and/or gaps filled to prevent possible water intrusion.

Recommended DIY Project

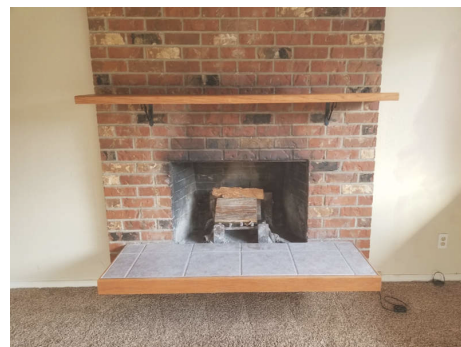
**Fireplace Notes: Type of fireplace & Photo**

Wood Burning

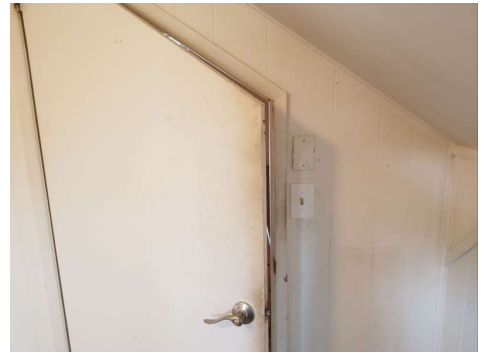
The door rubs and service is recommended.

Contact a qualified handyman.

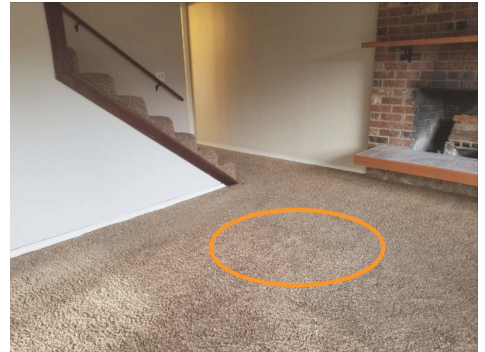
## 13.3.1 Flooring

**FLOOR SQUEAKS**

The floor in several areas squeaked when walked upon. This is due to driven nails/screws missing the joists. There are several method for repairs. We recommend that repairs be made to eliminate the noise.

Contact a qualified professional.

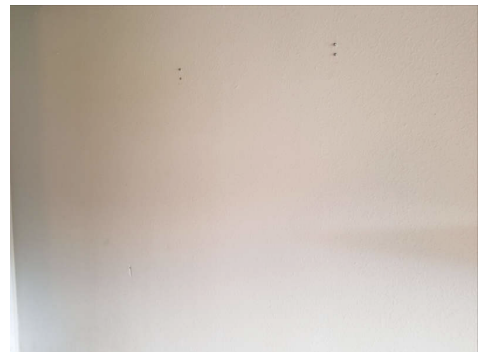
## 13.4.1 Walls and Ceiling

**NORMAL WEAR AND TEAR**

Sections of the walls or ceiling have cosmetic damage (scuffs, scrapes, nail holes etc) that you should view yourself and correct as desired.

Recommended DIY Project

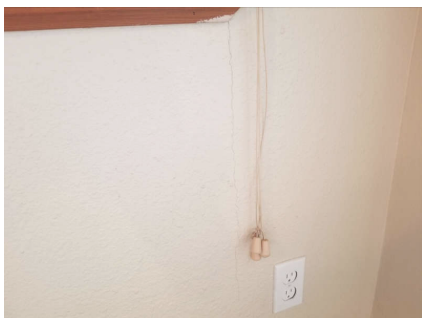
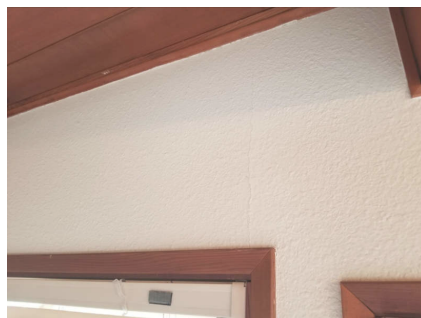
## 13.4.2 Walls and Ceiling

**TYPICAL SETTLEMENT CRACKING/NAIL POPS**

Observed typical settlement type cracking and nail pops on walls and ceilings. Recommend repairs as needed. Home owner to identify all areas for repair.

Recommend monitoring.

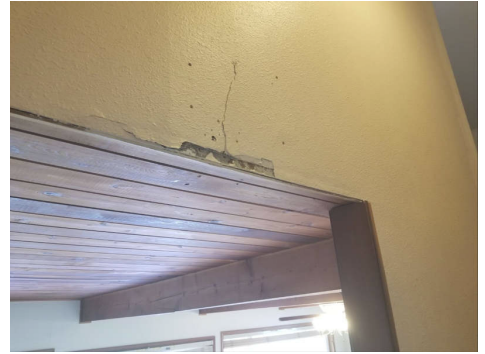
## 13.4.3 Walls and Ceiling

**WALL/CEILING DAMAGED**

The wall/ceiling has some damage and repair is recommended.

Medium Priority

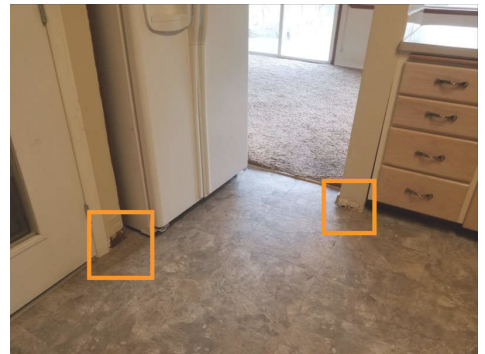
## 13.4.4 Walls and Ceiling

**MISSING/DAMAGED WALL BASE**

Wall base is missing or damaged. Recommend repair or replacement as needed.

Low Priority

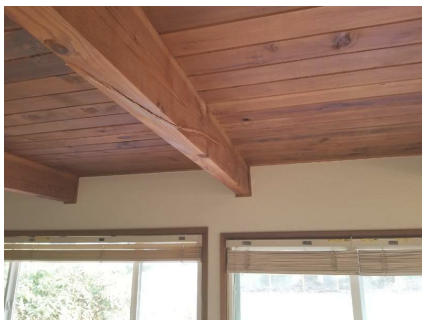
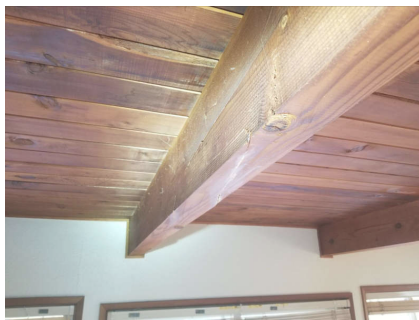
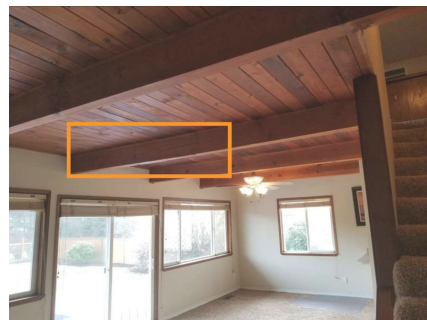
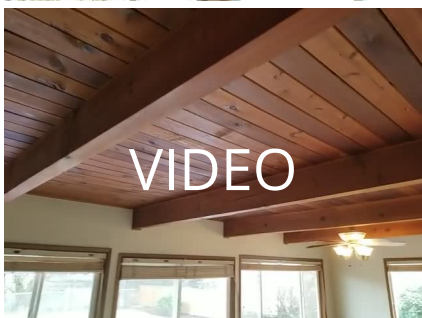
## 13.4.5 Walls and Ceiling

**CRACKED BEAM**

A section of one of the 4 beams over the living room had a crack. The cracking pattern looks to be that of a warped piece of lumber, though you may wish to seek a second opinion from a qualified specialist.

Medium Priority

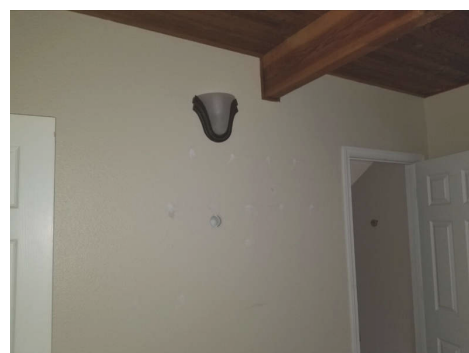
A light fixture did not have light bulbs or the bulbs were burnt out. Recommend replacing bulbs and testing.

Contact a qualified handyman.

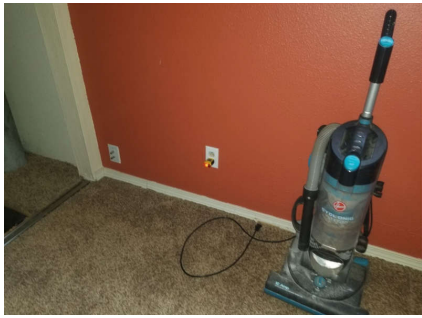
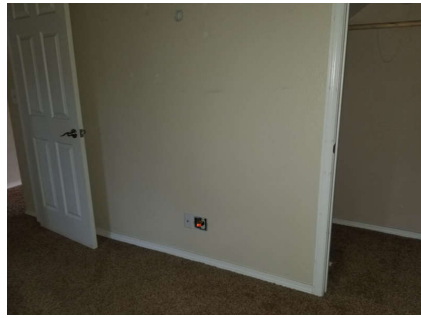
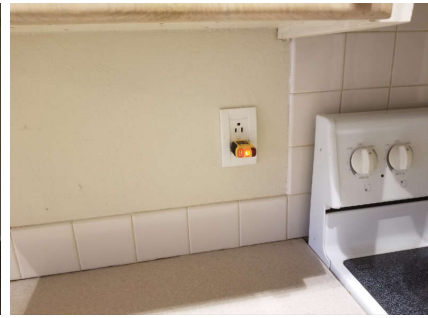
## 13.13.1 Outlets, Electrical

Several of the Interior Outlets are ungrounded. This is common in older homes. Grounding all Outlets would be a beneficial and recommended update.

Contact a qualified electrical contractor.

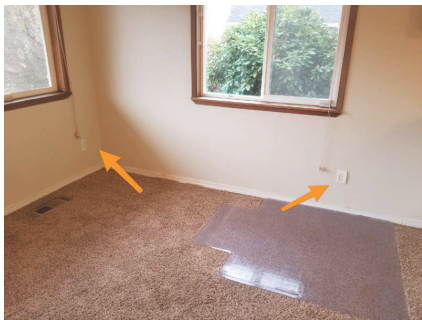
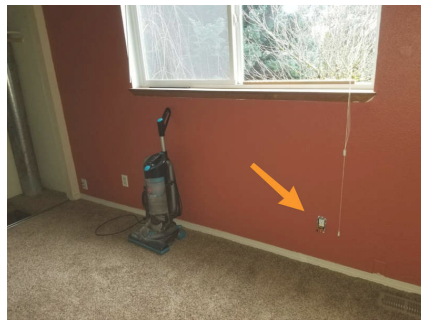
### 13.13.2 Outlets, Electrical

#### **NO POWER SUPPLY AT OUTLET**

Contact a qualified electrical contractor.

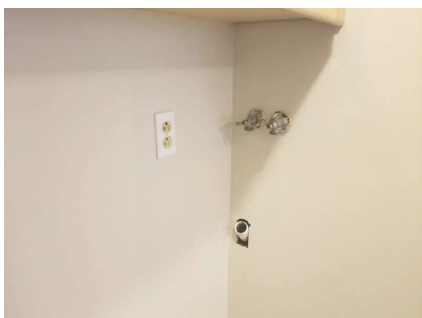
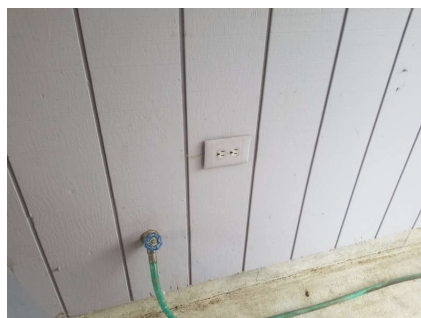
### 13.13.3 Outlets, Electrical

#### **LOOSE OUTLET**

A outlet was loose and should be serviced

Contact a qualified professional.

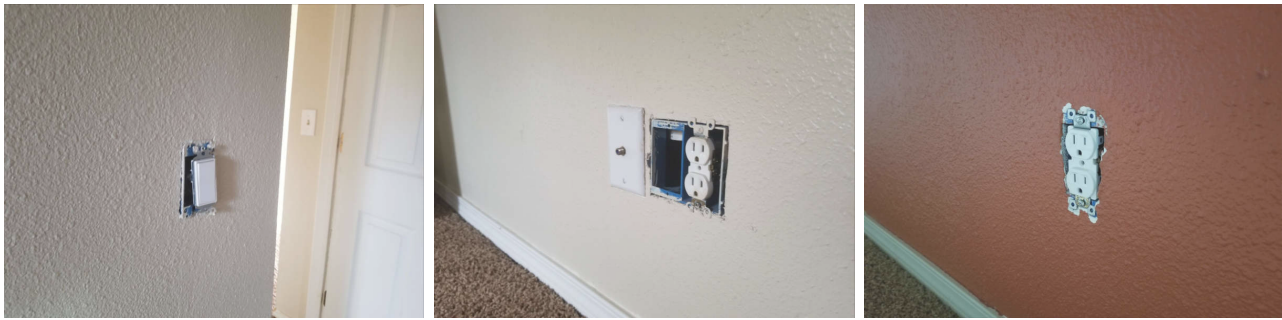
### 13.13.4 Outlets, Electrical

#### **MISSING COVERS**

There were missing covers on outlets, switches, and junction boxes that should be installed.

Contact a qualified handyman.

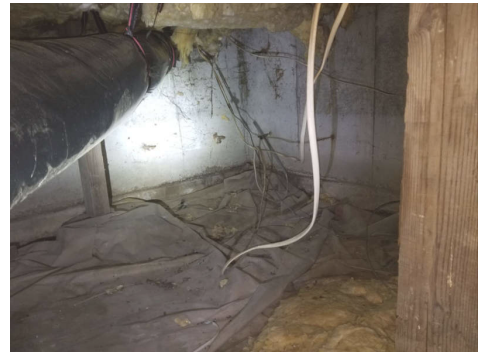
Wires were hanging, which are exposed to damage. We recommend any wires be properly protected and supported off the ground to the floor joists and/or beams as needed.

Contact a qualified professional.

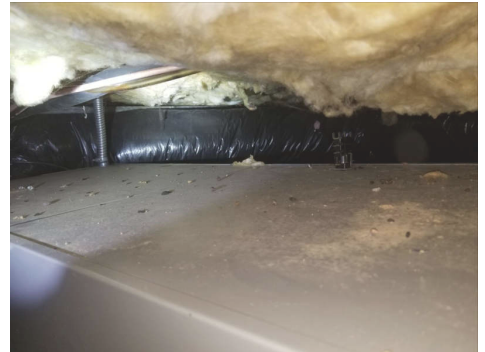
## 15.1.2 Crawlspace Notes

**RODENT ACTIVITY**

Evidence of rodent activity in the form of feces or urine stains was observed in the crawl space. We recommend sealing all access points and eliminating any active infestation.

Contact a qualified pest control specialist.

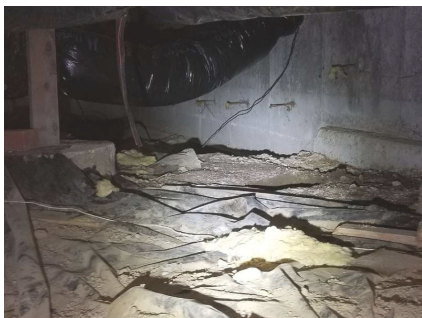
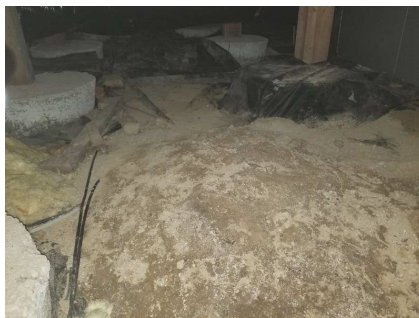
## 15.1.3 Crawlspace Notes

**VAPOR BARRIER MISSING**

Contact a qualified professional.
