THE SALLADE'S INSPECTION SERVICES

PHASE 2 (PRE INSULATION & DRYWALL)

Phase 2 Example
Godley, TX 76044

Mr & Mrs Texan
JULY 8, 2022

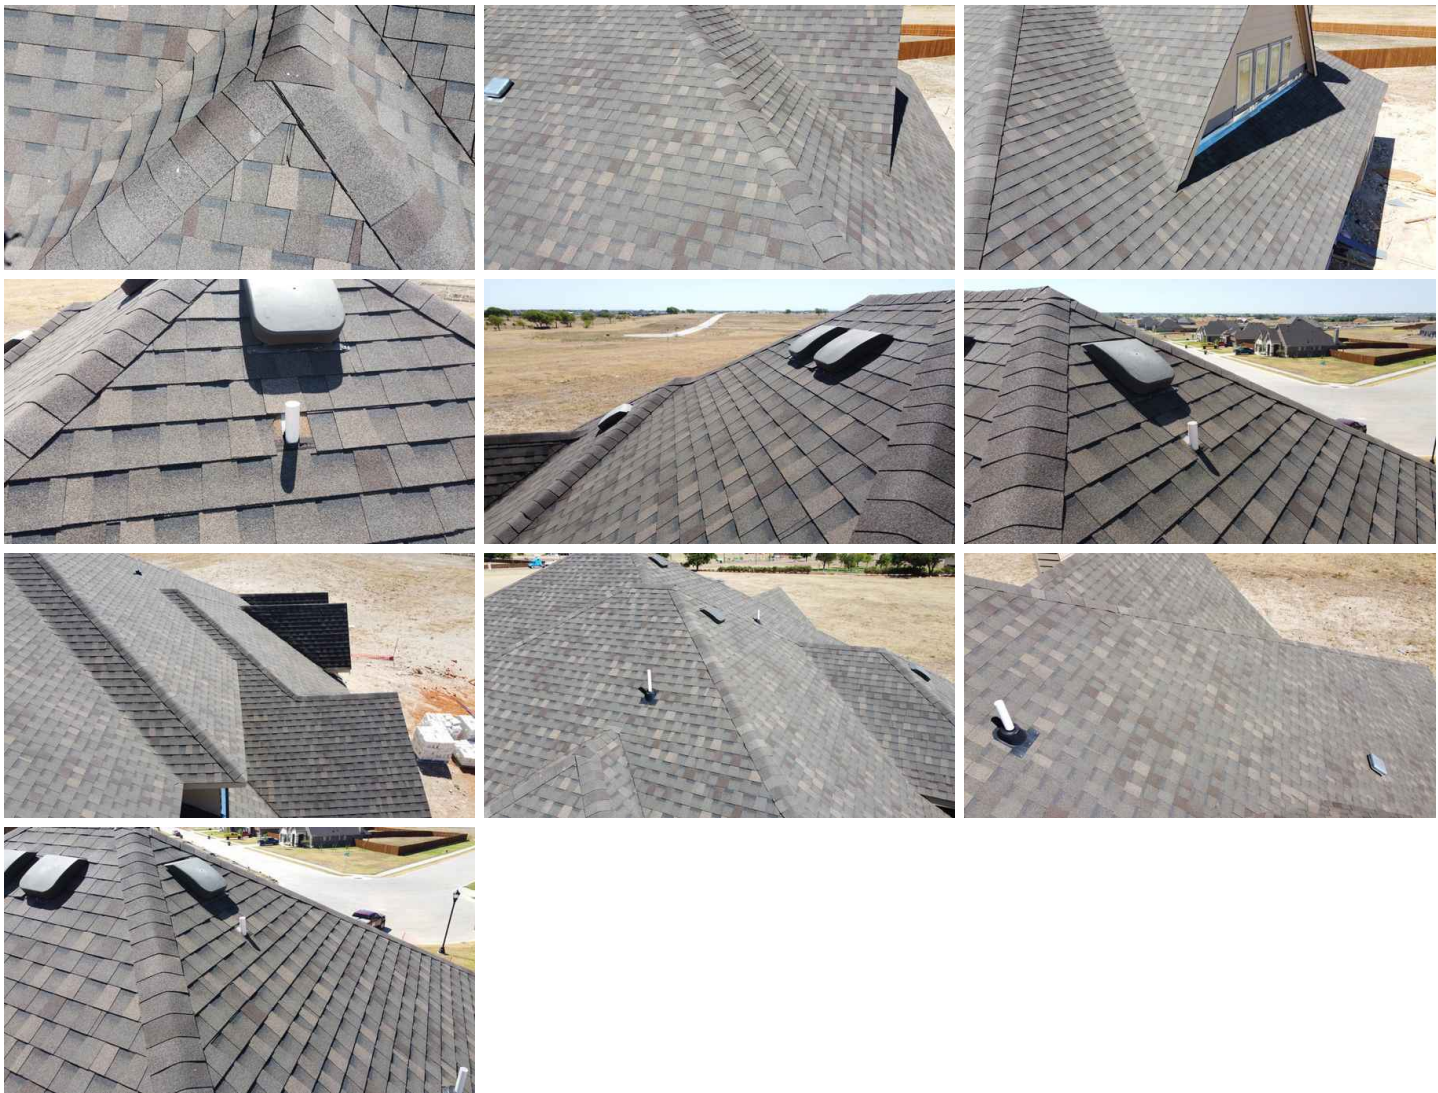
PICTURES FOR REFERENCE.

- Pictures of the roof covering for reference.

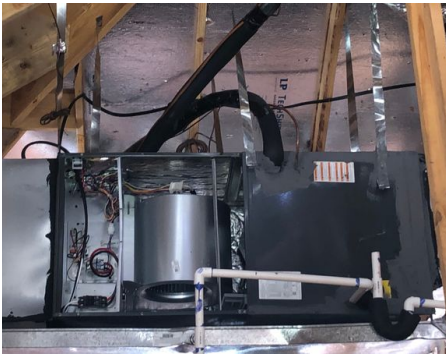
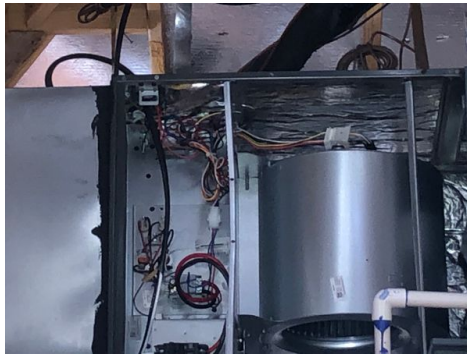
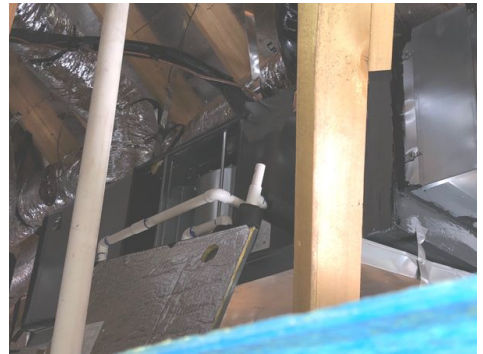
Mechanical systems: Mechanical systems OK

- Inspect the mechanical systems (HVAC, dryer vent and water heater flue installations for improper or incomplete installations.

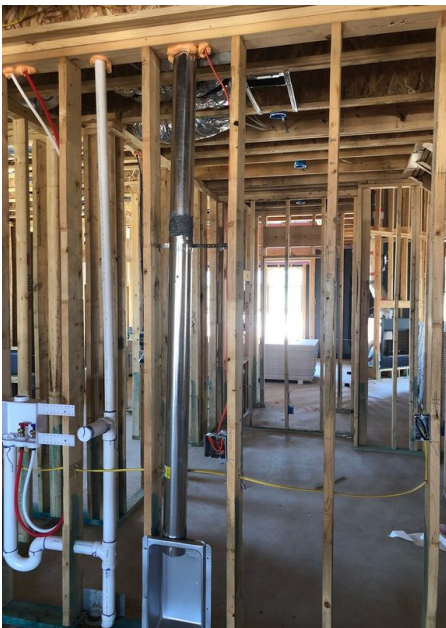
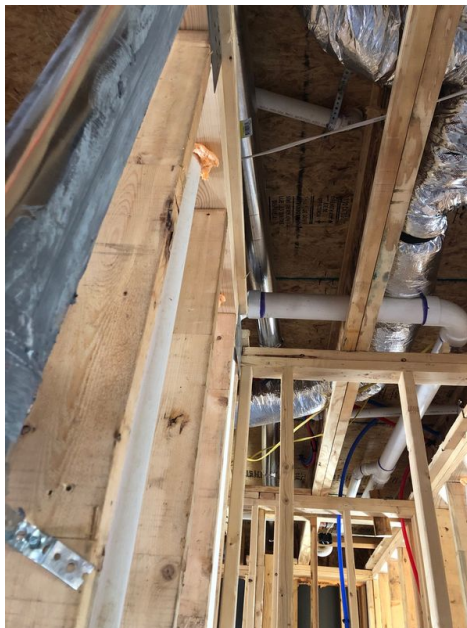
Mechanical systems: Dryer vent length ok

The cumulatively measured dryer vent length was less than 35 feet.

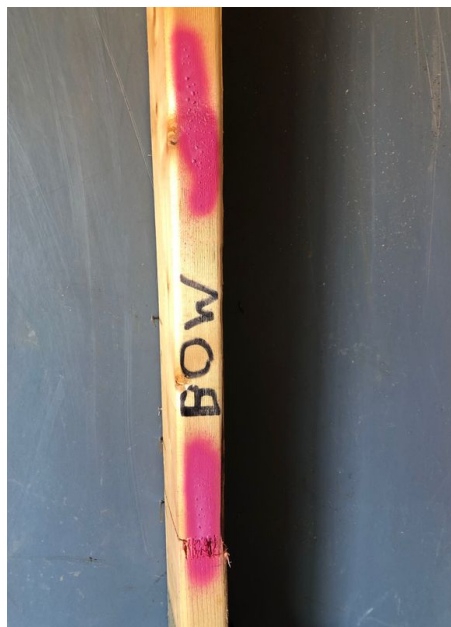
Framing Observations: How bowed studs are marked

Bowed studs are marked with the letters "BOW" written on the stud approximately 6' above the floor.

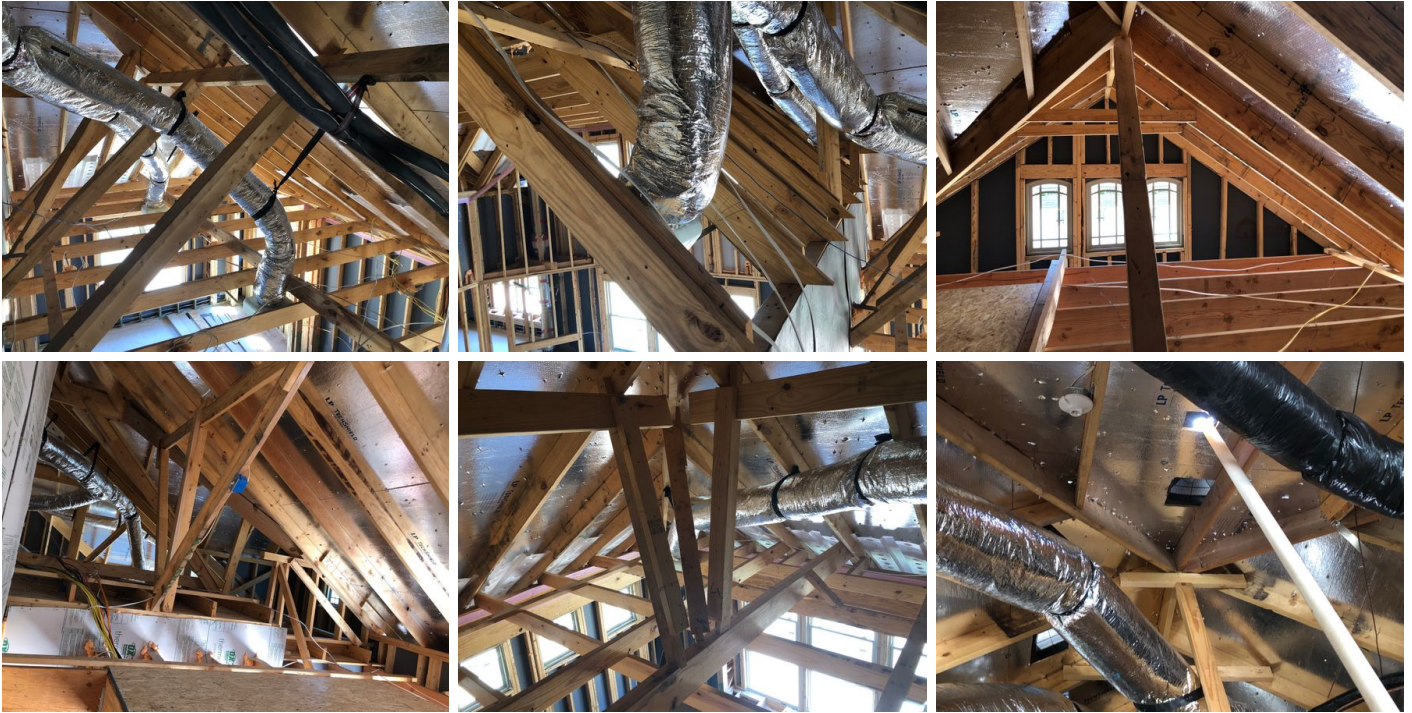
Framing Observations: Attic framing pictures

Pictures of the attic framing for reference.

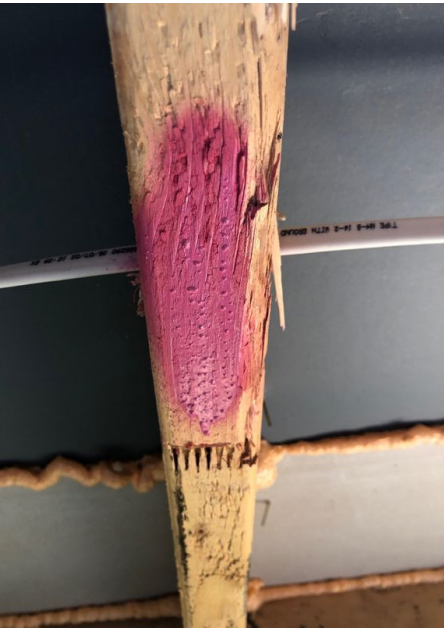
Electrical Observations: How nail plates are marked

Studs in need of a nail plate are makes with a sharpie made rectangle.

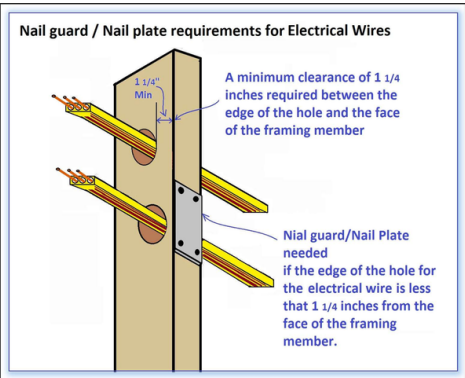
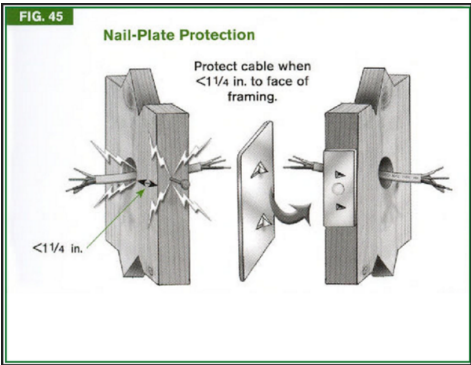
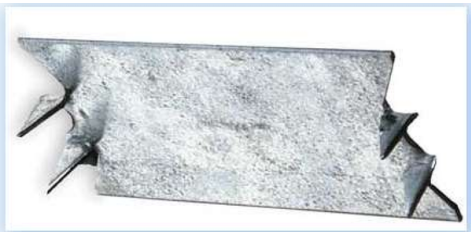
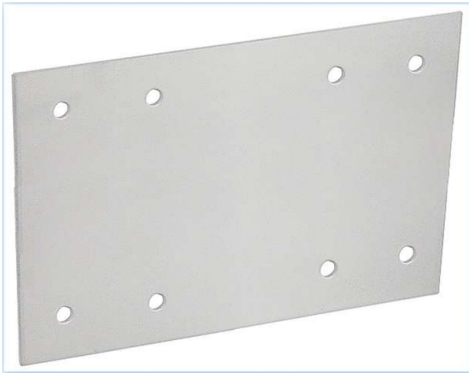
NAIL PLATE ILLUSTRATIONS AND CODE REFERENCE

Illustrations of nail plate examples.
IRC International Residential Code: reference below:
IRC 3702.1 Bored holes & standoff clamps 1 1/4 inch setback.
Protect cables w/ 1/16 inch steel plate (or L&L plate) if closer than 1 1/4 inch to framing surface. F45
