BOGGS INSPECTION SERVICES

BOGGS INSPECTION REPORT

1234 W Main St
Olympia, WA 98513

MARCH 18, 2023

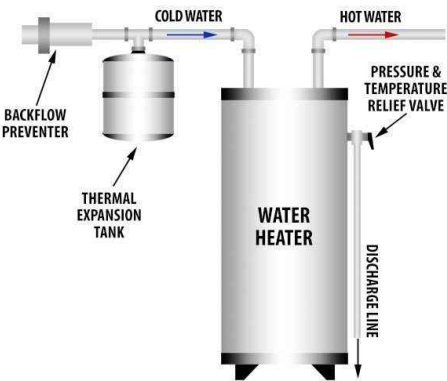
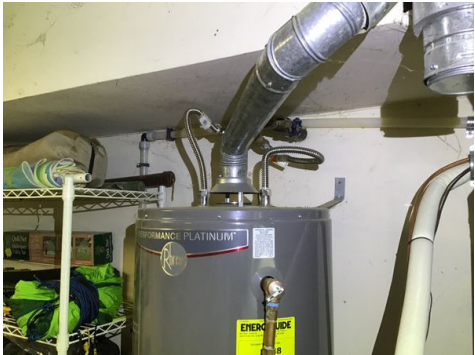
Expansion Tank

TYPICAL RESIDENTIAL INSTALLATION

Contact a qualified plumbing contractor.

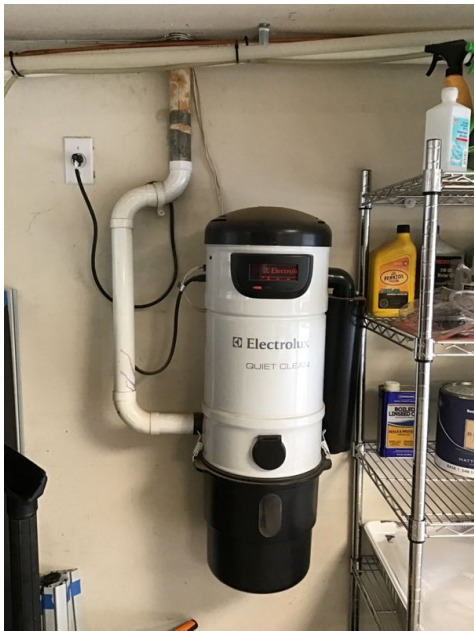
Garage

BUILT-IN VACUUM SYSTEM

A built-in vacuum system is present. The testing of these are beyond the scope of the inspection. Recommend following up with the seller to determine functionality.

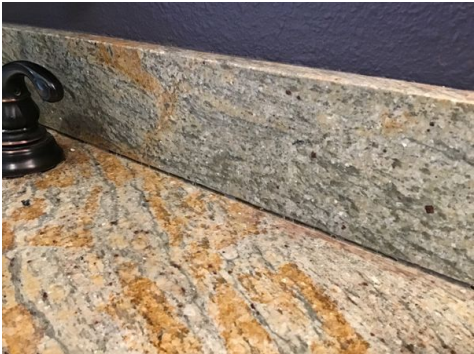
Master Bath

The countertop caulk/grout is failing. This is a normal maintenance issue which needs to be reapplied periodically.

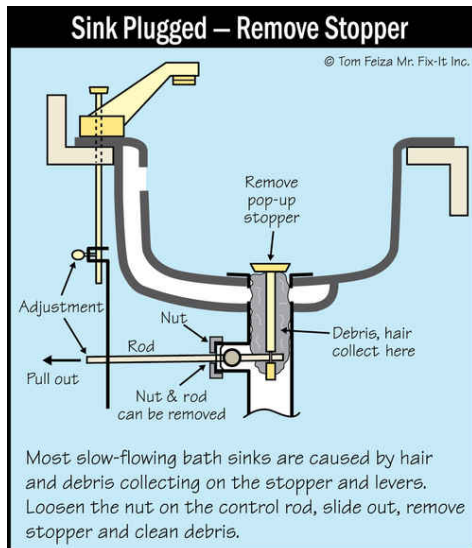
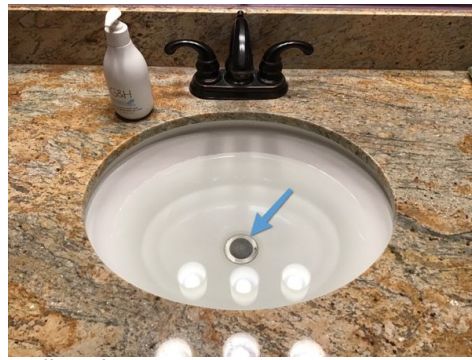
Hall Bath

STOPPER - DAMAGED/MISSING

The sink stopper is either missing or did not operate properly. Repair/replacement recommended.

Contact a handyman or DIY project

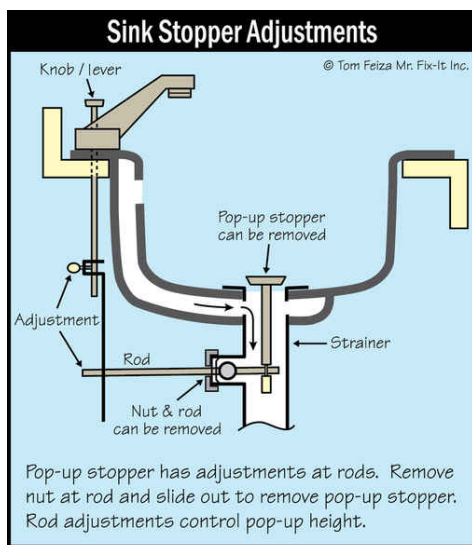
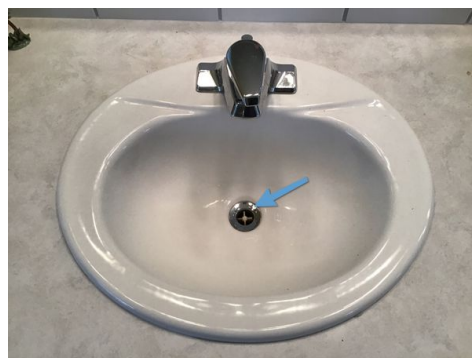
Basement Bath

DRAIN - RUST/CORROSION

Rust/Corrosion noted on sink drain line(s). Repair/replacement recommended as leaking may occur in the near future.

Contact a qualified plumbing contractor.

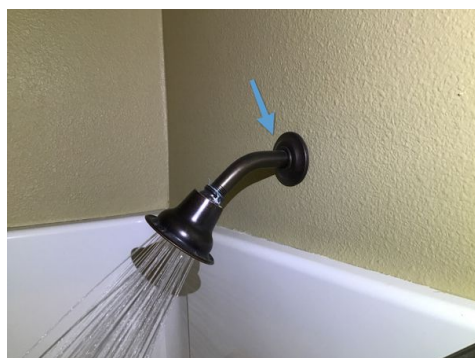
Guest Master

The tub/shower fixture supply pipes are loose inside the wall. Pipes which are not properly secured inside the wall may develop leaks over time. Further evaluation and/or repair/replacement is recommended.

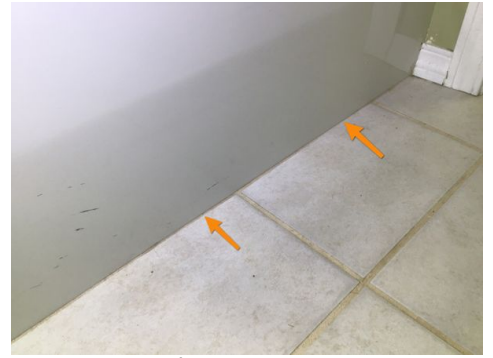
Basement Bath

The caulking/grout on the floor in front of tub/shower has failed. Failed caulking/grout may allow moisture to penetrate into and decay the underlayment and should be repaired.

Contact a qualified professional.

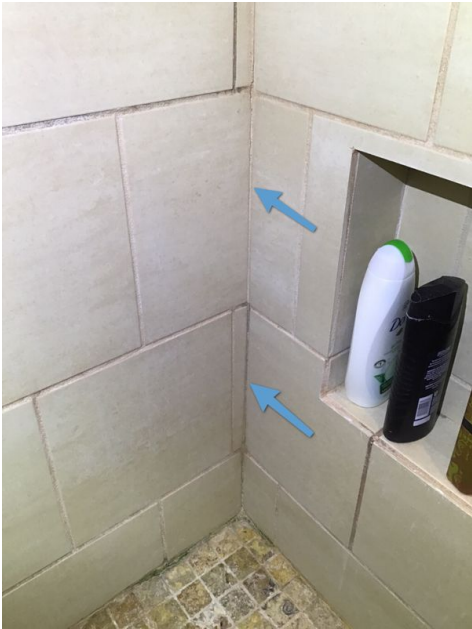
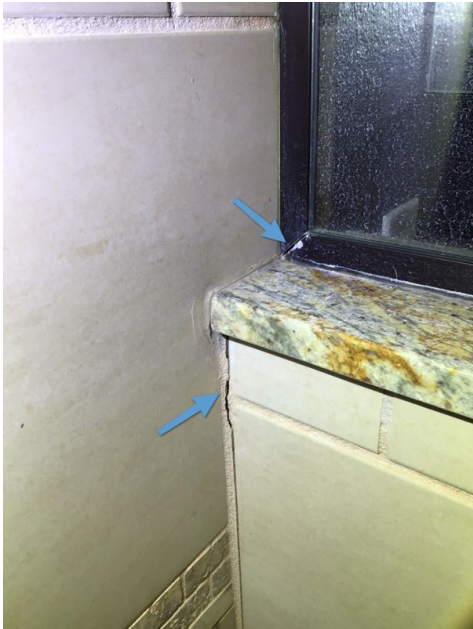
Master Bath

The tub/shower surround grout and or caulking is showing signs of deterioration. Any damaged or deteriorated caulking or grout should be repaired. Tile grout should be thoroughly sealed according to manufacturer's specifications and recommendations. Be aware hidden conditions may exist.

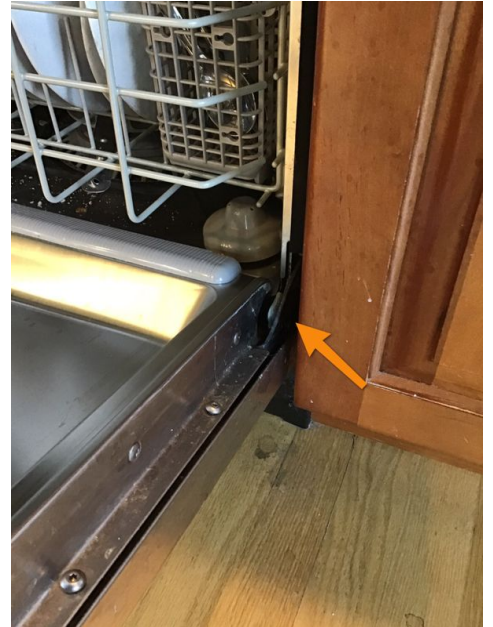
DOOR - SPRINGS DAMAGED

The dishwasher door springs is damaged, weak or out of adjustment. Repair/replacement is recommended.

Contact a qualified appliance repair professional.

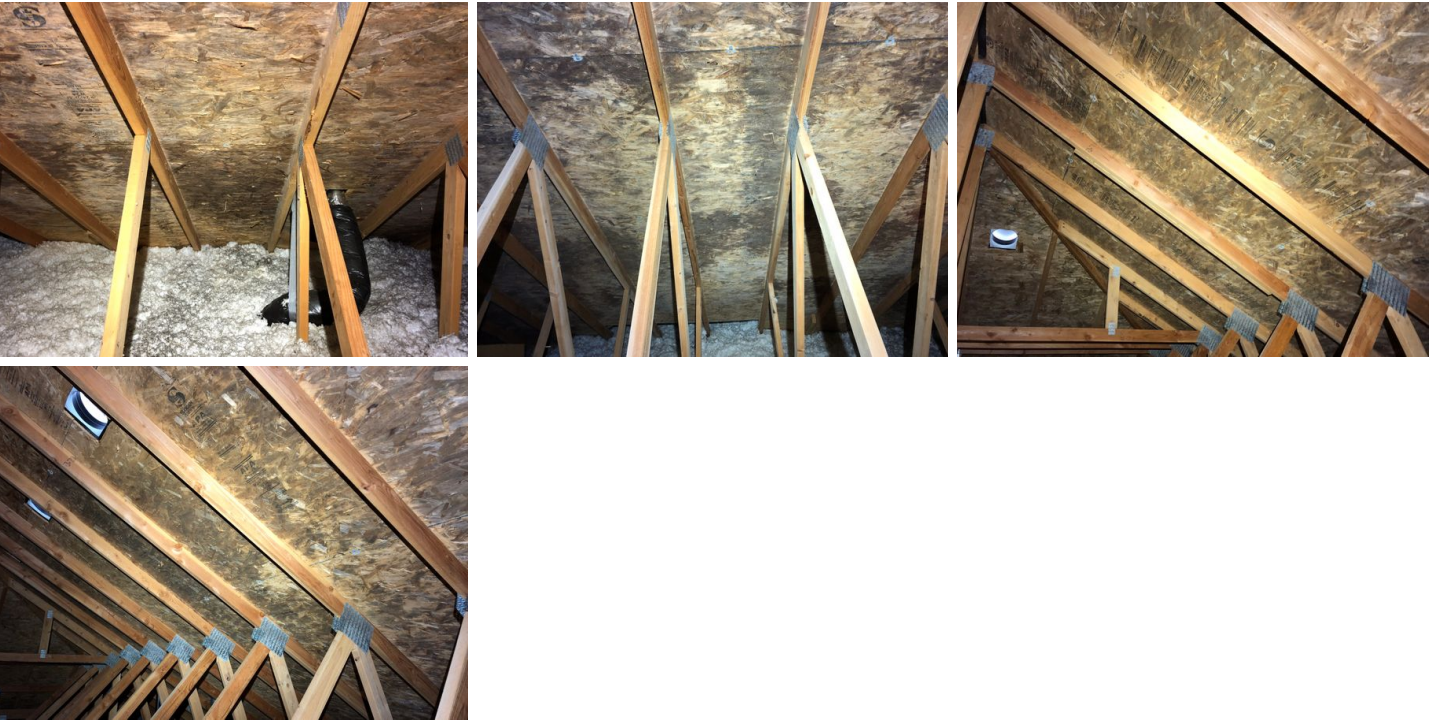
Microbial growth is present in the attic. White/dark discoloration on the underside of the roof sheathing may relate to ventilation conditions with the roof, even if it appears the roof is adequately vented. Roof leaks, fans ducted into the attic space and inadequate attic insulation may also be contributing factors. Sometimes, the discoloration has occurred at the time of construction when building materials were left outside in the weather. For evaluation and possible mitigation, consult with a qualified industrial hygienist or mold/moisture mitigation specialist to determine (1) possible health risks (2) appropriateness of and any need for mold testing (3) any specific measures needed for remediation. Correcting any issues with roof ventilation, roof leaks, open fan ducts in the attic and attic insulation may be helpful. Also, ask the seller about the history and what corrective actions, such as increasing roof ventilation or repairing open ducts, may have already been done.

Contact a qualified environmental contractor

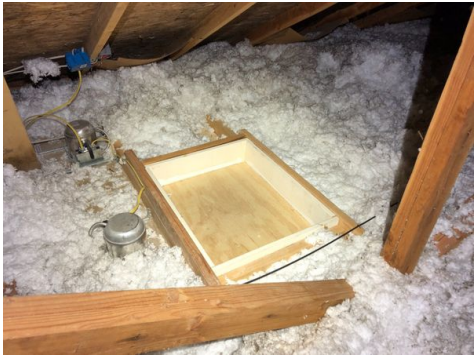
1006C

INSULATION - MISSING ON ACCESS LID

Insulation is missing on the attic access lid. Newer standards require insulation be installed over the interior attic access lid. Recommend upgrading this insulation.

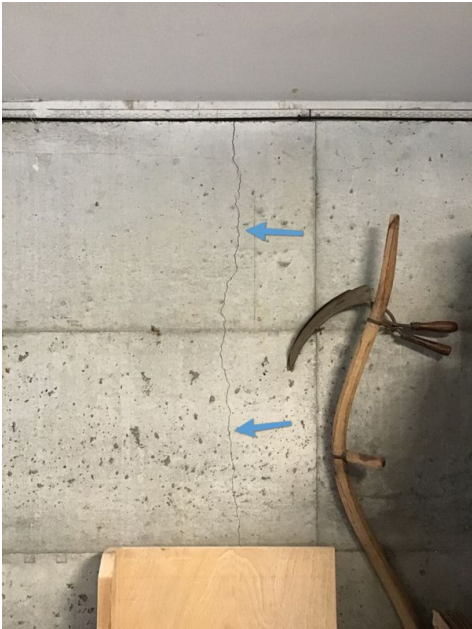
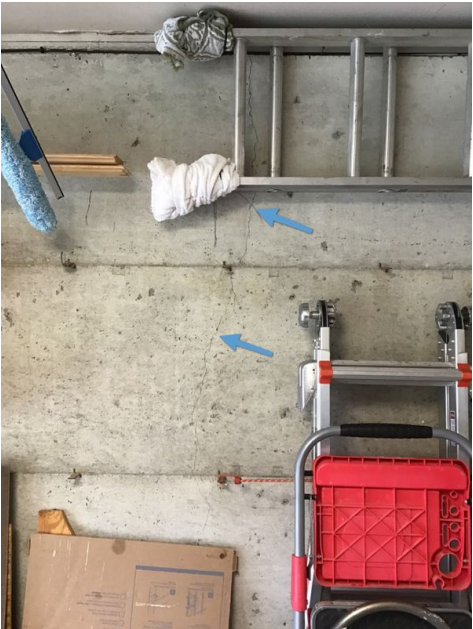
Garage

CRACKS - MINOR

Contact a qualified professional.
