PROPERTY INSPECTION REPORT

Concerning: 1234 Main Street, The Colony TX 75056
(Address or Other Identification of Inspected Property)

By: Tristan Eager - TREC #22148 07/19/2018 8:00 am
(Name and License Number of Inspector) (Date)

Type of Building: Single Family (2-story)

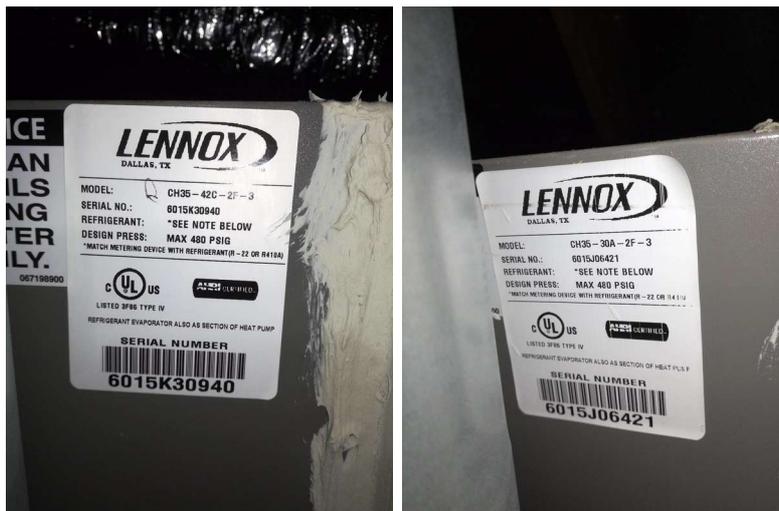
1: Air Conditioner Performance

- 9 degree cooling difference between register by north dining room and return register (63F/72F)
- 7 degree cooling difference between register by master bedroom and return register (65F/72F)
- Similar conditions observed at other registers
