# MOUNTAINS TO SOUND HOME INSPECTION LLC

## HOME INSPECTION REPORT

702 N Mason Ave  
Tacoma WA 98406

MAY 21, 2019

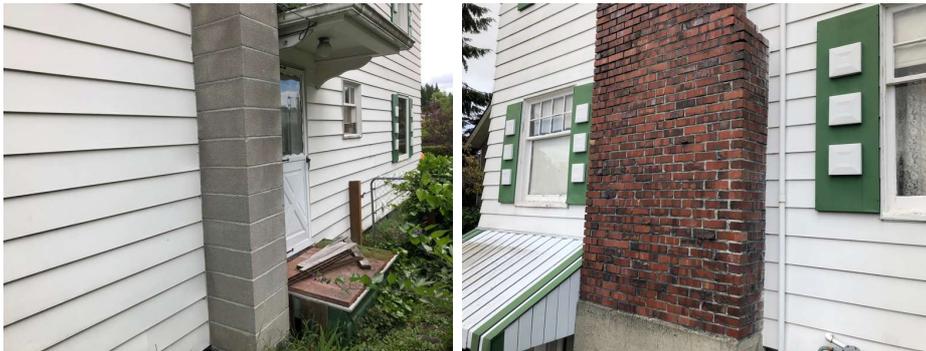
**Exterior Chimney: Serviceable Condition**

The exterior chimney was in serviceable condition. See additional notes in the roofing section of this report.

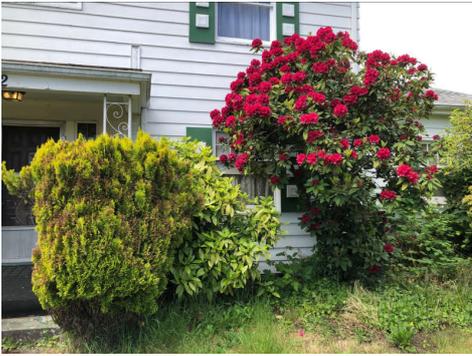
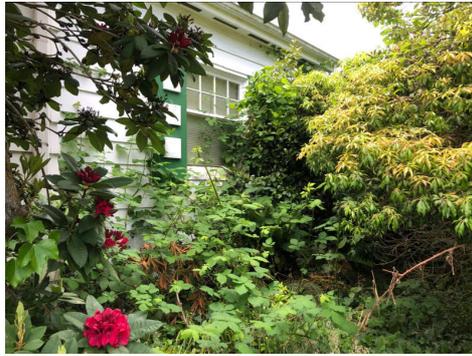
3.5.1 Exterior Siding Notes

**VEGETATION IS ENCROACHING**

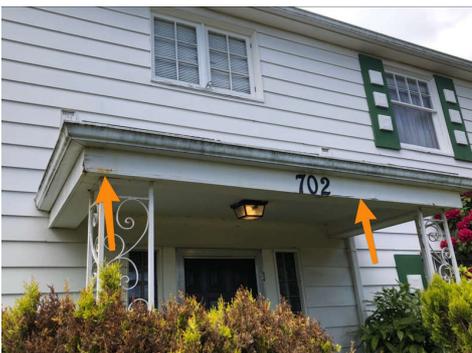
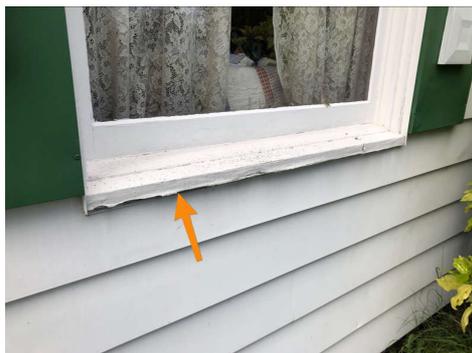
3.5.2 Exterior Siding Notes

**DAMAGED SIDING**

Contact a qualified handyman.

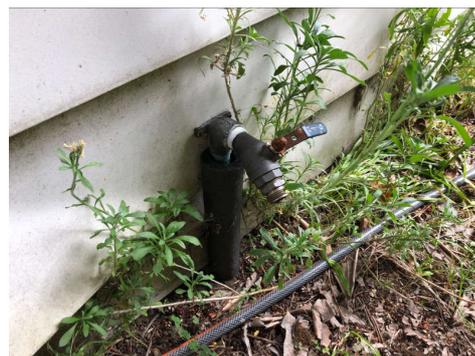
3.8.1 Exterior Plumbing

**HOSE BIB NOT FUNCTIONAL**

Contact a qualified plumbing contractor.

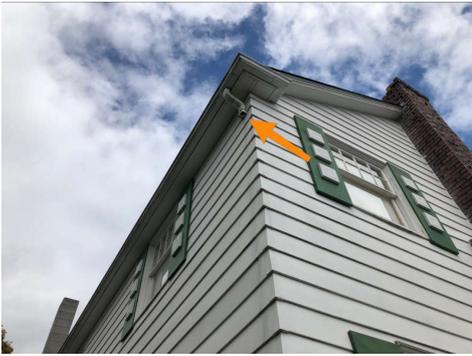
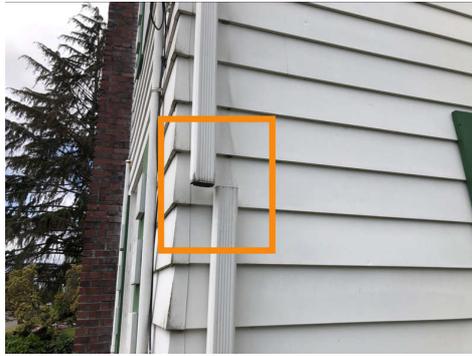
3.9.1 Downspouts

**SOME DOWNSPOUTS ARE MISSING OR NEED TO BE RECONNECTED OR SERVICED**

Contact a qualified roofing professional.

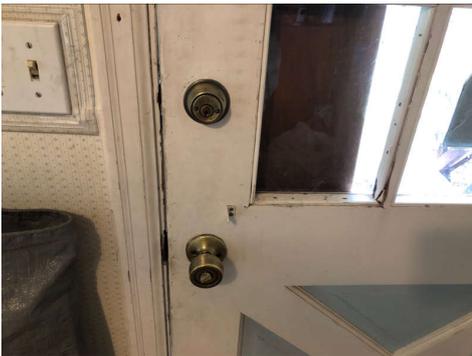
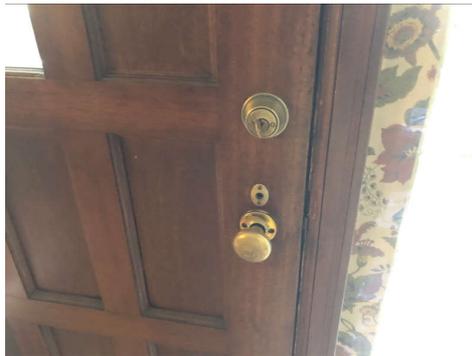
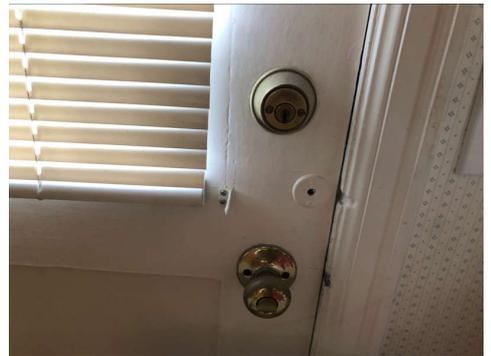
3.10.1 Exterior Doors

**DOUBLE CYLINDAR (2 KEYS)**

Contact a qualified handyman.

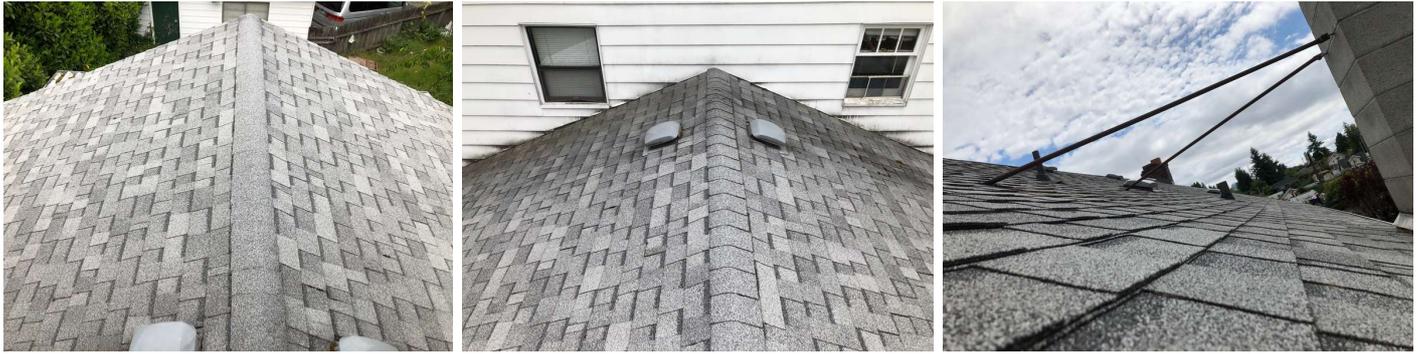
### Composition Shingle Roof Notes: Acceptable

The roof is in generally acceptable condition. Any exceptions will be noted below. NOTE: This is not guarantee against leaks.

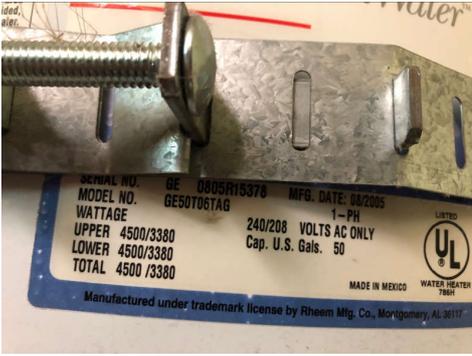
The water heater is nearing the end of its average expected life of 15 years. Replacement may be needed in the near future.

Contact a qualified plumbing contractor.

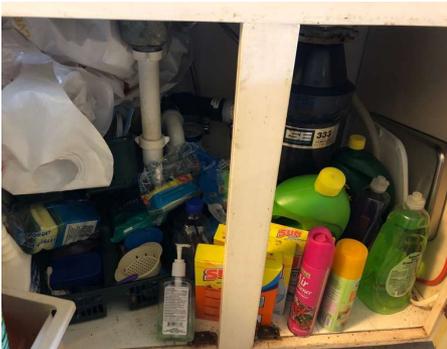
#### Under Sink Photos

The presence of seller's items limited our view of the cabinet and plumbing below the sink.

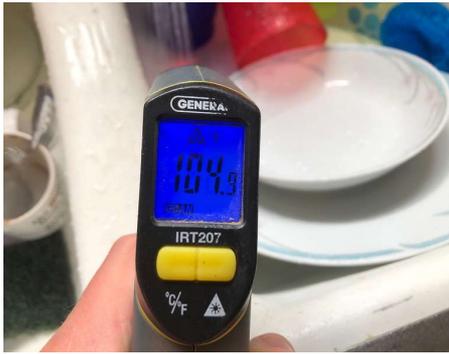
The Water temp at the Kitchen Faucet is Currently noted in the photo below. The U.S. Consumer Product Safety Commission (CPSC) urges all users to keep their water heater temps at 120 degrees Fahrenheit to prevent scalding and bacteria prevention reasons.

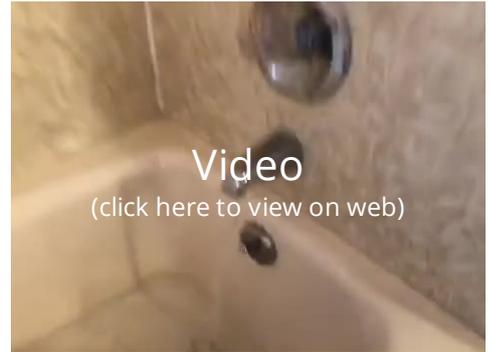
The water pressure was low when turned to the hot side. Recommend further evaluation to determine the cause and repair as needed.

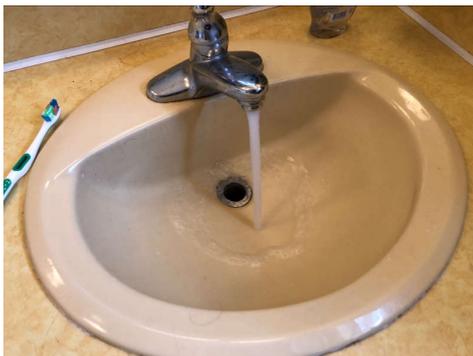
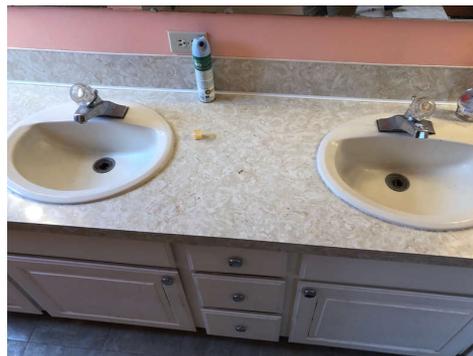
11.1.2 Sink and Faucet

### SINK STOPPER(S) MISSING

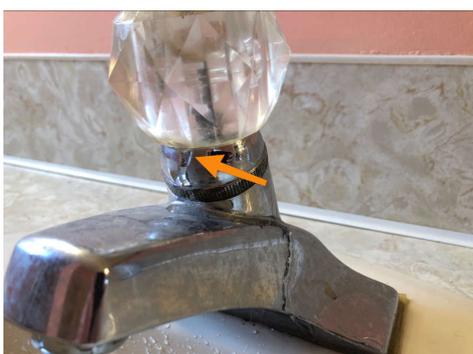
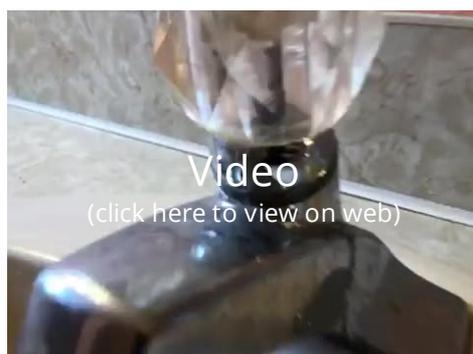
11.1.3 Sink and Faucet

### FAUCET HANDLE LEAK

The faucet handle leaks while in use. Recommend repairs.

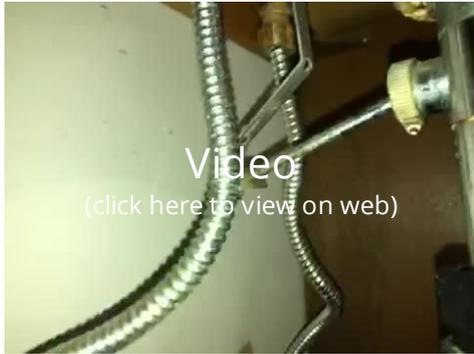
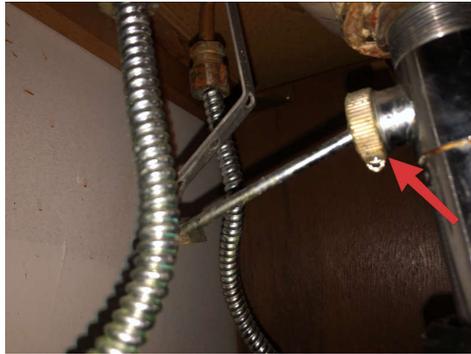
## 11.2.1 Trap and Drain

**LEAK AT DRAIN LINE BELOW THE SINK**

There is a leak at the drain line below the sink which should be repaired as necessary.

Contact a qualified professional.

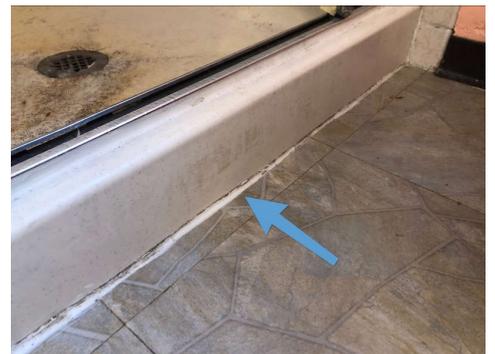
## 11.4.1 Tub-Shower

**MISSING OR DETERIORATED CAULK/GROUT**

The tub surround is has missing or deteriorated caulk/grout. Recommend caulking or sealing to prevent moisture intrusion.

Contact a qualified professional.

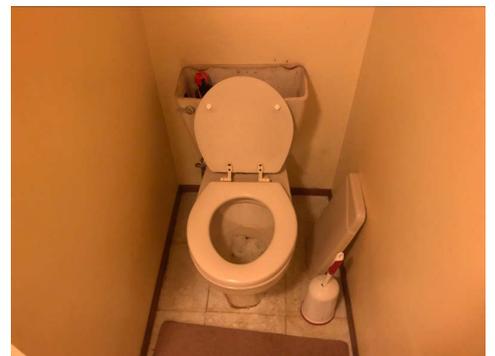
## 11.5.1 Toilet

**TOILET DOES NOT FLUSH**

Contact a qualified professional.

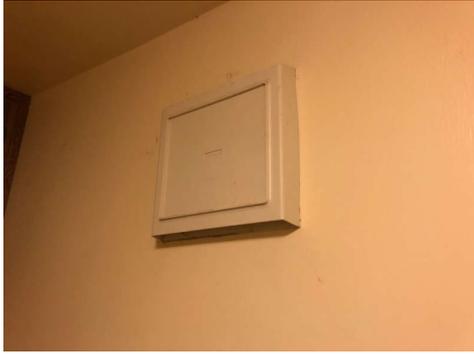
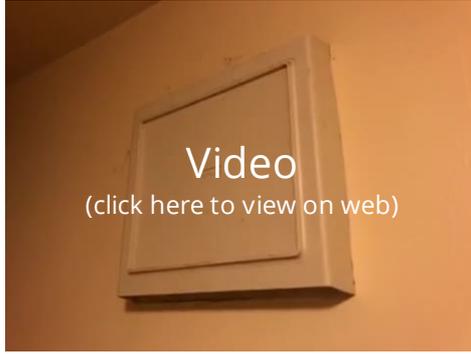
## 11.8.1 Exhaust Fan

**THE EXHAUST FAN IS NOISY**

Contact a qualified handyman.

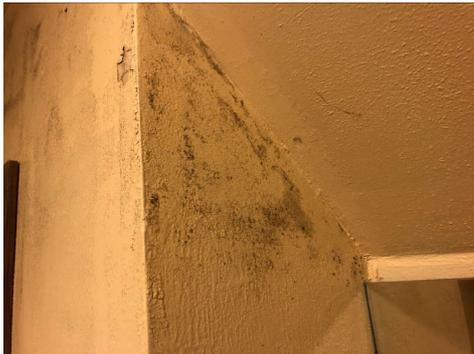
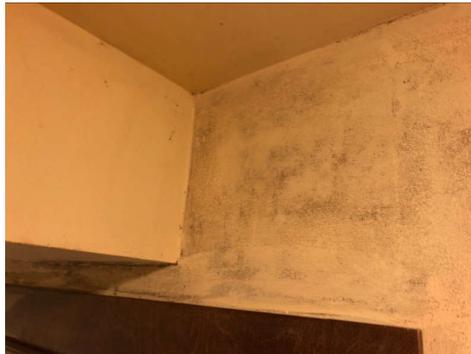
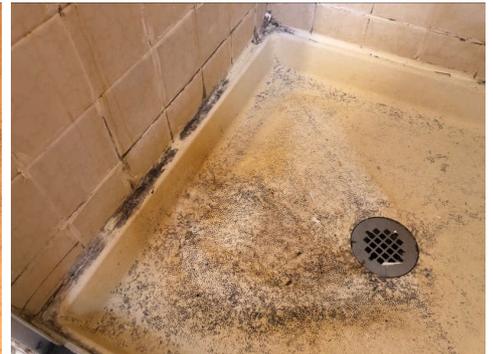
11.11.1 Walls and Ceiling

**BLACK STAINING**

There was black staining on the bathroom walls. Recommend further evaluation and service.

Contact a qualified professional.

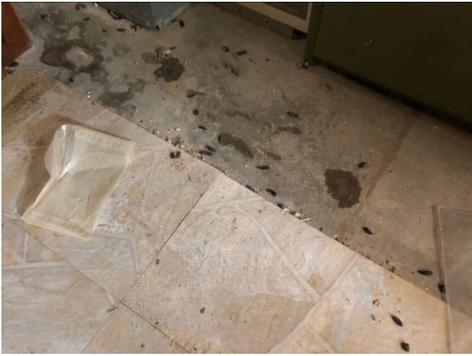
Evidence of rodent activity was observed in the interior of the home. We recommend further investigation and treatment.

Contact a qualified pest control specialist.

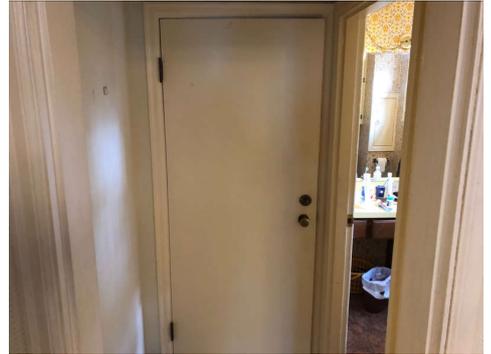
13.2.1 Doors

**DOOR RUBS**

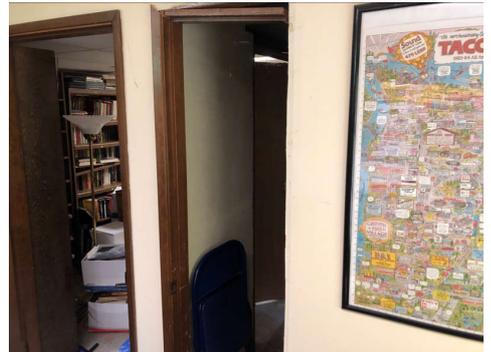
13.2.2 Doors

**DOOR MISSING**

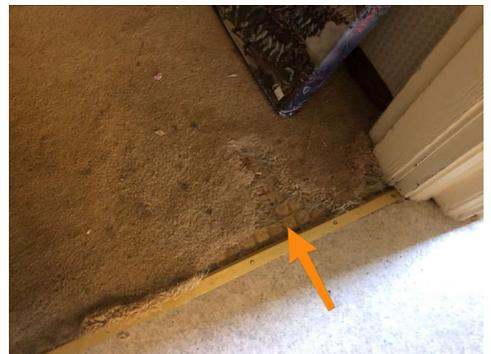
13.3.1 Flooring

**CARPETS WORN OR DETERIORATED**

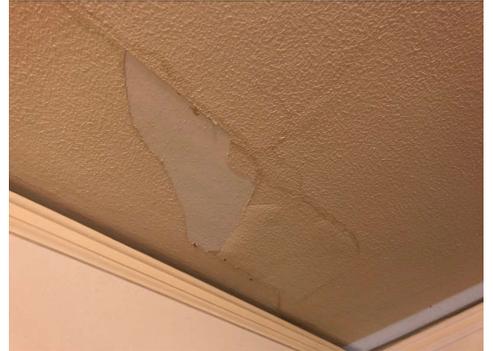
13.4.1 Walls and Ceiling

**NORMAL WEAR AND TEAR**

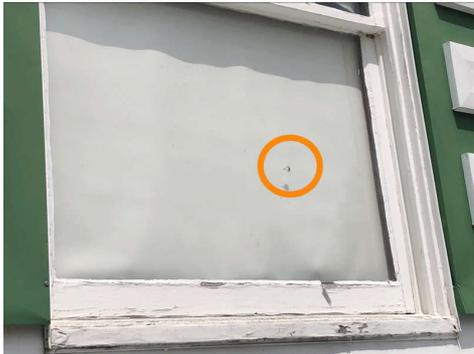
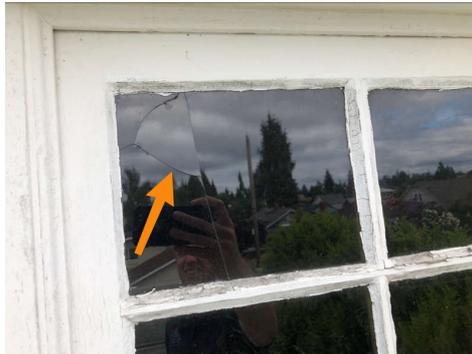
**WINDOW IS CRACKED**

A window is cracked or broken and recommended to be serviced or replaced as necessary by a qualified technician.

Contact a qualified window repair/installation contractor.

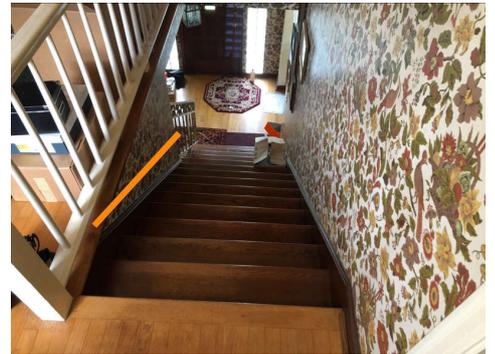
## NO HANDRAIL ON THE STAIRS

There is no handrail on the stairs, which is an essential safety feature that should be added as necessary by a qualified contractor.

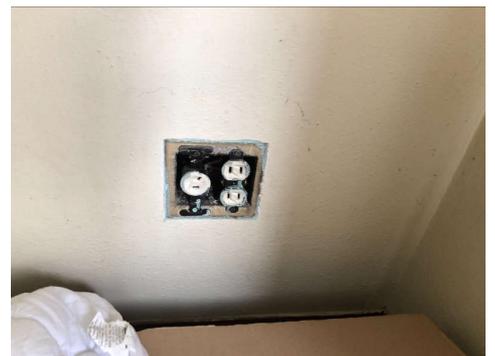
### 13.12.1 Outlets, Electrical

## MISSING COVERS

There were missing covers that should be installed

Contact a qualified handyman.

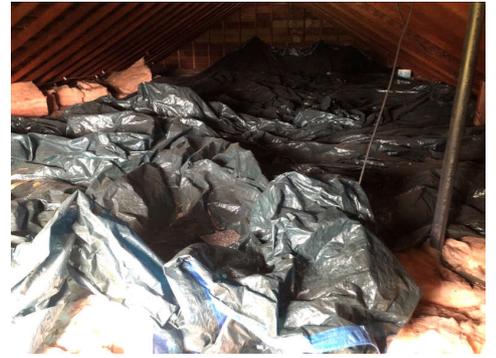
There was a tarp laid out across the attic floor which may indicate a past leak. Recommend further evaluation and more information from sellers.

Contact a qualified professional.

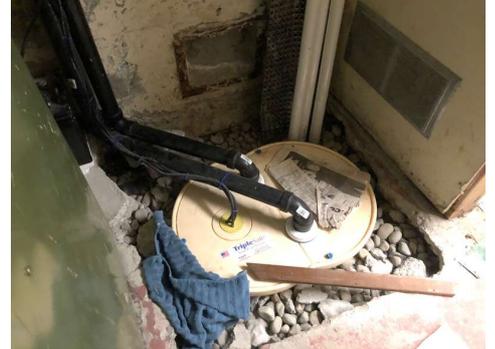
### APPEARED SERVICEABLE

The sump pump controls were not accessible but appeared to be serviceable.

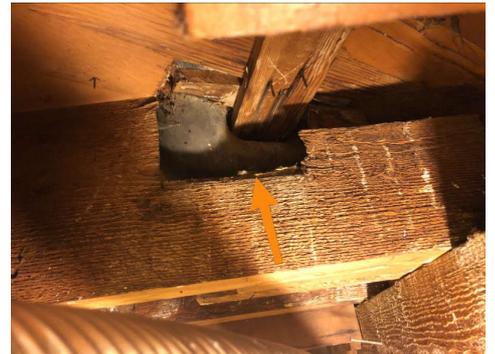
15.2.1 Sub-floor Structure

Structural beam was cut or modified to the point where repair may be needed. Recommend evaluation and repair of this condition.

Contact a qualified professional.
